APPENDIX A2

D-CP1

D-CP5

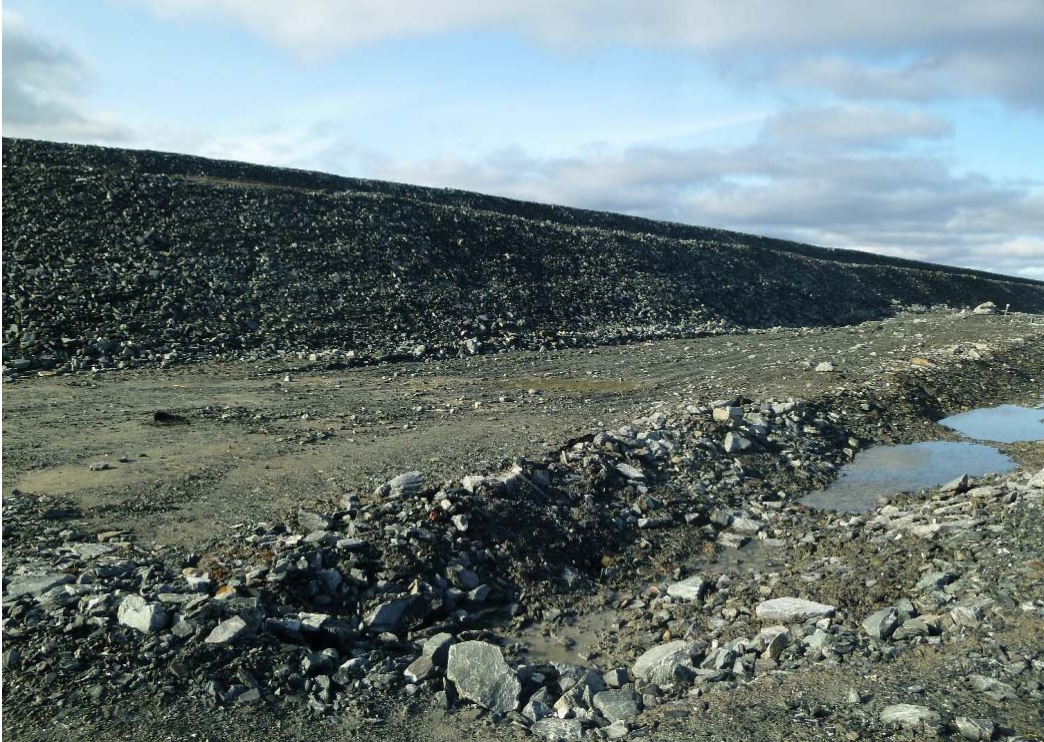
Photograph 18: D-CP1, Downstream Slope near Station 1+220, and Looking Northwest (19 September 2017)

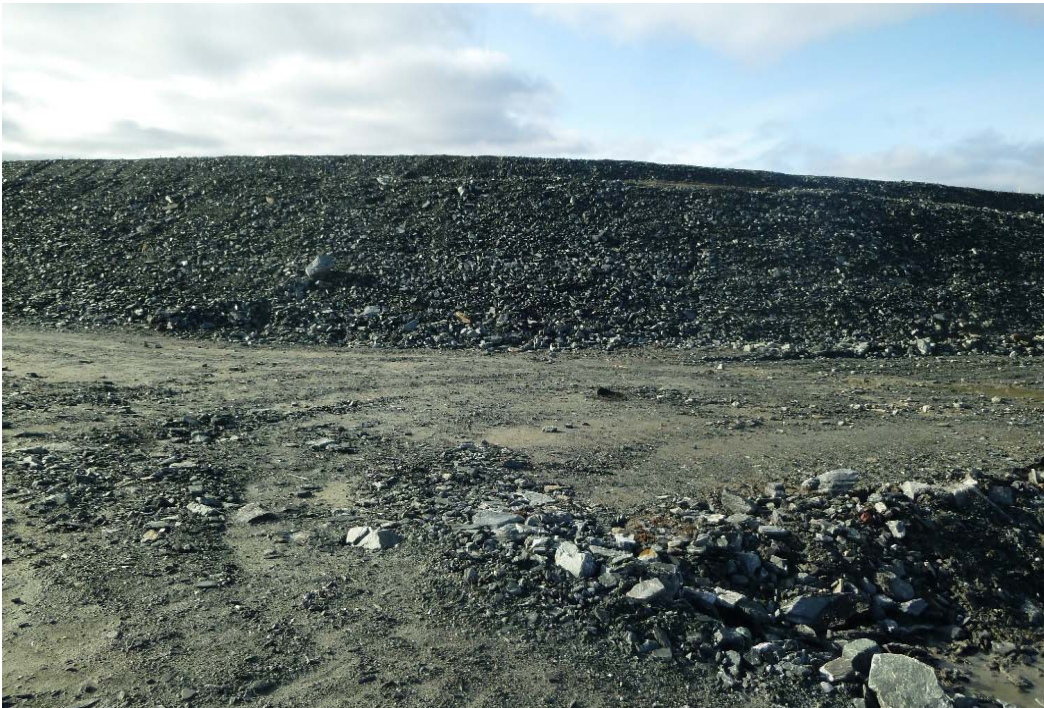
Photograph 19: D-CP1, Downstream Slope at Corner of Dike near Station 1+210, and Looking Northwest (19 September 2017)

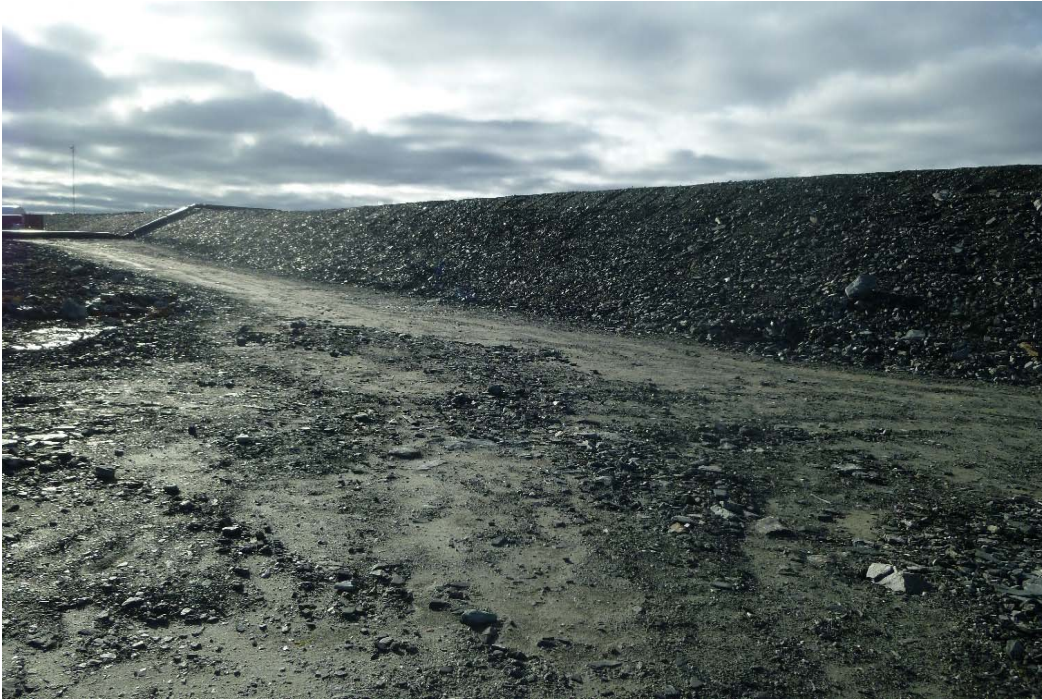
Photograph 20: D-CP1, Downstream Slope of Dike from Corner of Dike near Station 1+210 to South Abutment, Looking South (19 September 2017)

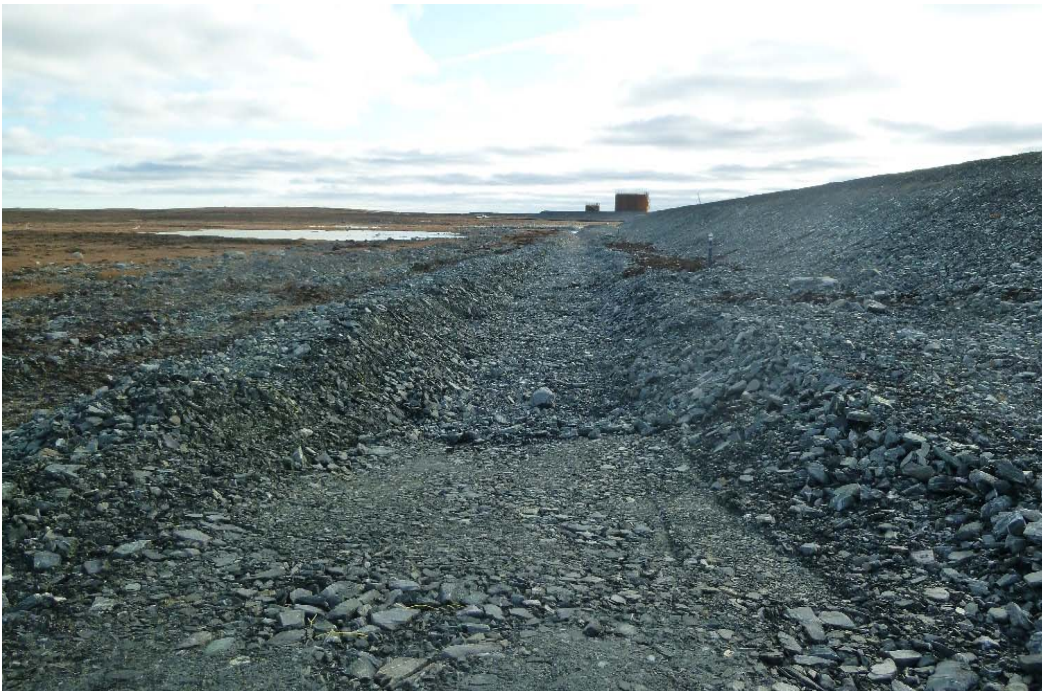
Photograph 21: D-CP1, Downstream Seepage Collection Channel from North End near Station 1+510, Looking South (19 September 2017)

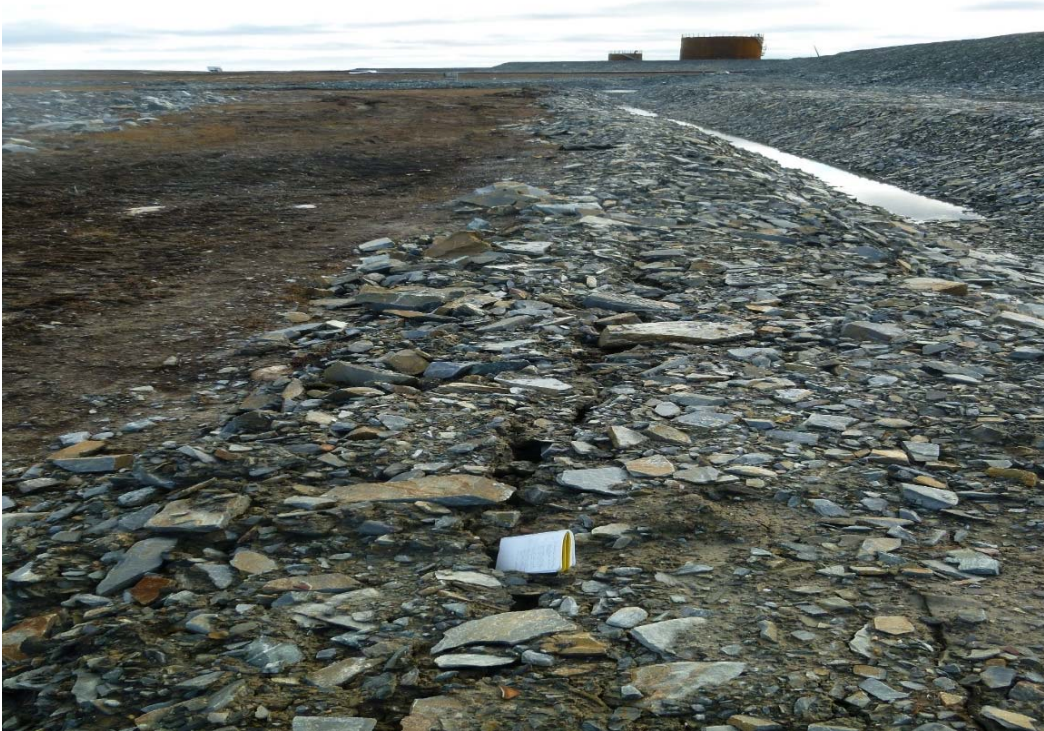
Photograph 22: D-CP1, Cracking Downstream of the Seepage Collection Channel near Station 1+330, Looking South (19 September 2017)

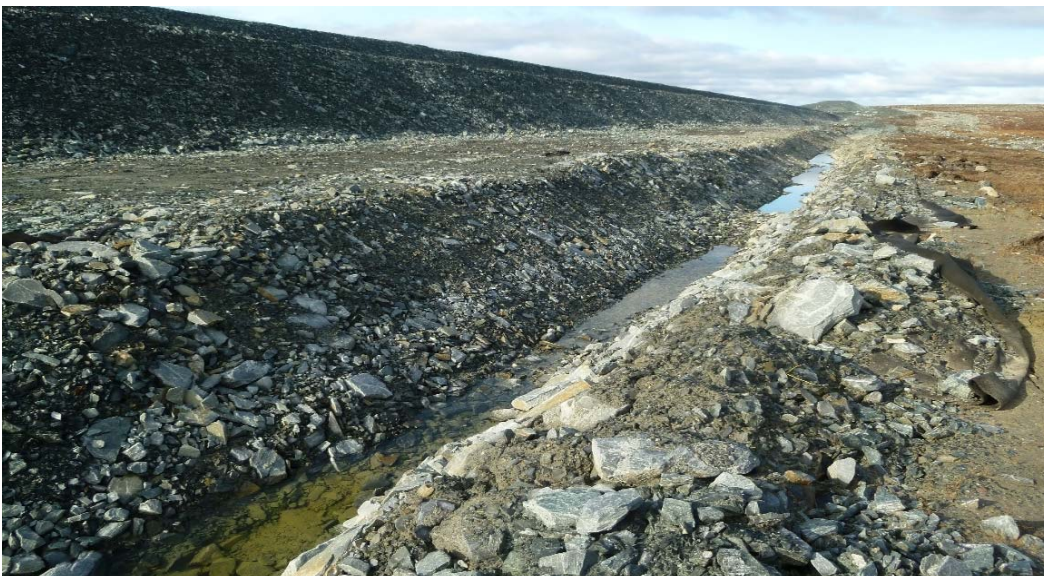
Photograph 23: D-CP1, Downstream Seepage Collection Channel near Station 1+285, and Looking North (19 September 2017)

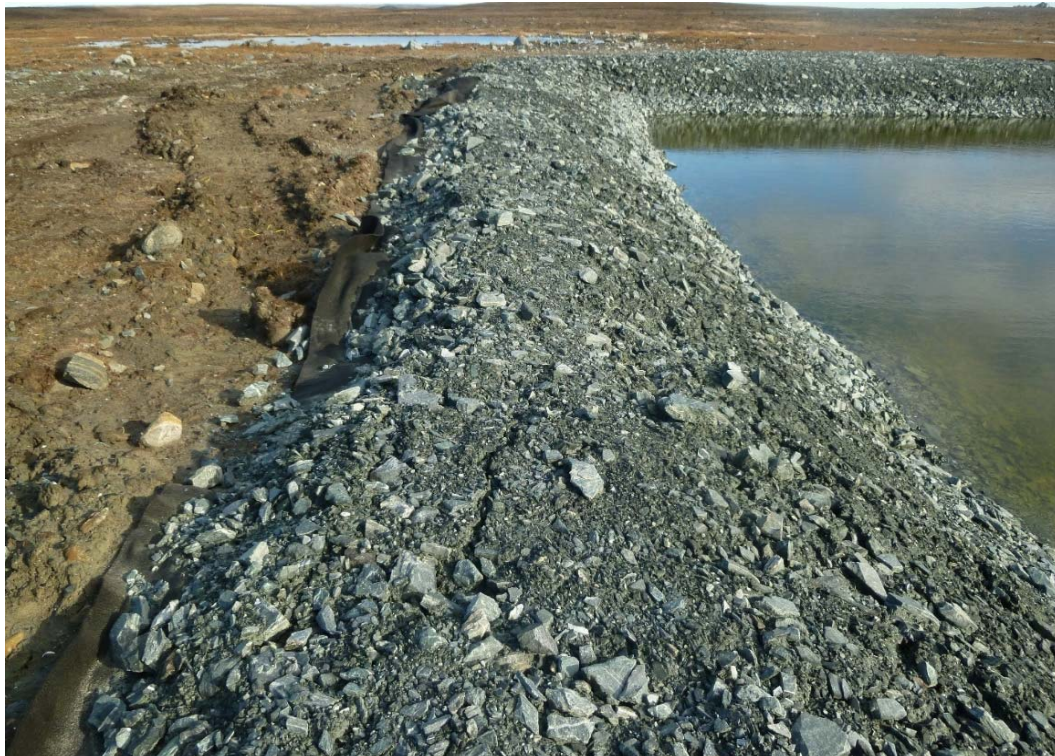
Photograph 24: D-CP1, North Side of Downstream Pond, and Some Cracking/slumping, Looking East (19 September 2017)

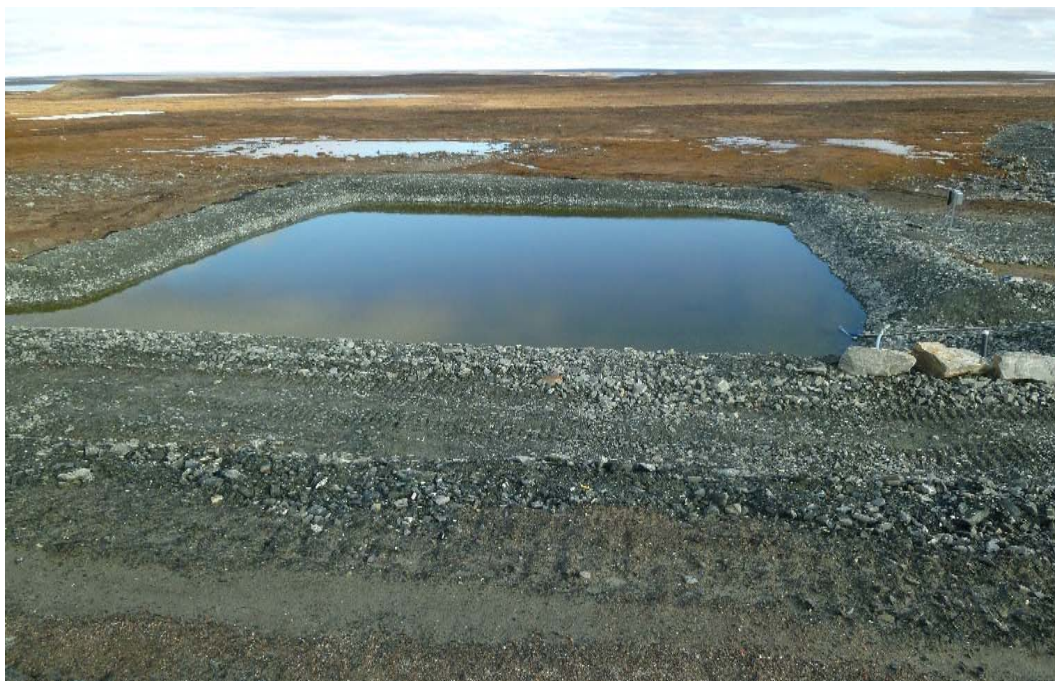
Photograph 25: D-CP1, Downstream Sump, Looking East (19 September 2017)

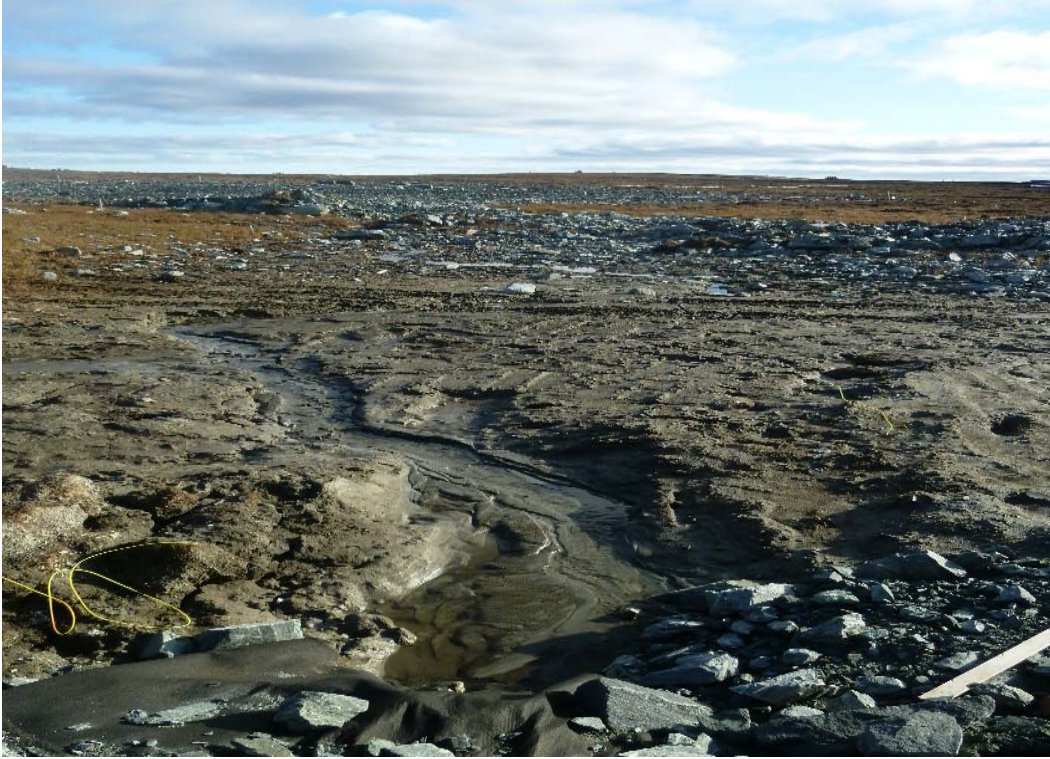
Photograph 26: D-CP1, Water Flowing Towards Southeast Corner of Pond, Looking Southeast (19 September 2017)

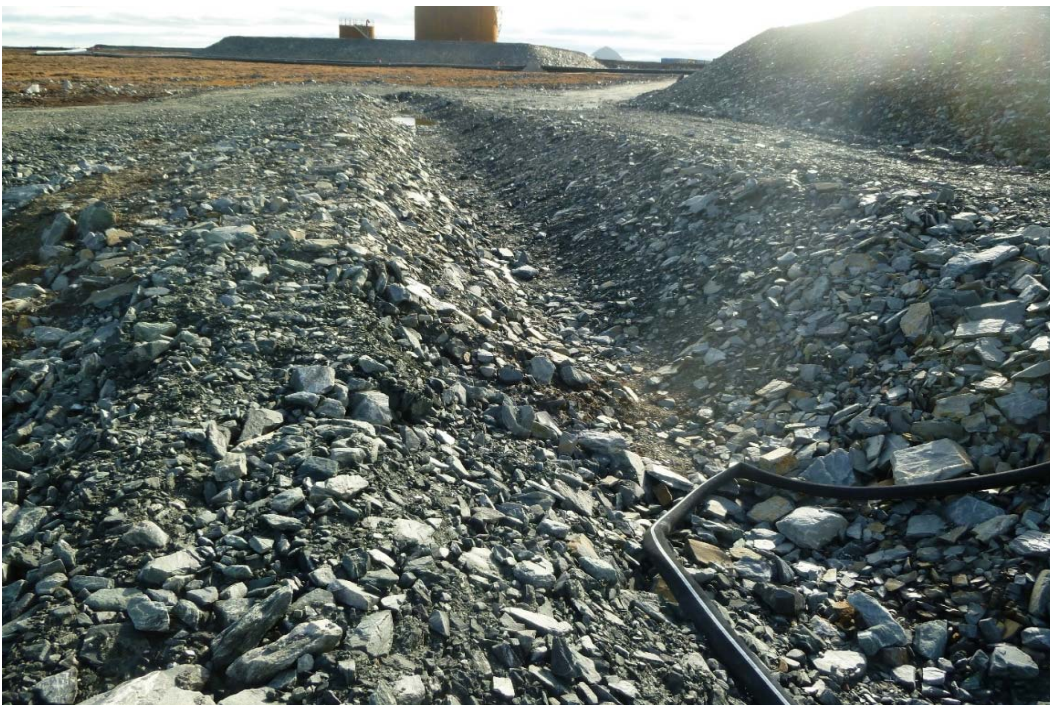
Photograph 27: D-CP1, Downstream Channel, Looking South from Sump (19 September 2017)

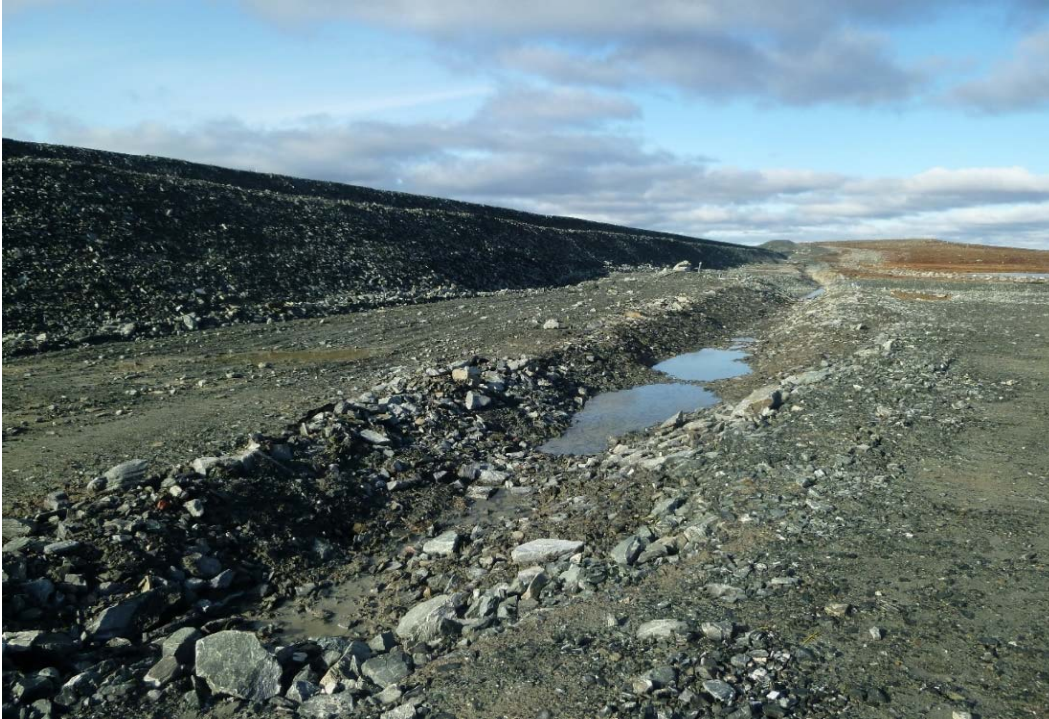
Photograph 28: D-CP1, Overview of Channel and Downstream Slope of Dike near Station 1+210, Looking North (19 September 2017)

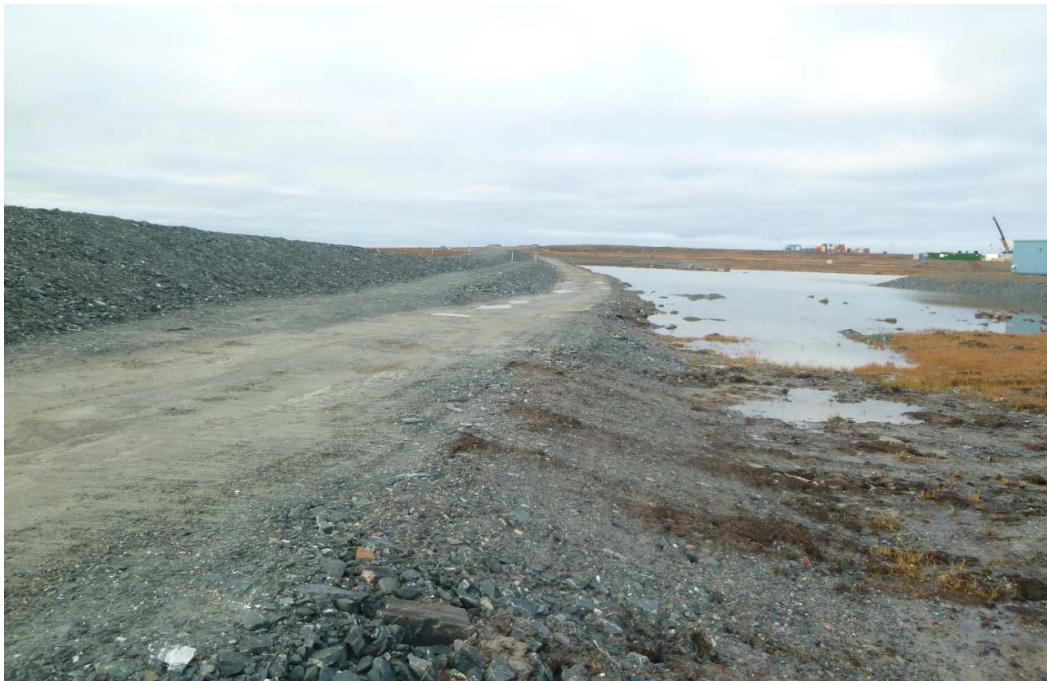
Photograph 30: D-CP5, Overview of Northeast End of Upstream Dike Toe near Station 1+300, and Looking Southwest (19 September 2017)

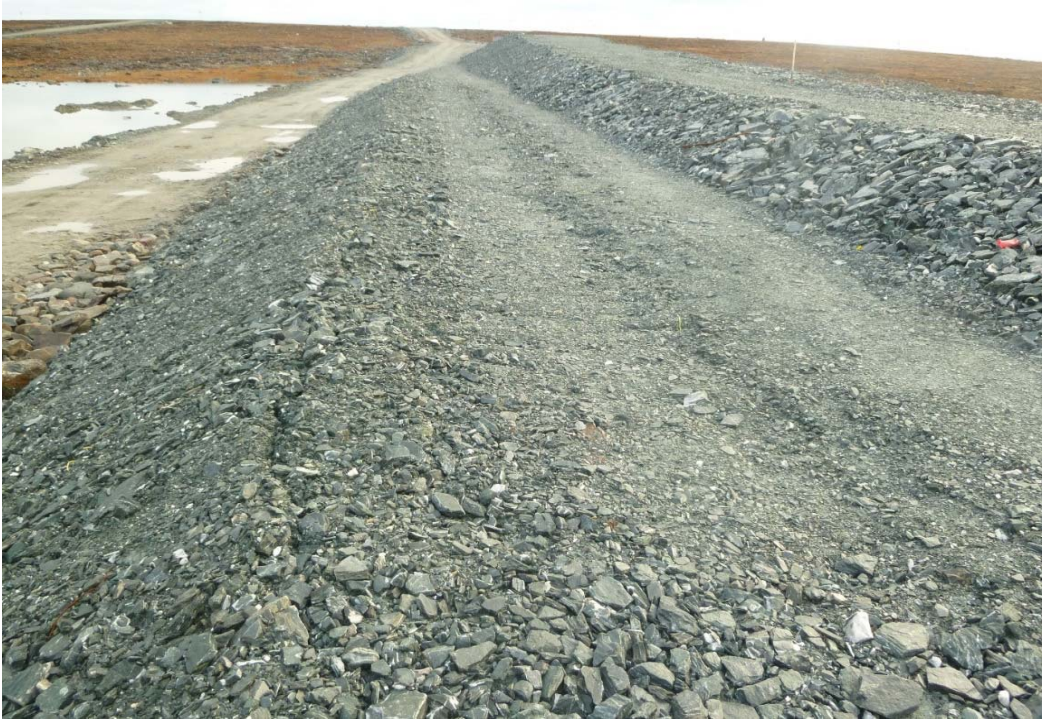
Photograph 31: D-CP5, Minor Settlement and Cracking on Upstream Crest and Slope, near Station 1+210 (19 September 2017)

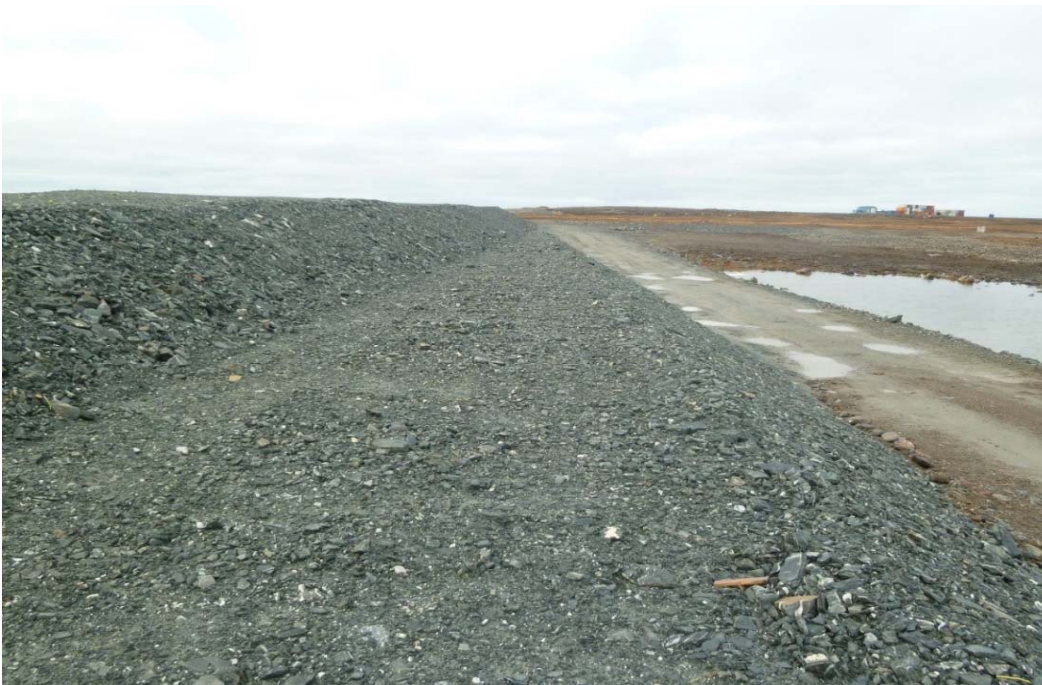
Photograph 32: DPC-5, Upstream Crest near Station 1+150, and Looking Southwest (19 September 2017)

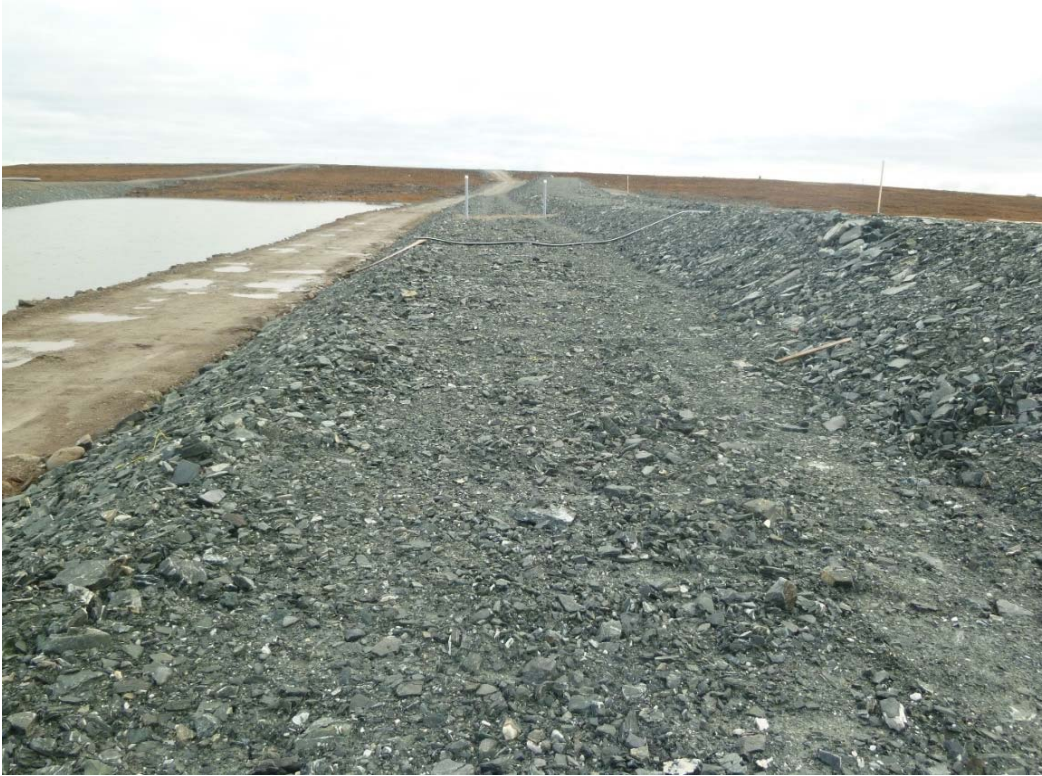
Photograph 33: DPC-5, Upstream Crest near Station 1+150, and Looking Northeast (19 September 2017)

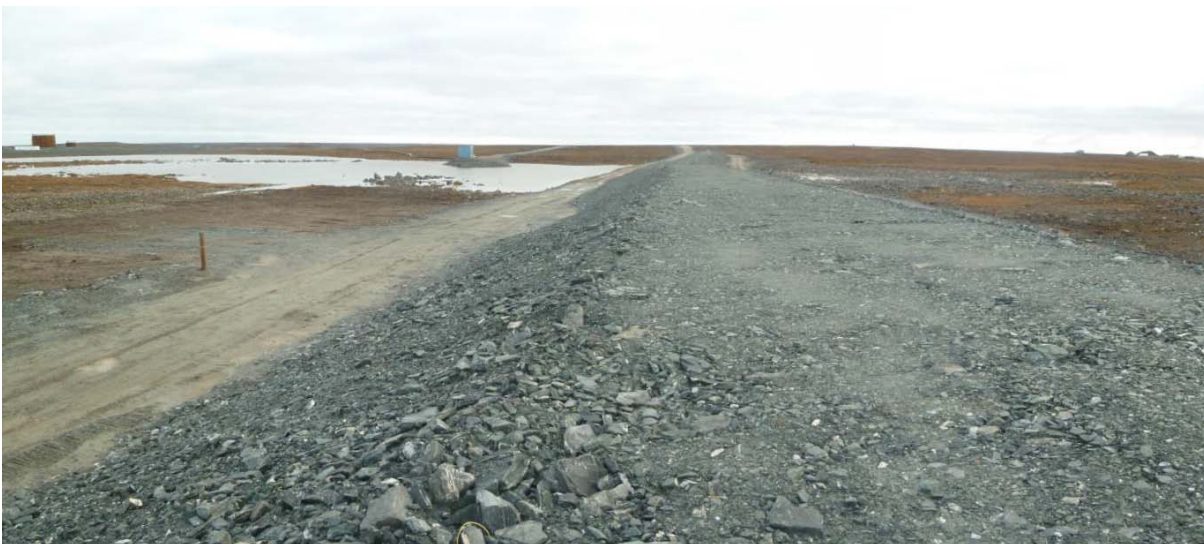
Photograph 34: D-CP5, Crest at Southwest Abutment near Station 1+025, and Looking Northeast (19 September 2017)

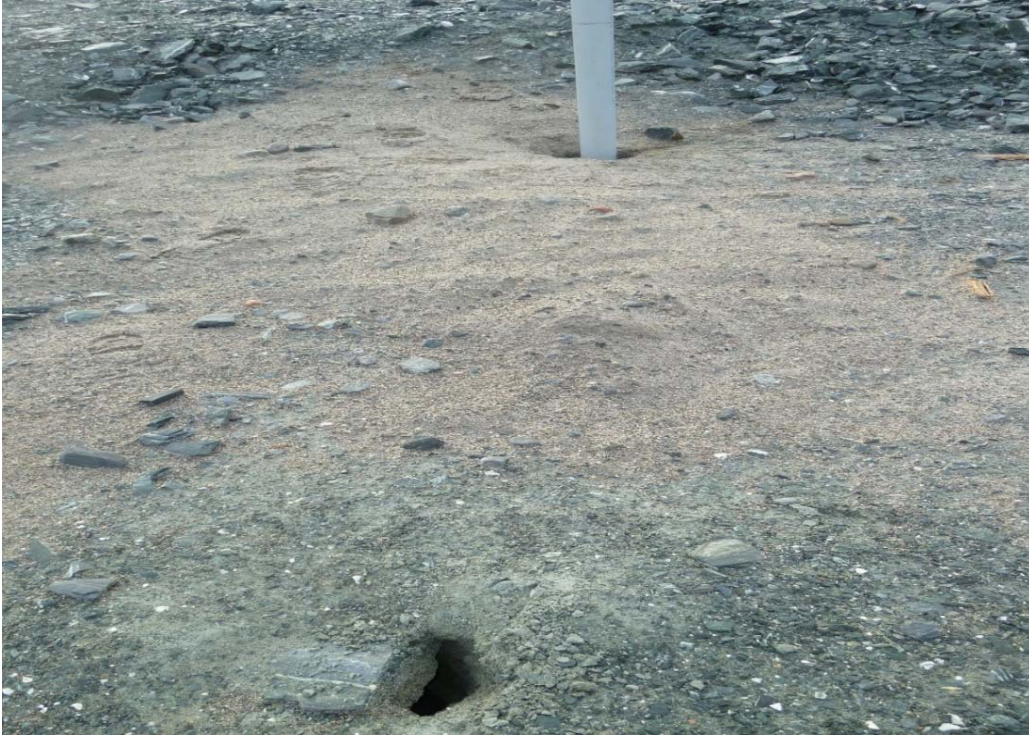
Photograph 35: D-CP5, Small Hole in Upstream Crest near Station 1+185. Vertical Temperature Cable (VGTC-2) in Background (19 September 2017)

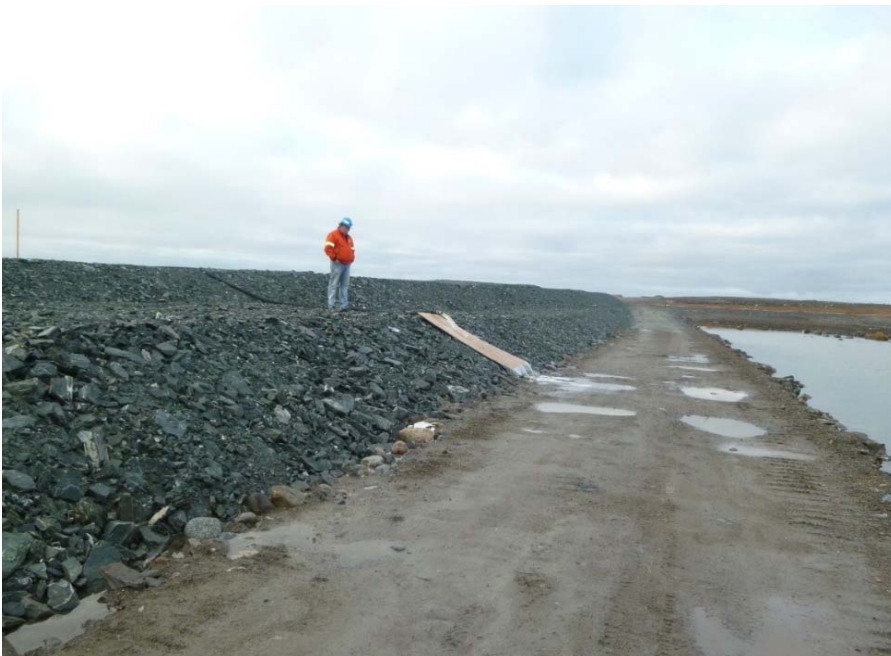
Photograph 36: D-CP5, Pump Back Discharge on Upstream Slope (prior to being extended) near Station 1+170 (19 September 2017)

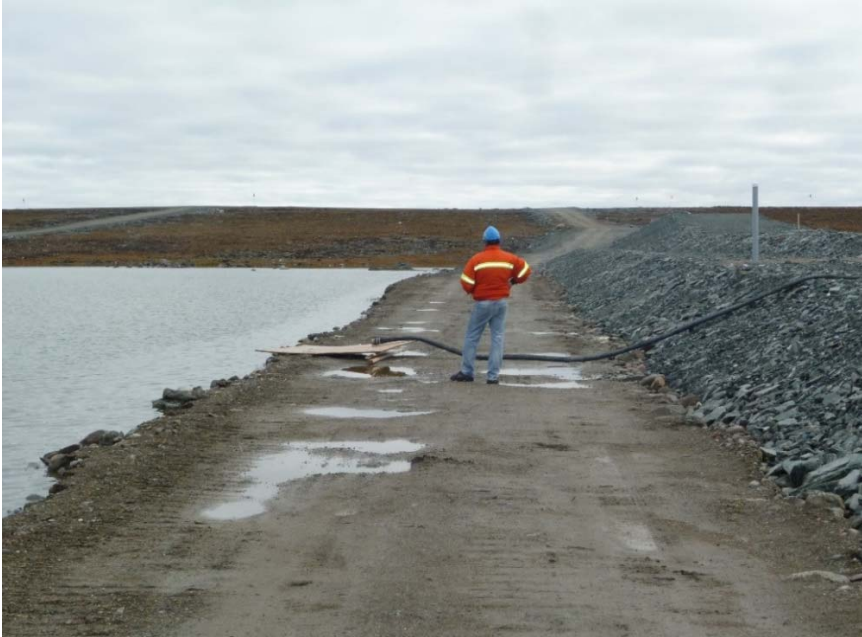
Photograph 37: D-CP5, Pump Back Discharge on Upstream Slope (after being extended) near Station 1+170 (19 September 2017)

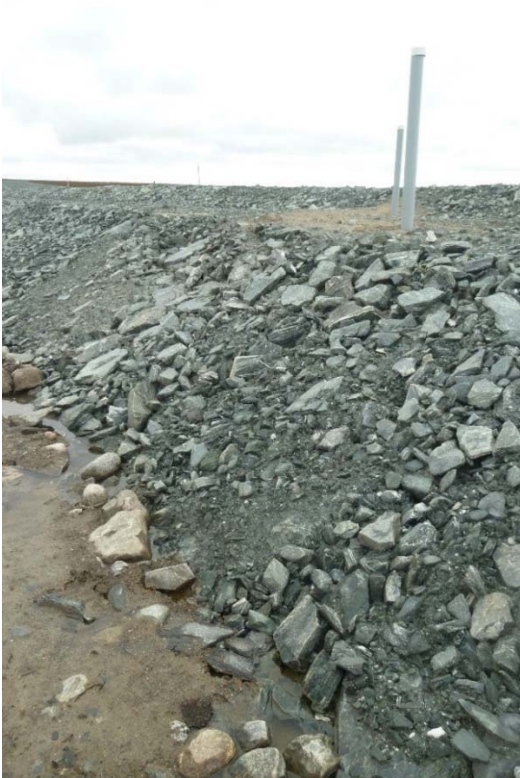
Photograph 38: D-CP5, Ponded Water at Upstream Toe of Dike near Station 1+185. Vertical Temperature Cables (VGTC-1 and 2) in Background (19 September 2017)

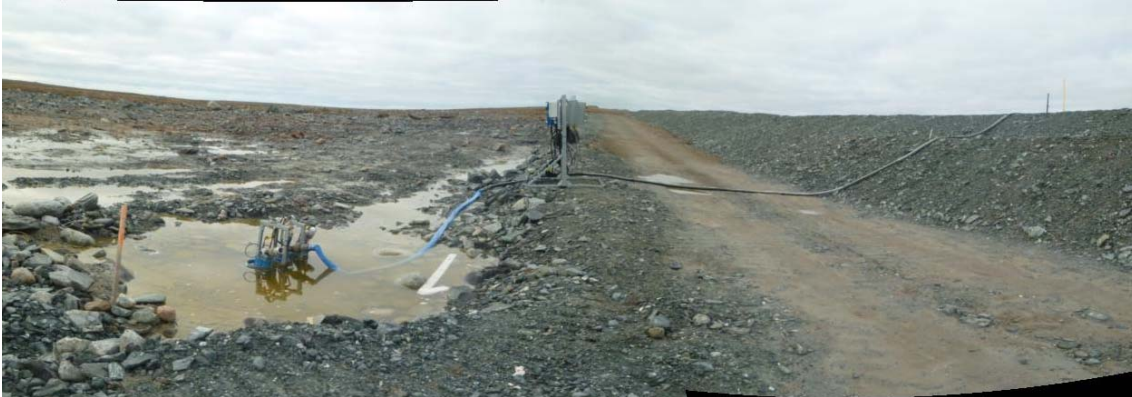
Photograph 39: D-CP5 Downstream Sump and Pump Back Line near Station 1+170, Looking Southwest (19 September 2017)

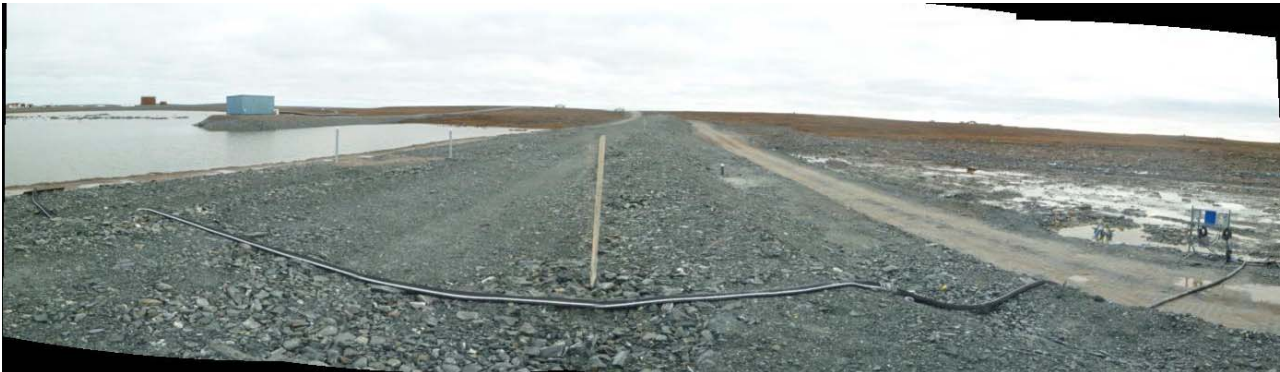
Photograph 40: D-CP5, Dam Crest, Downstream Sump, and Pump Back Line near Station 1+170, Looking Northeast (19 September 2017)

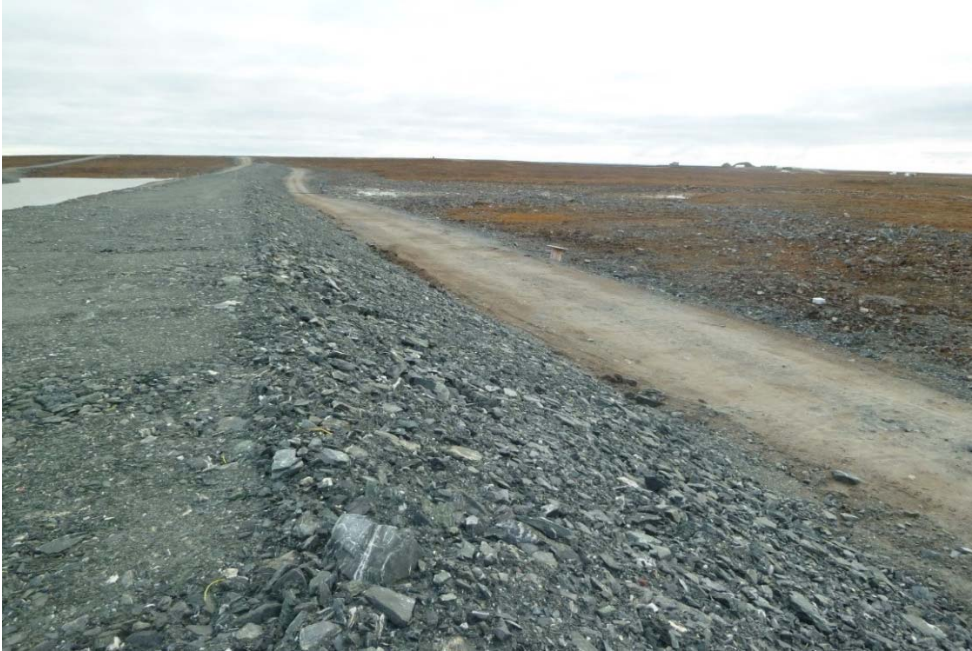
Photograph 41: D-CP5, Dike Crest and Downstream Slope near Station 1+030, Downstream Face and Crest (19 September 2017)

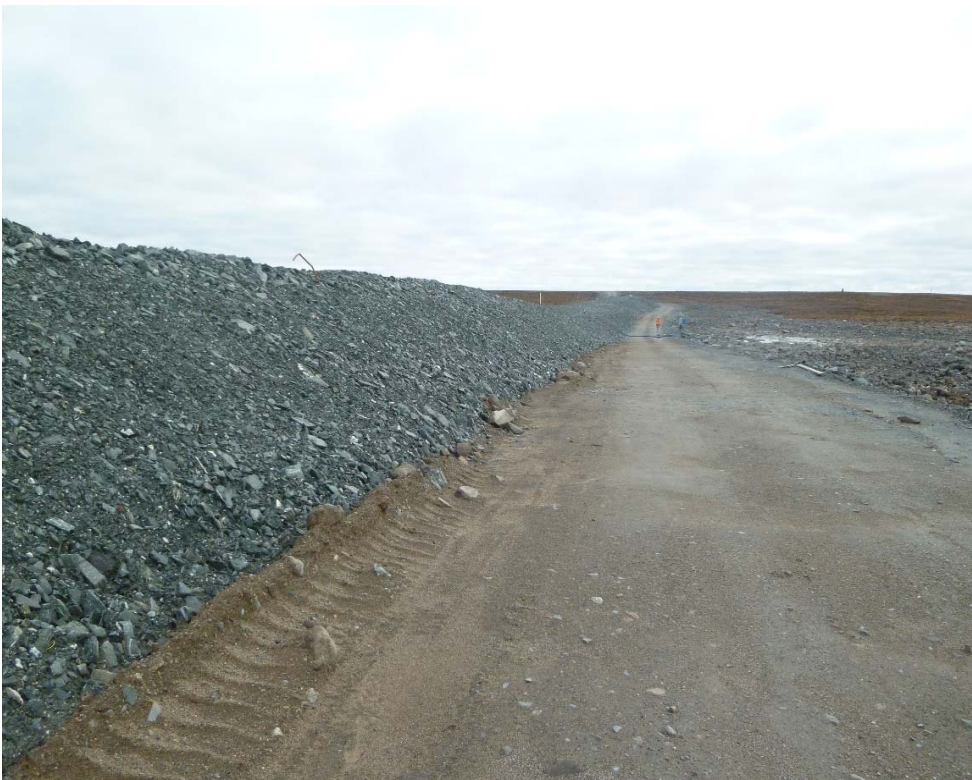
Photograph 42: D-CP5, Downstream Slope near Station 1+050, and Looking Southwest (19 September 2017)

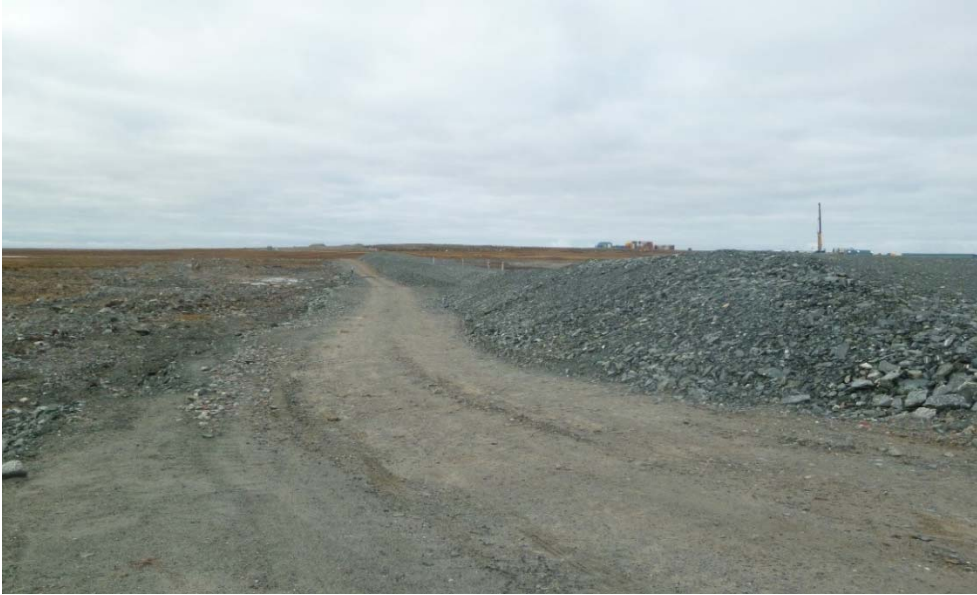
Photograph 43: D-CP5, Overview of Downstream Slope from Northeast Abutment, Looking Southwest (19 September 2017)

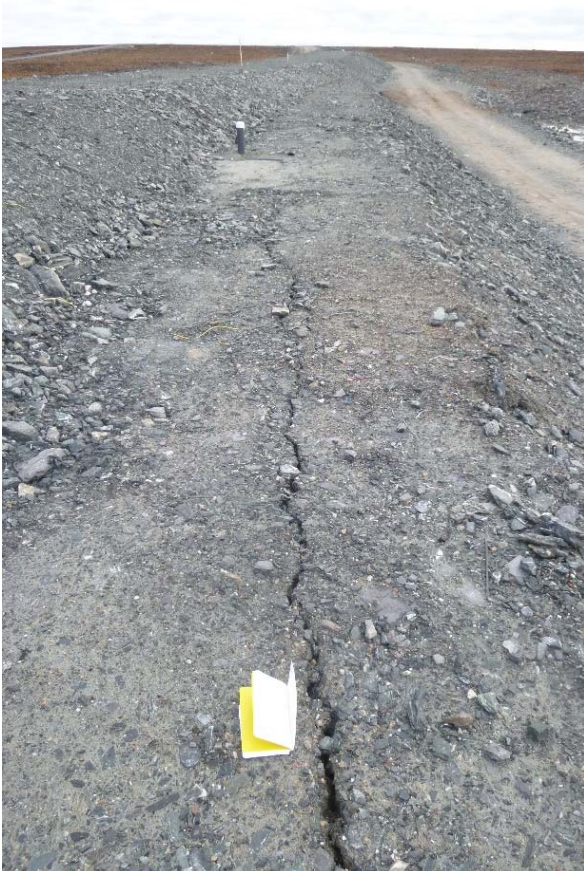
Photograph 44: D-CP5, Cracking on Downstream Berm Crest near 1+ 175, Looking Northeast (19 September 2017)

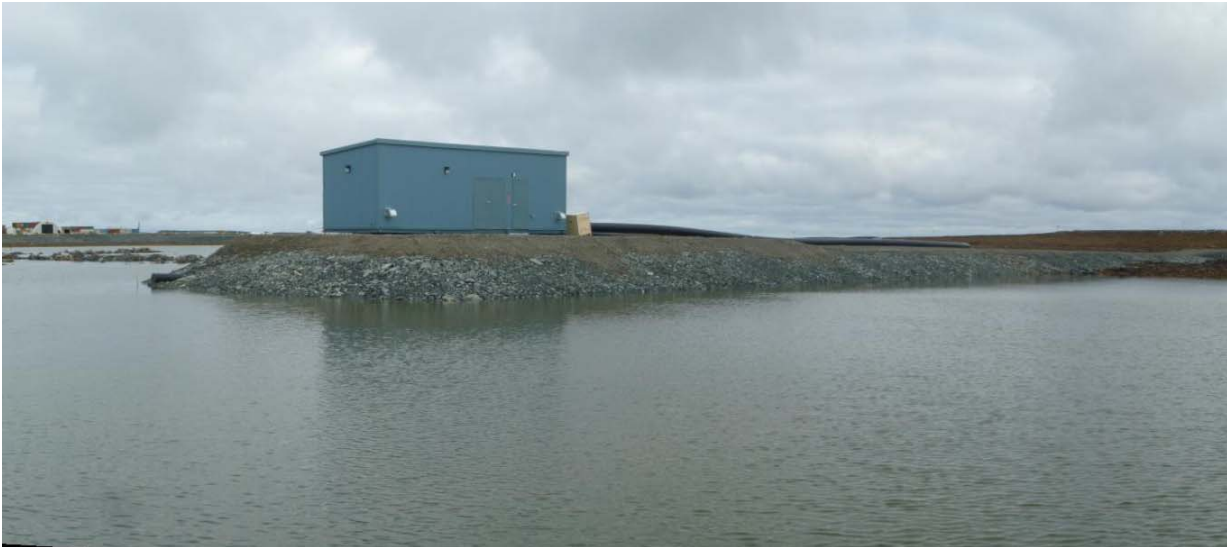
Photograph 45: D-CP5, Jetty 5 and Pumping Station, Looking Northeast (19 September 2017)

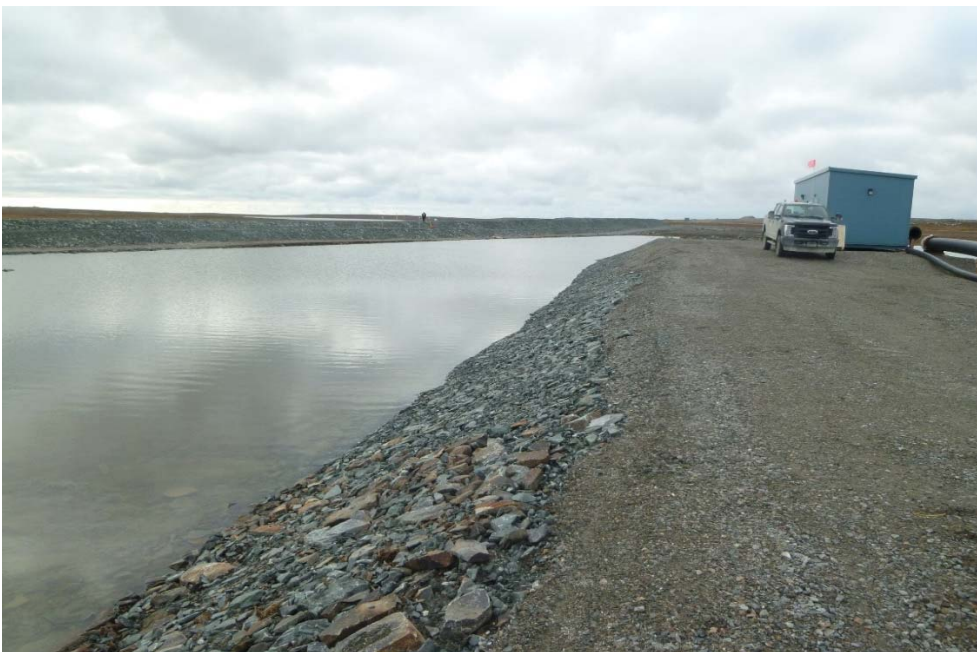
Photograph 46: D-CP5, Jetty 5 and Pumping Station. South Slope of Jetty, Looking West (19 September 2017)

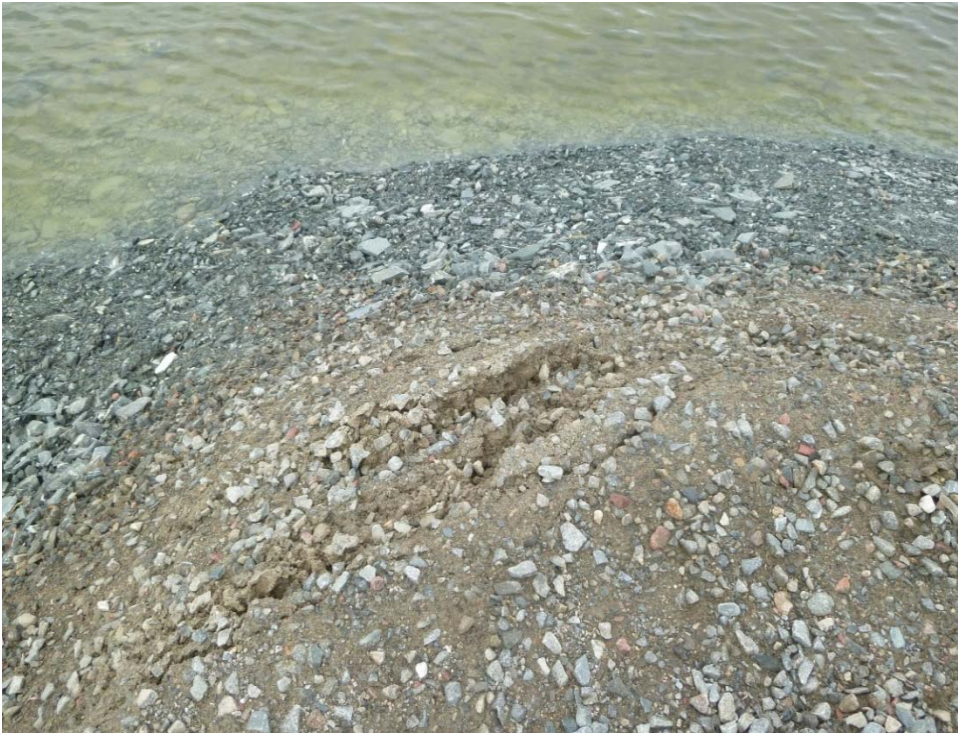
Photograph 47: D-CP5, Jetty 5, Cracking and Settlement of the Southwest Toe of the Jetty (19 September 2017)

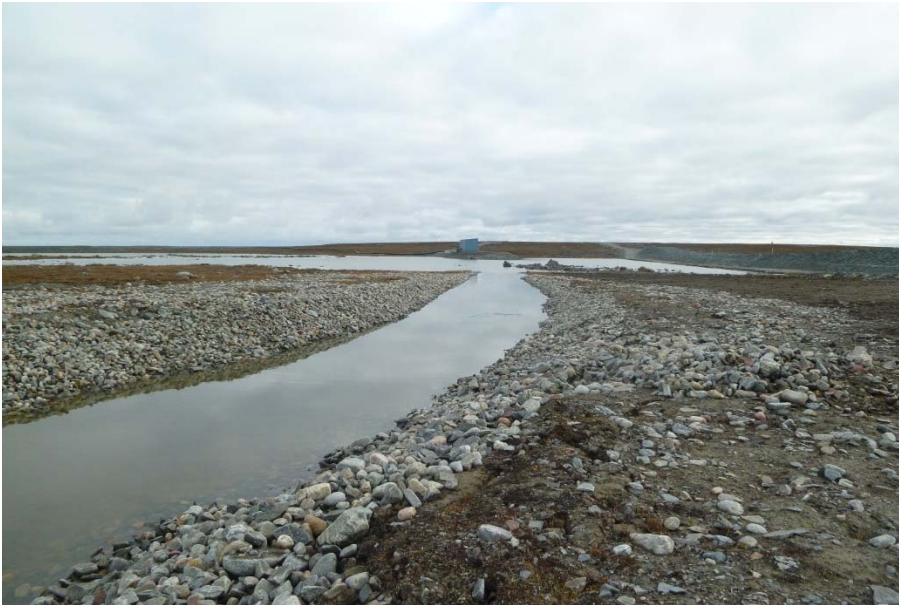
Photograph 48: Channel 5, Looking Northeast from near Station 0+250 (19 September 2017)

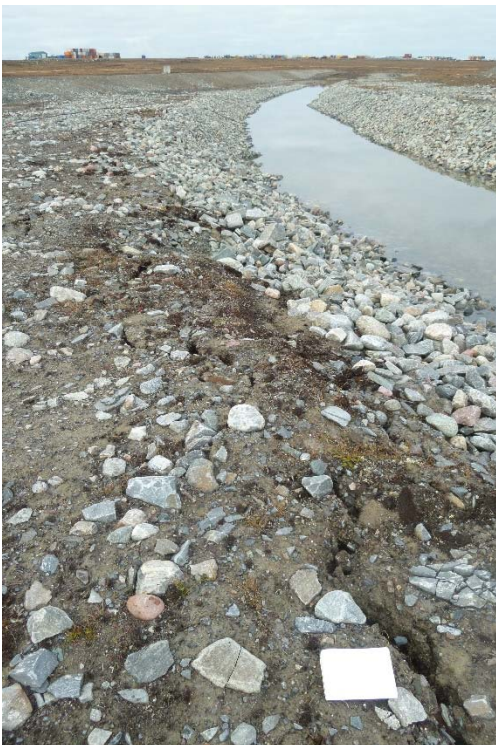
Photograph 49: Channel 5, Looking West from near Station 0+250. Some Cracking Adjacent to Channel (19 September 2017)

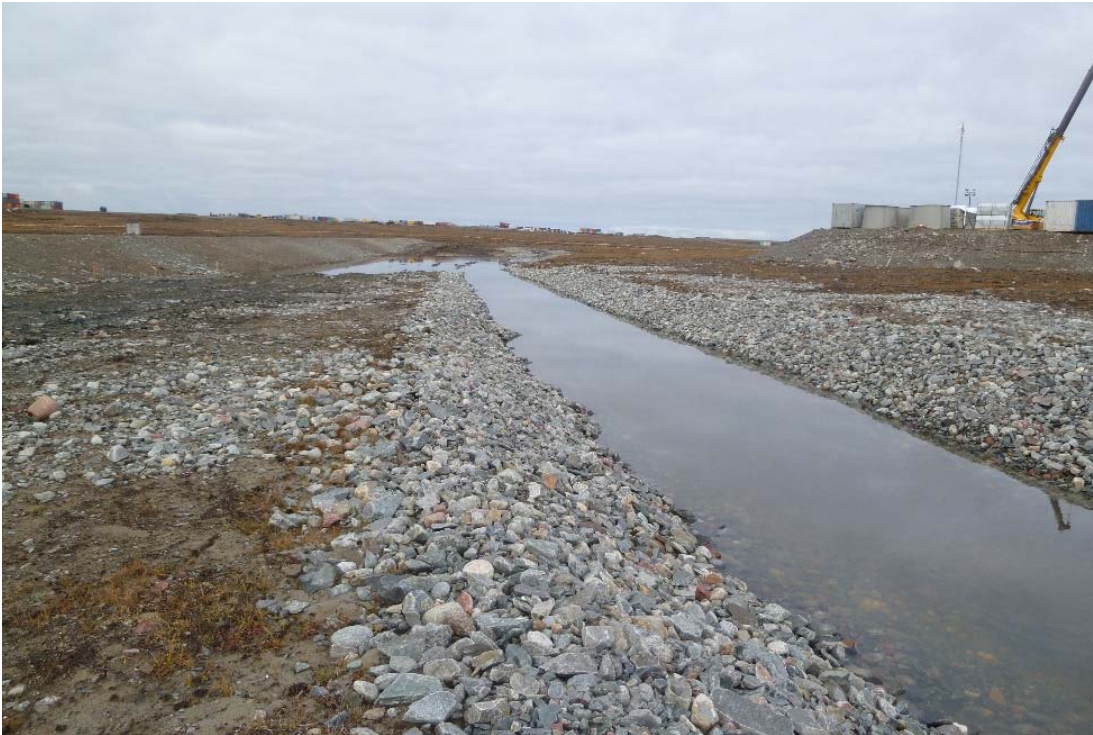
Photograph 50: Channel 5, Looking West near Station 0+210 (19 September 2017)

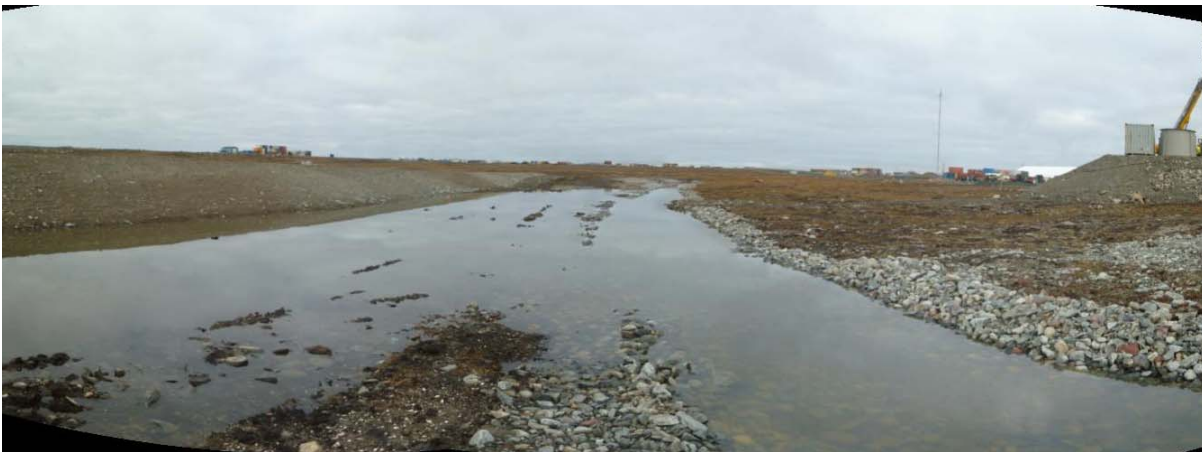
Photograph 51: Channel 5, Looking West near Station 0+145. Water has Overflowed Channel 5 and is Ponding against Berm 3 (19 September 2017)
