APPENDIX A2

D-CP1

D-CP5

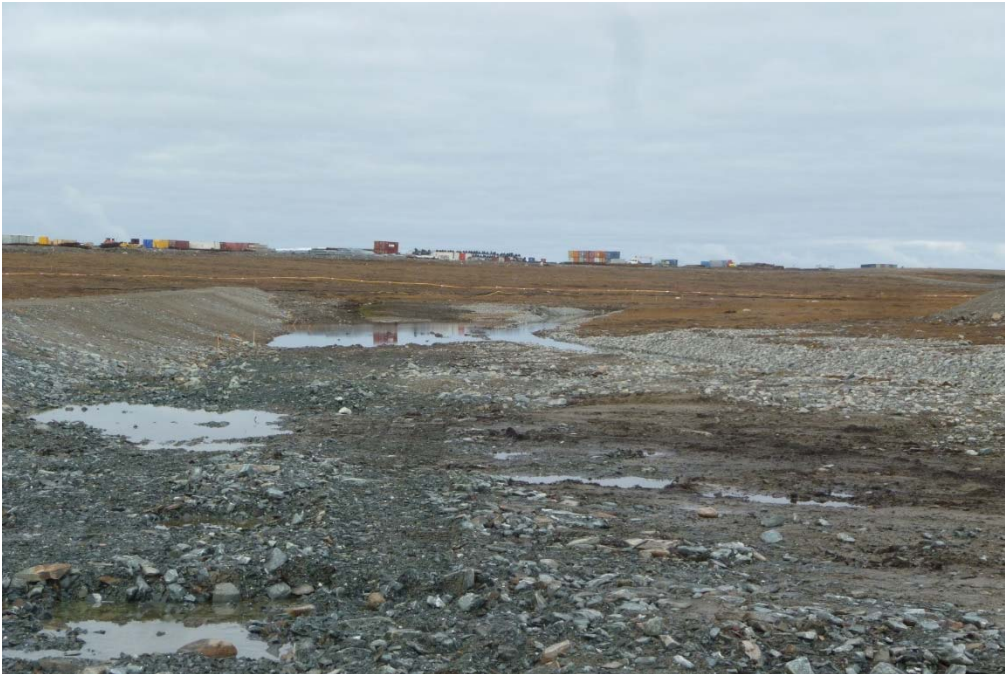
Photograph 52: View of Upstream Slope of Berm 3 and Channel 5, Looking Northwest (19 September 2017)

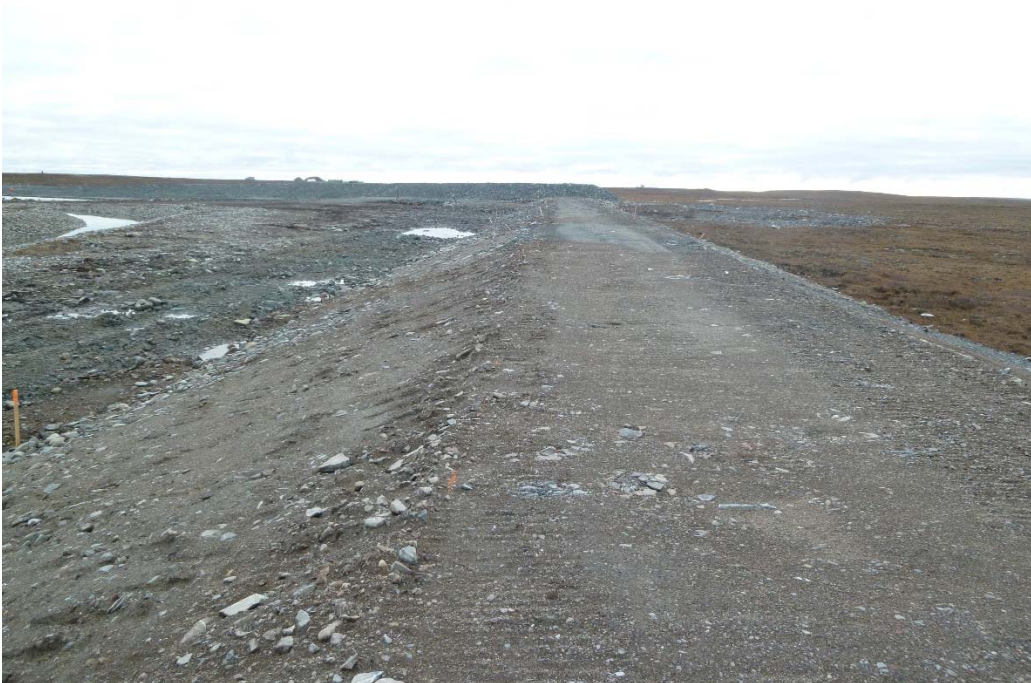
Photograph 53: Berm 3, Upstream Slope and Crest near Station 0+230, Looking Southeast. D-CP5 in Background and Channel 5 at Far Left (19 September 2017)

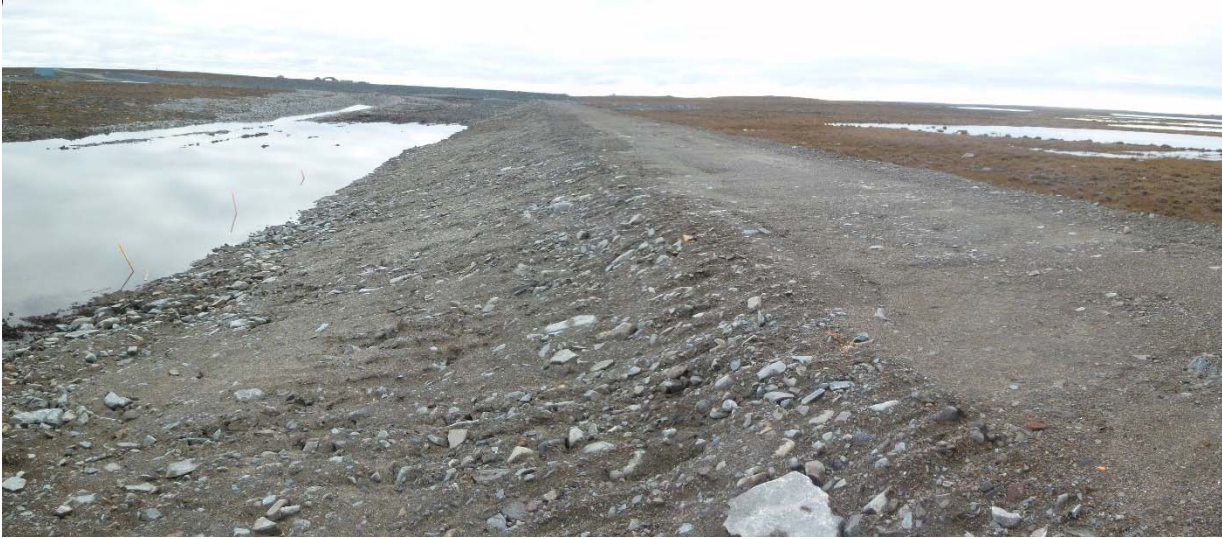
Photograph 54: Berm 3, Upstream Slope and Crest with Water Ponded on Upstream near Station 0+140, Looking Southeast (19 September 2017)

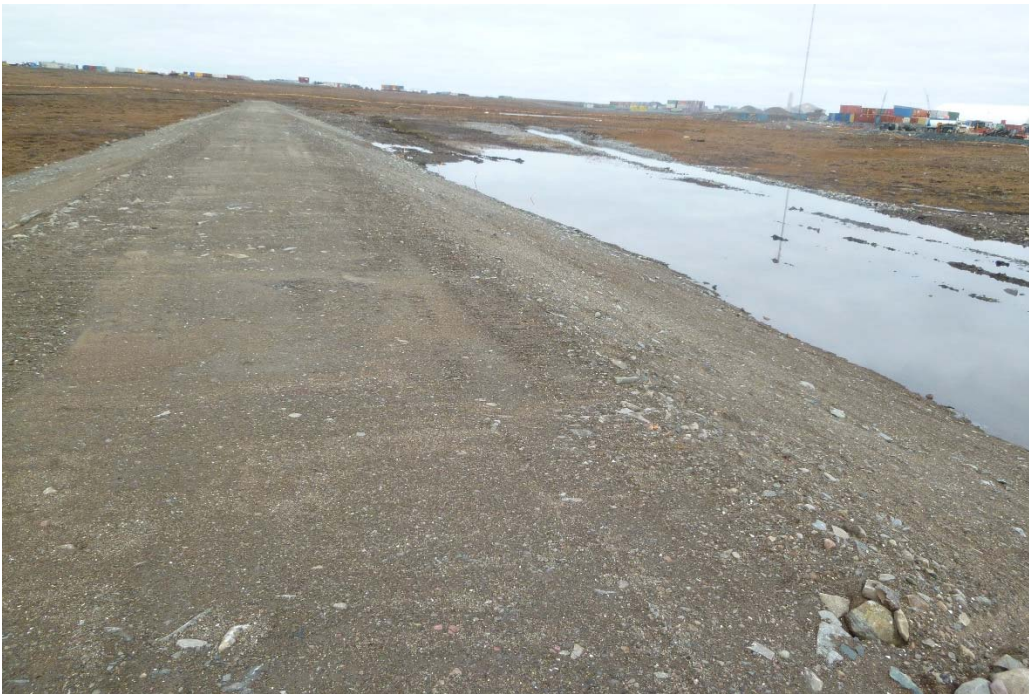
Photograph 55: Berm 3, Upstream Slope and Crest with Water Ponded on Upstream near Station 0+180, Looking Northwest (19 September 2017)

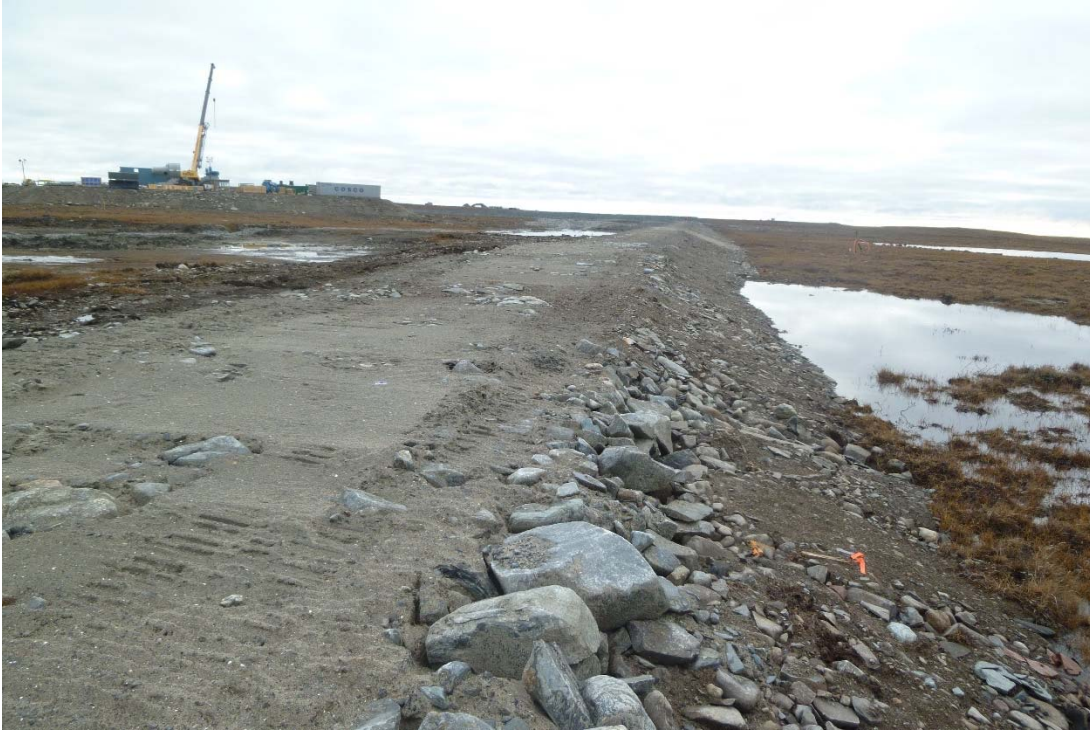
Photograph 56: Berm 3, Downstream Slope and Crest, Small Pond of Water against Downstream Toe near Northwest Abutment, Looking Southeast (19 September 2017)

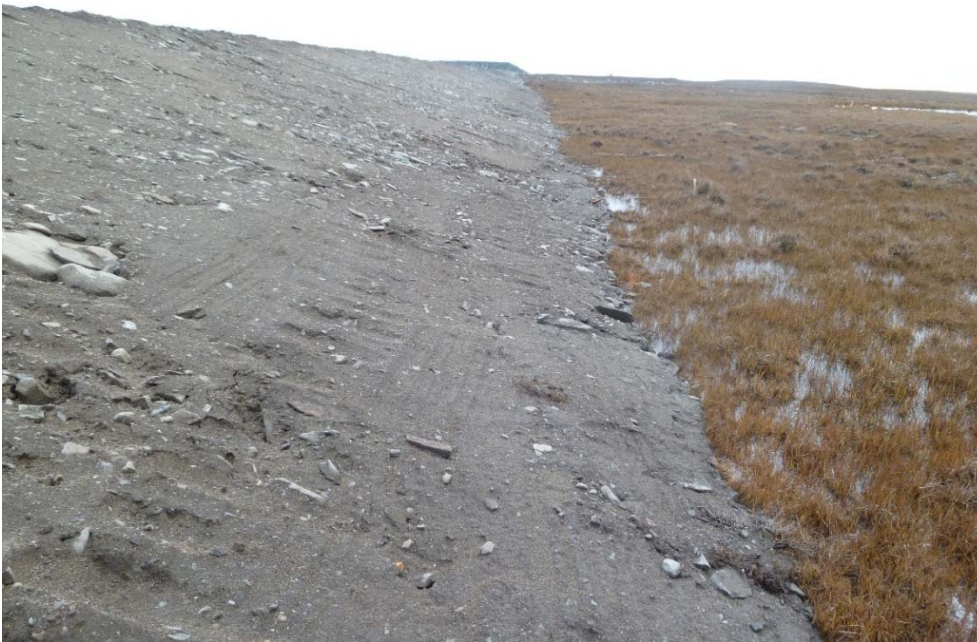
Photograph 57: Berm 3, Downstream Slope near Mid-point of Dike, Water Poned within Vegetation, Looking Southeast (19 September 2017)

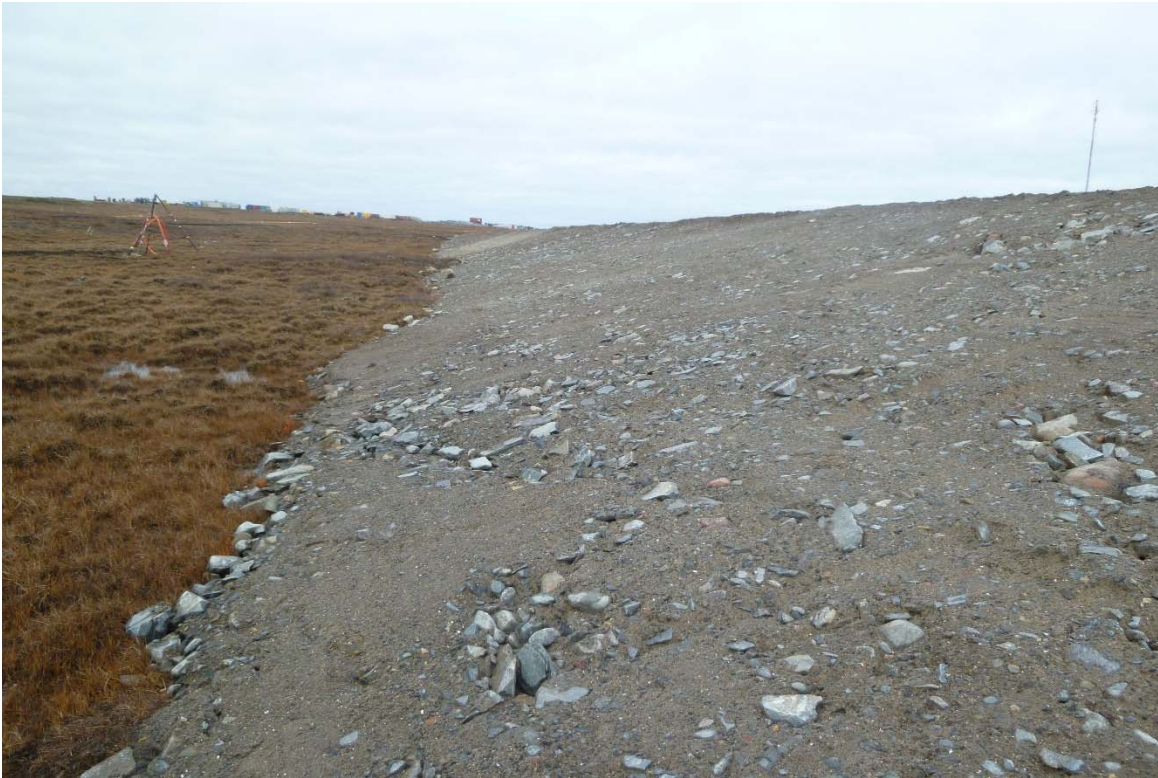
Photograph 58: Berm 3, Downstream Slope near Mid-point of Dike, Looking Northwest (19 September 2017)

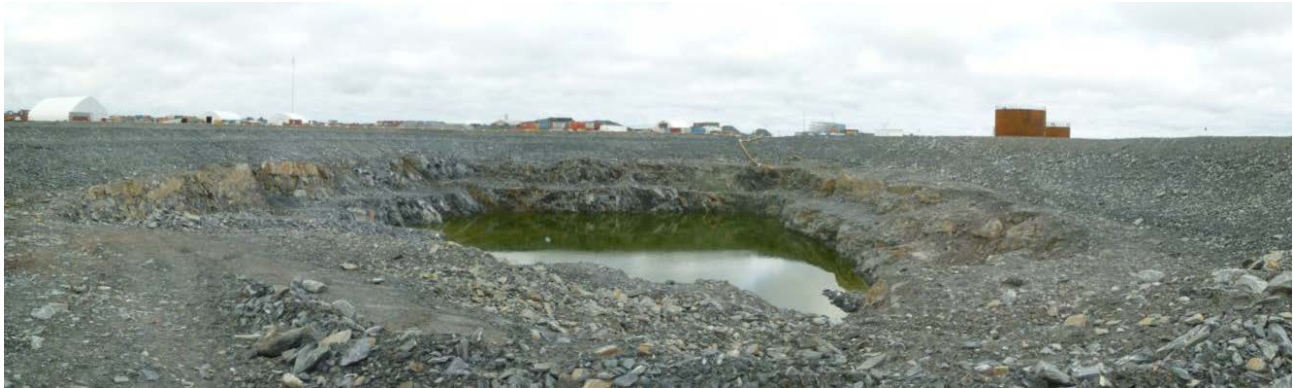
Photograph 59: Saline Pond, Looking Northwest at Pond and Perimeter Berm (19 September 2017)

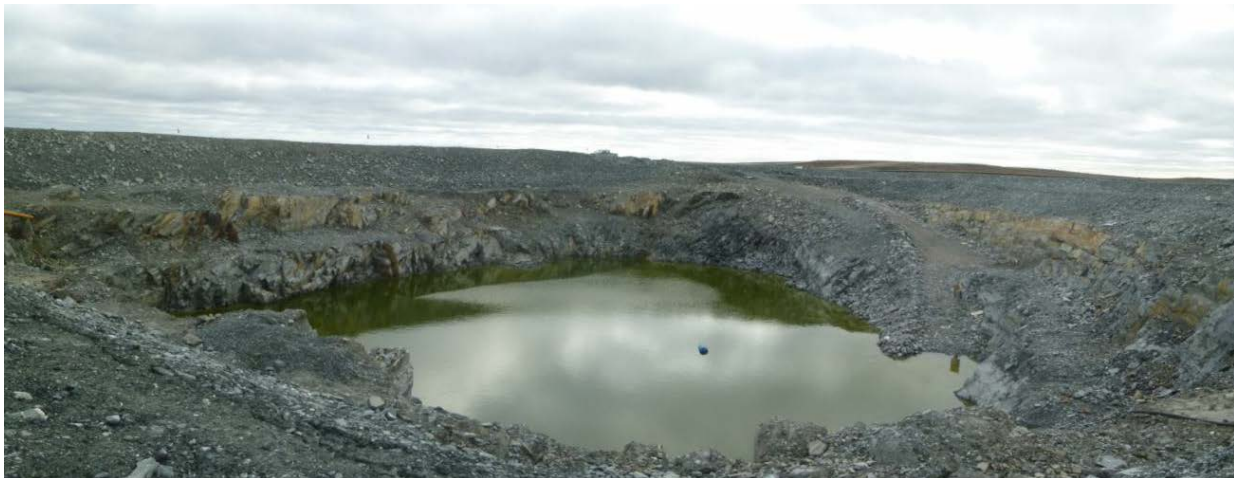
Photograph 60: Saline Pond, Looking East (19 September 2017)

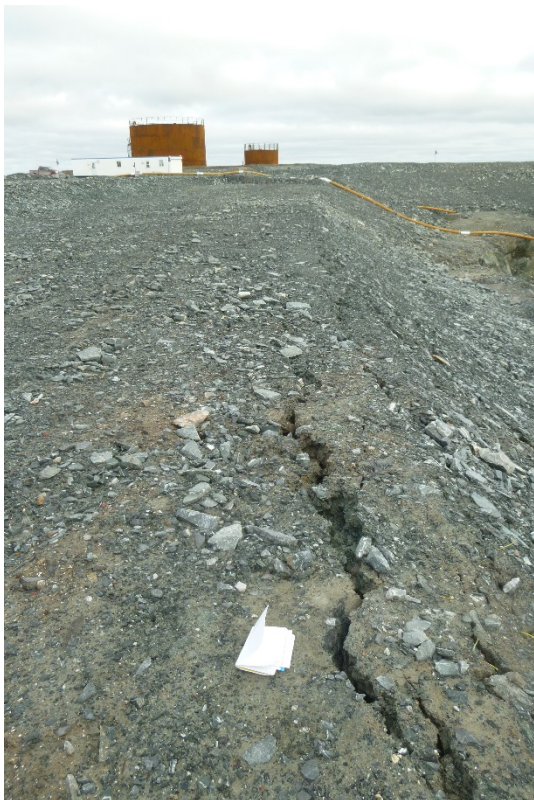
Photograph 61: Saline Pond, Cracking in Perimeter Berm on Northwest Side of Pond (19 September 2017)

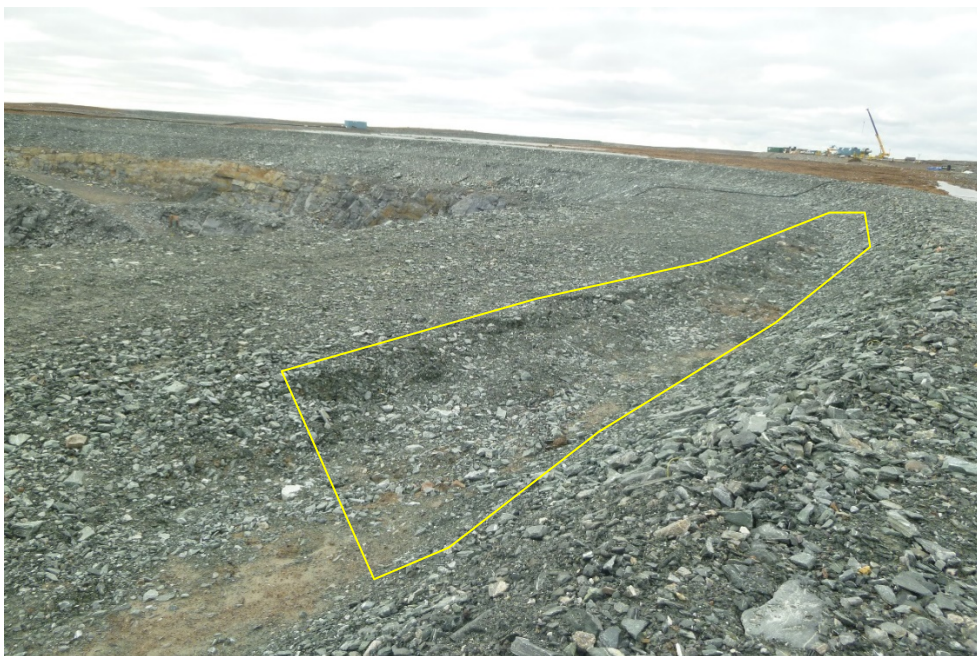
Photograph 62: Saline Pond, Possible Settlement near Toe of Northwest Perimeter Berm (19 September 2017)

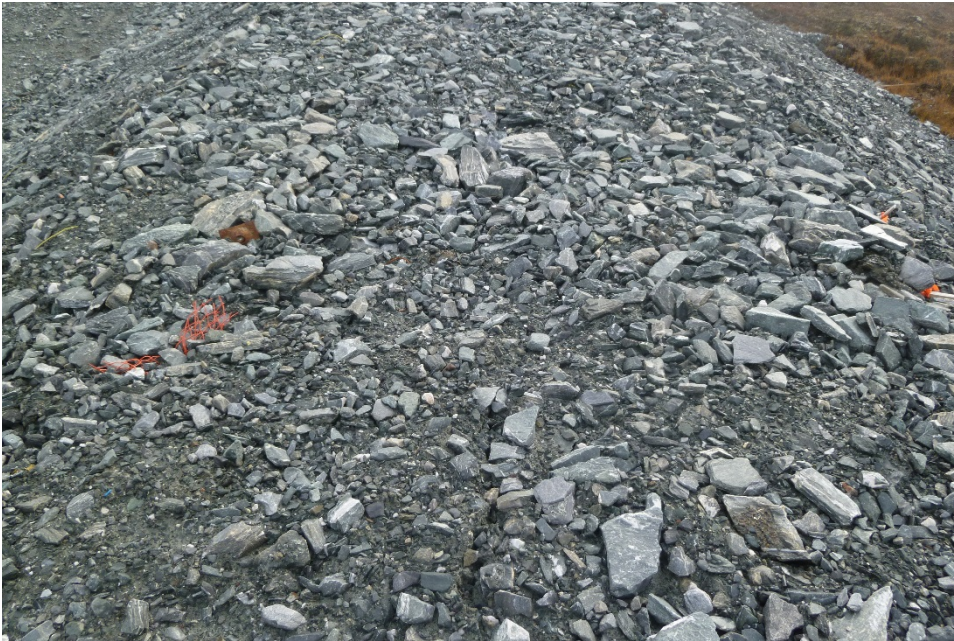
Photograph 63: Saline Pond, Southwest Perimeter Berm Minor Cracking in Berm Crest (19 September 2017)

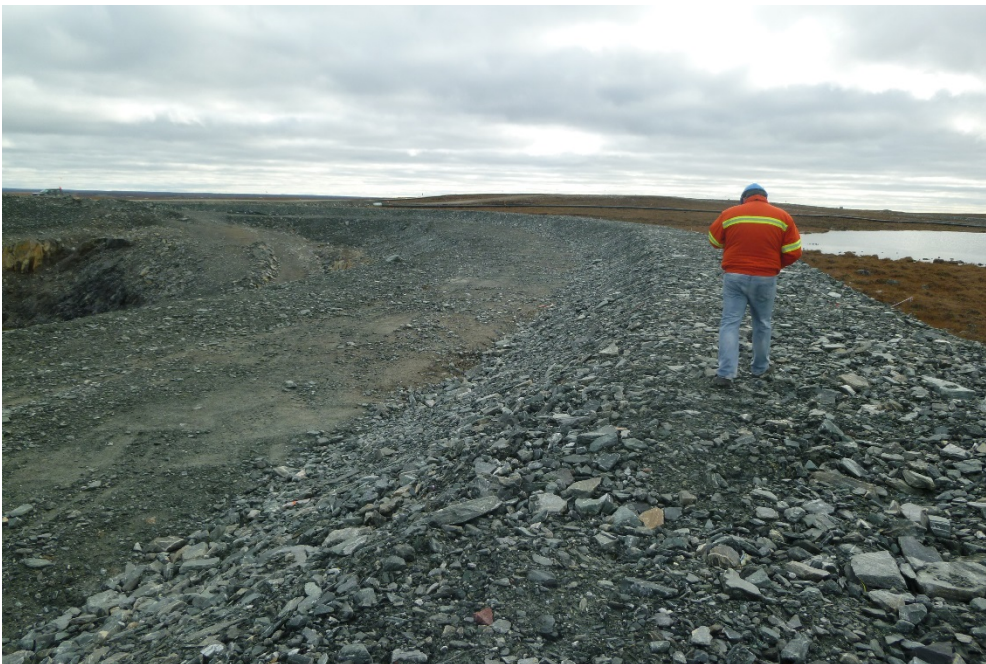
Photograph 64: Saline Pond, Southwest Perimeter Berm Looking Southeast. Collection Pond CP5 to Right of Photo (19 September 2017)

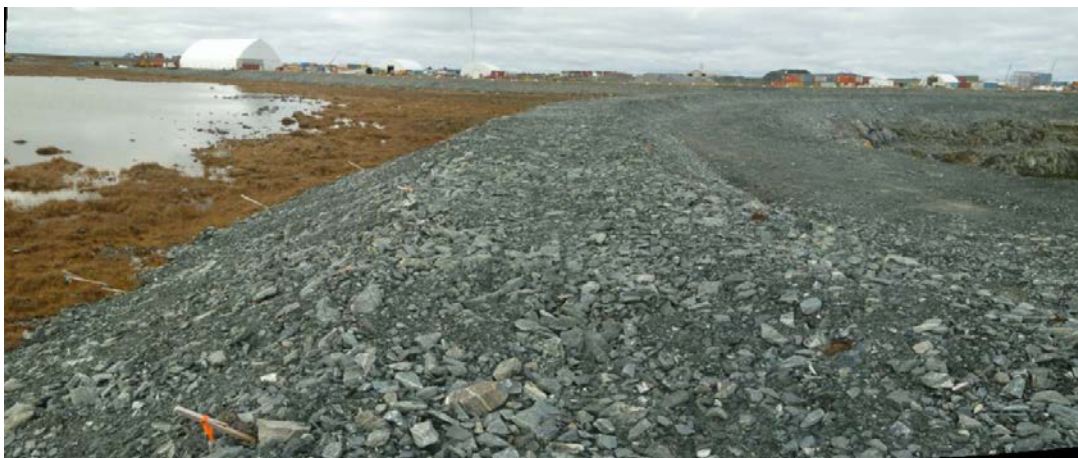
Photograph 65: Saline Pond, Southwest Perimeter Berm Looking Southwest. Collection Pond CP5 to Left of Photo (19 September 2017)

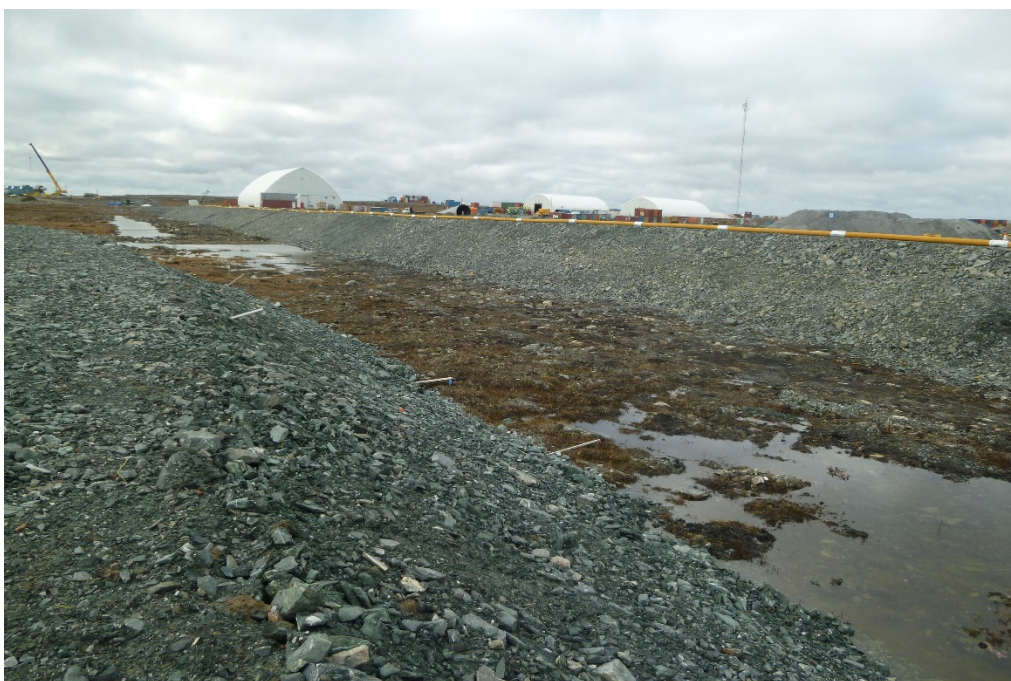
Photograph 66: Saline Pond, Downstream Slope of the Northwest Perimeter Berm and Area between Saline Pond and DCP3-A. Small Amount of Water Ponded Adjacent to the Saline Pond Perimeter Berm (19 September 2017)

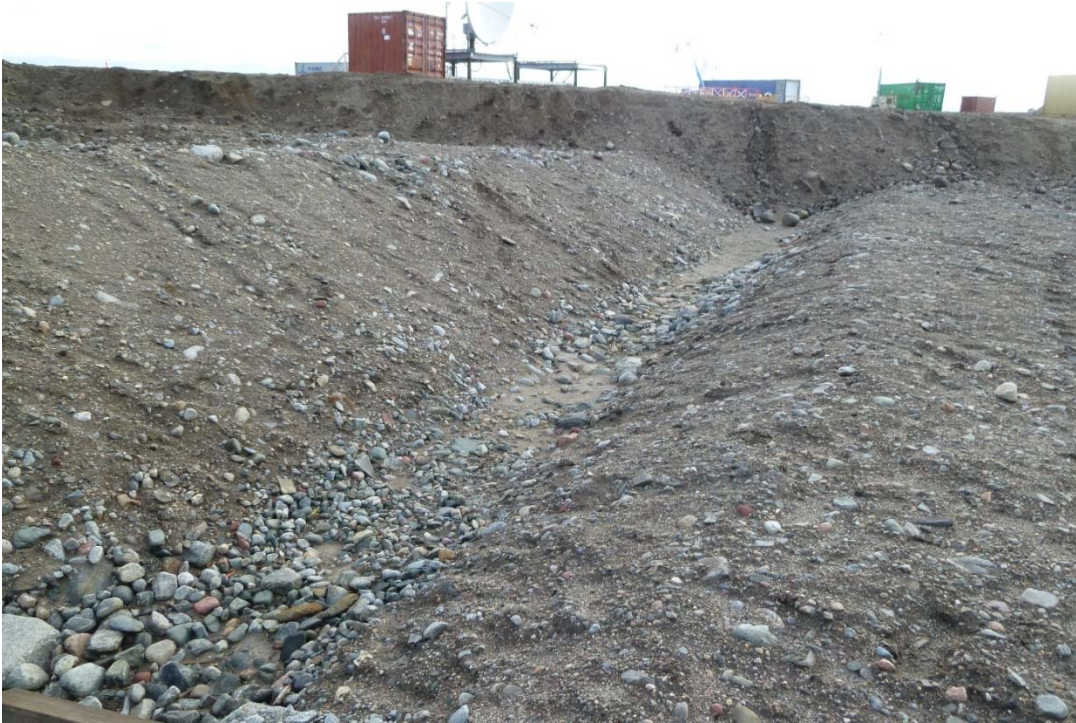
Photograph 67: Unlined Extension of East End of Channel 2, Looking Southeast at Start of Channel (20 September 2017)

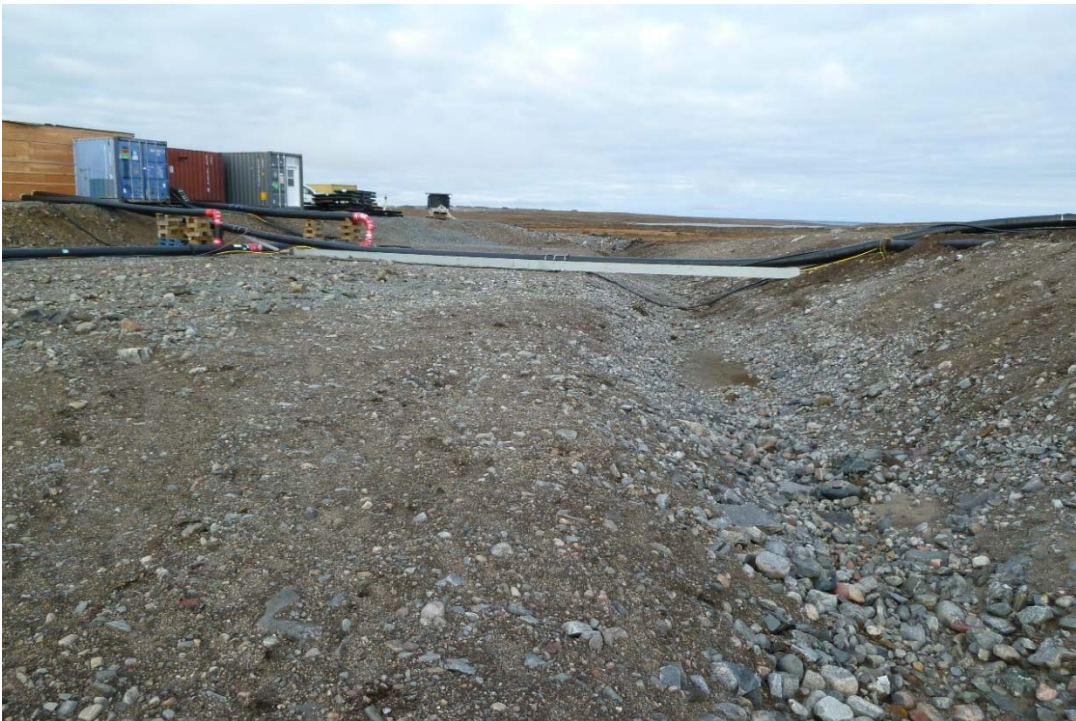
Photograph 68: Unlined Extension of East End of Channel 2, Looking Northwest (20 September 2017)

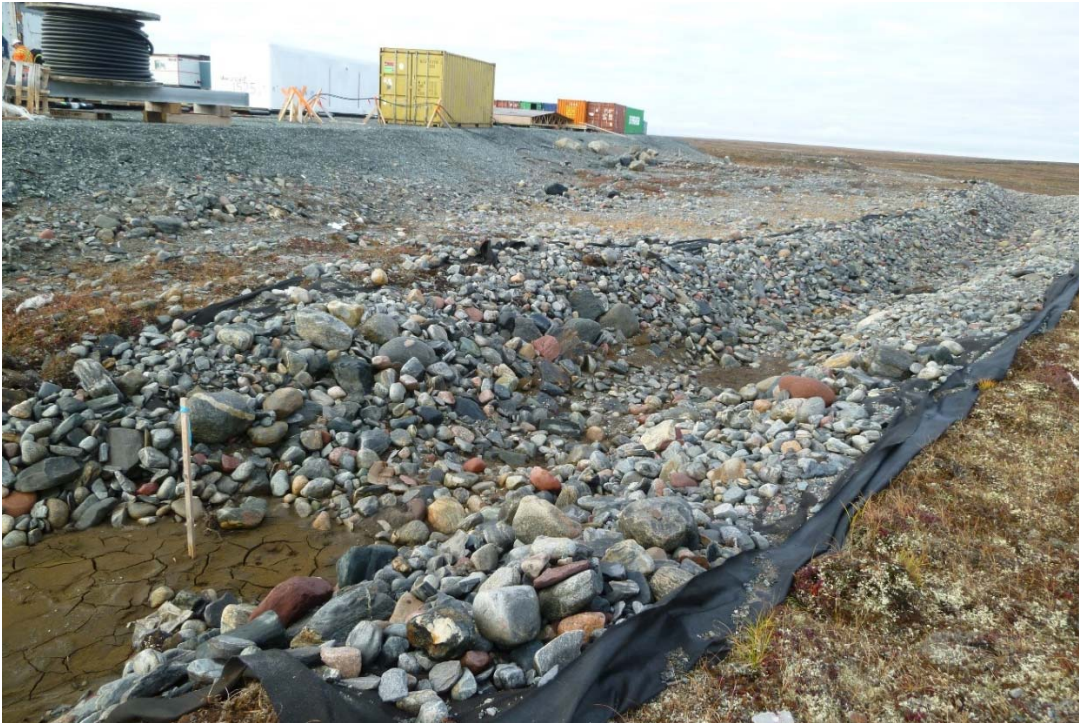
Photograph 69: Channel 2, Start of Lined Channel at East End, Looking Southwest. Industrial Pad in Background (20 September 2017)

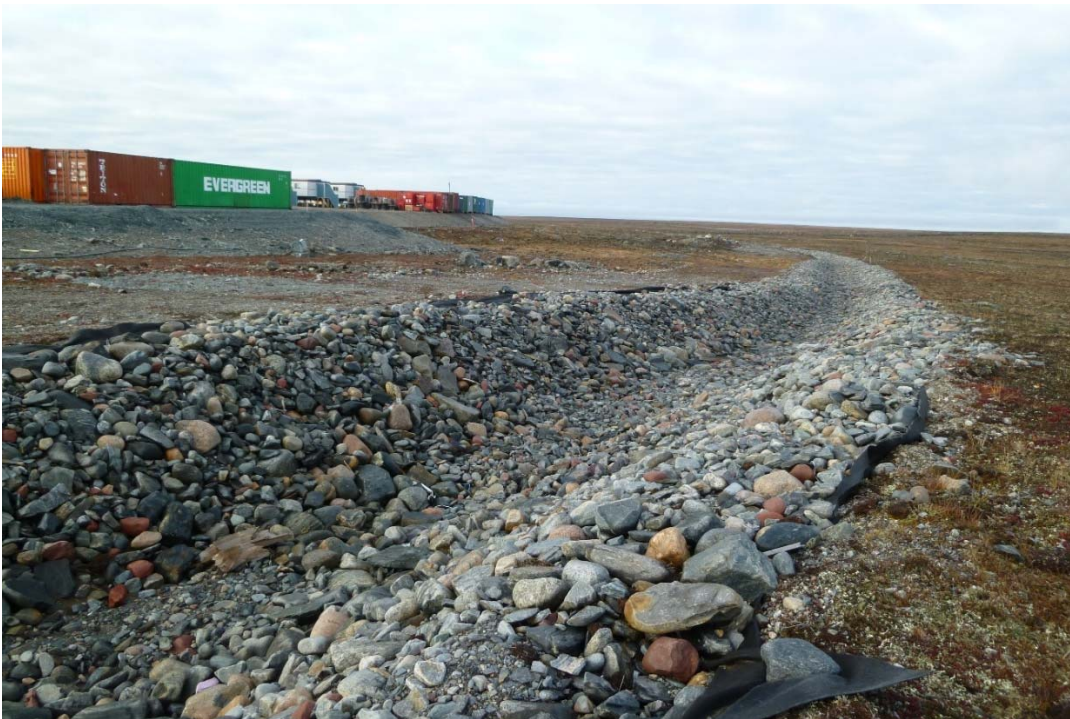
Photograph 70: Channel 2, Eastern Section, Looking West (20 September 2017)

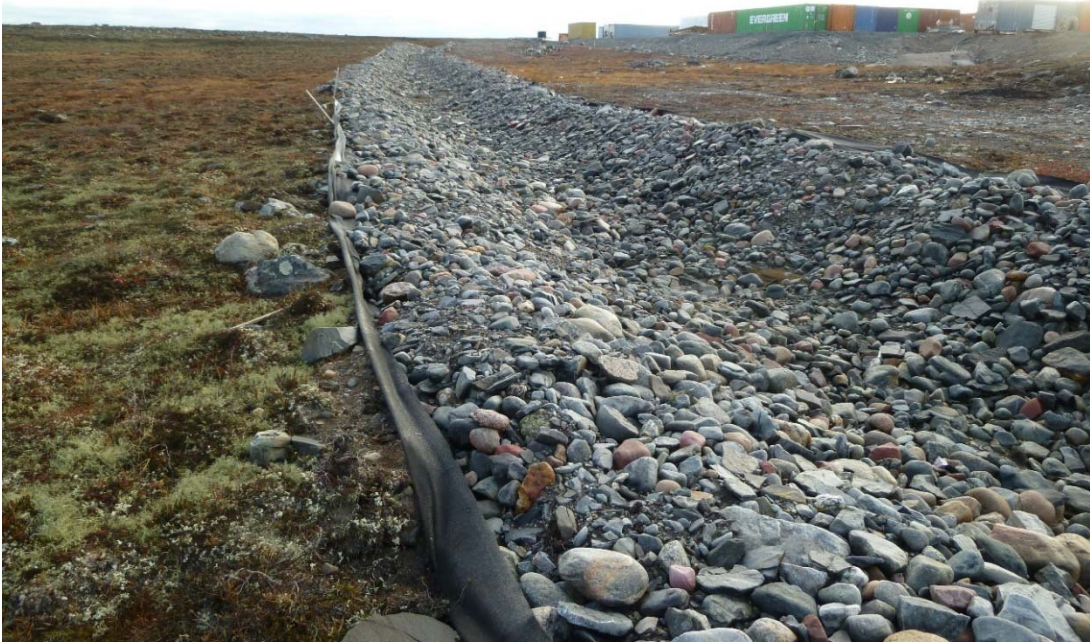
Photograph 71: Channel 2, Western Section, Looking East (20 September 2017)

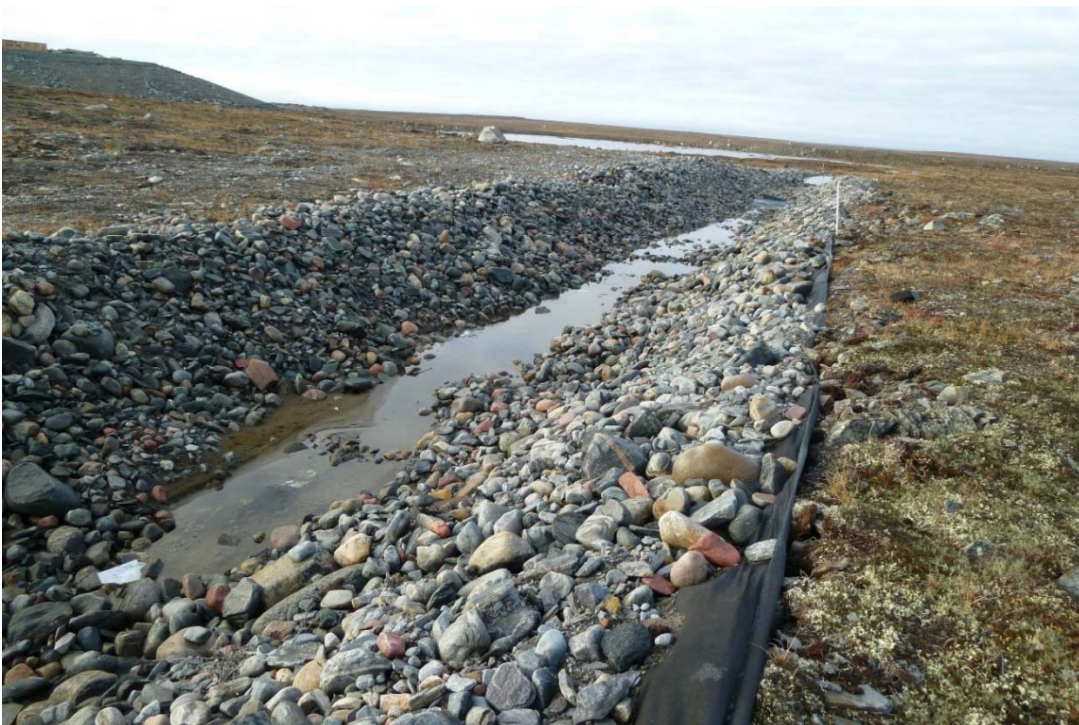
Photograph 72: Channel 2, West End near Outlet, Looking West. Some Water Ponded in Base of Channel (20 September 2017)

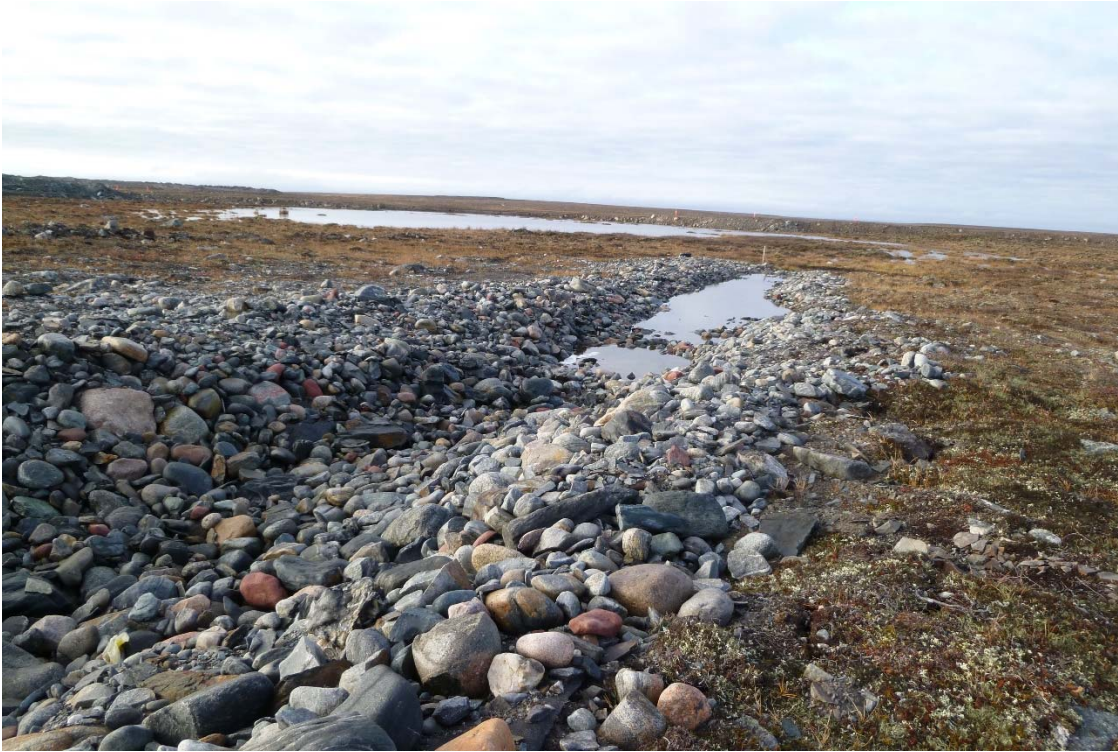
Photograph 73: Channel 2, Outlet of Channel at West End (20 September 2017)
