APPENDIX A3

Culvert #3 and Culvert #4

Culvert 6, Wesmeg Borrow and Tiriganiaq Esker Areas

Waste Rock and Ore Storage Piles

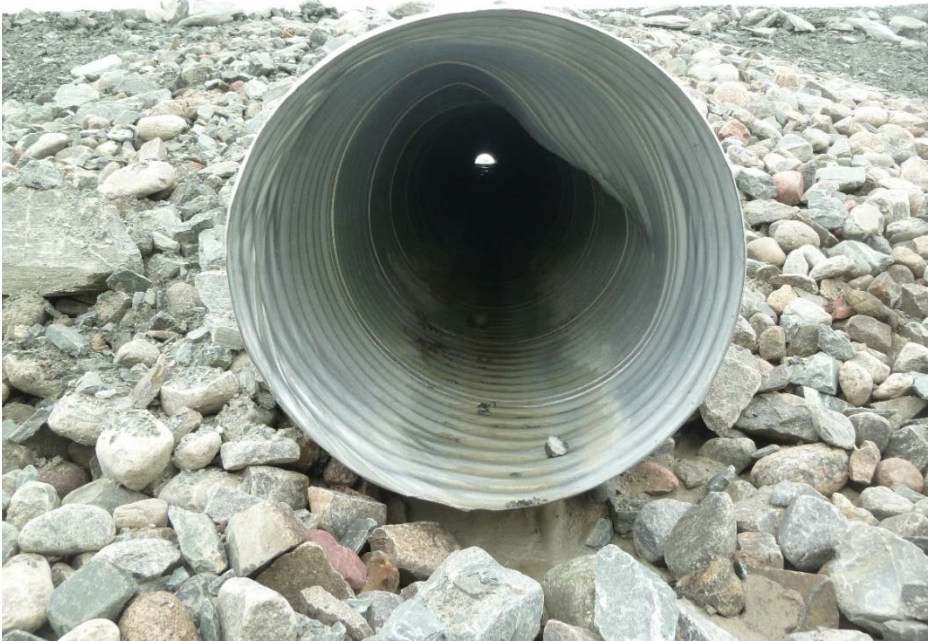
Photograph 5: Culvert #4, Looking Through Upstream End of Culvert. Some Damage Visible (21 September 2017)

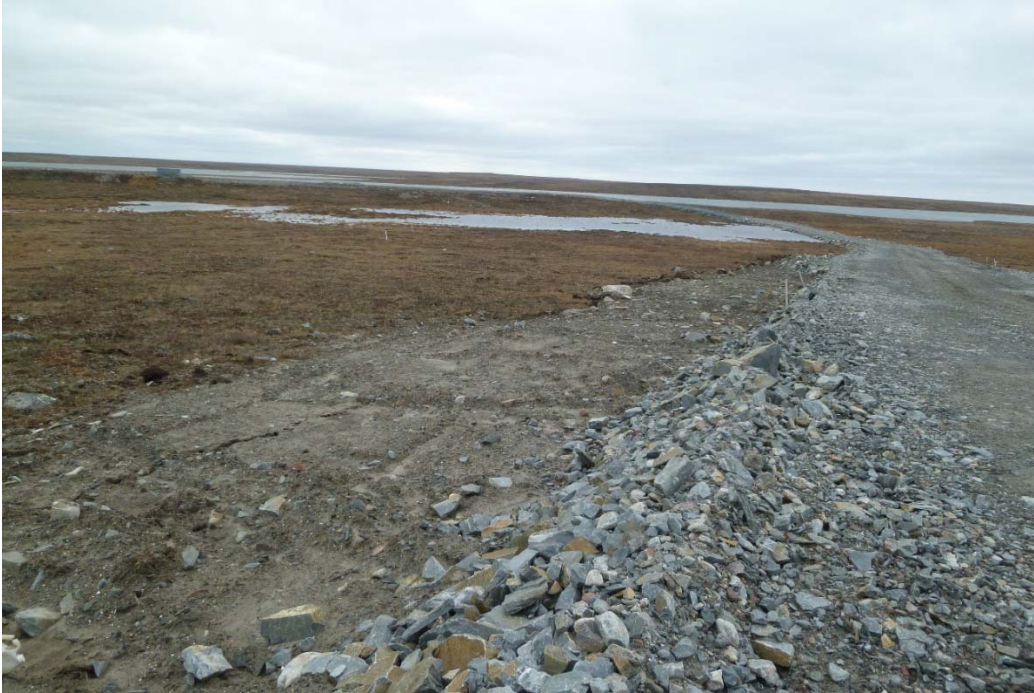
Photograph 13: Road to Wesmeg Borrow, Stripping along Edge of Road has been Recontoured, Water Poned against Road in Low Area in Background, Looking West (21 September 2017)

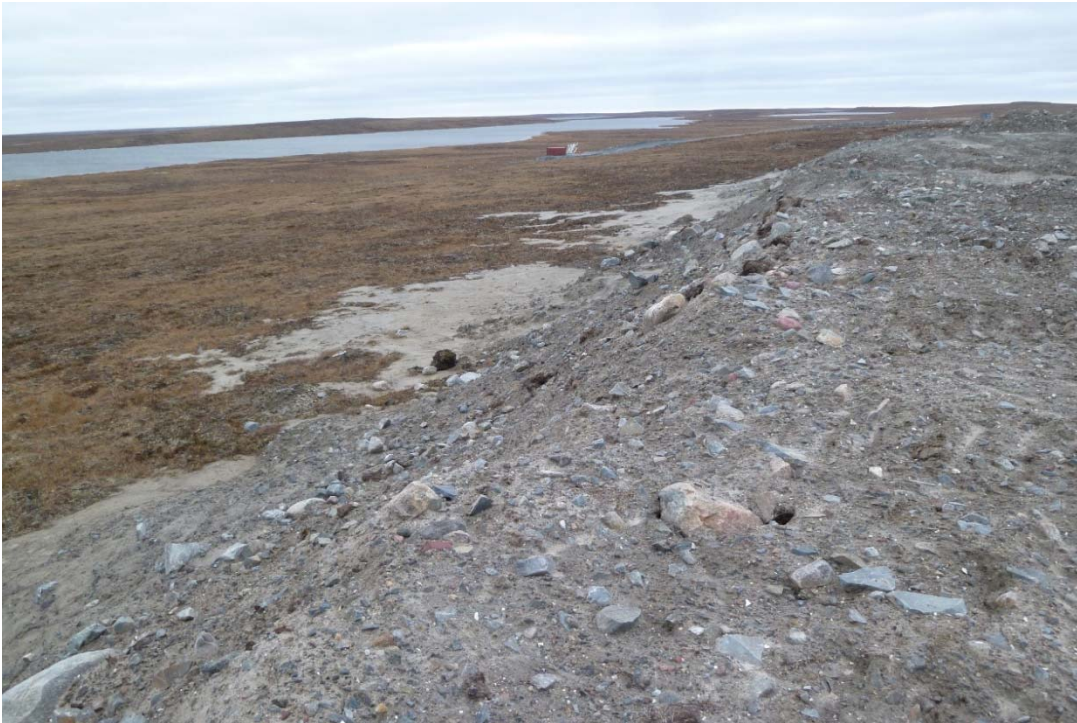
Photograph 15: Wesmeg Borrow, Erosion Downslope, Looking Northwest (21 September 2017)

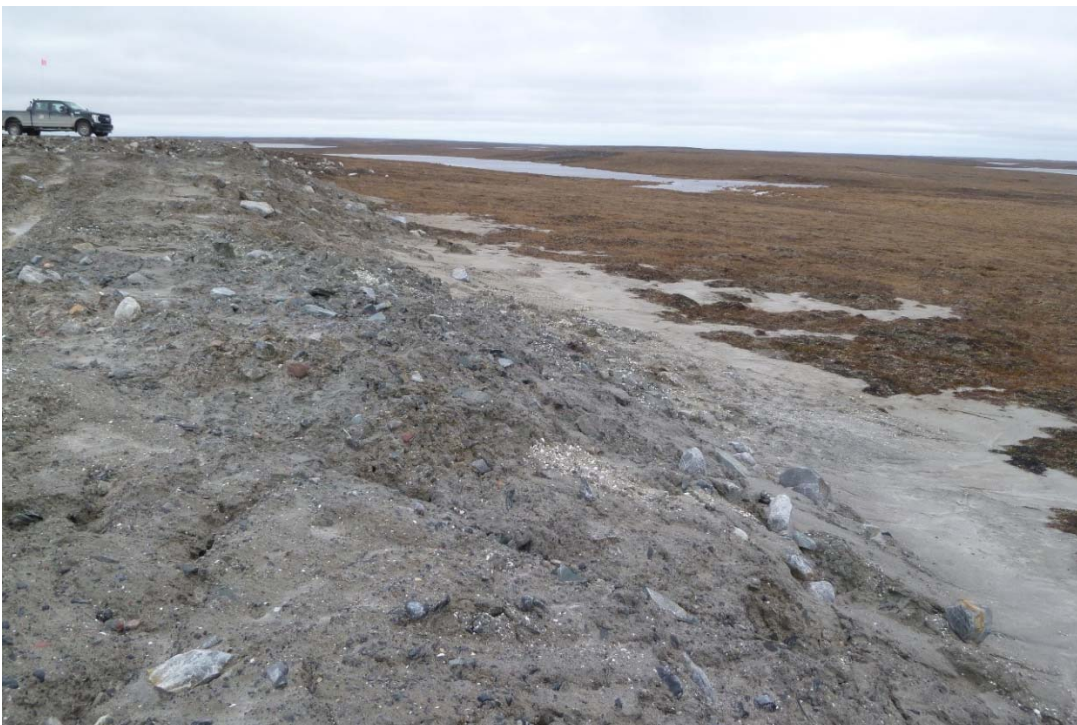
Photograph 16: Wesmeg Borrow, Erosion Downslope, Looking Southeast (21 September 2017)

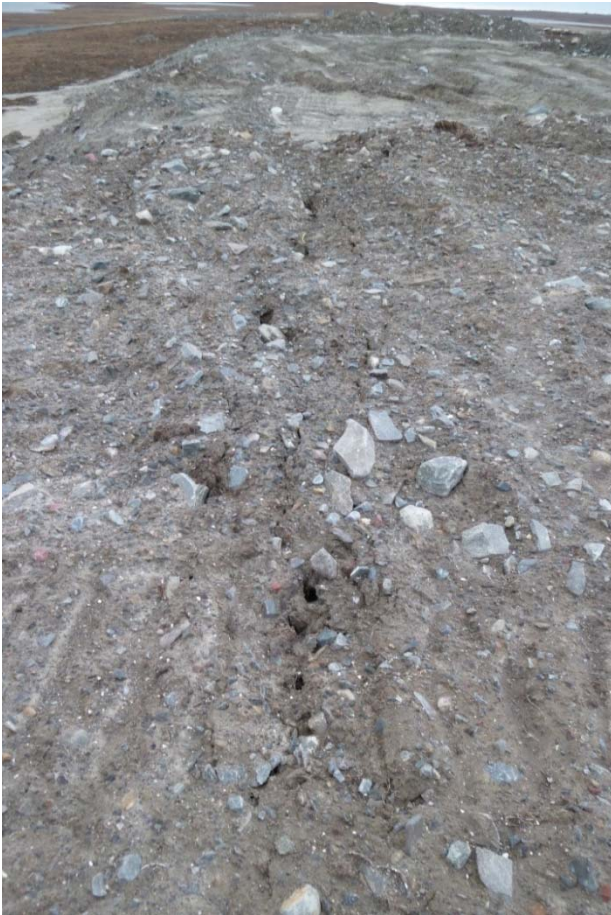
Photograph 17: Wesmeg Borrow Cracking Along Crest of Slope (21 September 2017)

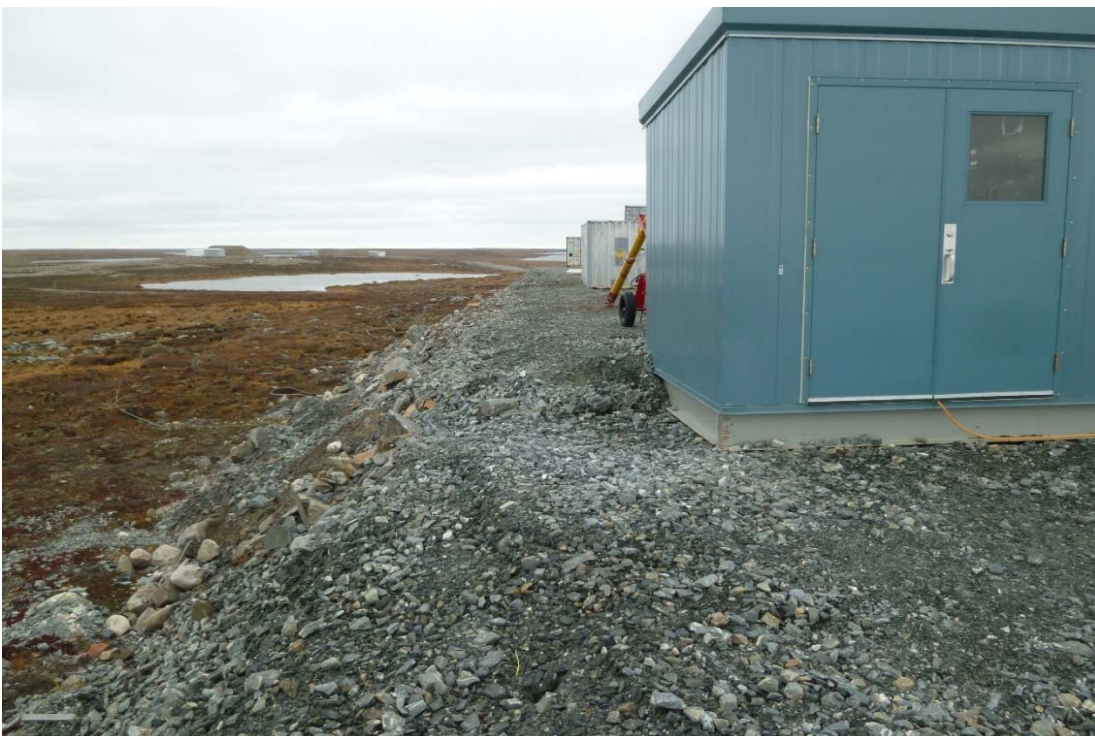
Photograph 24: ANFO Plant Pad, Some Erosion and Settlement on Southwest Slope, Looking Northwest (21 September 2017)

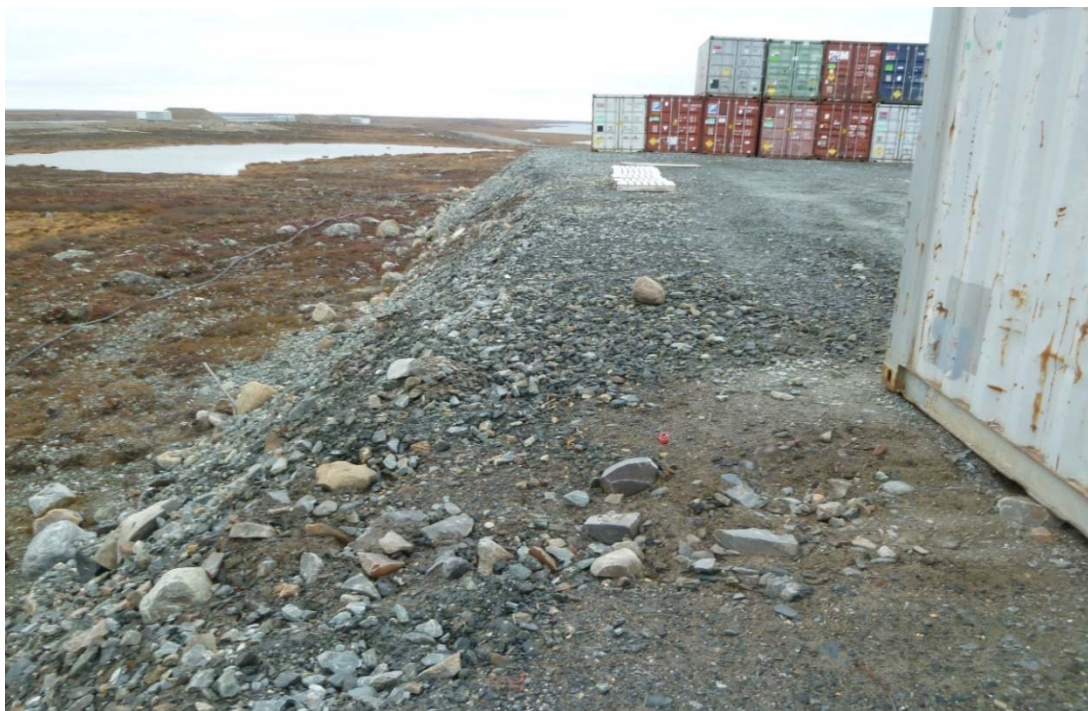
Photograph 25: ANFO Plant Pad, Some Erosion on Southwest Slope, Looking Northwest (21 September 2017)

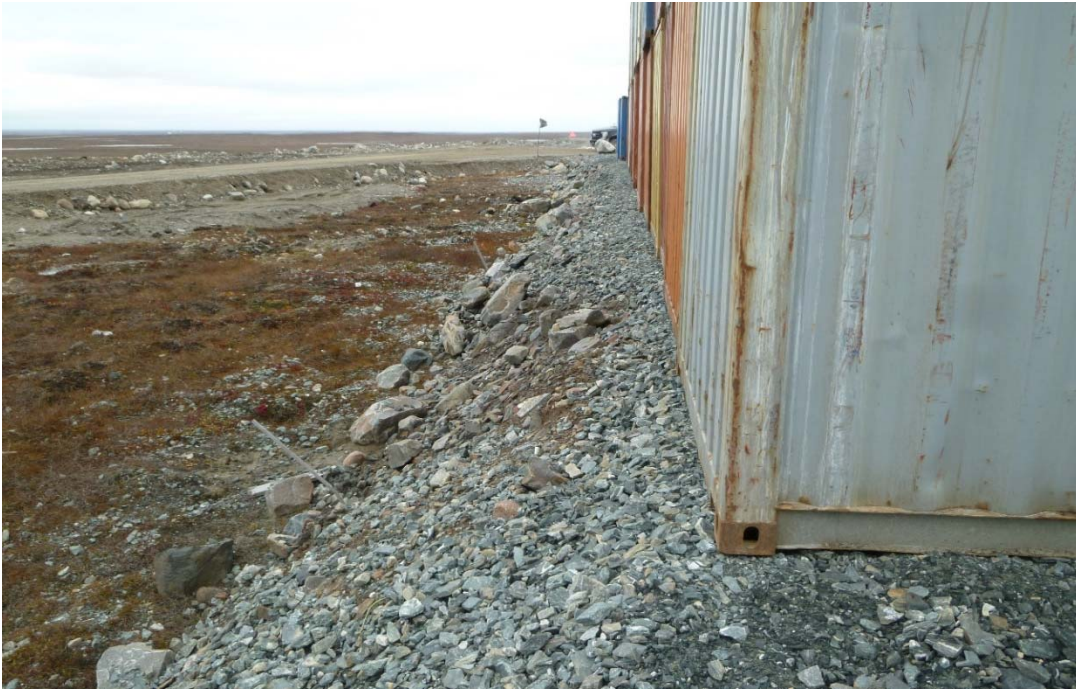
Photograph 27: ANFO Plant Pad, East Slope, Looking North. Sea-containers are Located Very Close to Crest (21 September 2017)

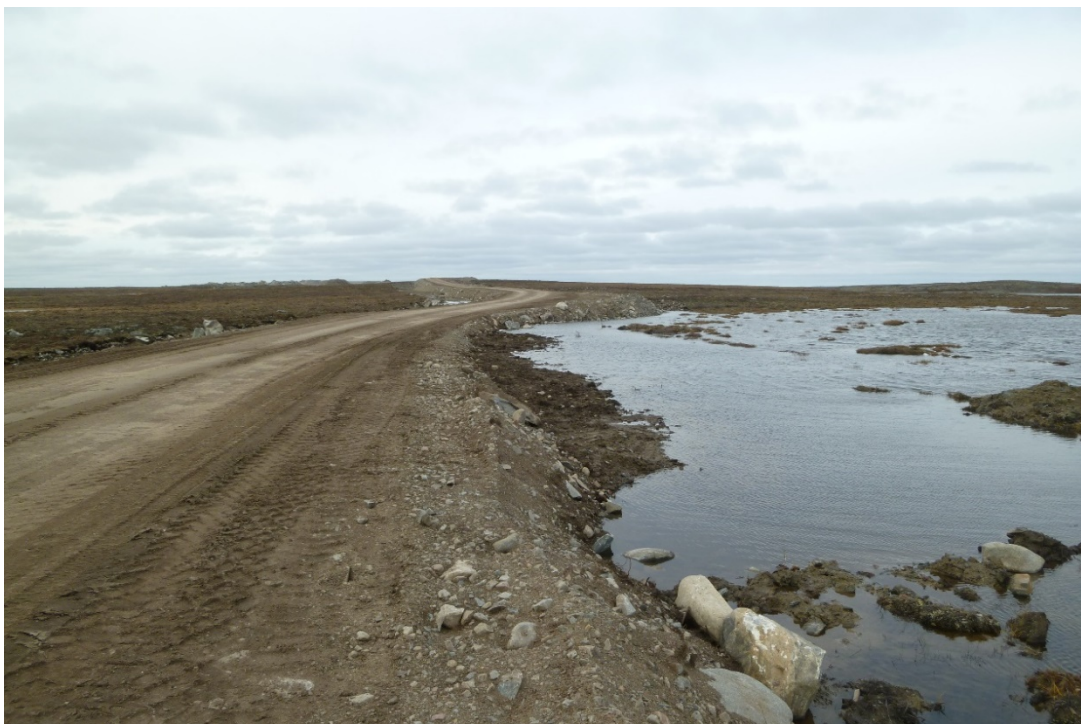
Photograph 30: Emulsion Plant Access Road, Lake H15E Ponding on Northeast Side of the Road near South End of Road. No Culvert Installed (21 September 2017)

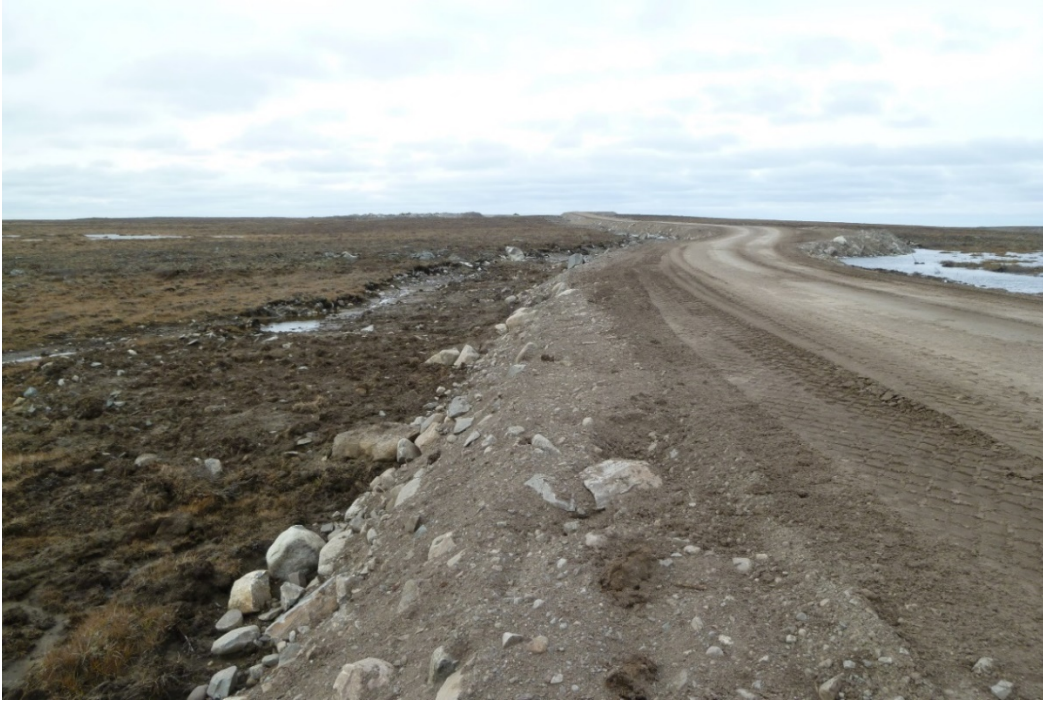
Photograph 31: Emulsion Plant Access Road, Lake H15E in top Right of Photo (Photograph 30), and Minimal Water on Southwest Side of Access Road. No Culvert in Place (21 September 2017)

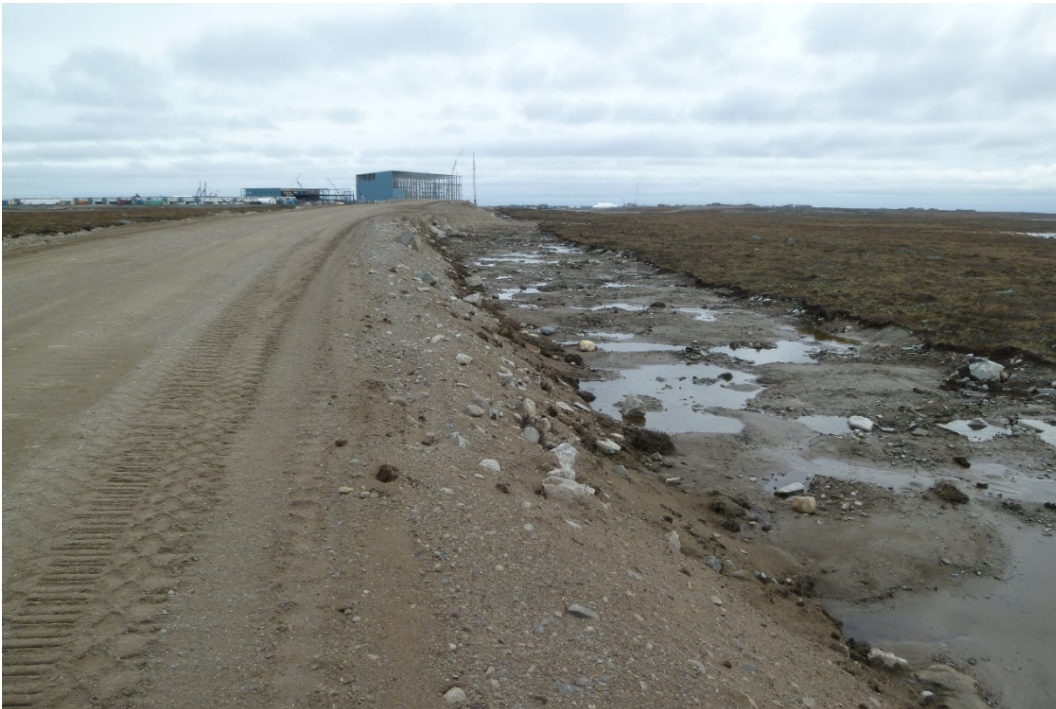
Photograph 32: Emulsion Plant Access Road, Area Stripped Adjacent to the Road with Small Amount of Ponding, Looking Southeast (21 September 2017)

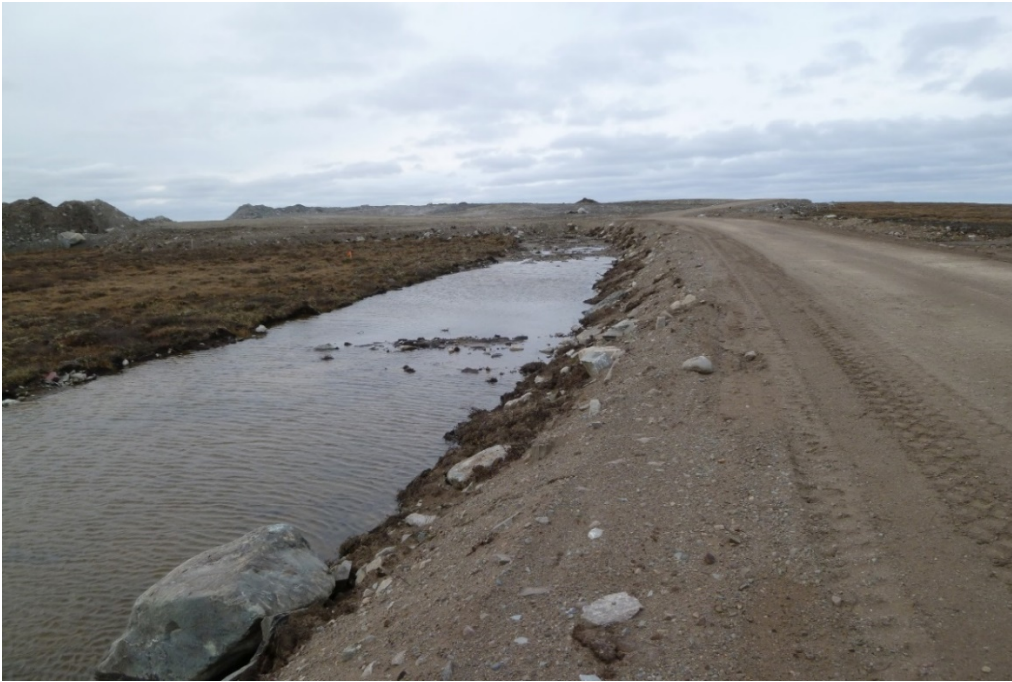
Photograph 33: Emulsion Plant Access Road, Water Poned on Southwest Side of Road where Stripping was Completed, Looking Northwest (21 September 2017)

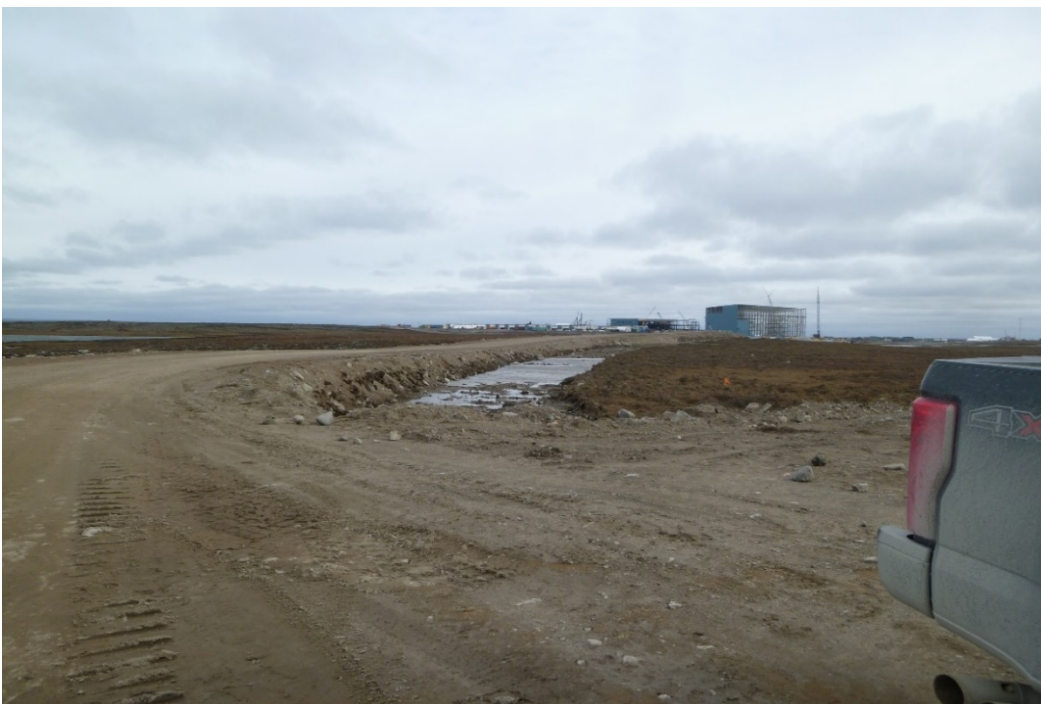
Photograph 39: Emulsion Plant Access Road, Looking South from Emulsion Plant Pad. Water Poned on Southwest Side of Road where Foundation was Stripped (21 September 2017)
