APPENDIX A4

Industrial Pad and Other Site Facilities: Landfarm, Effluent Water Treatment Plant Pad and Intake, Underground Portal No. 1 and Underground Portal No. 2, Fuel Storage, Ventilation Intake Pad, Exploration Landfill, and Operation Landfill

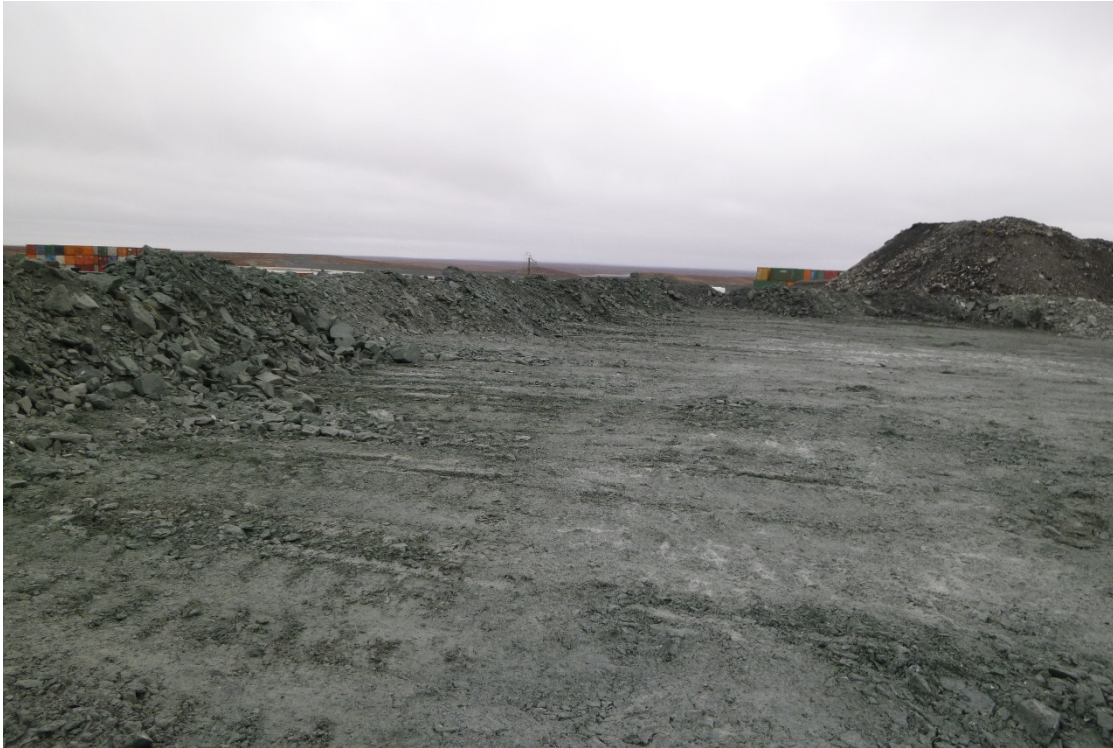
Photograph 9: Waste Rock Storage pile, Top of Pile, Safety Berms in Place (21 September 2017)

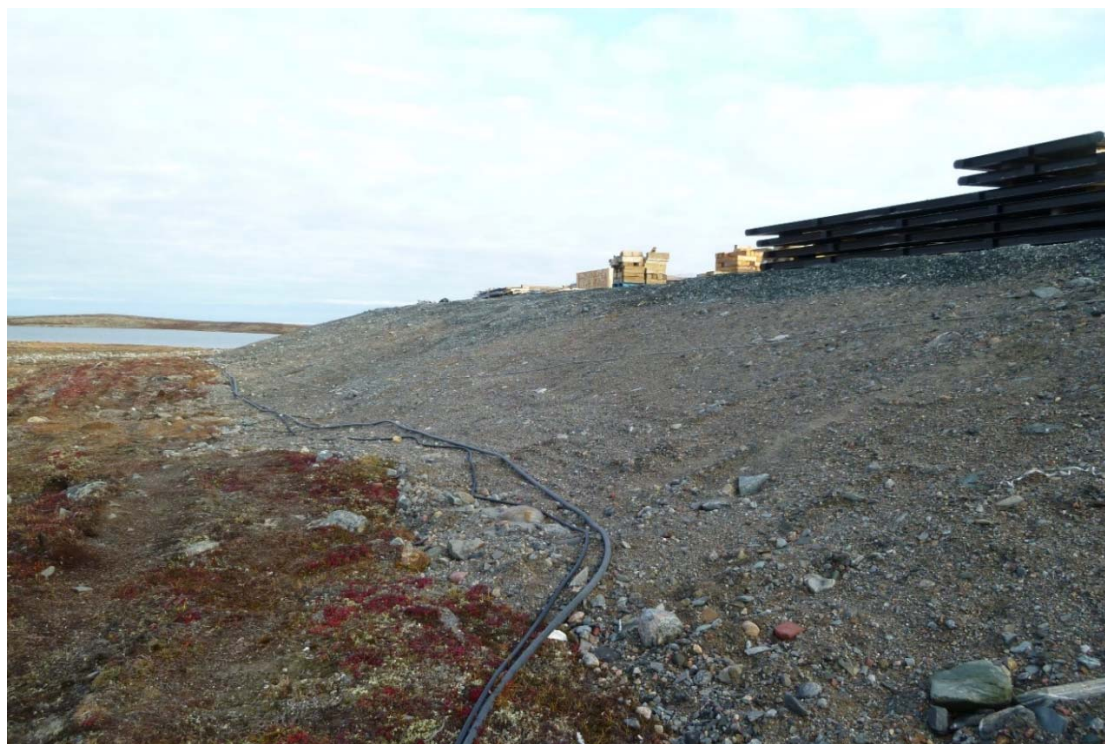
Photograph 2: Industrial Pad, North End of West Slope, Looking North (20 September 2017)

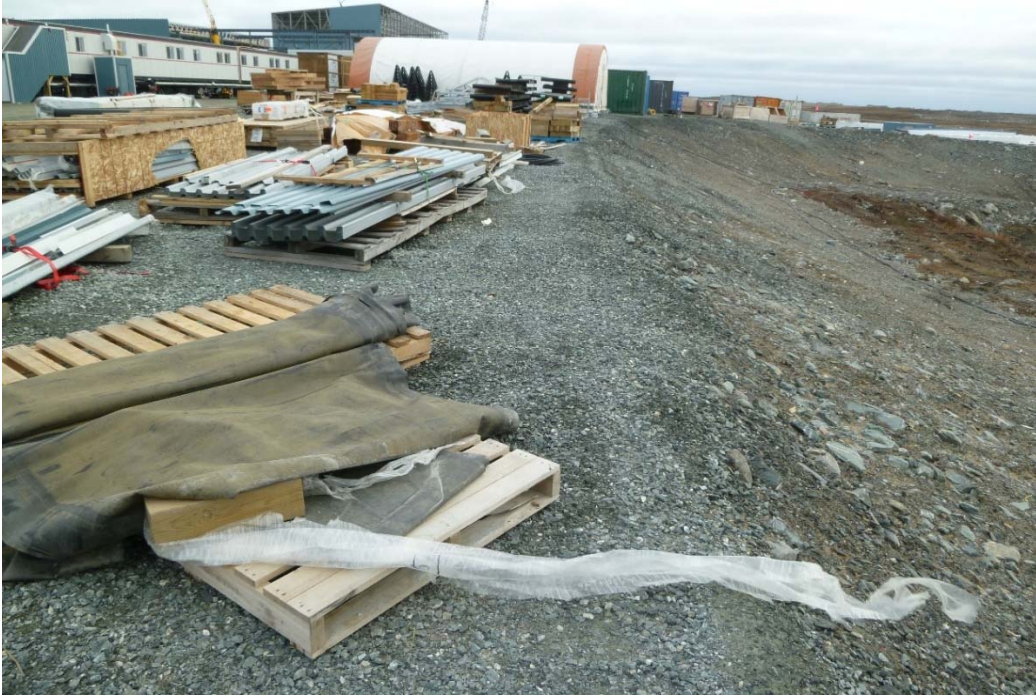
Photograph 3: Industrial Pad, North End of West Slope with Access Ramp in back Right of Photograph, Looking South (20 September 2017)

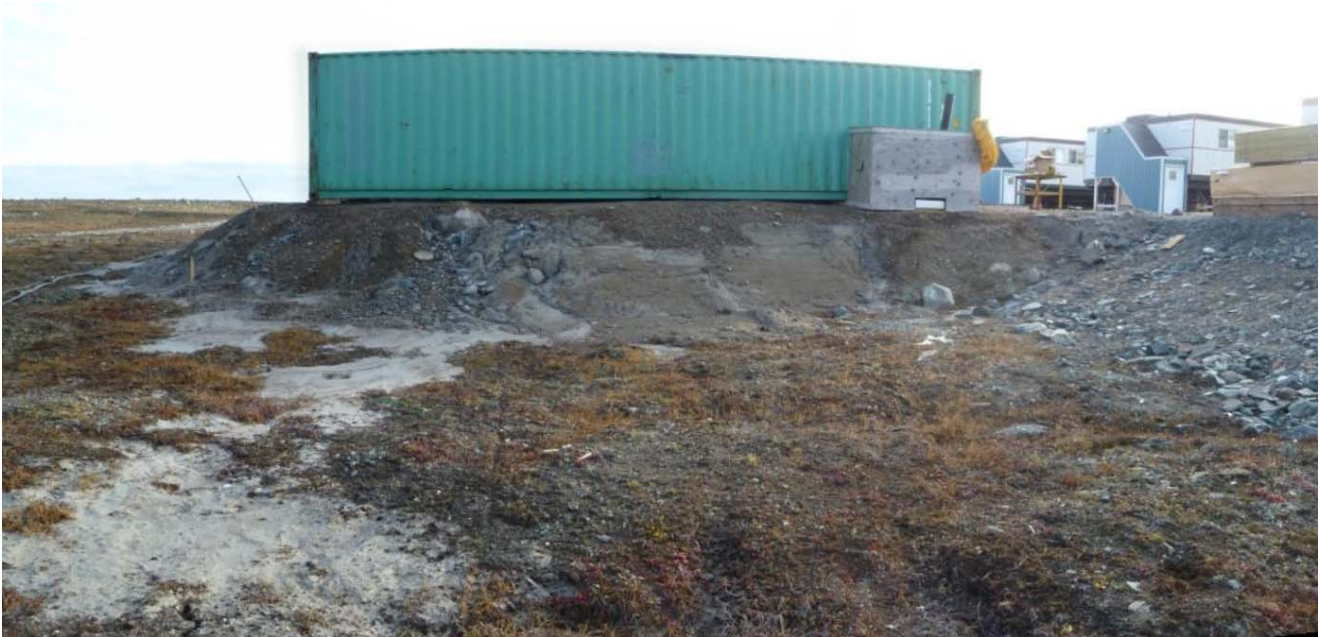
Photograph 4: Industrial Pad, Erosion of North Slope, Looking East (20 September 2017)

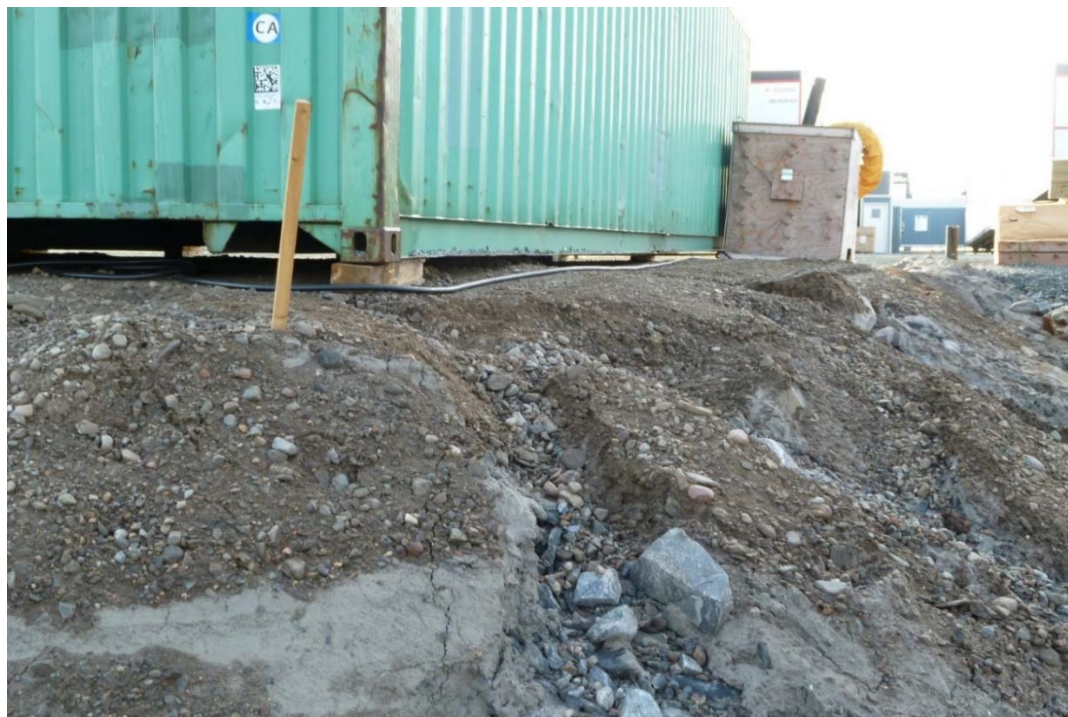
Photograph 5: Industrial Pad, Erosion of North Slope (20 September 2017)

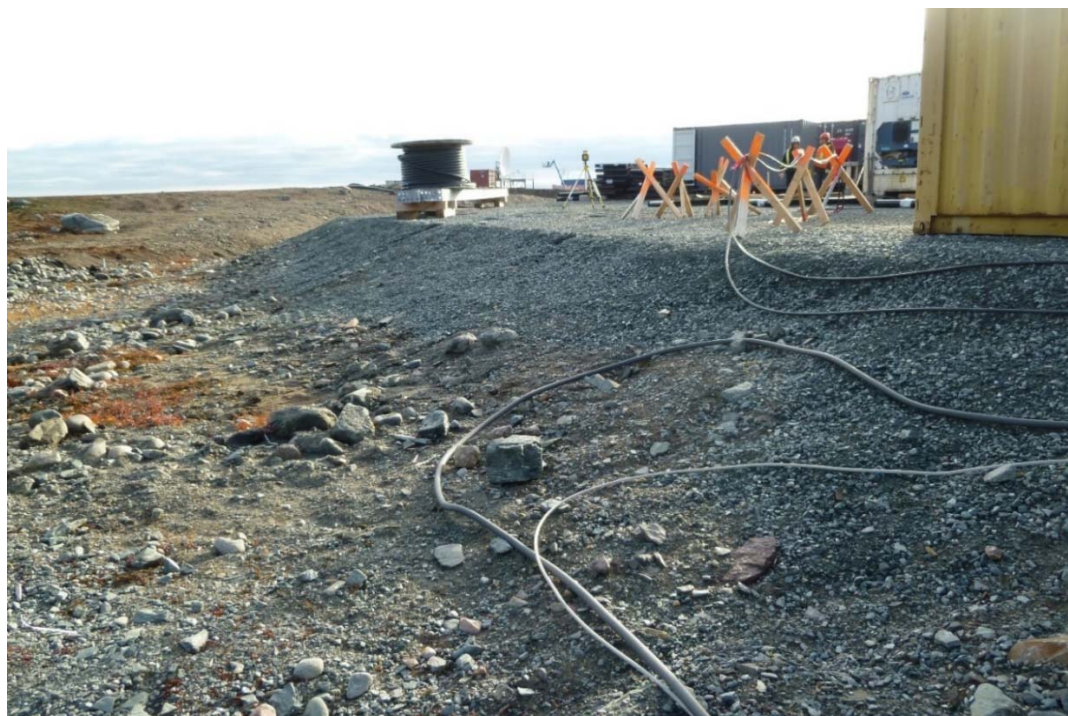
Photograph 6: Industrial Pad, East End of North Slope, Coarser Material, Less Erosion (20 September 2017)

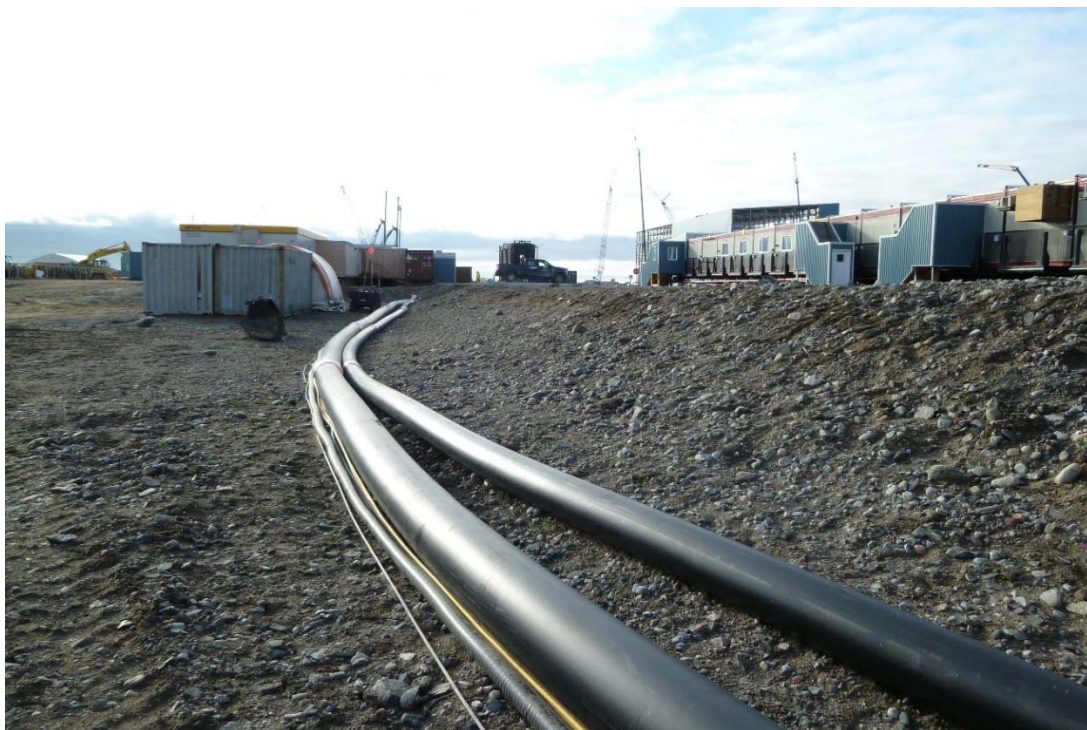
Photograph 7: Industrial Pad, North End of East Slope, Looking South (20 September 2017)

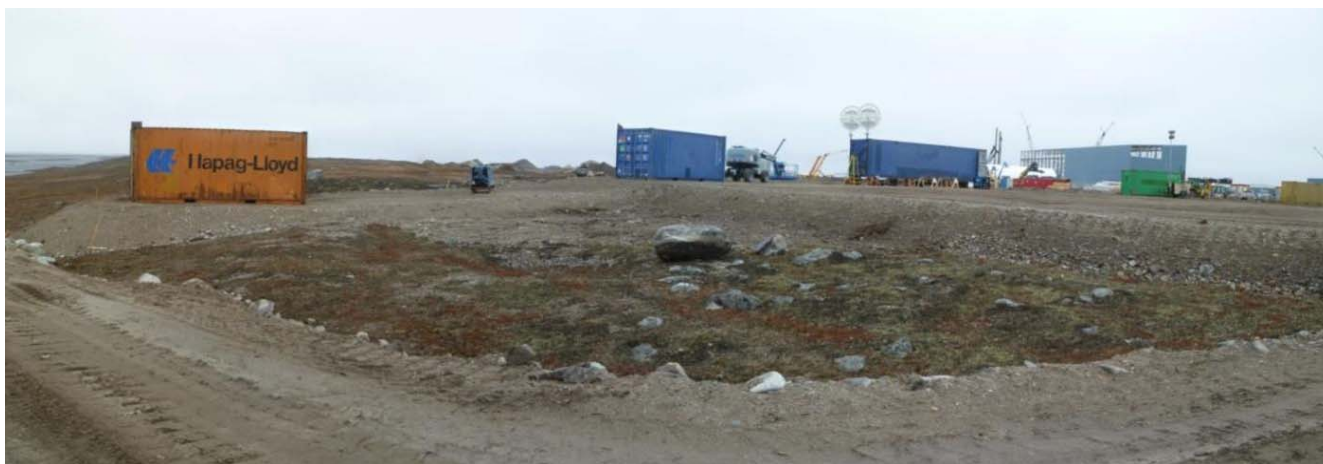
Photograph 8: Industrial Pad, Area at Northeast Corner of Site near Start of Water Intake Access Road, Looking South. (21 September 2017)

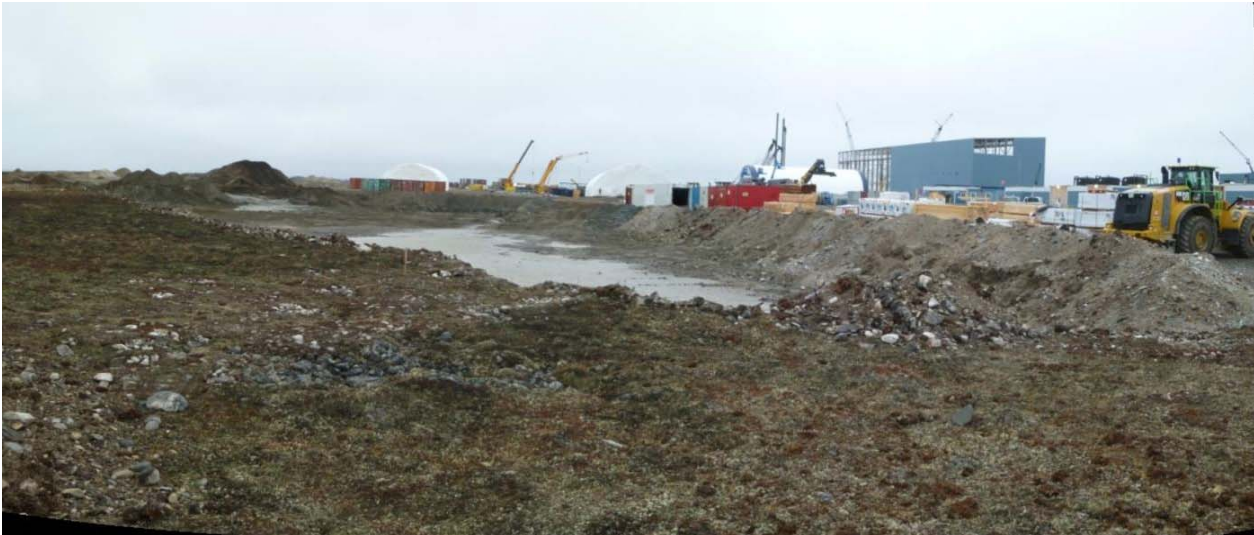
Photograph 9: Industrial Pad, Quarry Area East of the Industrial Pad, Looking South (21 September 2017)

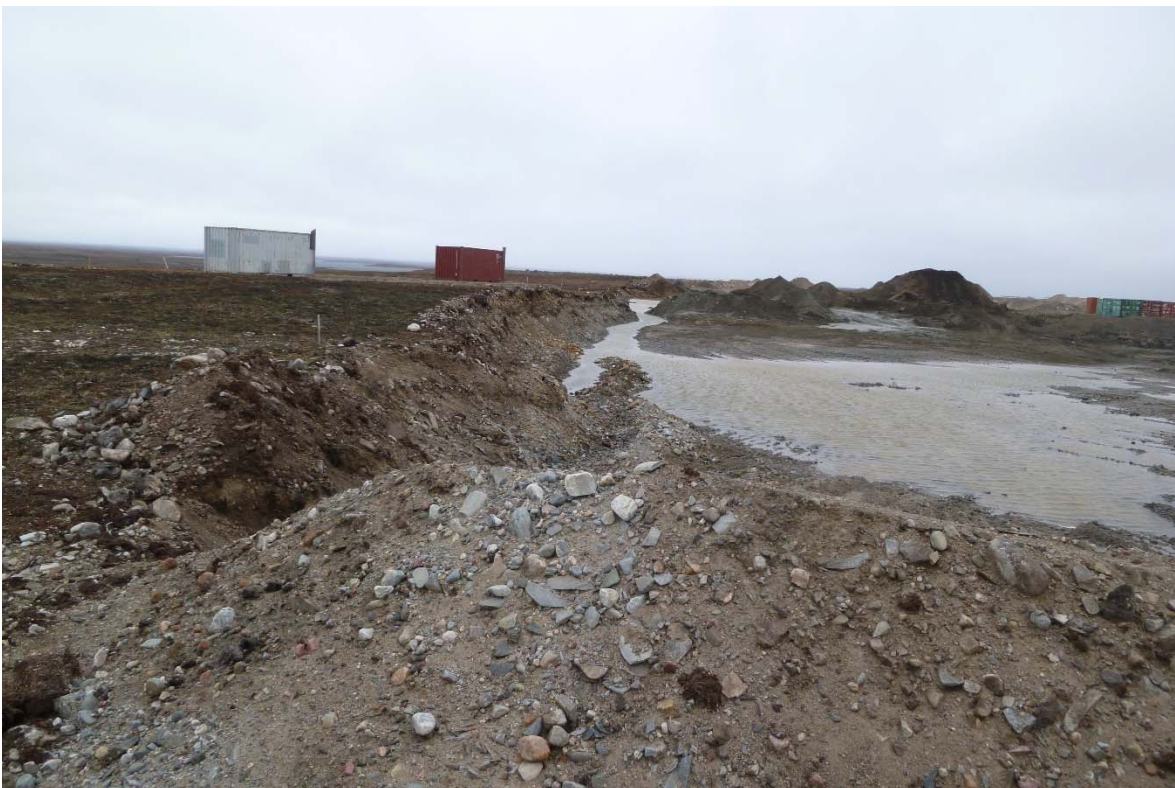
Photograph 10: Industrial Pad, Quarry Area East of Industrial Pad, Water Ponding and Ditching for Water Management, Looking South (21 September 2017)

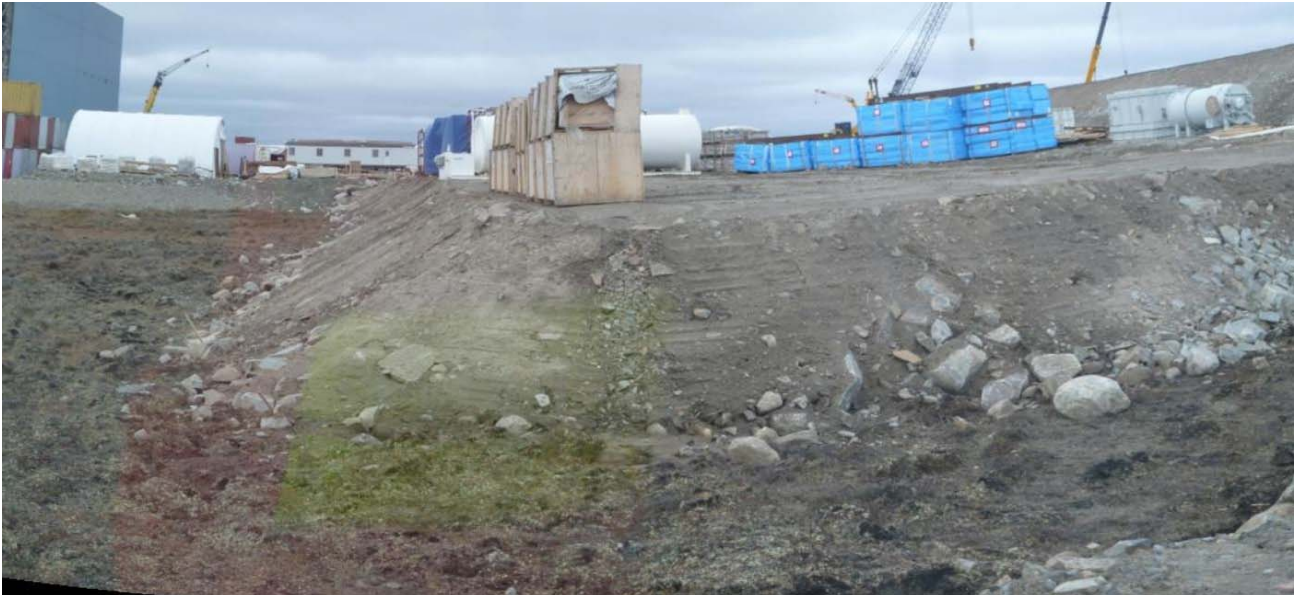
Photograph 11: Industrial Pad, Slopes of Pad Located West of Future Fuel Storage Area, Looking North (21 September 2017)

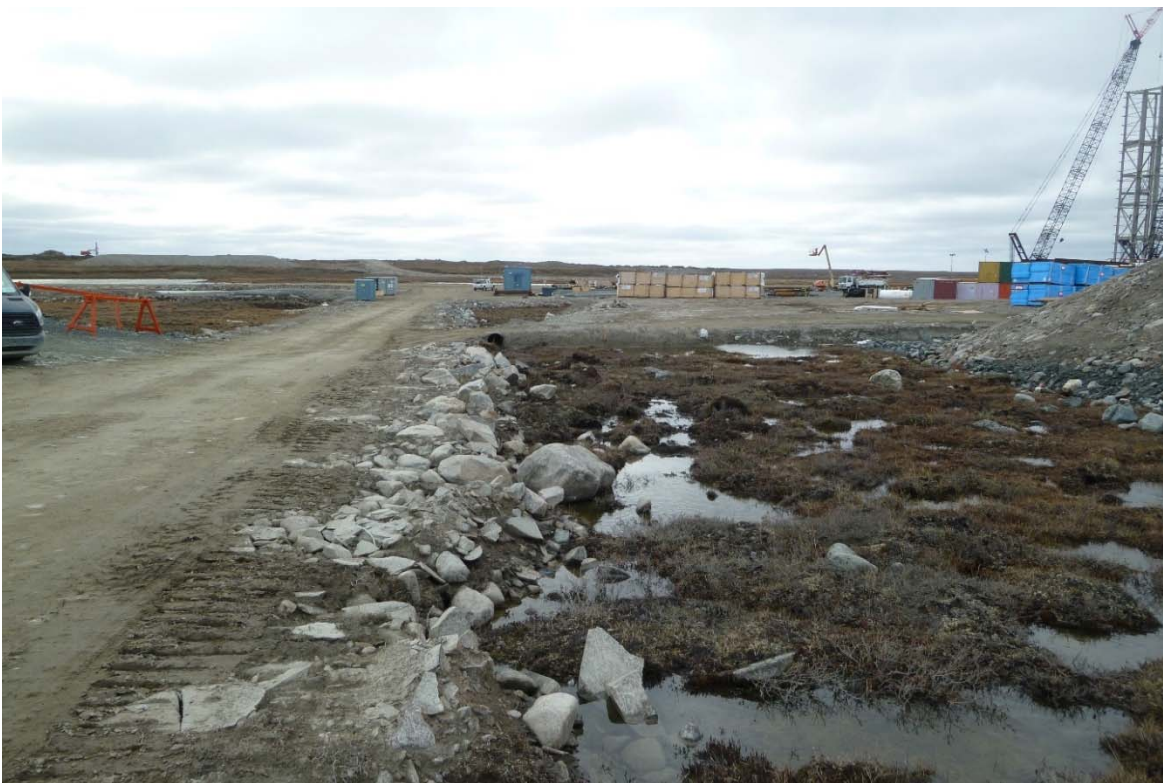
Photograph 12: Industrial Pad, Access Road at South End of Site, Culvert through Access is Exposed (21 September 2017)

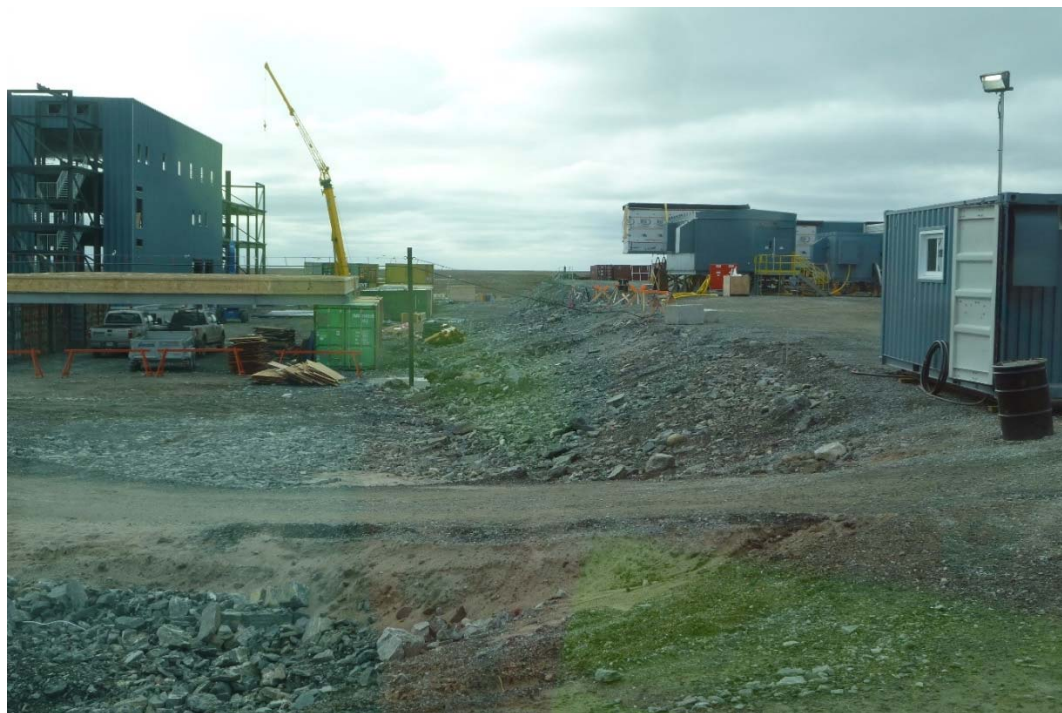
Photograph 13: Industrial Pad, Interior Slope north of Multi-services Building, Looking West (21 September 2017)

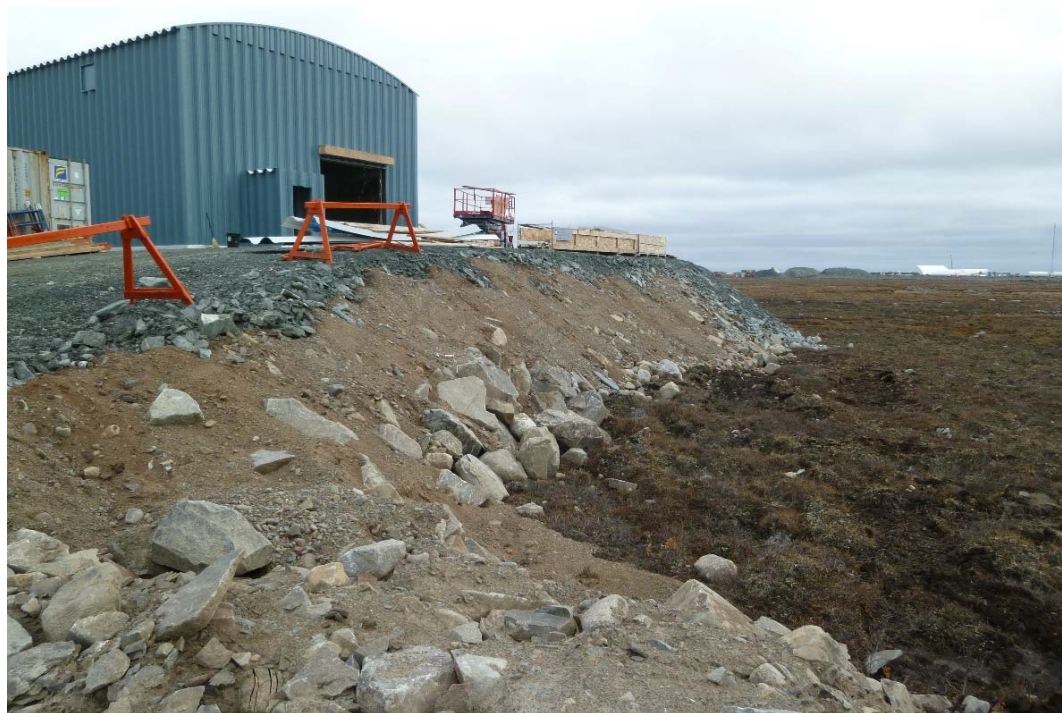
Photograph 14: Incinerator Pad, West Slope, Looking South. Variable Material Used for Pad Construction (21 September 2017)

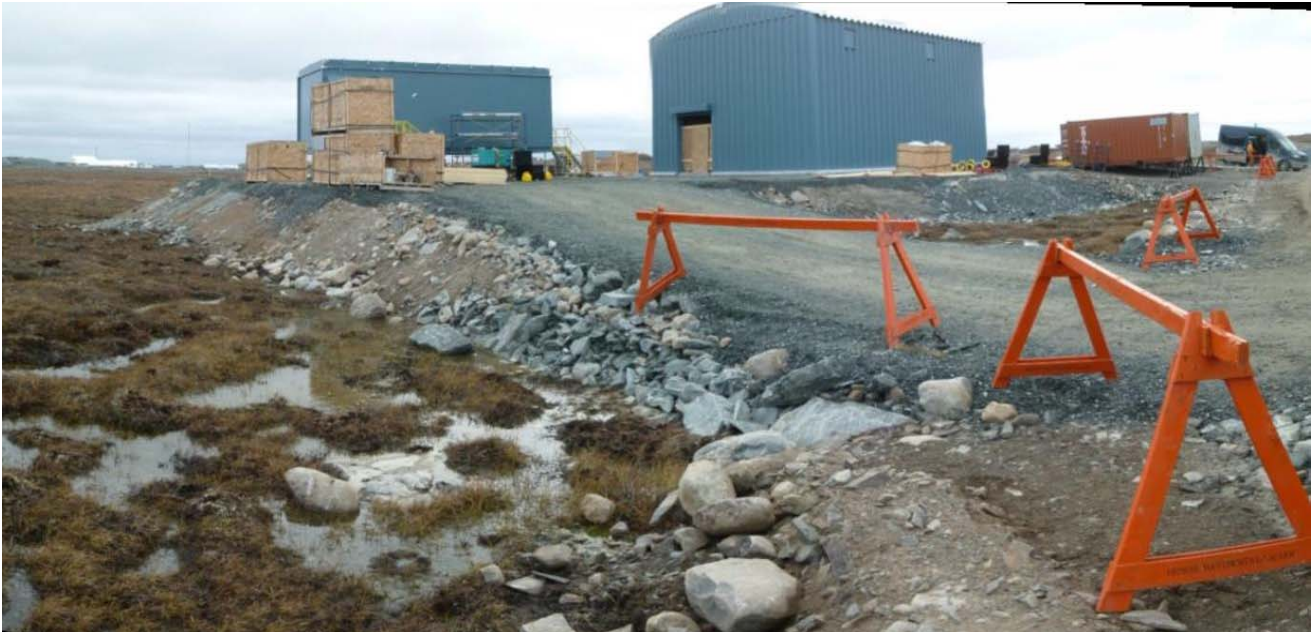
Photograph 15: Incinerator Pad, East Slope Looking South. Variable Material Used for Pad Construction. No Culvert Installed Through Access Road to Incinerator (21 September 2017)

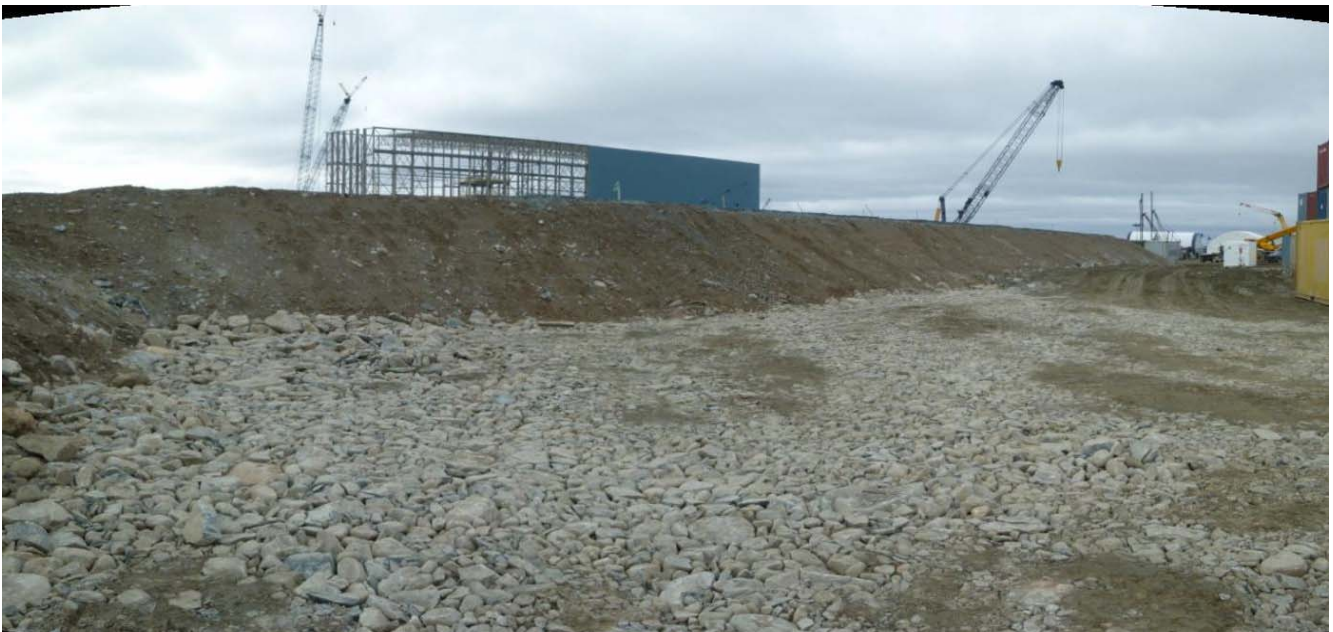
Photograph 16: Future Fuel Storage for Powerhouse, Downstream Face of East Slope, Looking Northwest (21 September 2017)

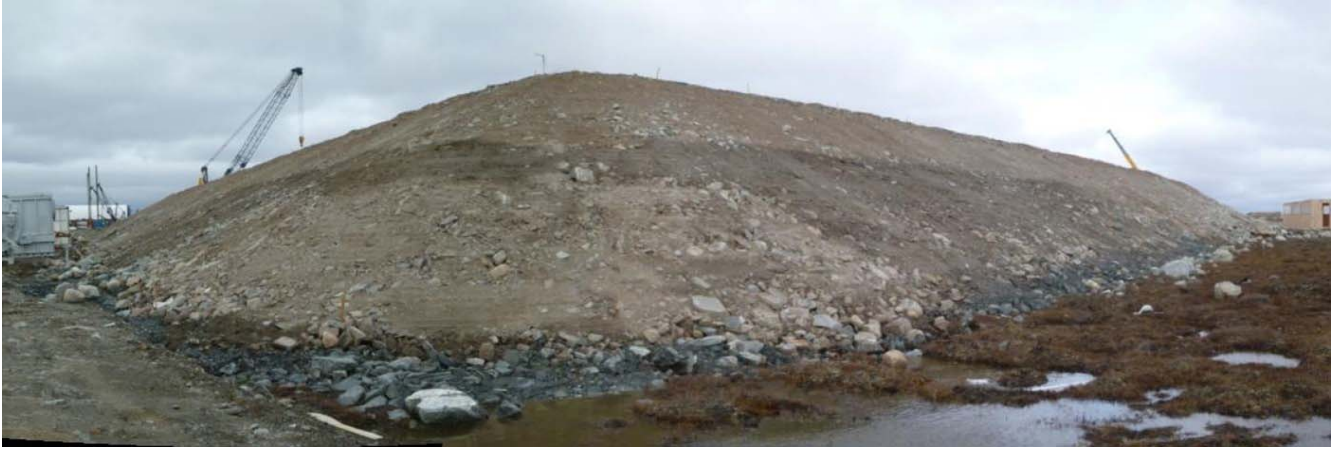
Photograph 17: Future Fuel Storage for Powerhouse, South and West Slopes, Looking Northeast (21 September 2017)

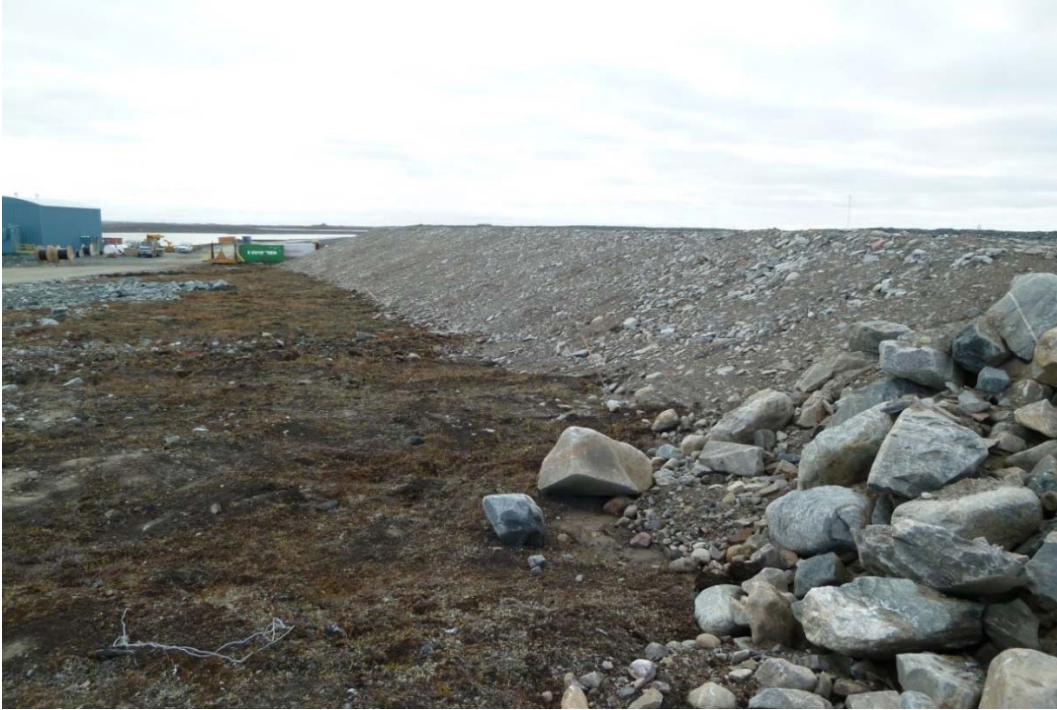
Photograph 18: Landfarm, East Slope, Looking South (20 September 2017)

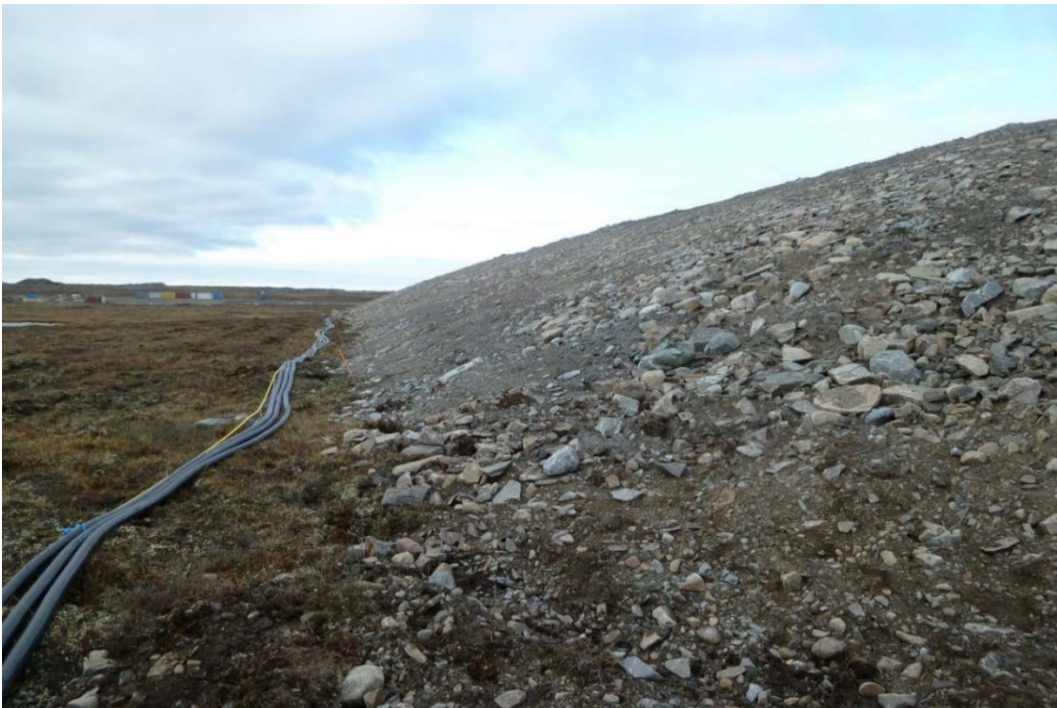
Photograph 19: Landfarm, South Slope Facing West (20 September 2017)

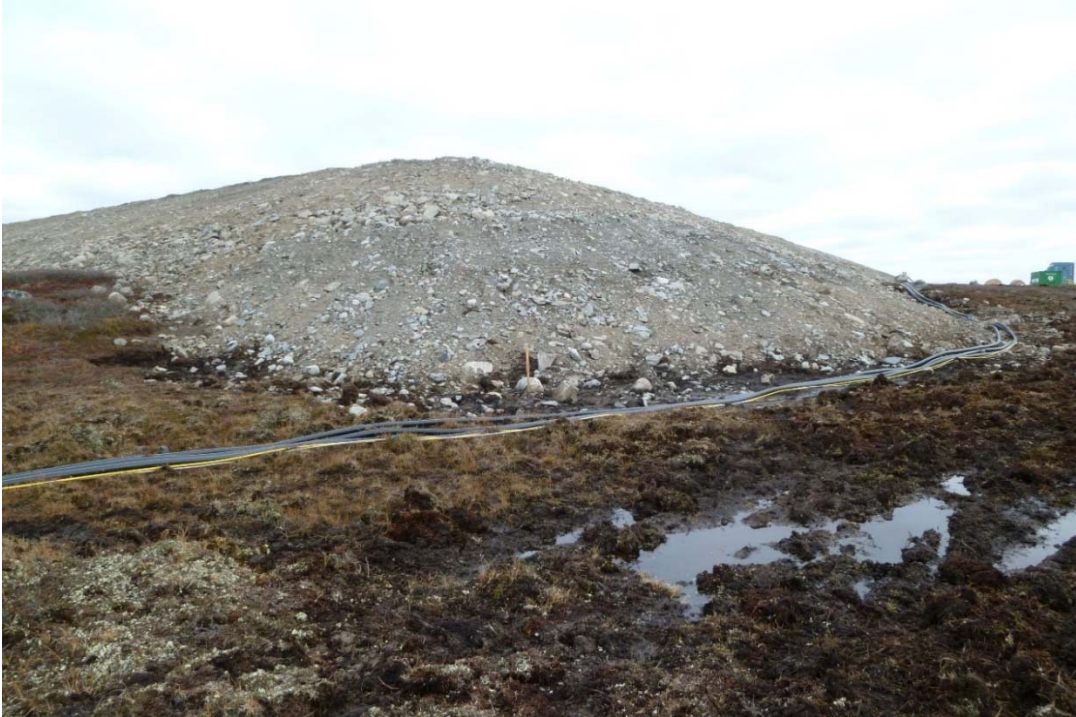
Photograph 20: Landfarm, South Corner Slope Facing North (20 September 2017)

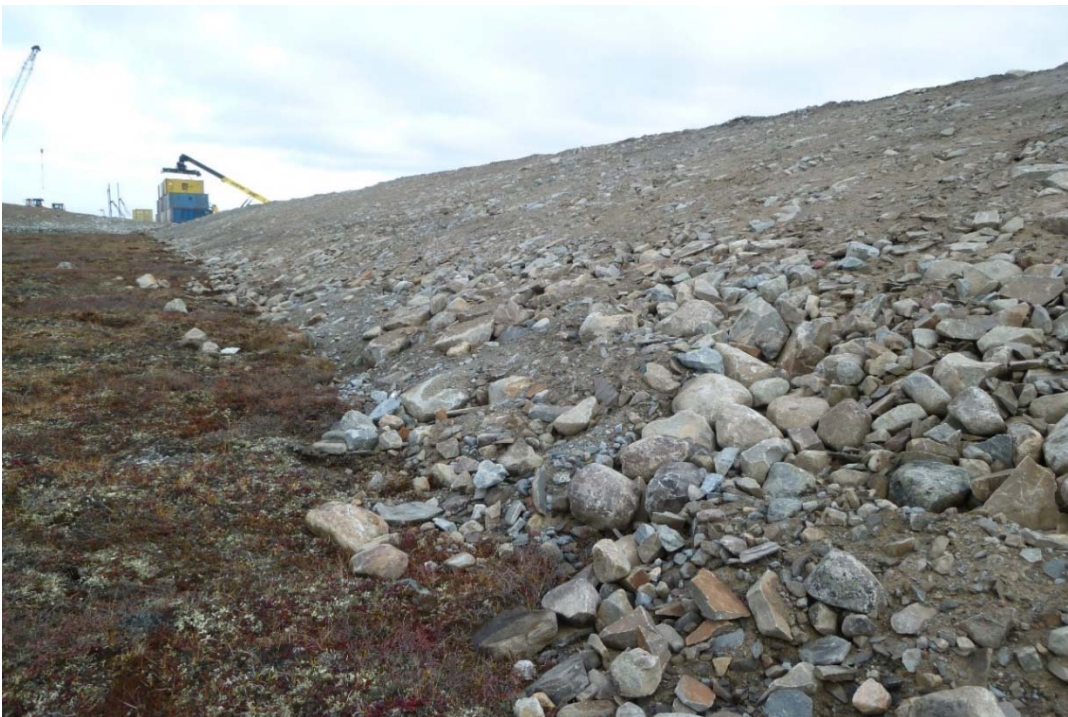
Photograph 21: Landfarm, West Slope Facing North (20 September 2017)

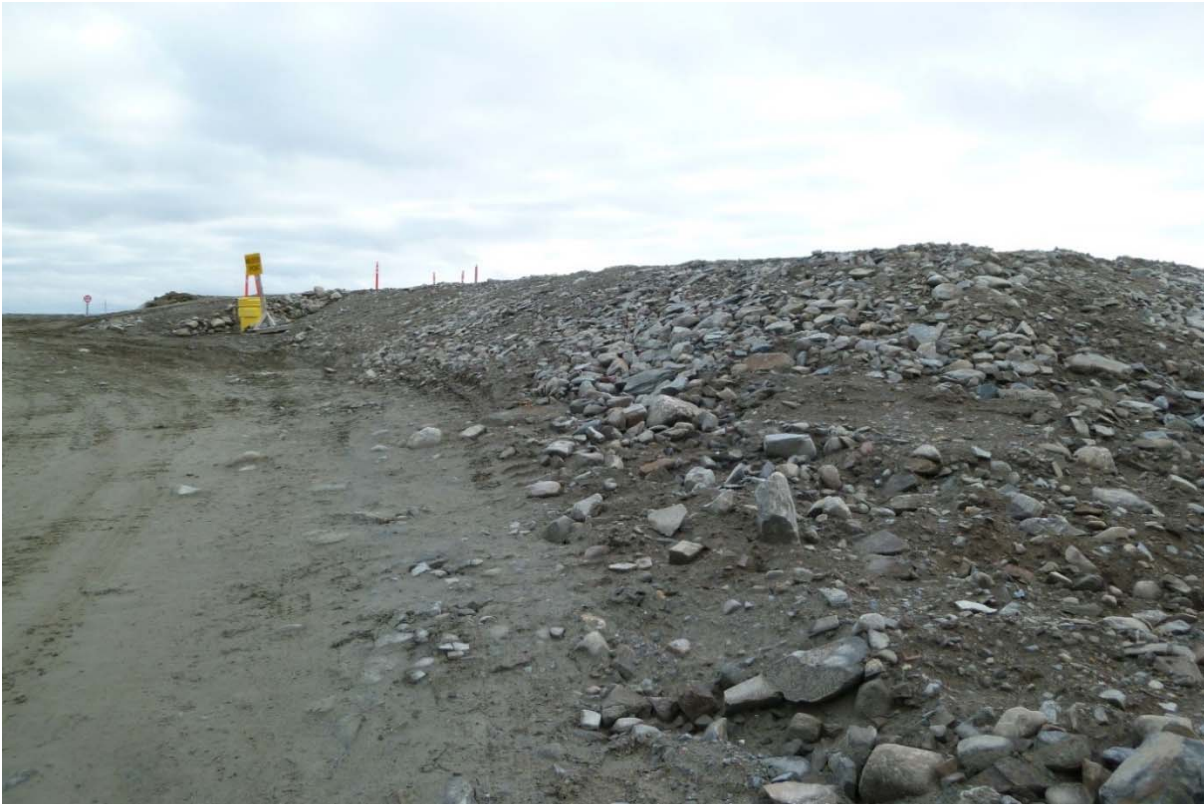
Photograph 22: Landfarm, North Slope Facing East from West Corner (20 September 2017)

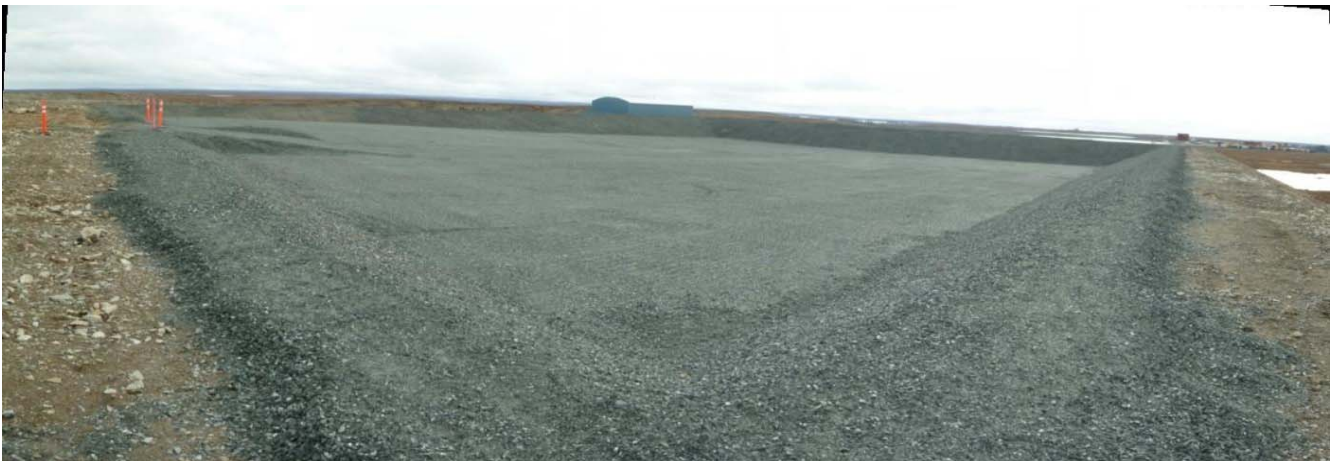
Photograph 23: Landfarm, Overview of Interior from West Corner (20 September 2017)

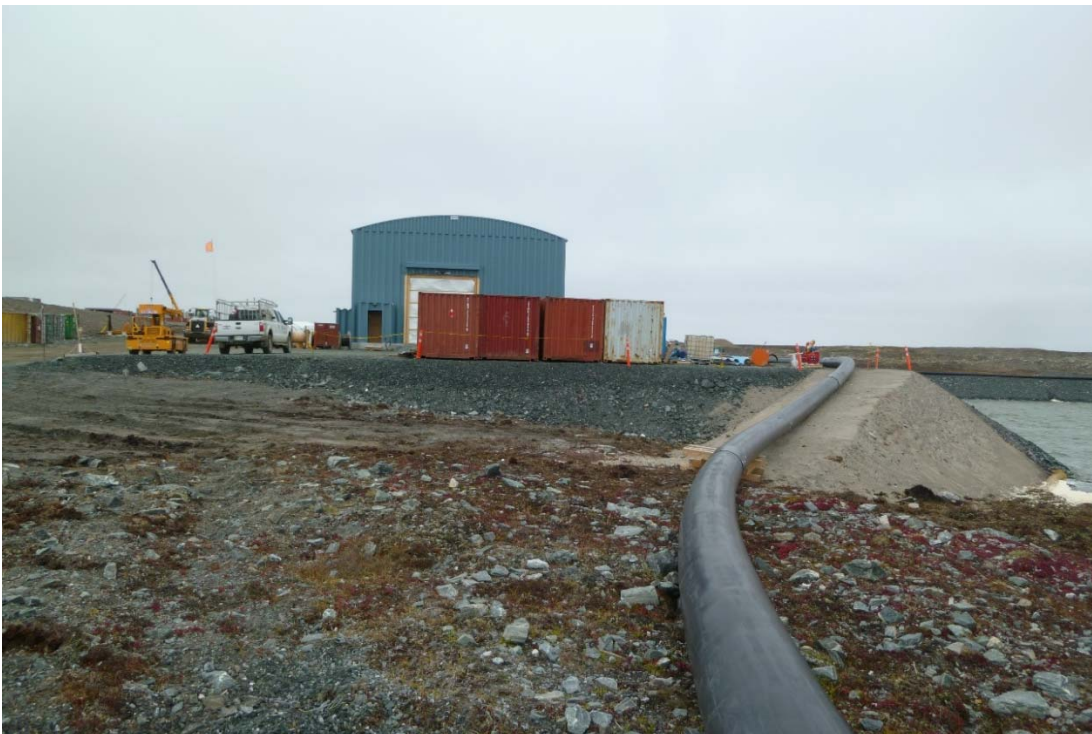
Photograph 25: Effluent Water Treatment Plant, South Slope of Pad, Looking North. Pipe Ramp Constructed with Sand that is Susceptible to Erosion (21 September 2017)

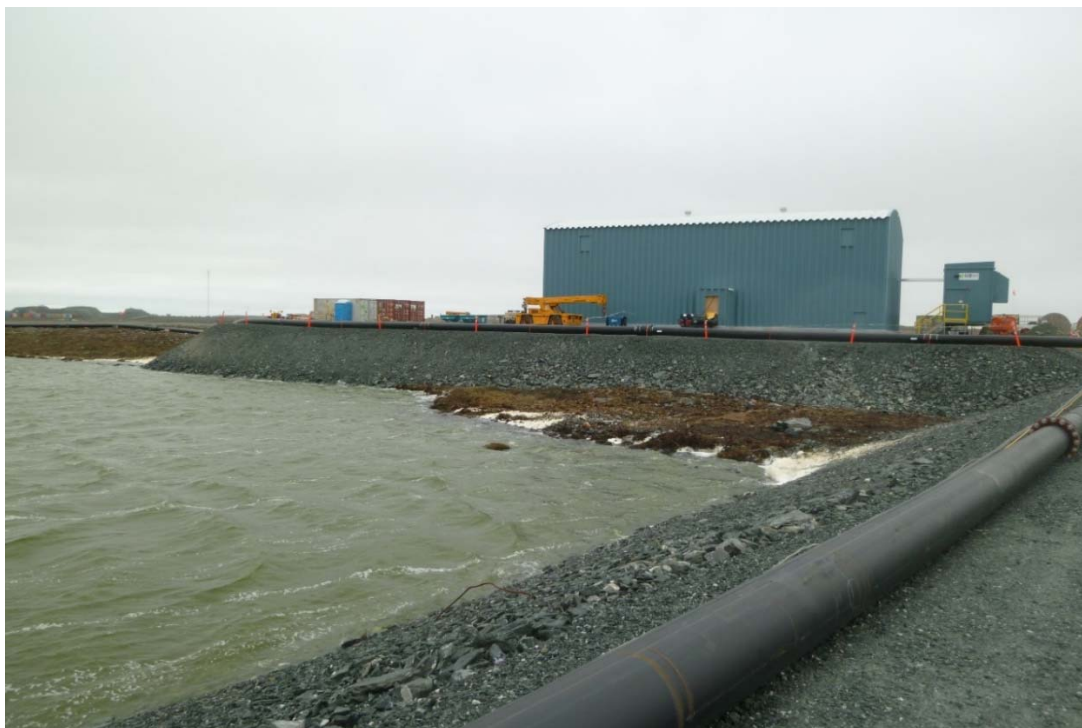
Photograph 26: Effluent Water Treatment Plant, East Slope of Pad, and Looking Southwest from Intake Causeway (21 September 2017)

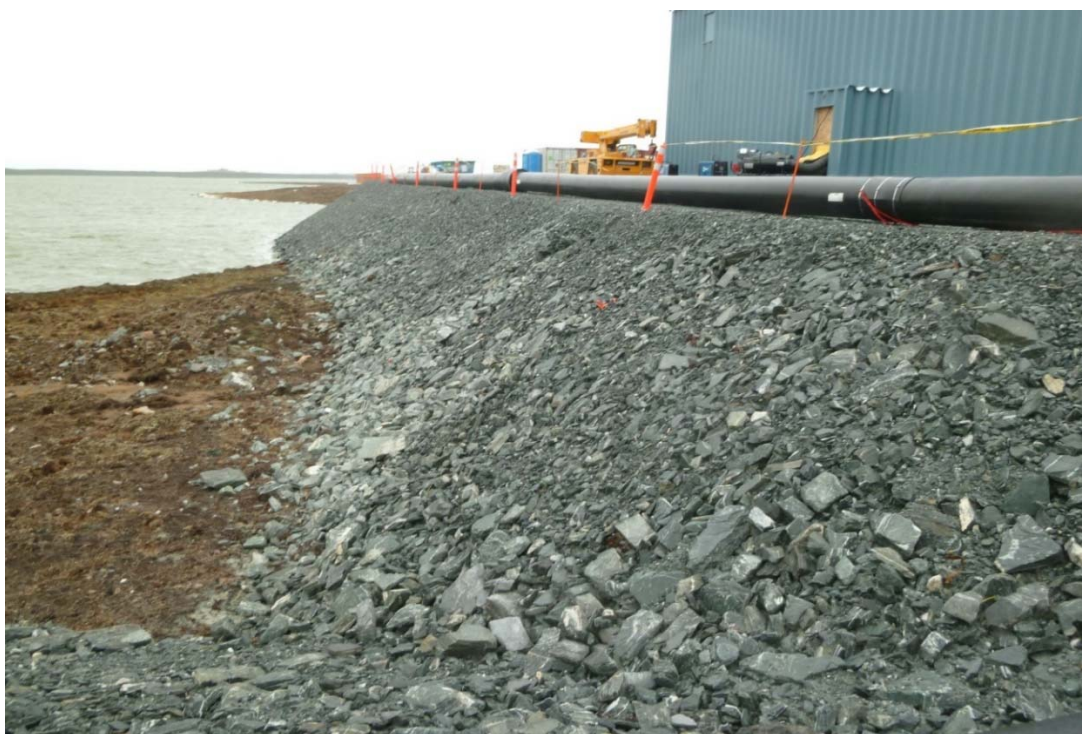
Photograph 27: Effluent Water Treatment Plant, East Slope of Pad, Looking Southeast (21 September 2017)

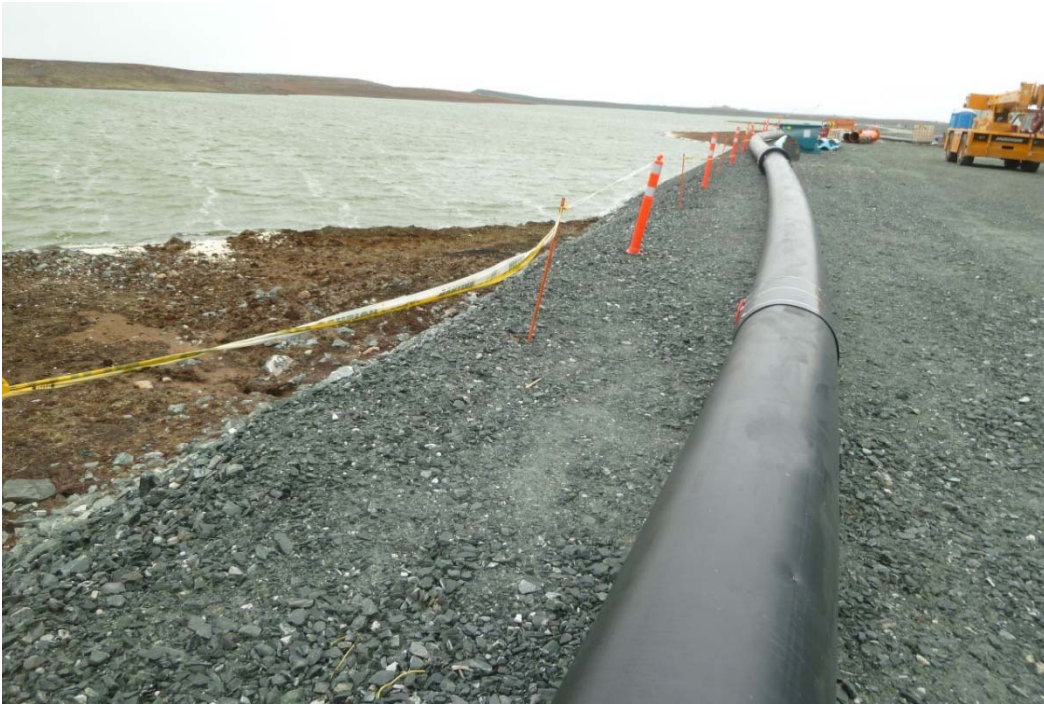
Photograph 28: Effluent Water Treatment Plant, Crest of Pad above East Slope, Looking South (21 September 2017)

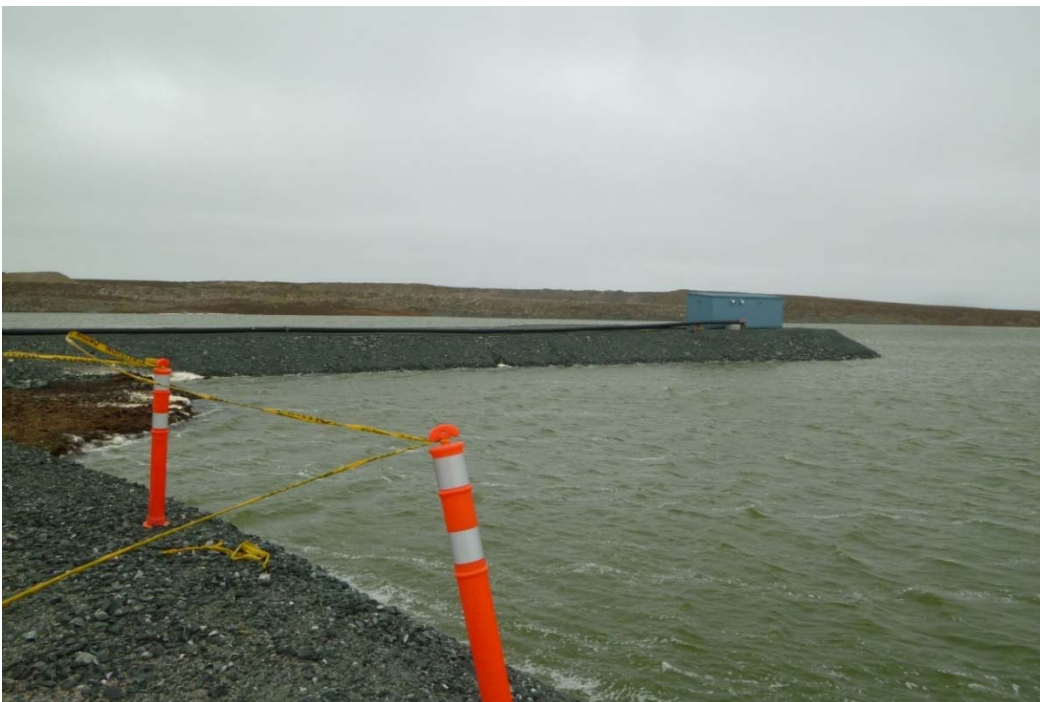
Photograph 29: Effluent Water Treatment Plant, Overview of Effluent Water Treatment Plant Intake Causeway, Looking North (21 September 2017)
