APPENDIX A4

Industrial Pad and Other Site Facilities: Landfarm, Effluent Water Treatment Plant Pad and Intake, Underground Portal No. 1 and Underground Portal No. 2, Fuel Storage, Ventilation Intake Pad, Exploration Landfill, and Operation Landfill

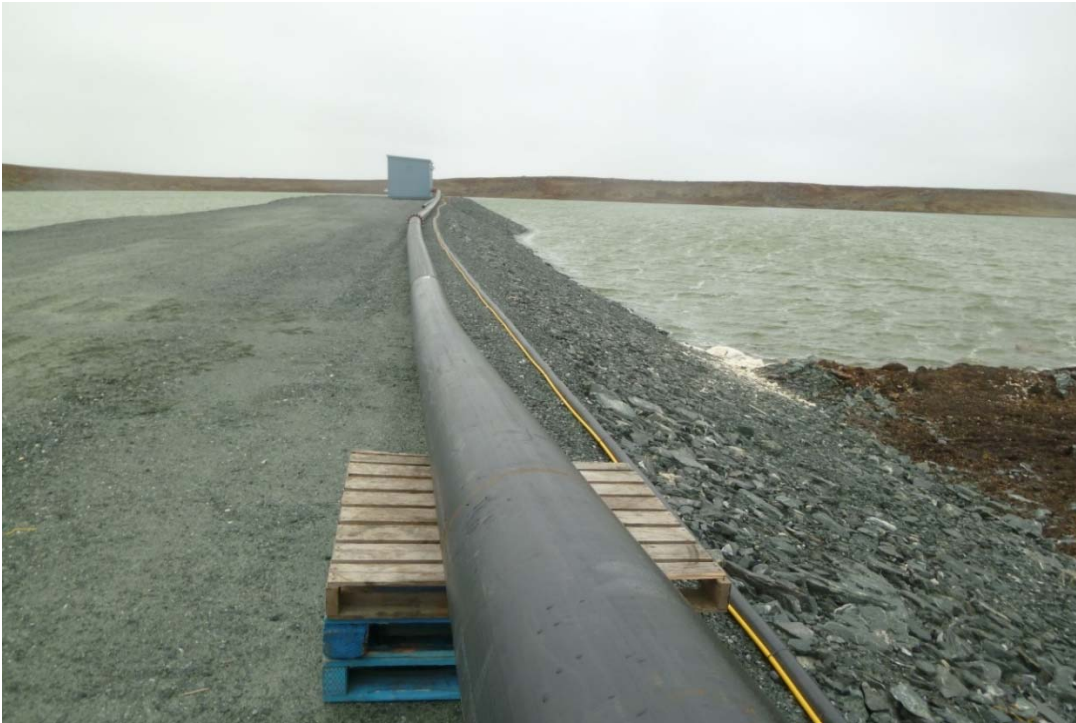
Photograph 30: Effluent Water Treatment Plant, Crest and South Slope of Intake Causeway, Looking East (21 September 2017)

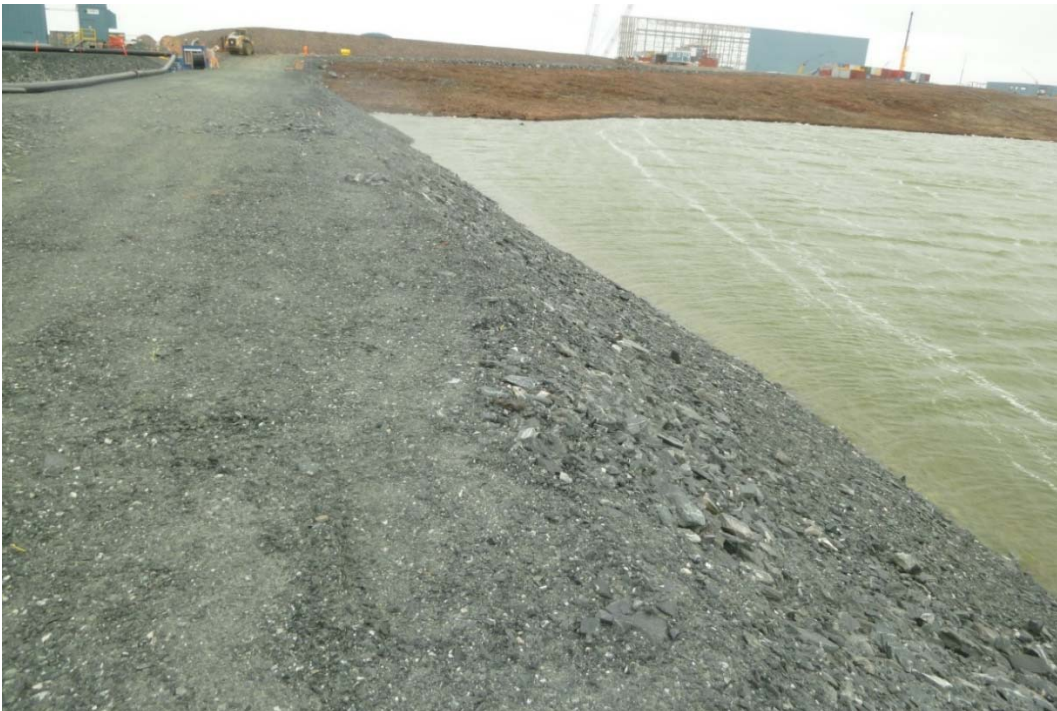
Photograph 31: Effluent Water Treatment Plant, North Slope of Intake Causeway, Looking West (21 September 2017)

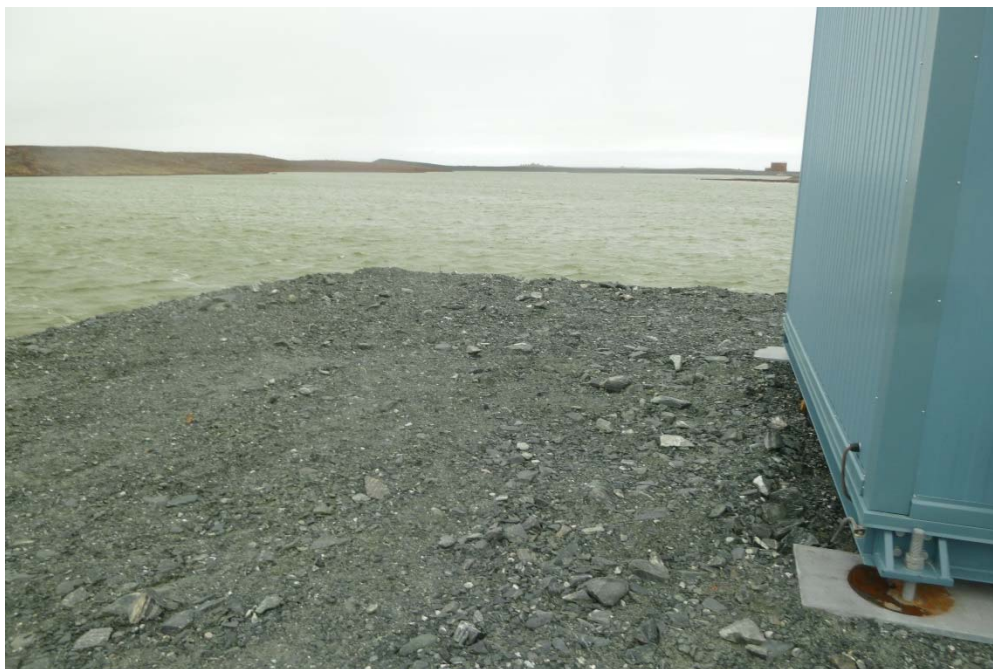
Photograph 32: Effluent Water Treatment Plant, End of Intake Causeway, Looking Northeast (21 September 2017)

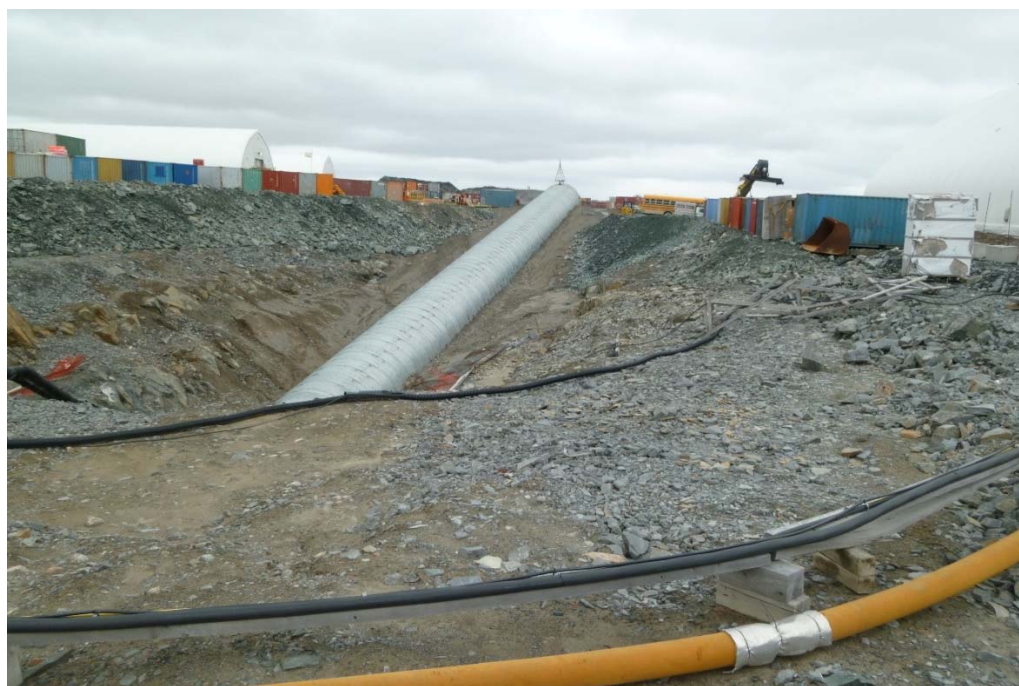
Photograph 35: Portal No. 1, Looking Northeast (21 September 2017)

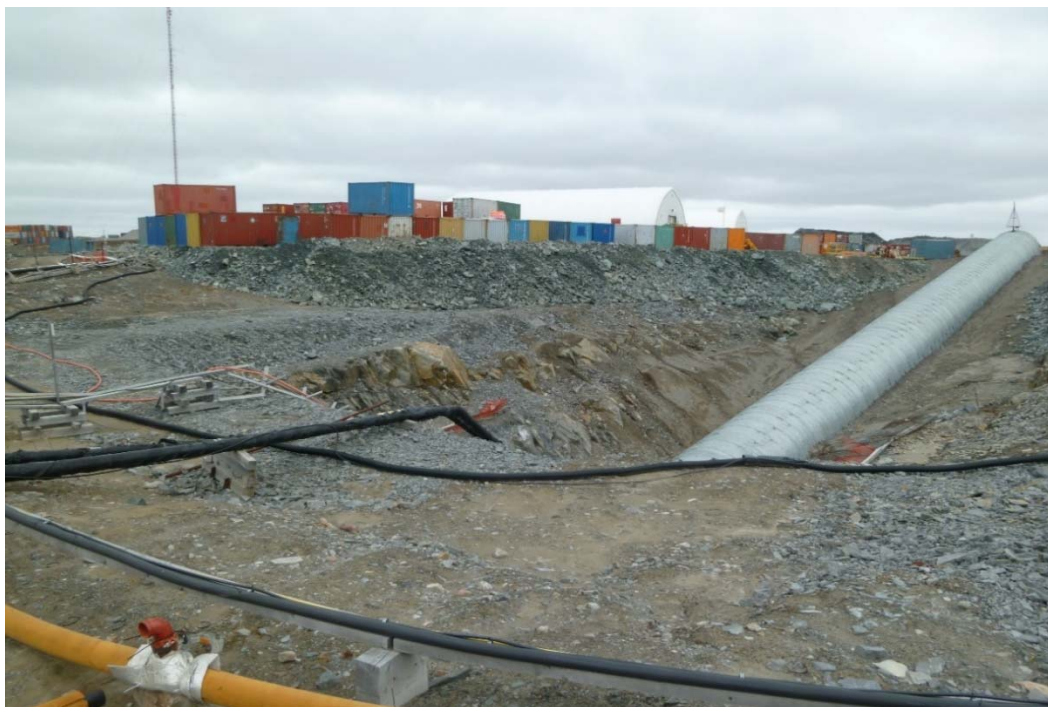
Photograph 36: Portal No. 1, Looking North at Perimeter Berm (21 September 2017)

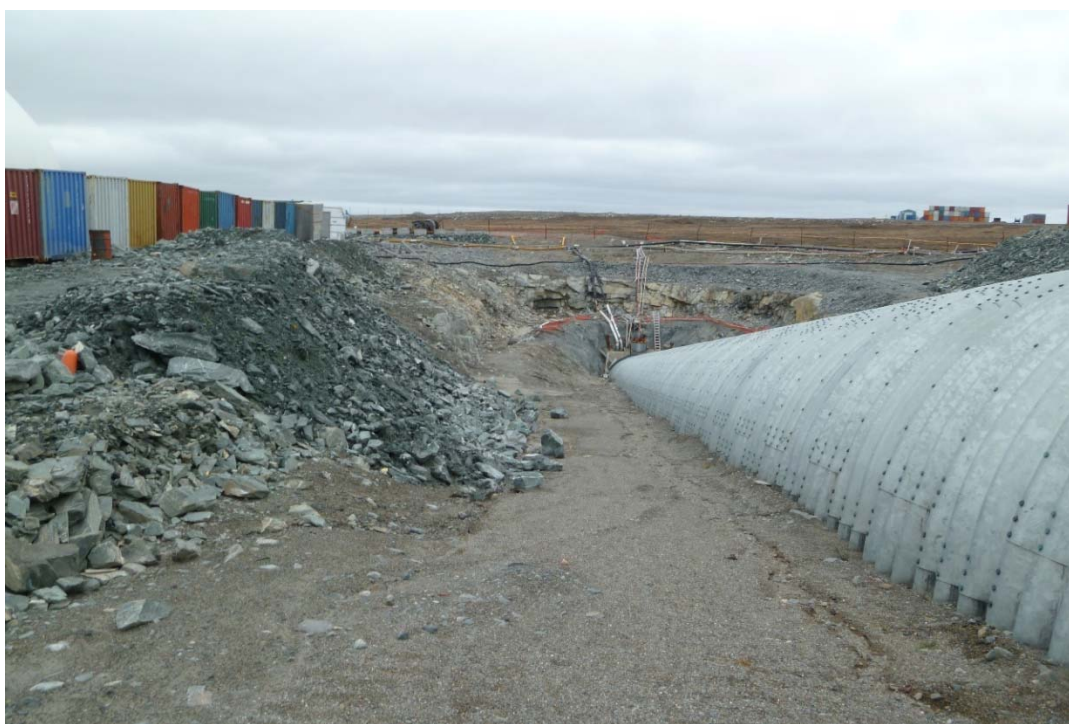
Photograph 37: Portal No. 1, looking Southwest at South Perimeter Berm and Rock Cut from Adjacent to Portal Entrance (21 September 2017)

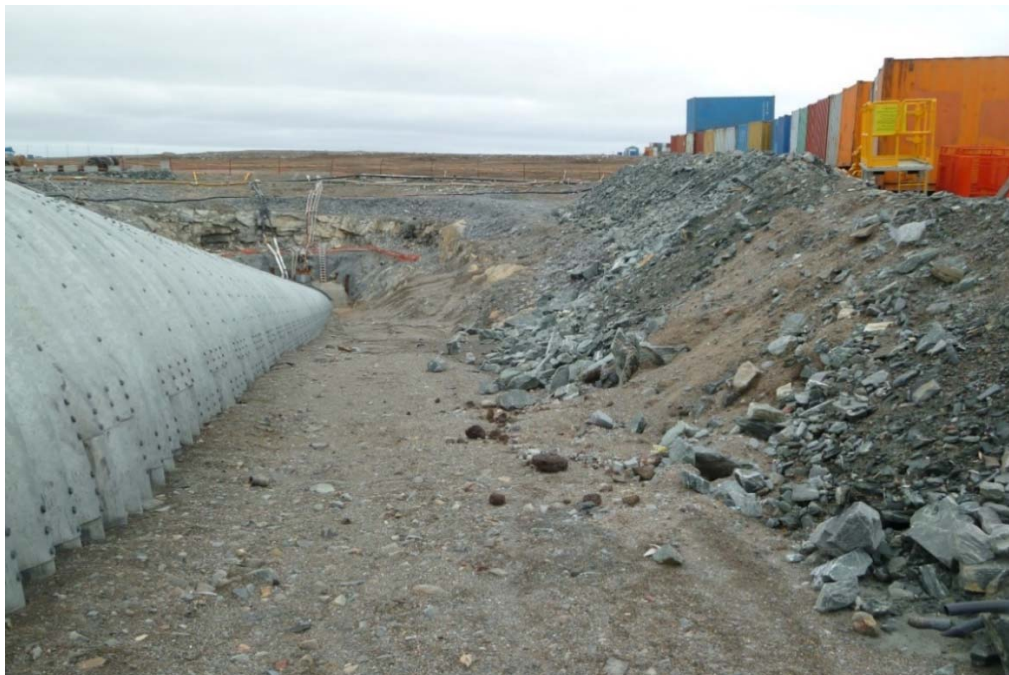
Photograph 38: Portal No. 1, Looking Southwest at North Perimeter Berm and Rock Cut from Adjacent to Portal Entrance (21 September 2017)

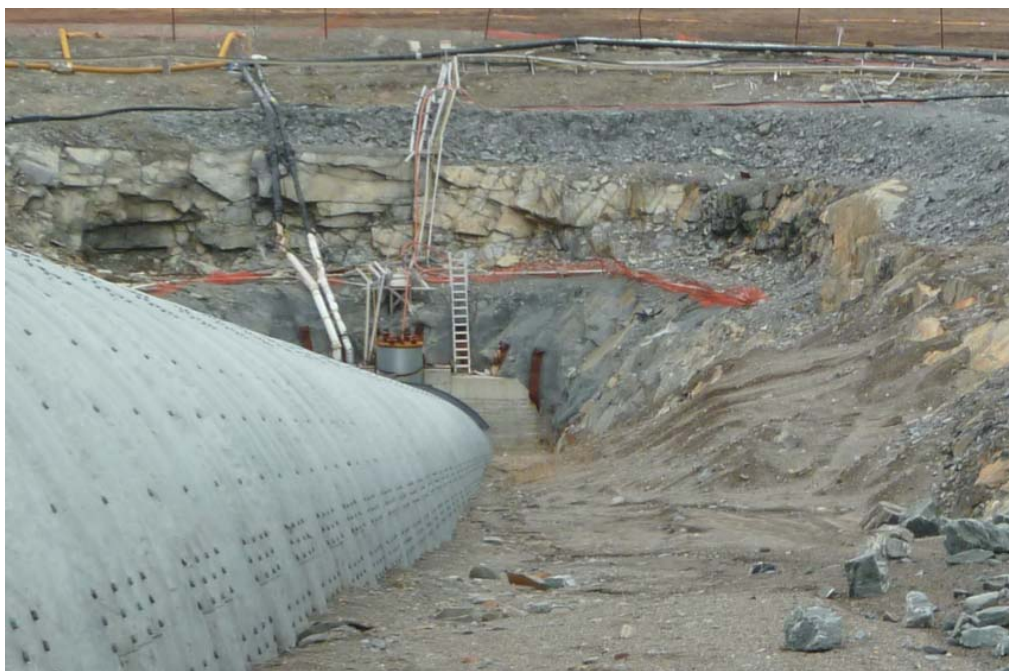
Photograph 39: Portal No. 1, Looking Southwest at Rock Slopes (21 September 2017)

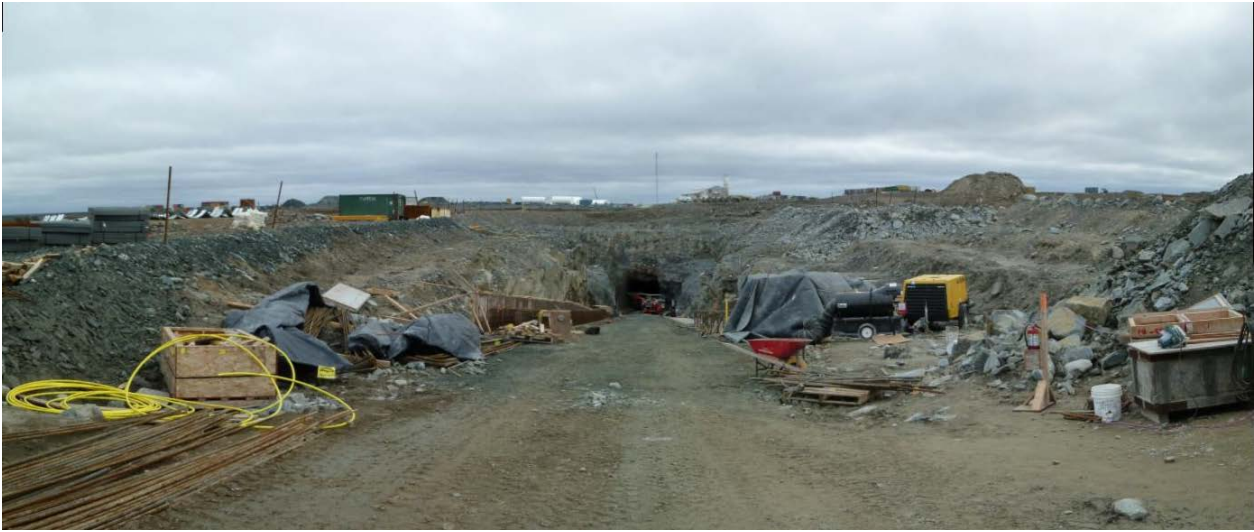
Photograph 40: Portal No. 2, Looking South (21 September 2017)

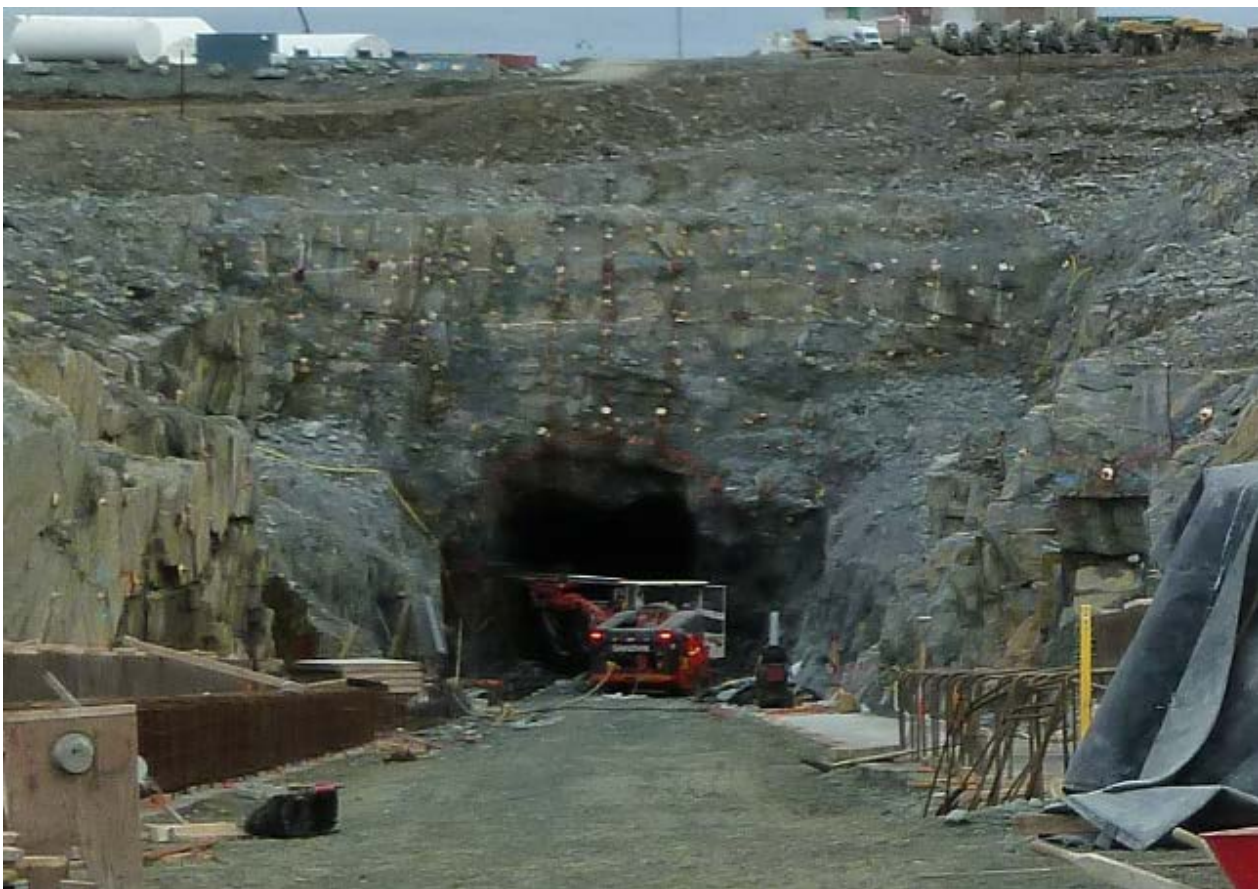
Photograph 41: Portal No. 2, Closeup of Portal Entrance, Looking South (21 September 2017)

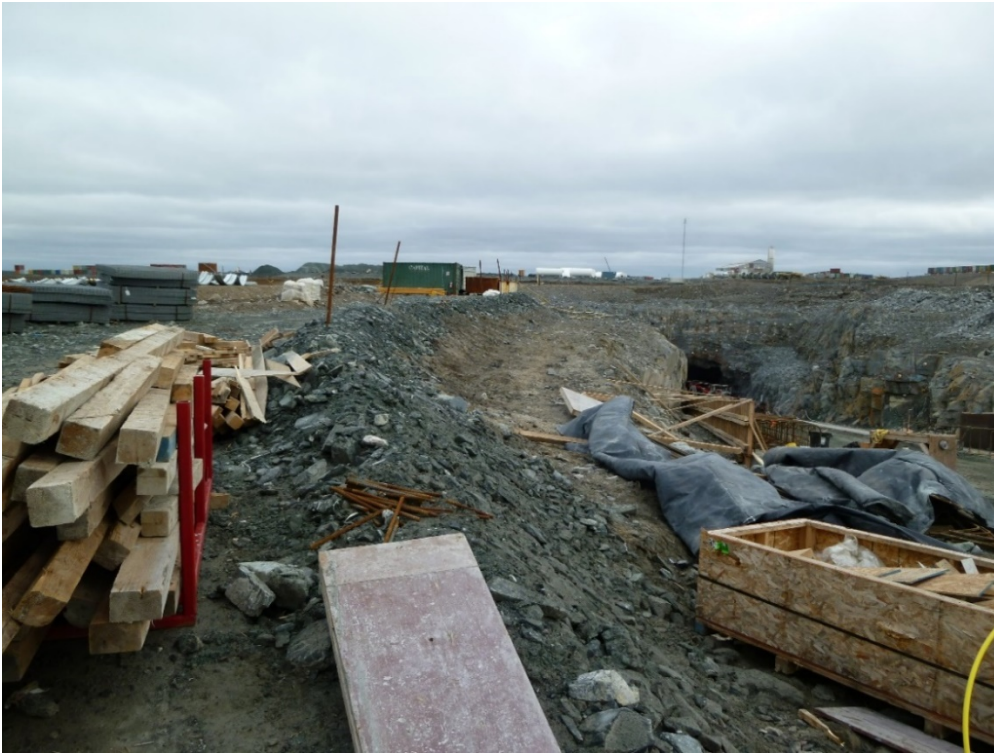
Photograph 42: Portal No. 2, East Perimeter Berm, Looking South (21 September 2017)

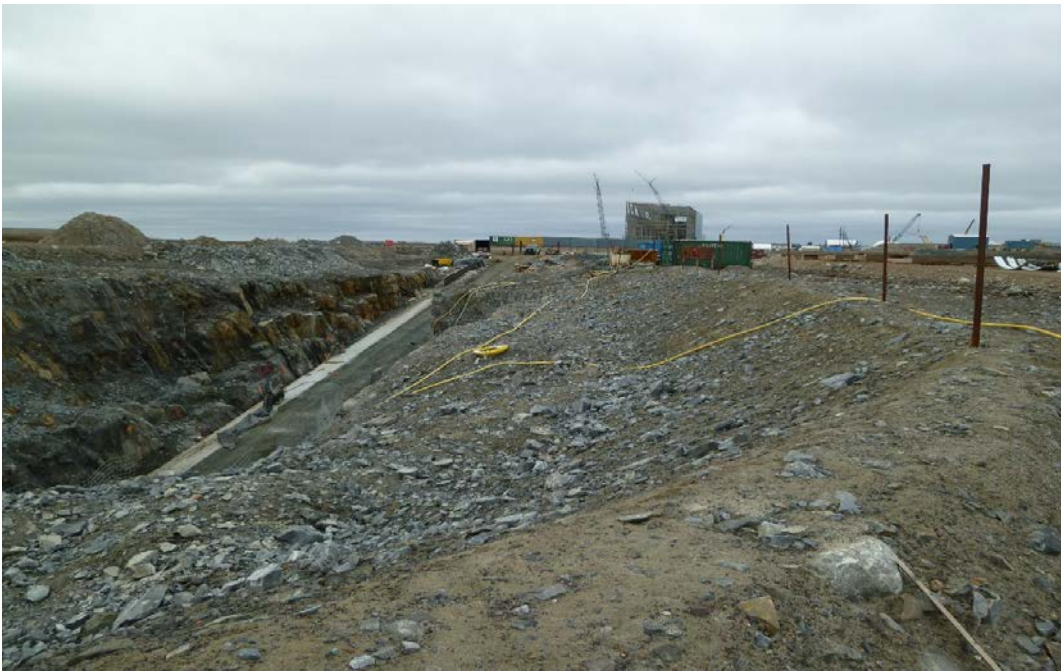
Photograph 43: Portal No. 2, East Perimeter Berm, Looking North (21 September 2017)

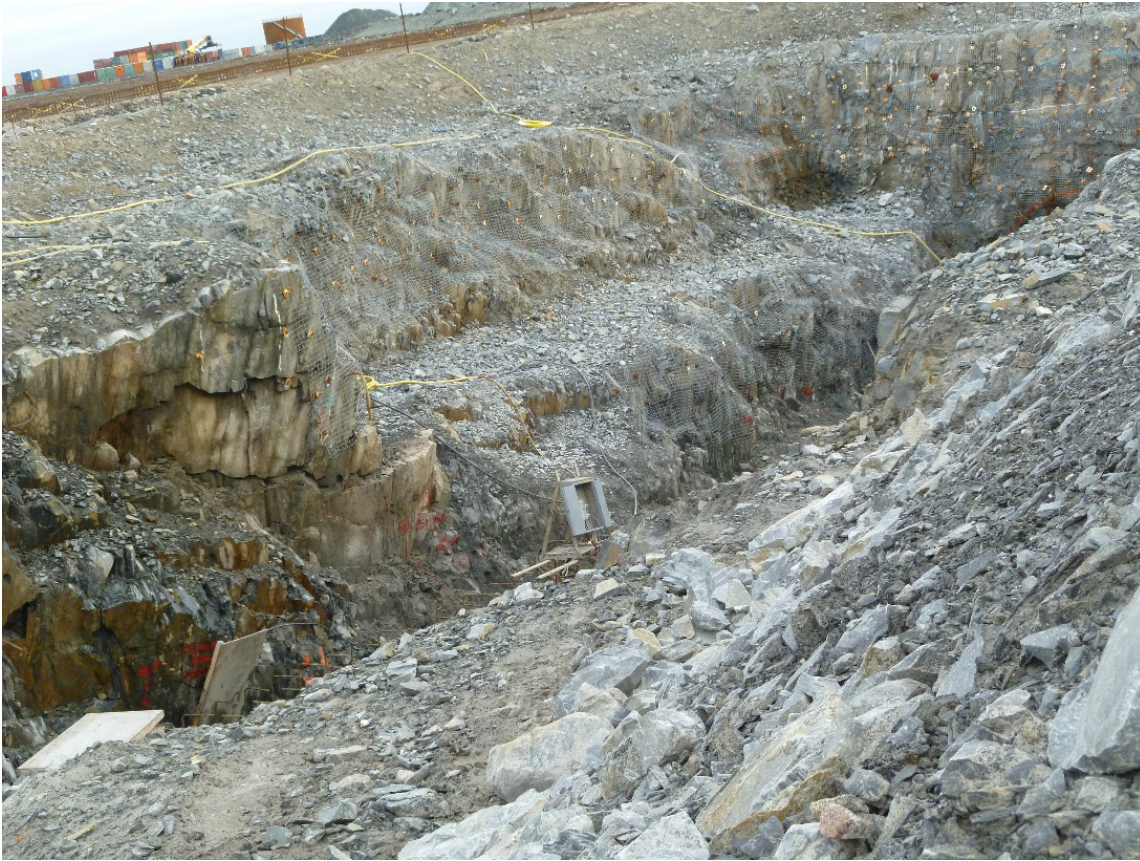
Photograph 44: Portal No. 2, East Rock Cut Face, Looking Southeast, and Some Evidence of Ravelling of Loose Rock onto the Rockfill Bench (21 September 2017)

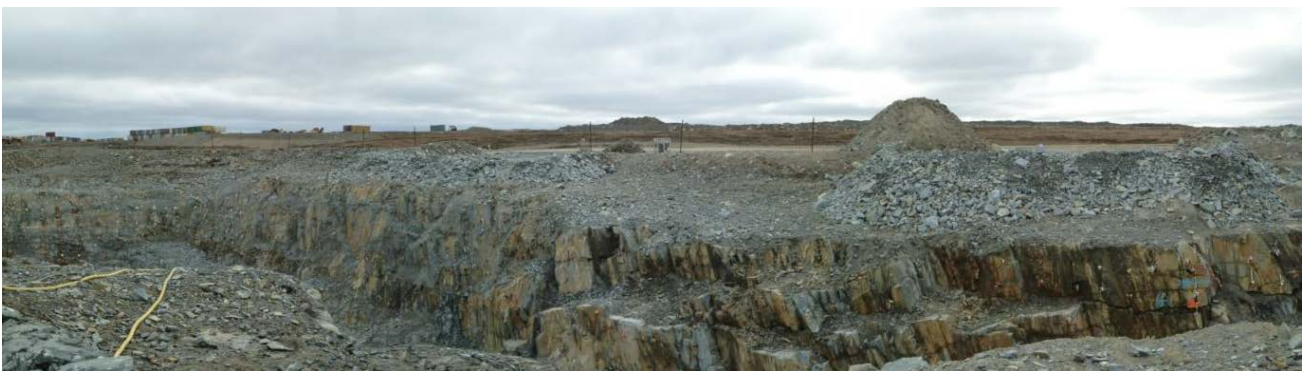
Photograph 45: Portal No. 2, West Perimeter Rock Cut Face and Perimeter Berm, Looking West (21 September 2017)

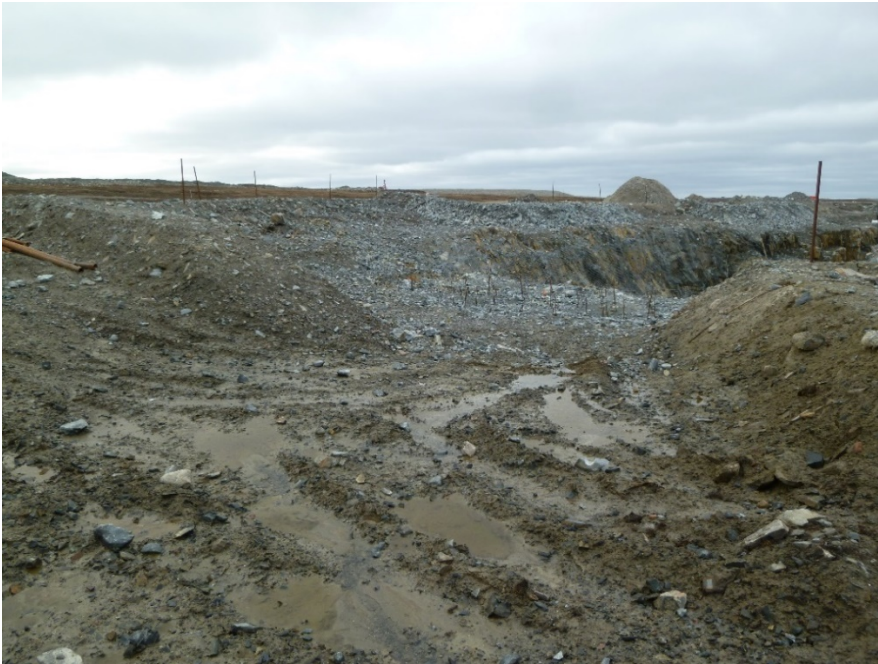
Photograph 46: Portal No. 2, Opening in Perimeter Berm above South End of Portal Cut, Looking Northwest. No Water Management (21 September 2017)

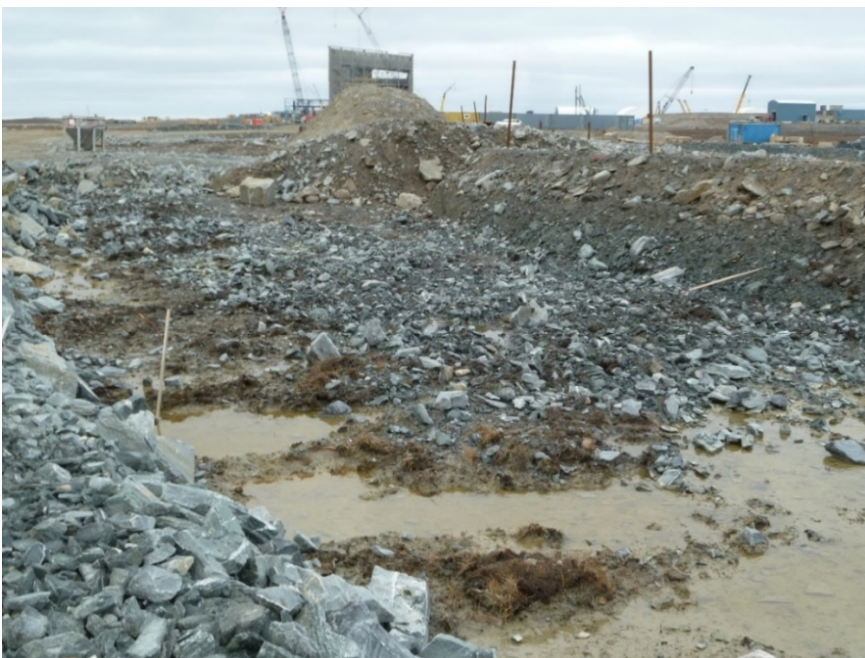
Photograph 47: Portal No. 2, Water Poned Adjacent to the West Side of the Portal Cut, Looking North. No Water Management (21 September 2017)

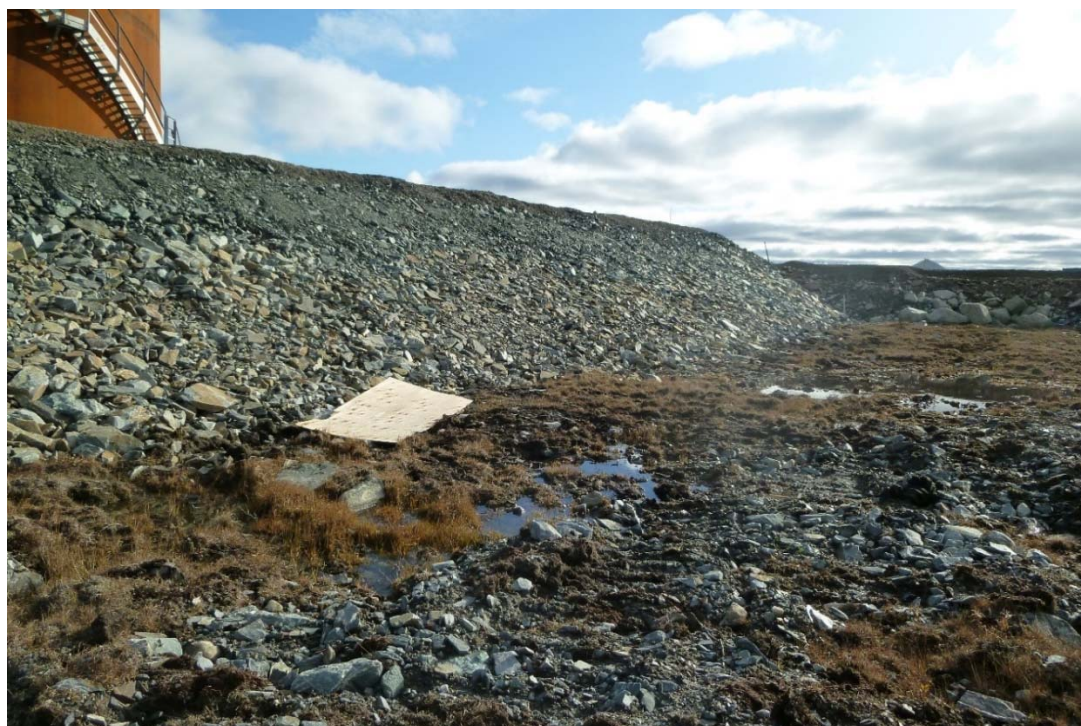
Photograph 49: New Fuel Tank Storage Area, Outer Slope of Northwest Berm, Looking Southwest (19 September 2017)

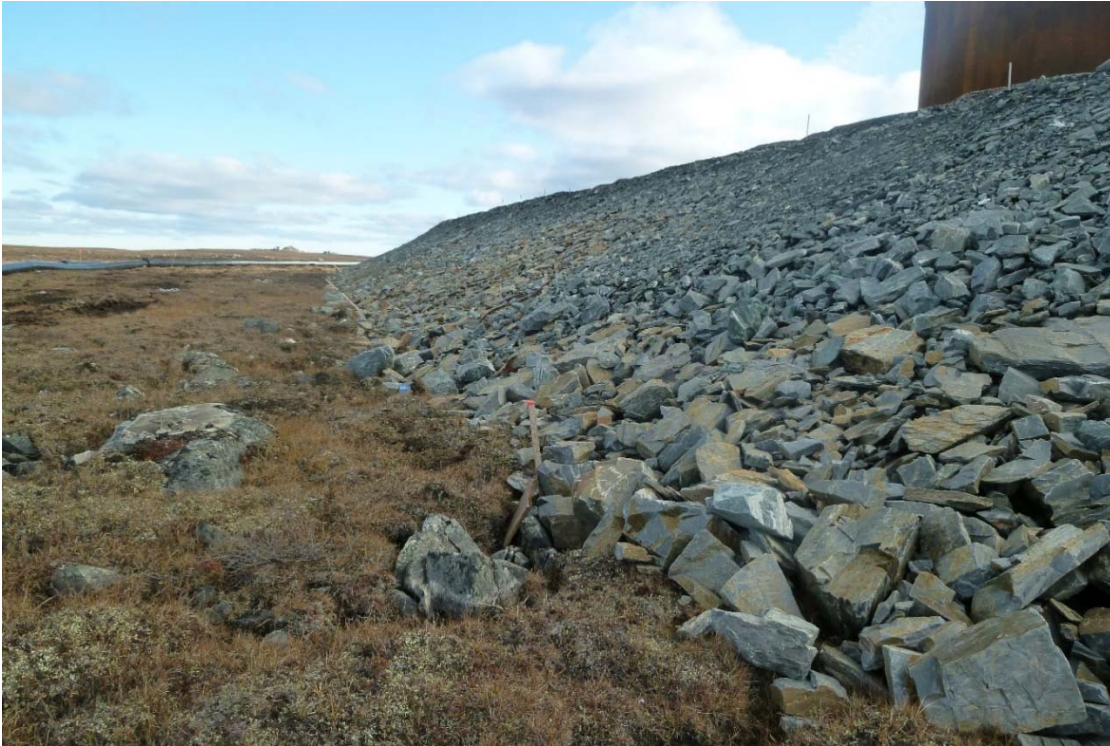
Photograph 50: New Fuel Tank Storage Area, Outer Slope of Northeast Berm, Looking Southeast (19 September 2017)

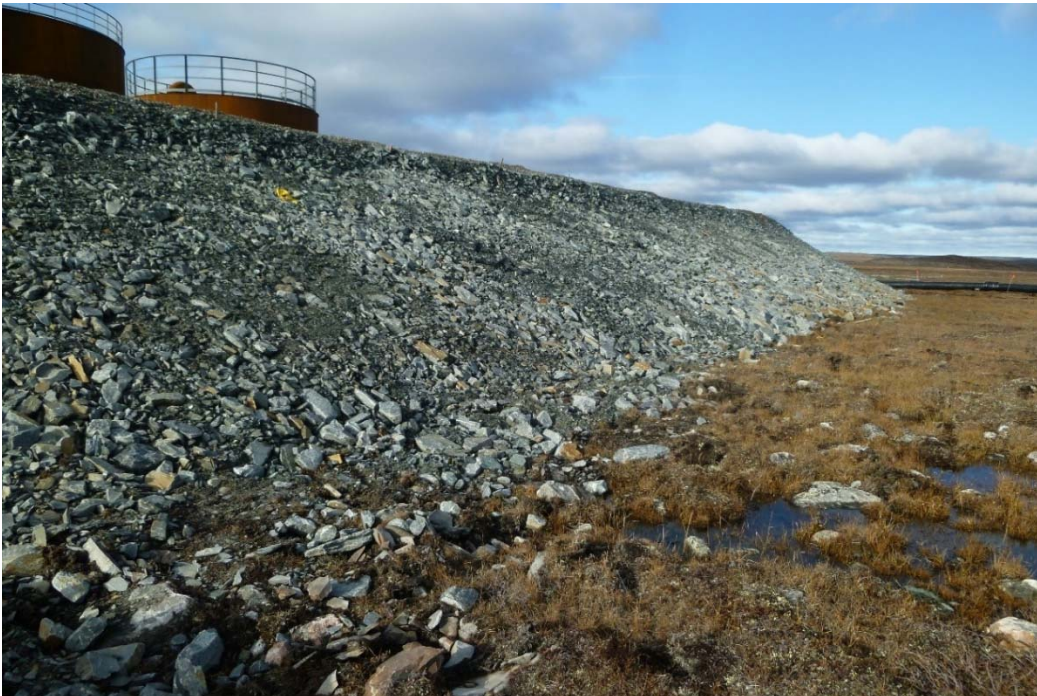
Photograph 51: New Fuel Tank Storage Area, Outer Slope of Southeast Berm, Looking Northeast (19 September 2017)

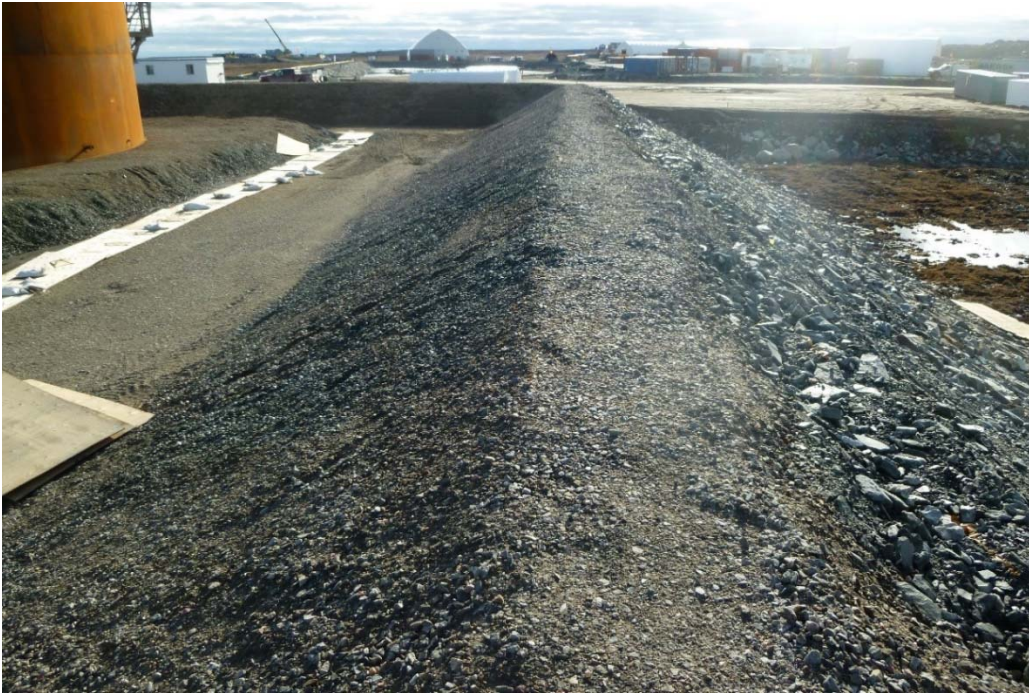
Photograph 52: New Fuel Tank Storage Area, Crest and Inside Slope of Northwest Berm, Looking Southwest (19 September 2017)

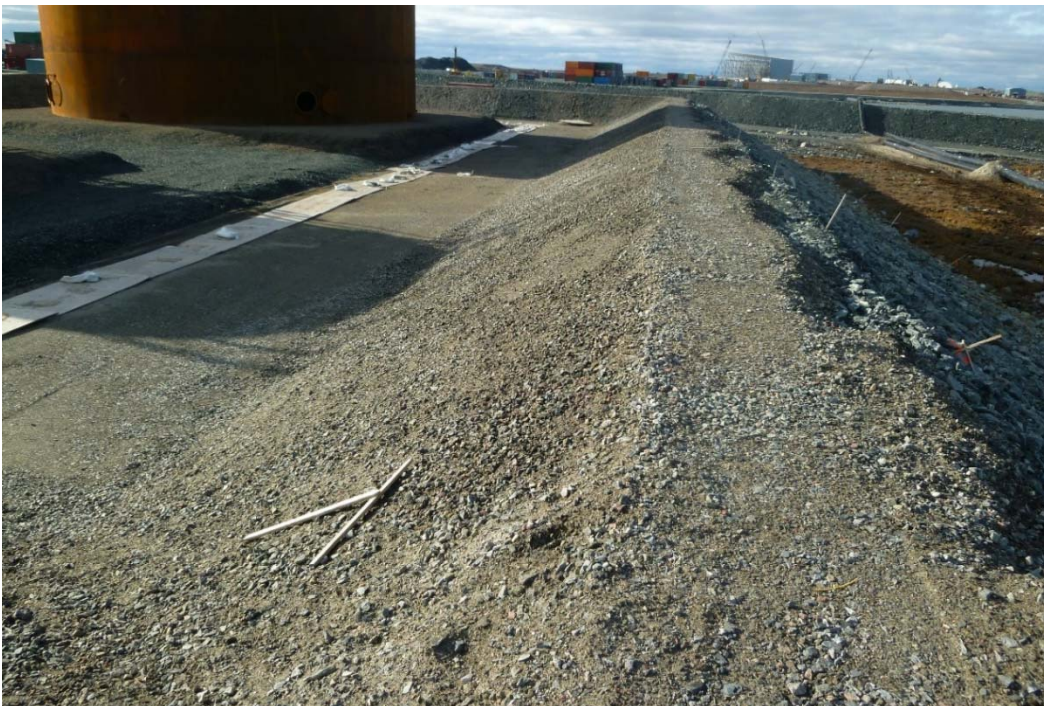
Photograph 53: New Fuel Tank Storage Area, Crest and Inside Slope of Northeast Berm, Looking Northwest (19 September 2017)

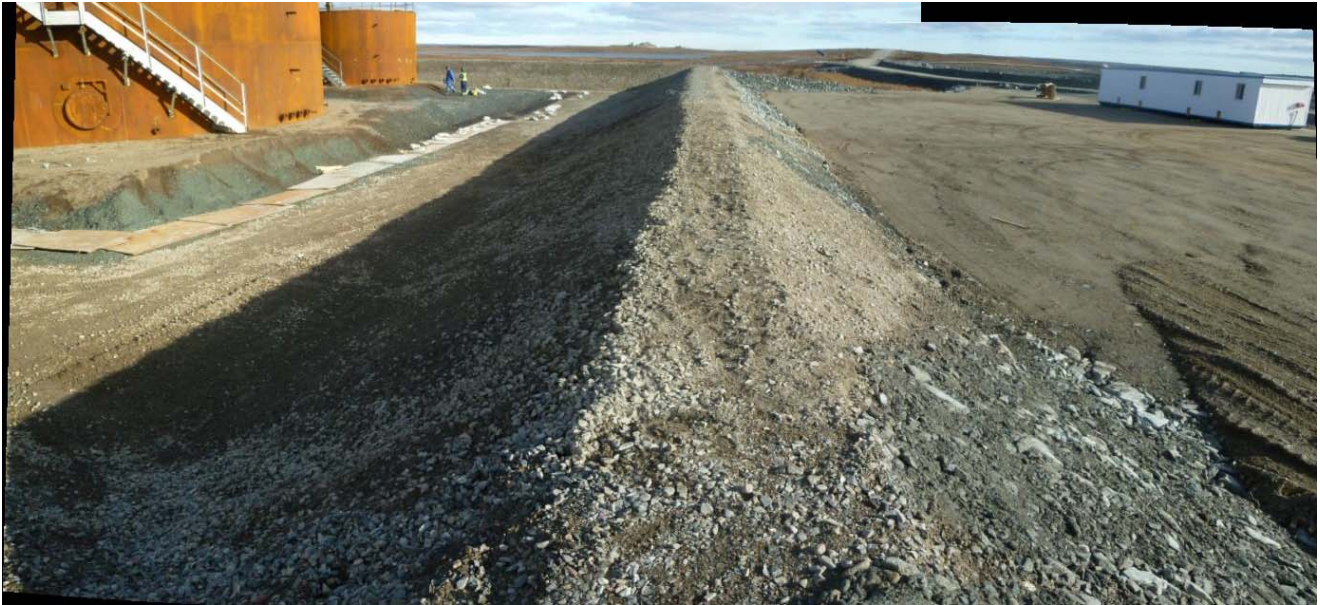
Photograph 54: New Fuel Tank Storage Area, Southwest Berm, Looking Southeast (19 September 2017)

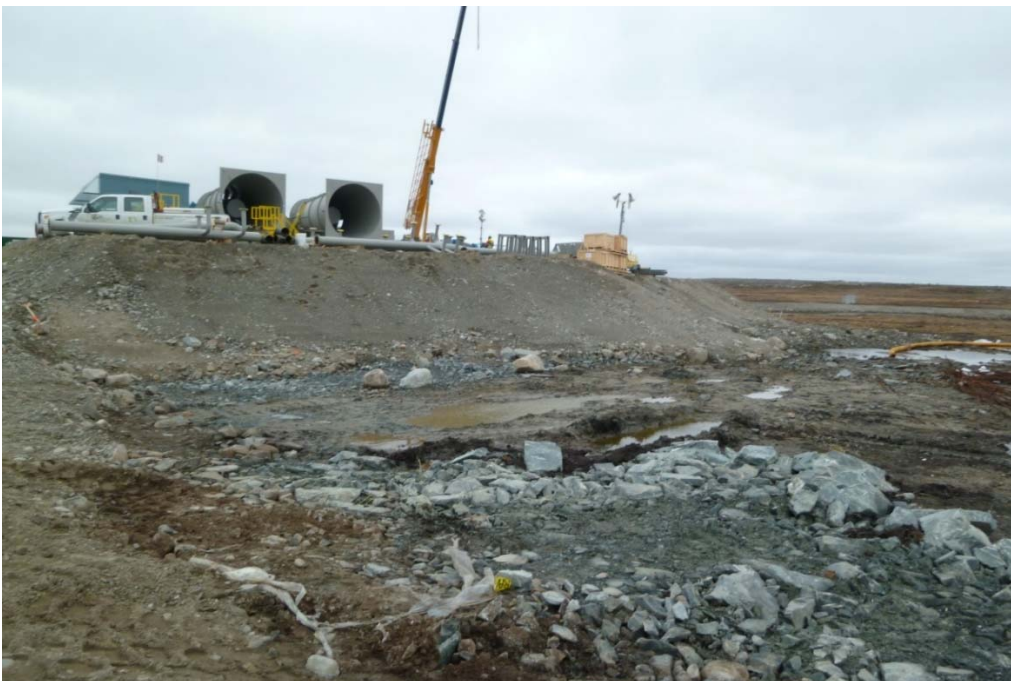
Photograph 56: Ventilation Intake Pad, West Slope, Looking East. Some Fine Grained Material used for Pad which may be Susceptible to Erosion (21 September 2017)

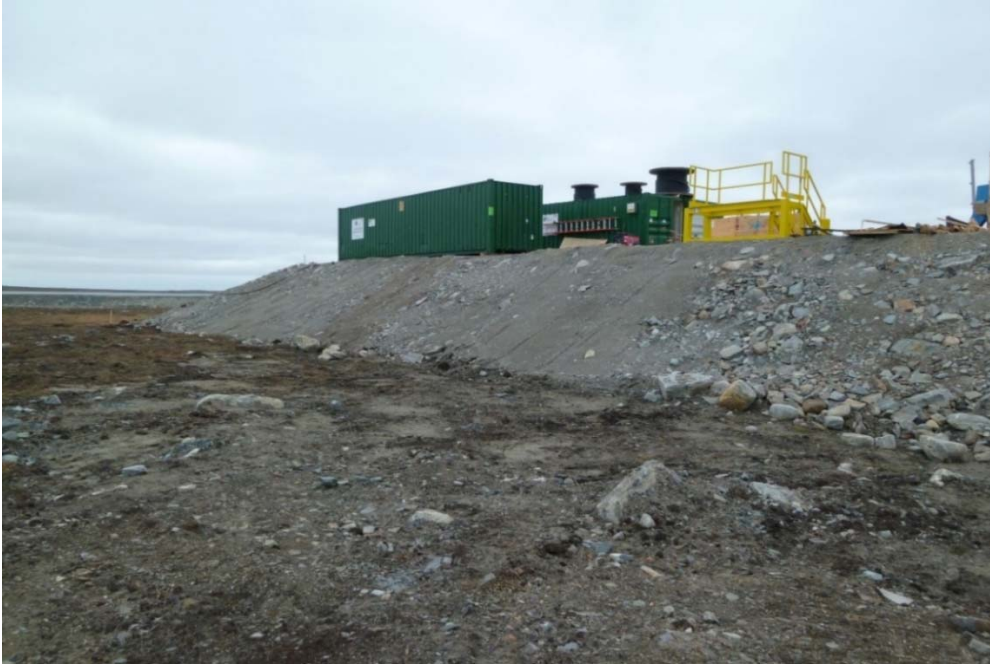
Photograph 57: Ventilation Intake Pad, East Slope, Facing Southwest (21 September 2017)

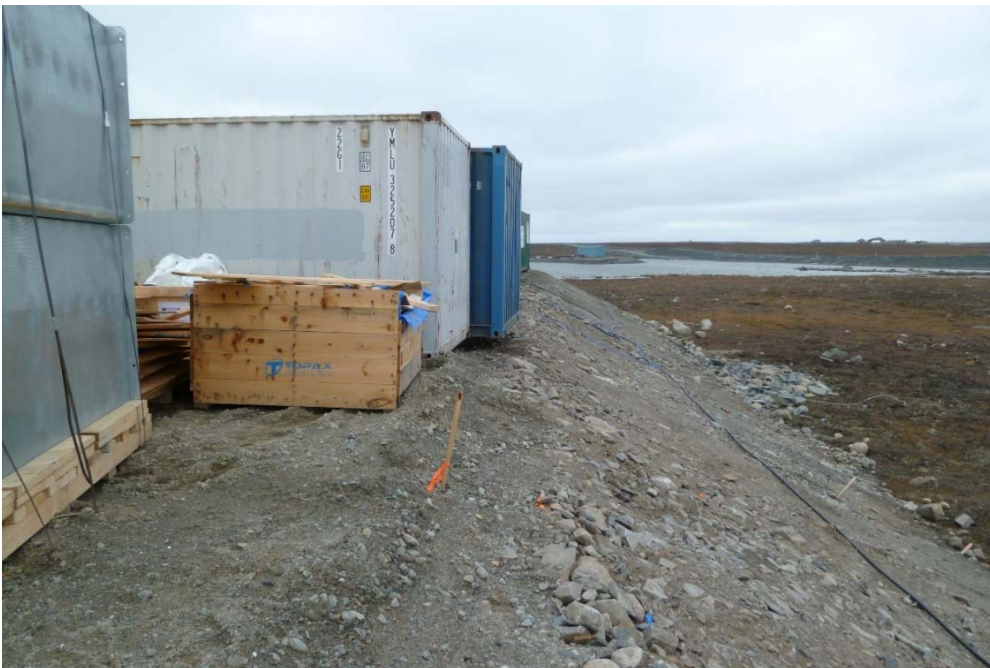
Photograph 58: Ventilation Intake Pad, Southwest Crest and Slope, Looking Southeast. Sea-containers are Located Very Close to Crest (21 September 2017)

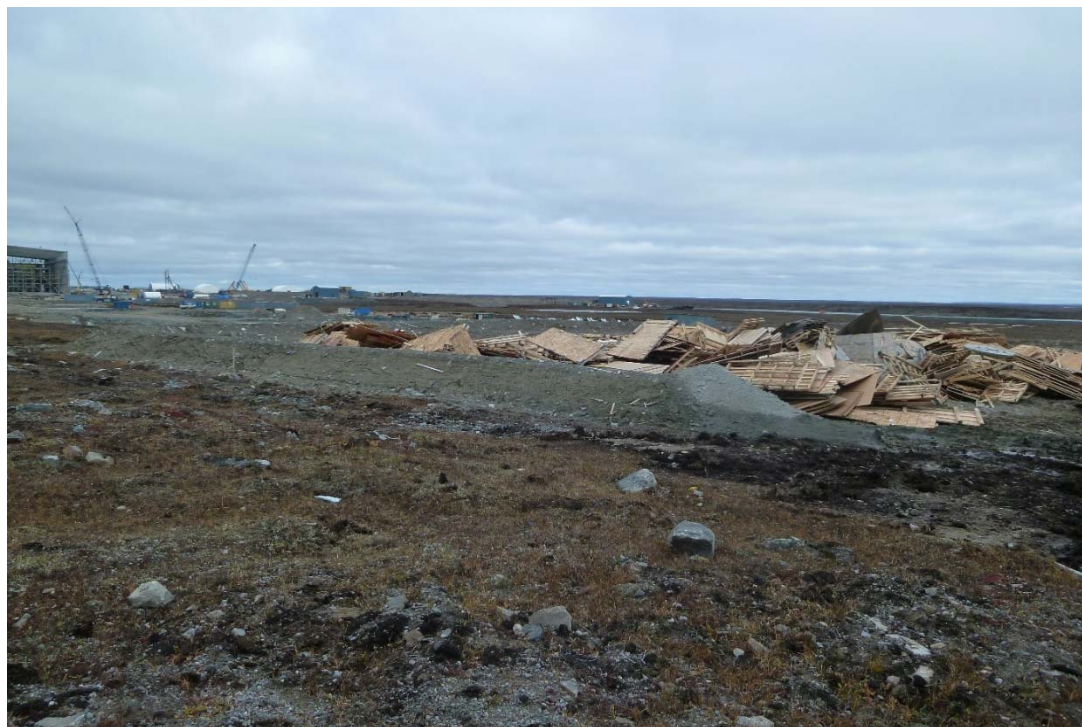
Photograph 60: Overview of the Exploration Landfill Looking Northeast (19 September 2017)

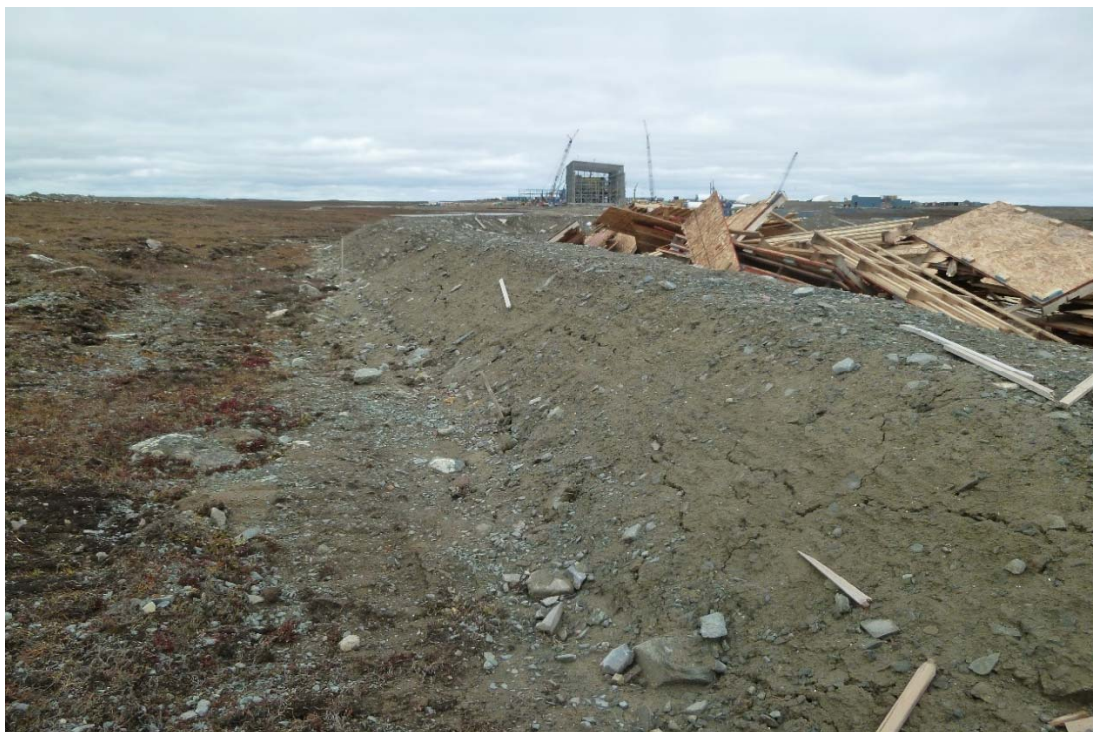
Photograph 61: Exploration Landfill, Downstream Slope of West Berm, Looking North, Cracking Visible (19 September 2017)

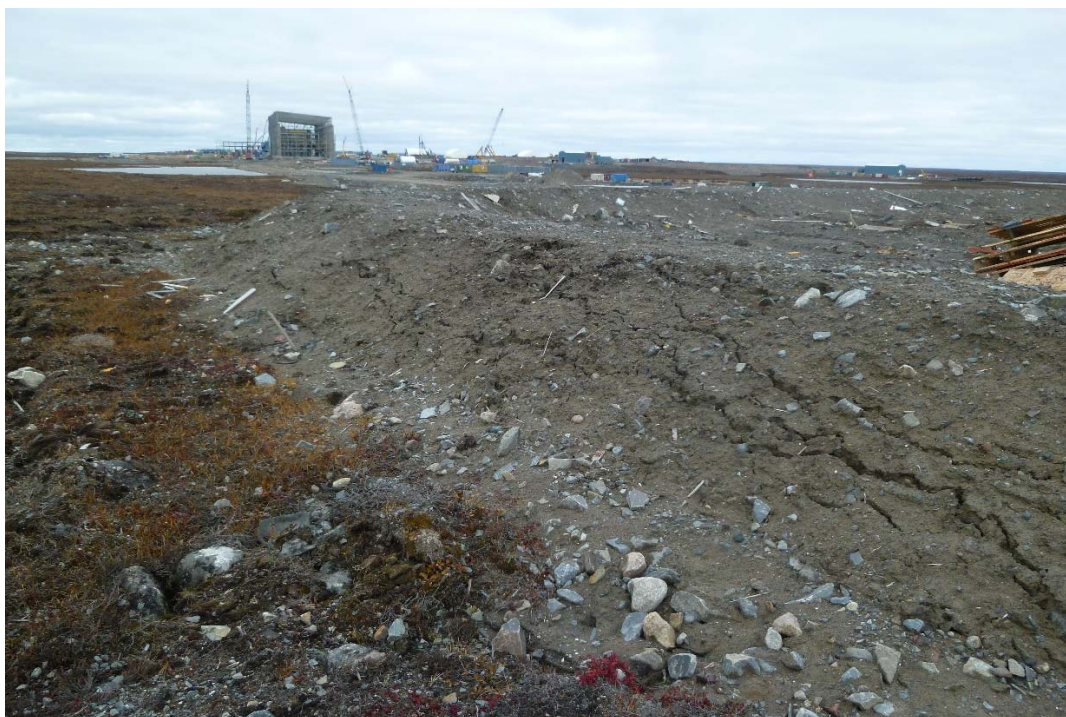
Photograph 62: Exploration Landfill, Downstream Slope of North End of West Berm, Cracking Visible (19 September 2017)

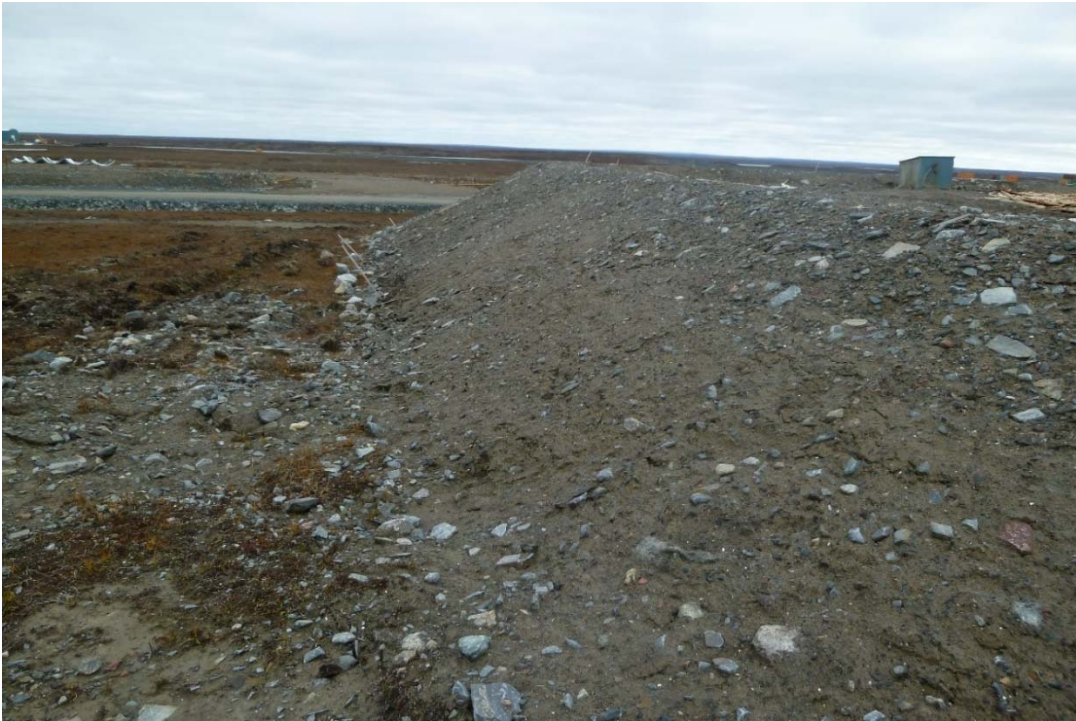
Photograph 63: Exploration Landfill, Downstream Slope of North Berm, and Looking East from West Corner (19 September 2017)

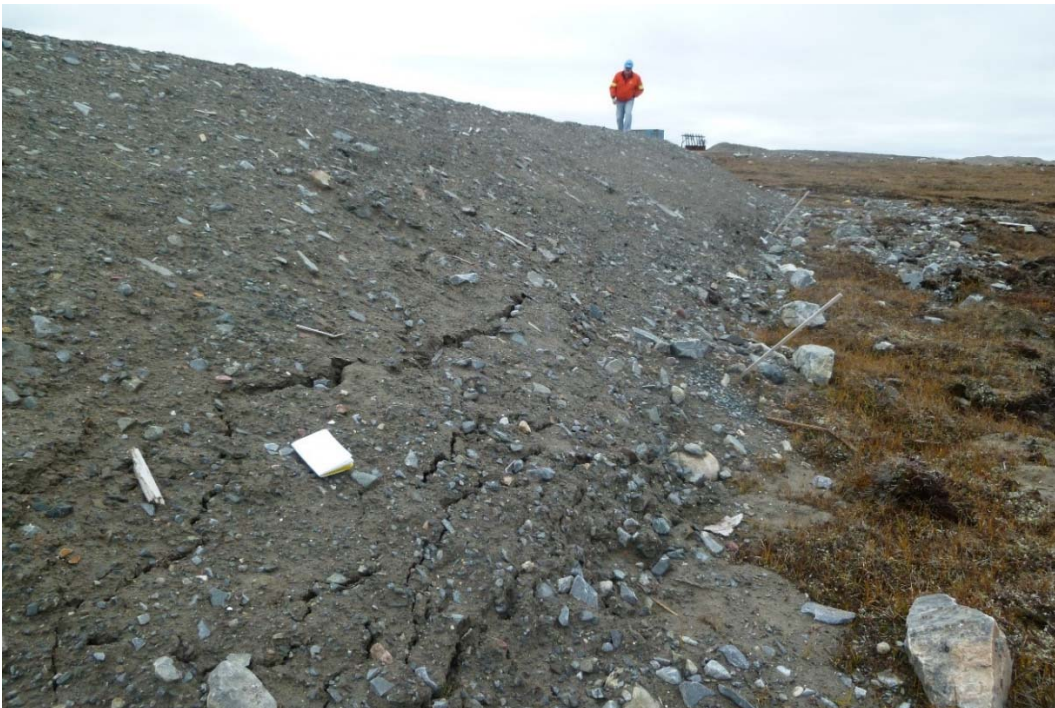
Photograph 64: Exploration Landfill, Cracking on Downstream Slope of North Berm, Looking West (19 September 2017)
