APPENDIX A4

Industrial Pad and Other Site Facilities: Landfarm, Effluent Water Treatment Plant Pad and Intake, Underground Portal No. 1 and Underground Portal No. 2, Fuel Storage, Ventilation Intake Pad, Exploration Landfill, and Operation Landfill

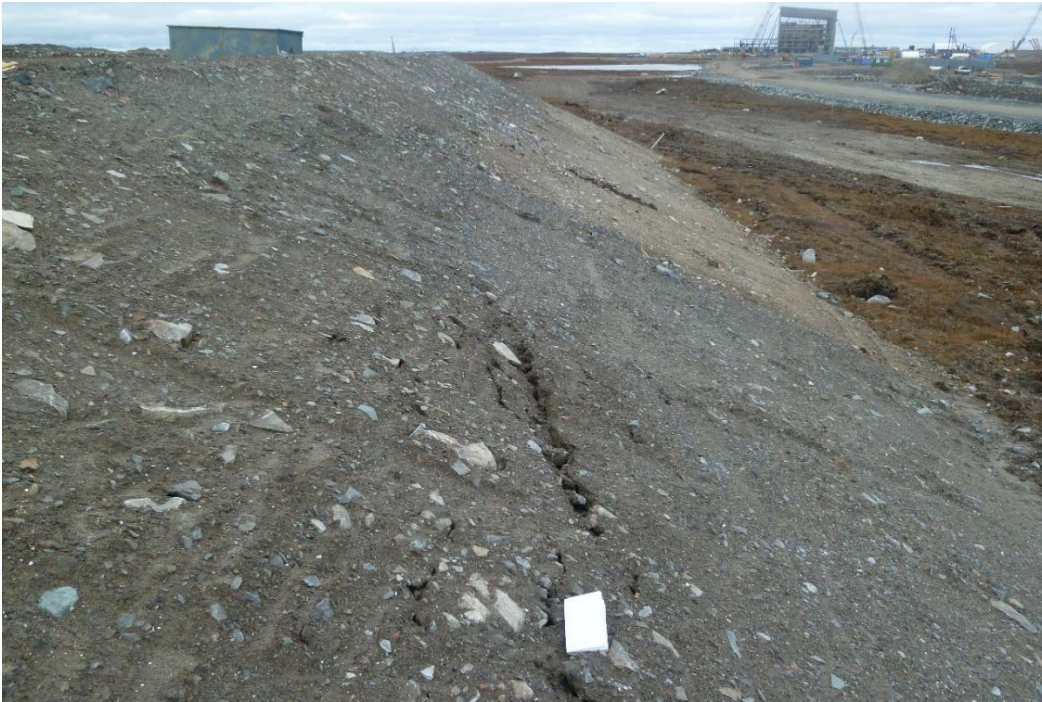
Photograph 65: Exploration Landfill, Cracking Mid Slope of East Berm, Looking North (19 September 2017)

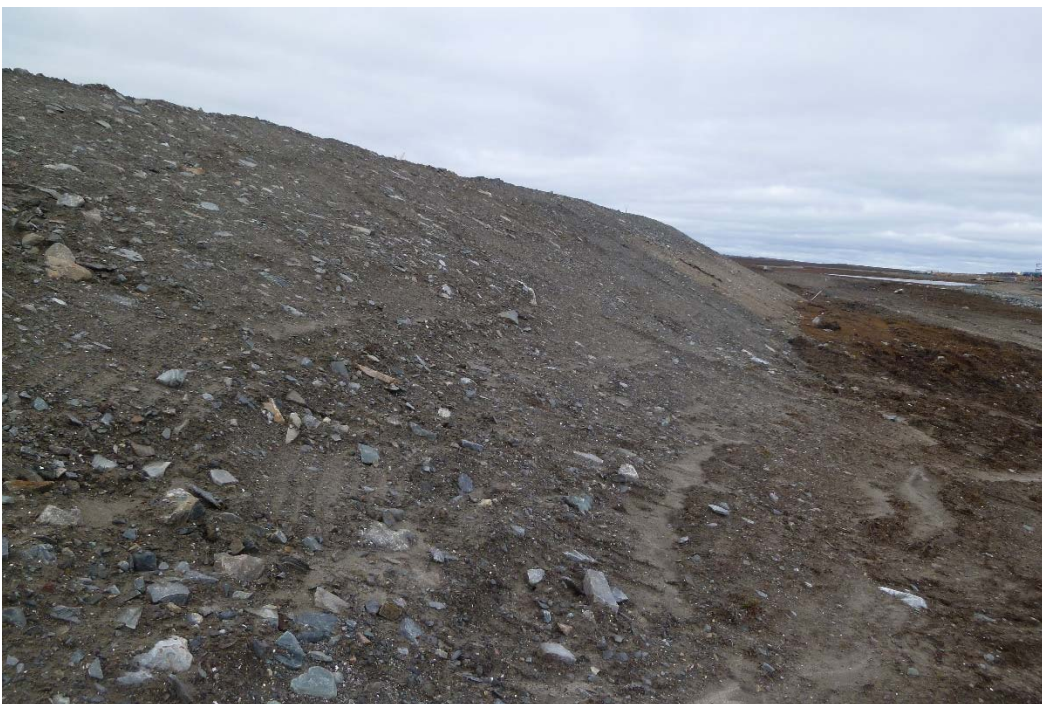
Photograph 66: Exploration Landfill, Downstream Slope of East Berm, Looking North (19 September 2017)

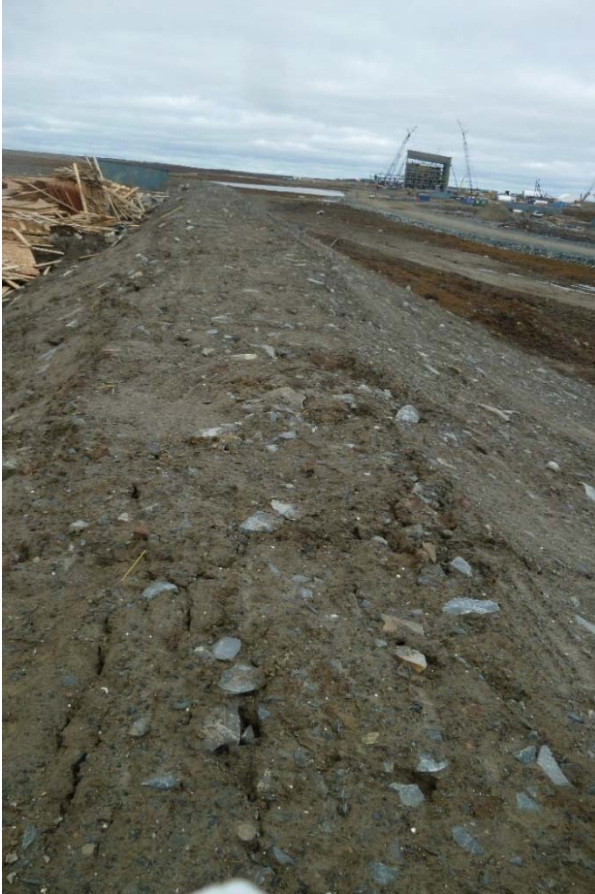
Photograph 67: Exploration Landfill, Crest of East Berm, Looking North. Cracking and some Erosion Visible (19 September 2017)

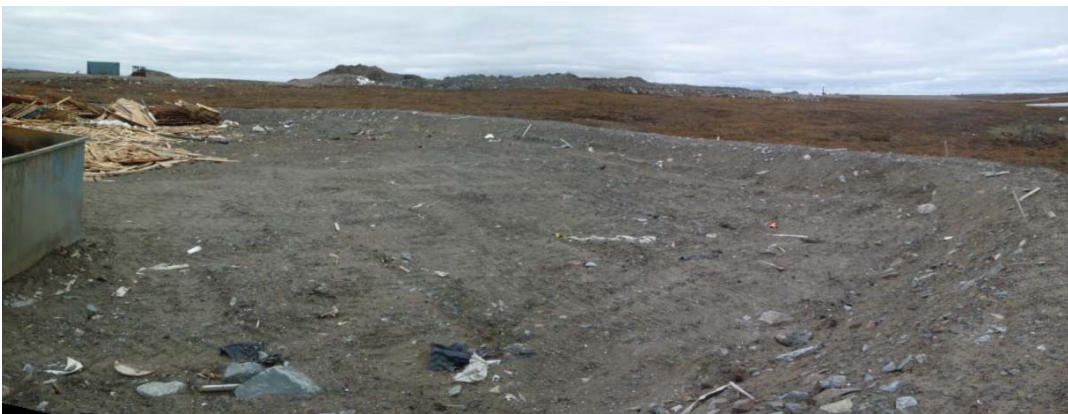
Photograph 68: Exploration Landfill, Interior and Upstream Slopes of North Berm, Looking North (19 September 2017)
