## APPENDIX A5

### Operation Landfill

# **APPENDIX A 6**

**Exploration Camp Pad and Access Road, Fresh Water Intake,  
Diffuser Access, Fuel Storage, and Landfarm**

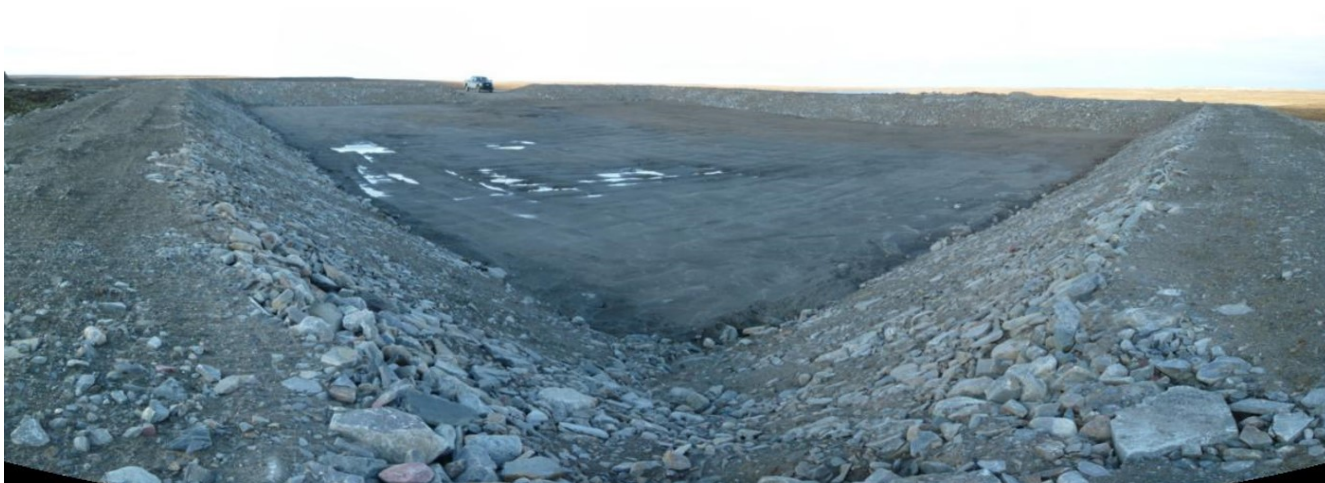
*Photograph 69: Operation Landfill, Overview of Interior of Facility from East Corner (20 September 2017)*

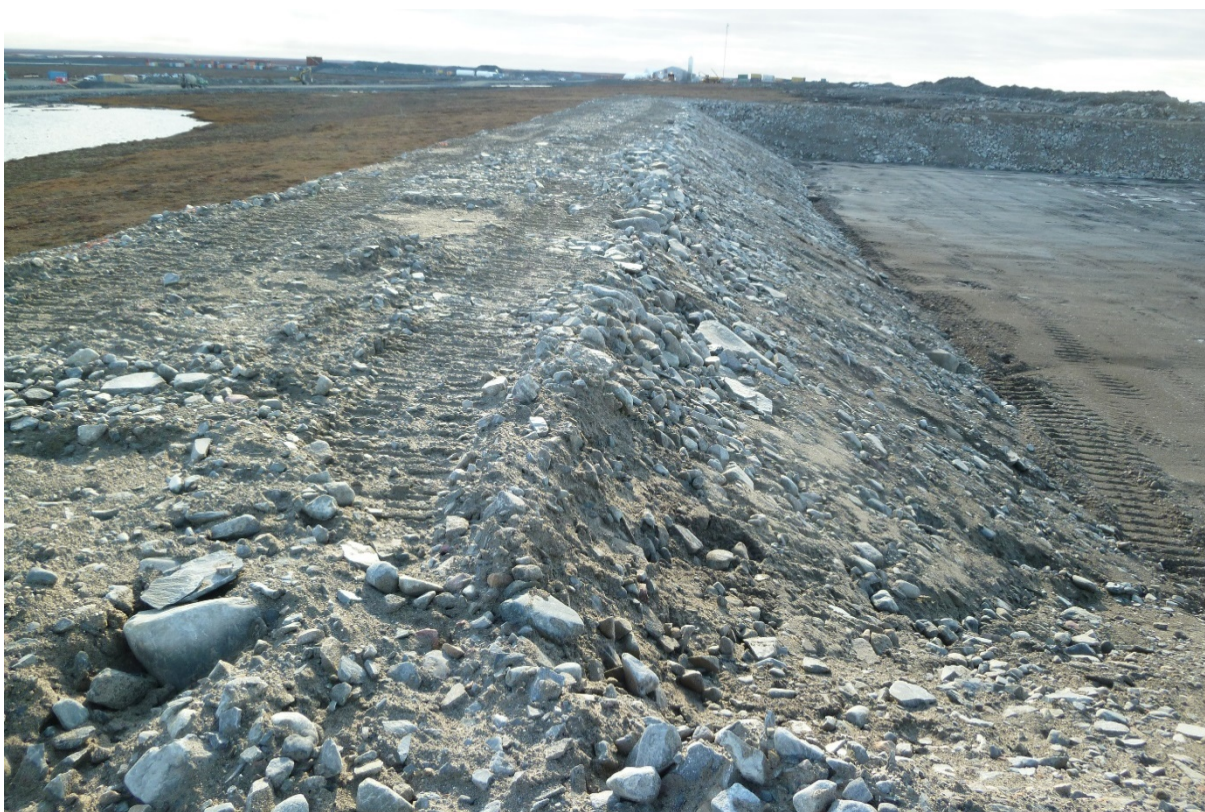
*Photograph 70: Operation Landfill, Crest and Interior Slope of Northeast Berm, Looking Southeast (20 September 2017)*

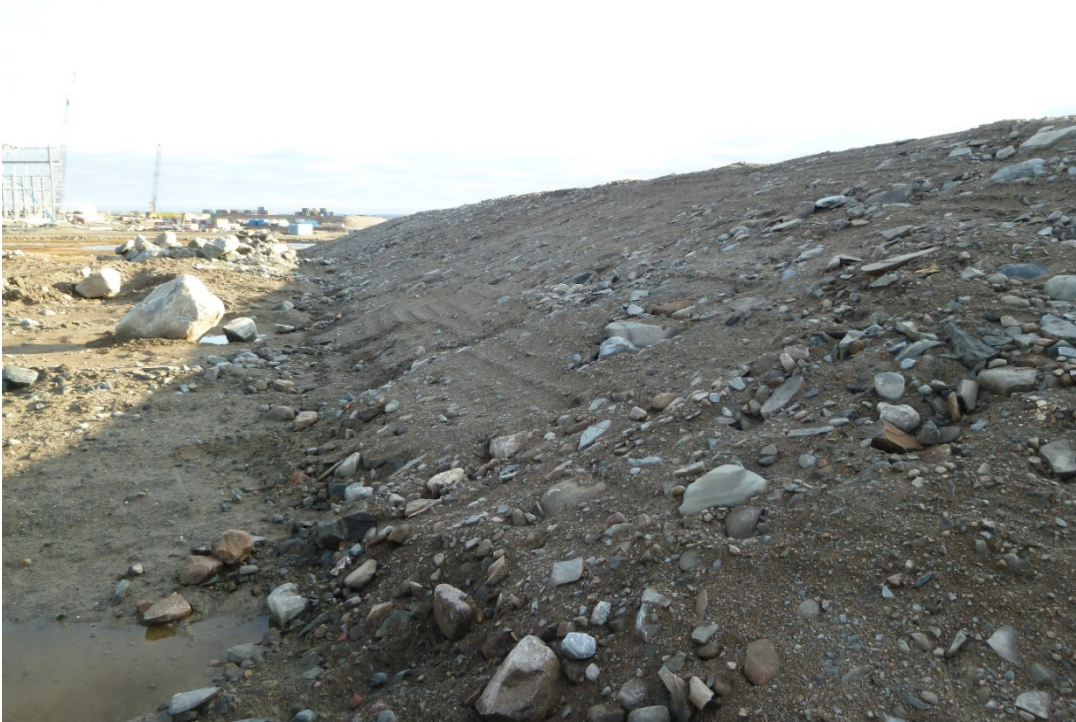
*Photograph 71: Operation Landfill, Exterior Slope of Northwest Berm Looking East from West Corner (20 September 2017)*

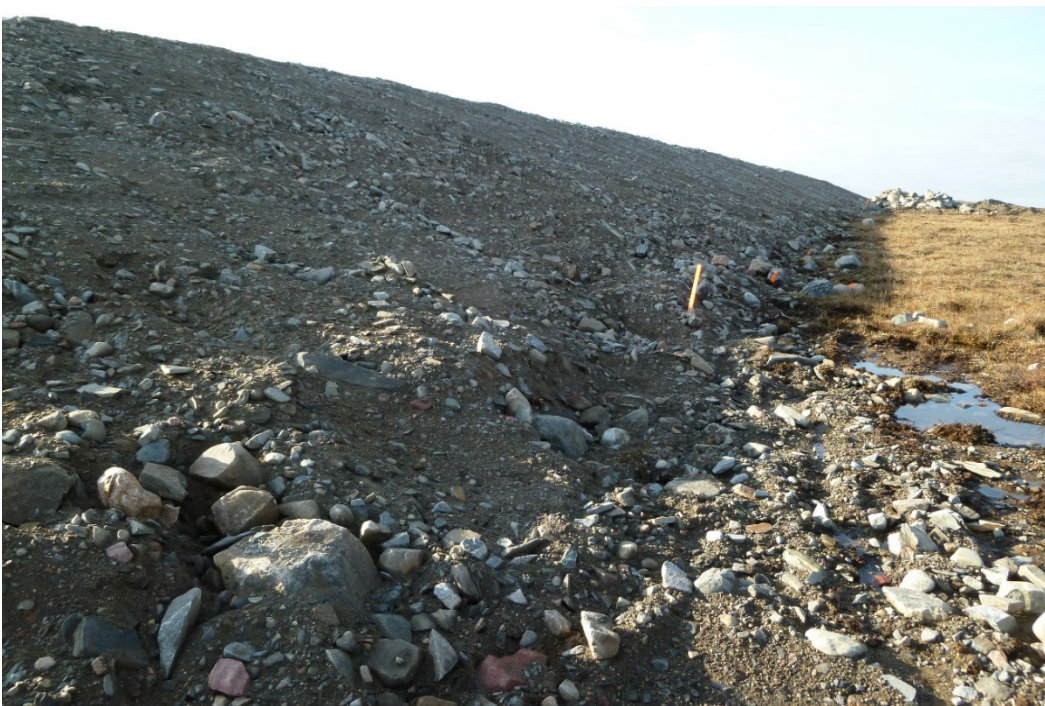
*Photograph 72: Operation Landfill, Exterior Slope of Northwest Berm, and Looking West from East Corner (20 September 2017)*

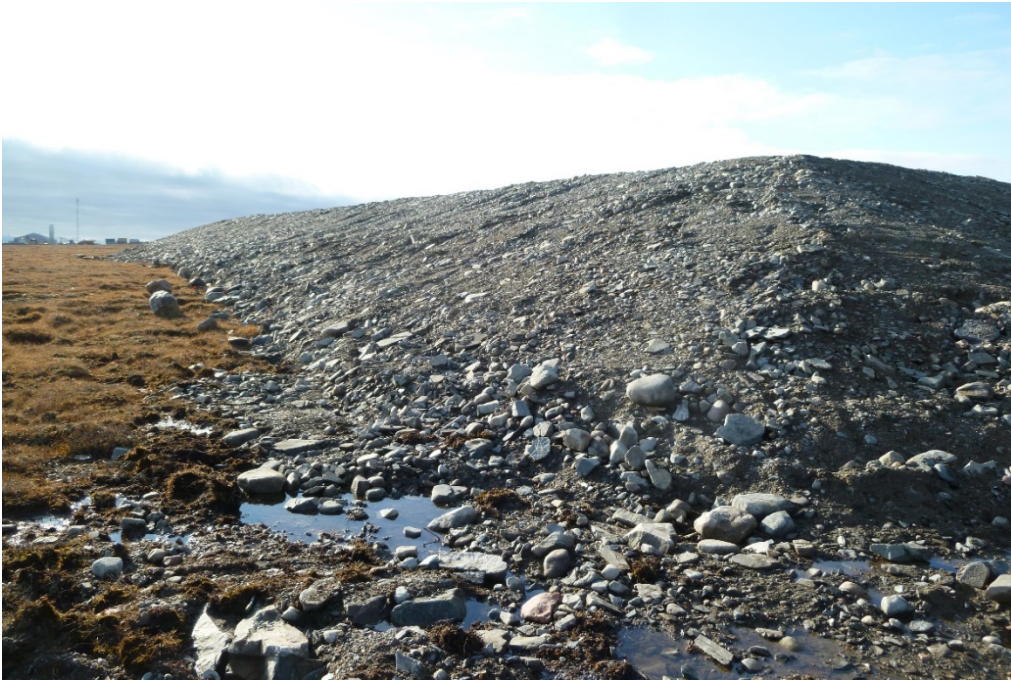
*Photograph 73: Operation Landfill, Exterior Slope of Northeast Berm, and Looking Southeast from North Corner (20 September 2017)*

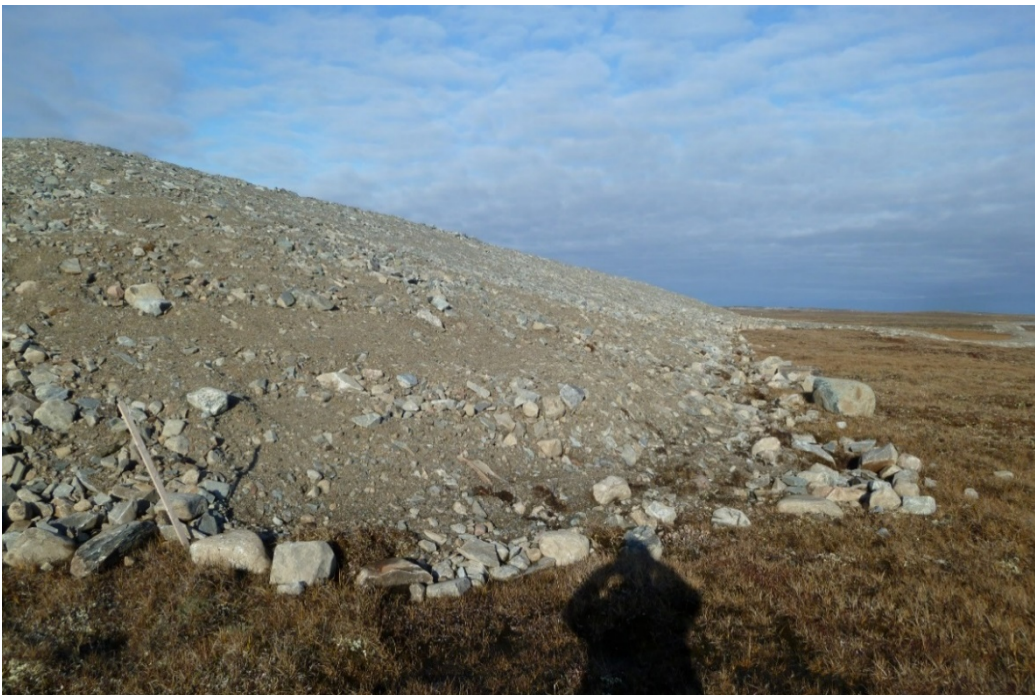
*Photograph 74: Operation Landfill, Exterior Slope of Northeast Berm, and Looking Northwest from East Corner (20 September 2017)*

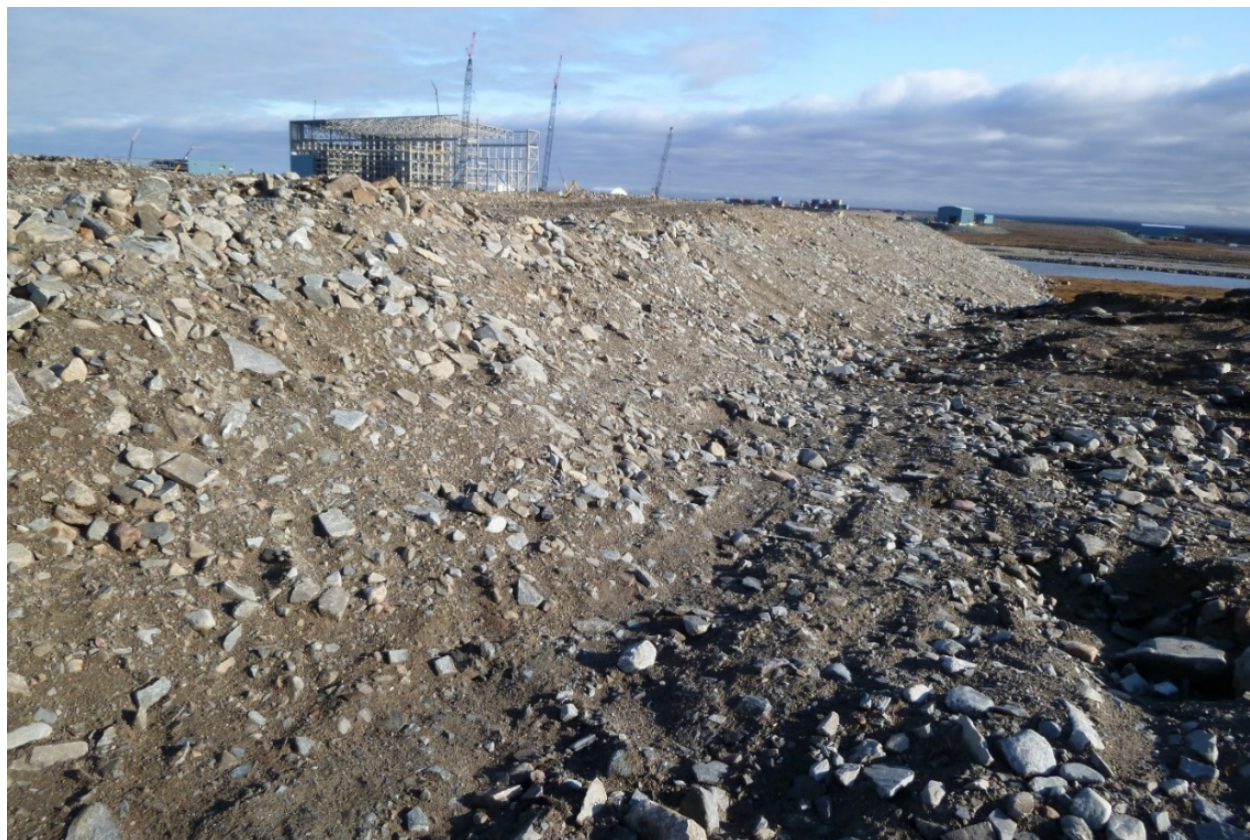
*Photograph 75: Operation Landfill, Exterior Slope of Southeast Berm Looking Northeast from South Corner (20 September 2017)*

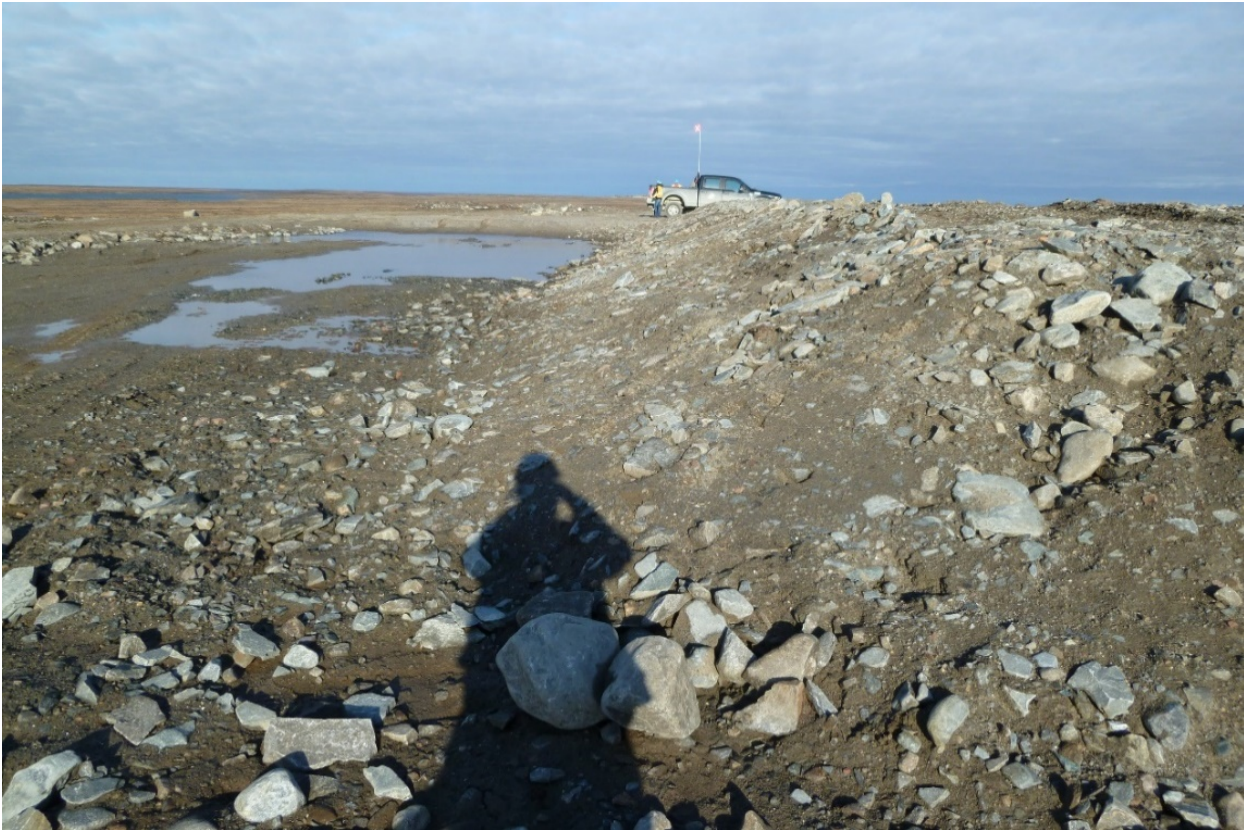
*Photograph 76: Operation Landfill, Exterior Slope of Southwest Berm, Looking Northwest from South Corner. Some Water Ponded Outside the Landfill Adjacent to the Access Ramp (20 September 2017)*

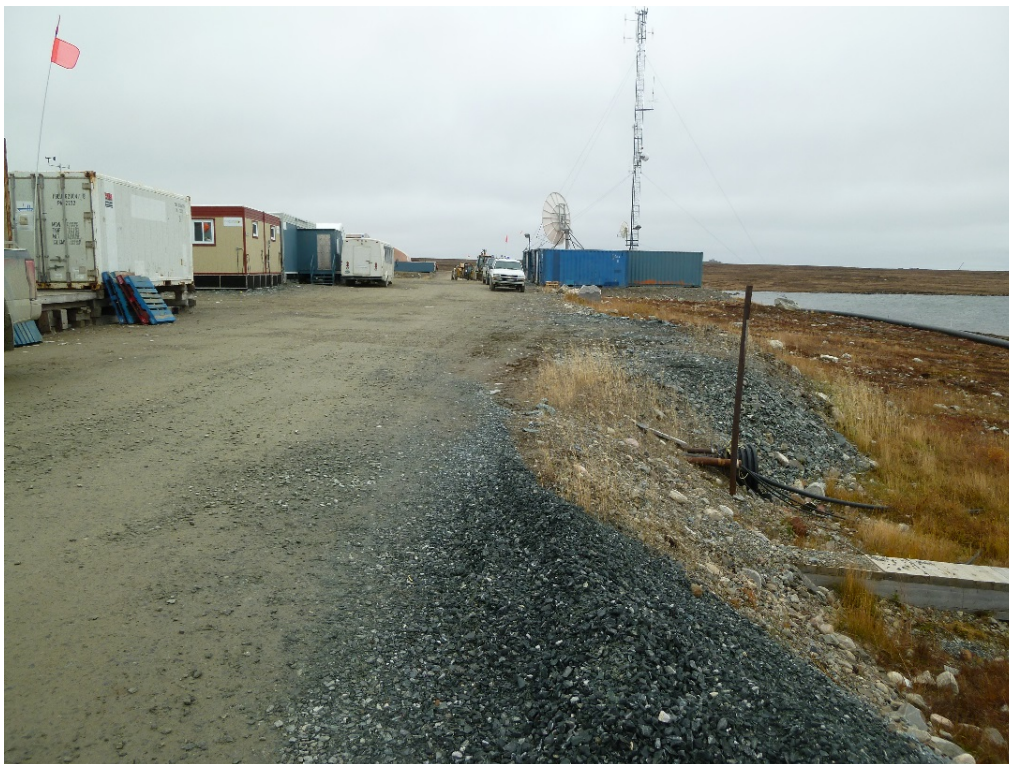
*Photograph 2: Exploration Camp Pad, North Slope, and Looking West, near Fresh Water Intake Access Road (21 September 2017)*

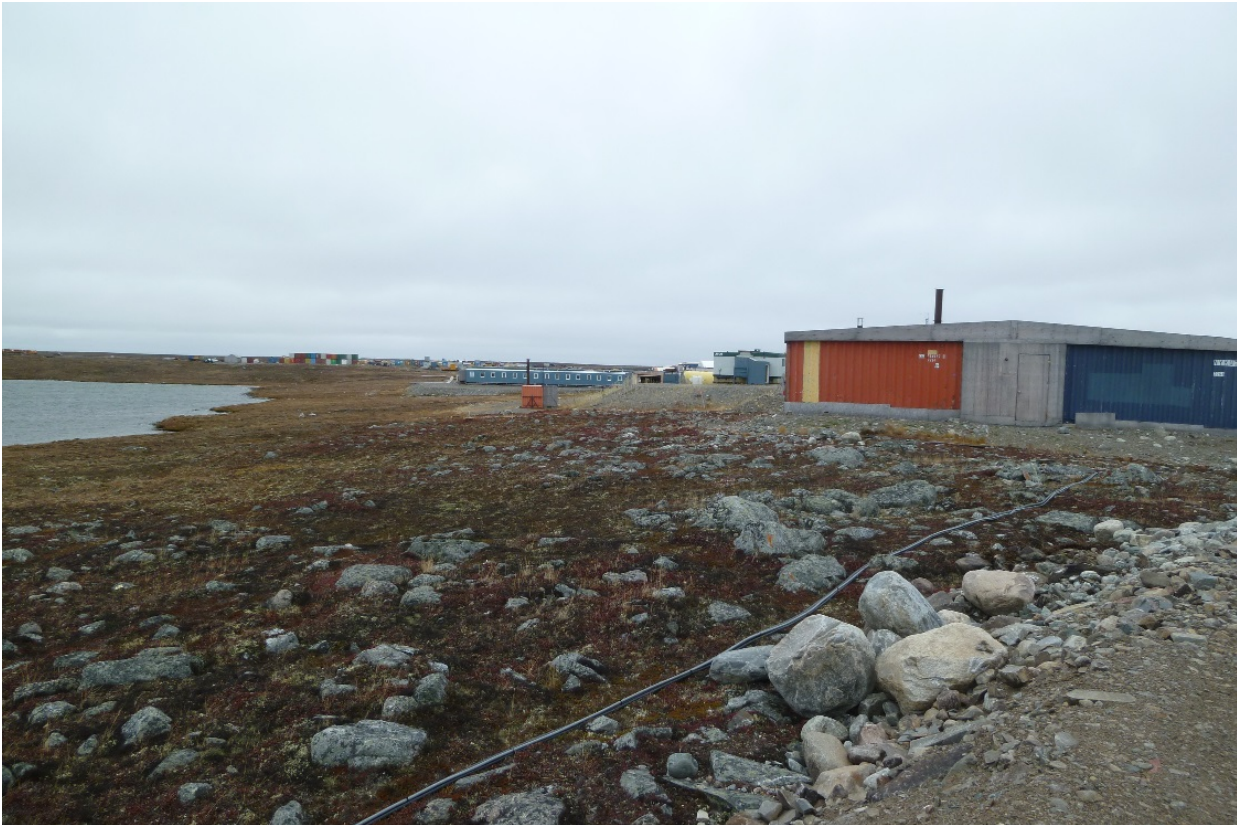
*Photograph 3: Exploration Camp Pad, South Slope, Looking West from East End (21 September 2017)*

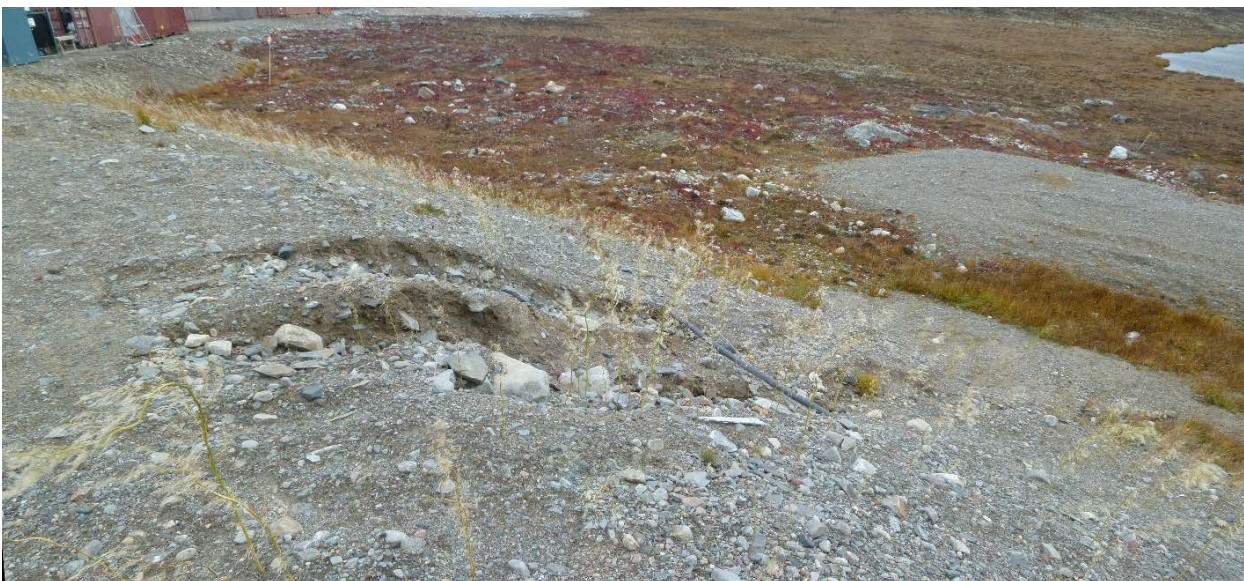
*Photograph 4: Exploration Camp Pad, Erosion on South Slope (21 September 2017)*

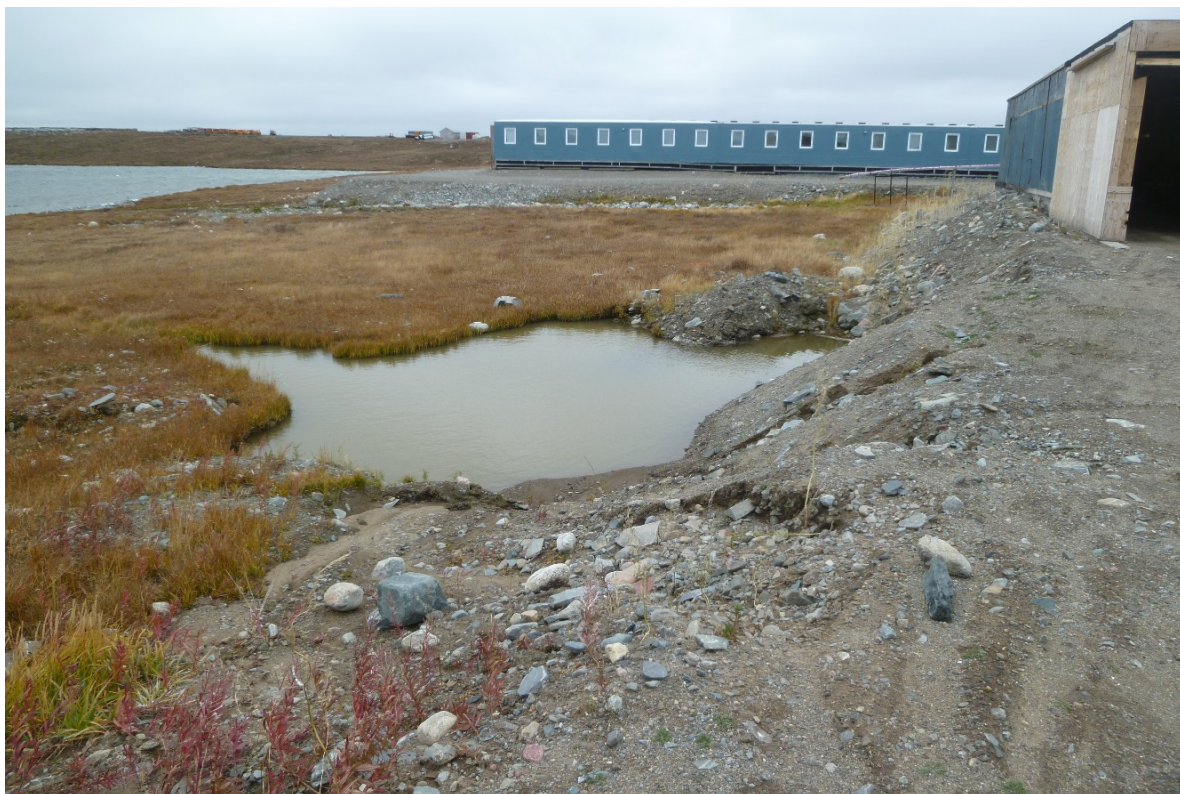
*Photograph 5: Exploration Camp Pad, Localized Ponding and Erosion on South Slope (21 September 2017)*

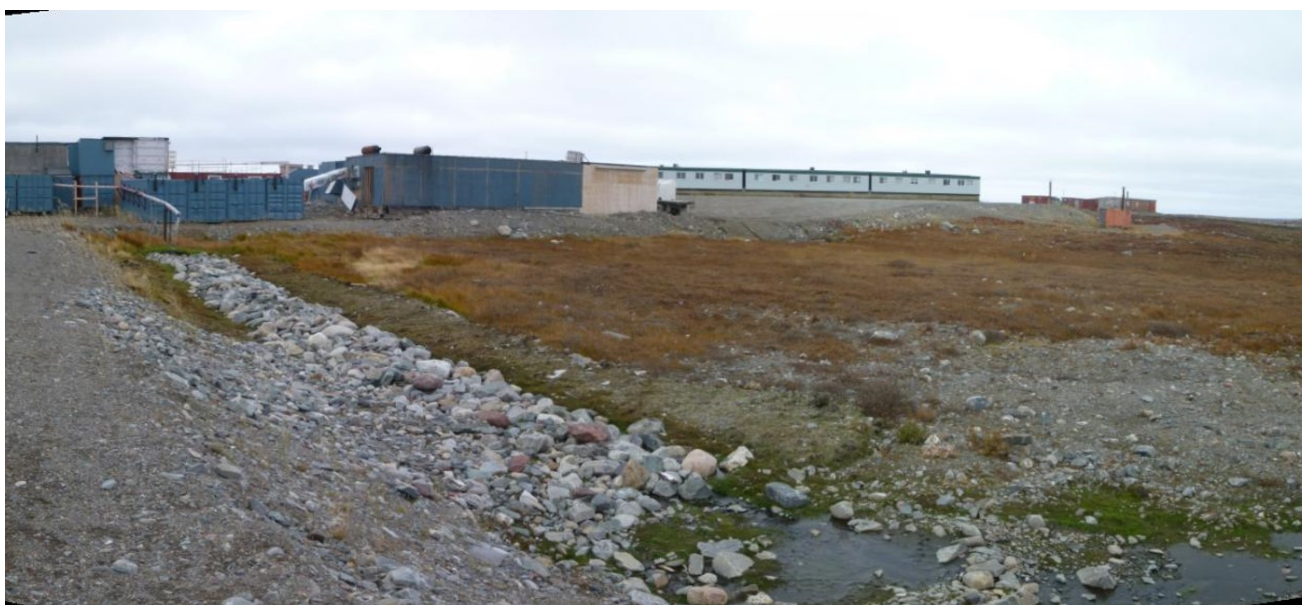
*Photograph 6: Exploration Camp Pad, South Slope Looking North. Water Treatment Discharge on Left (21 September 2017)*

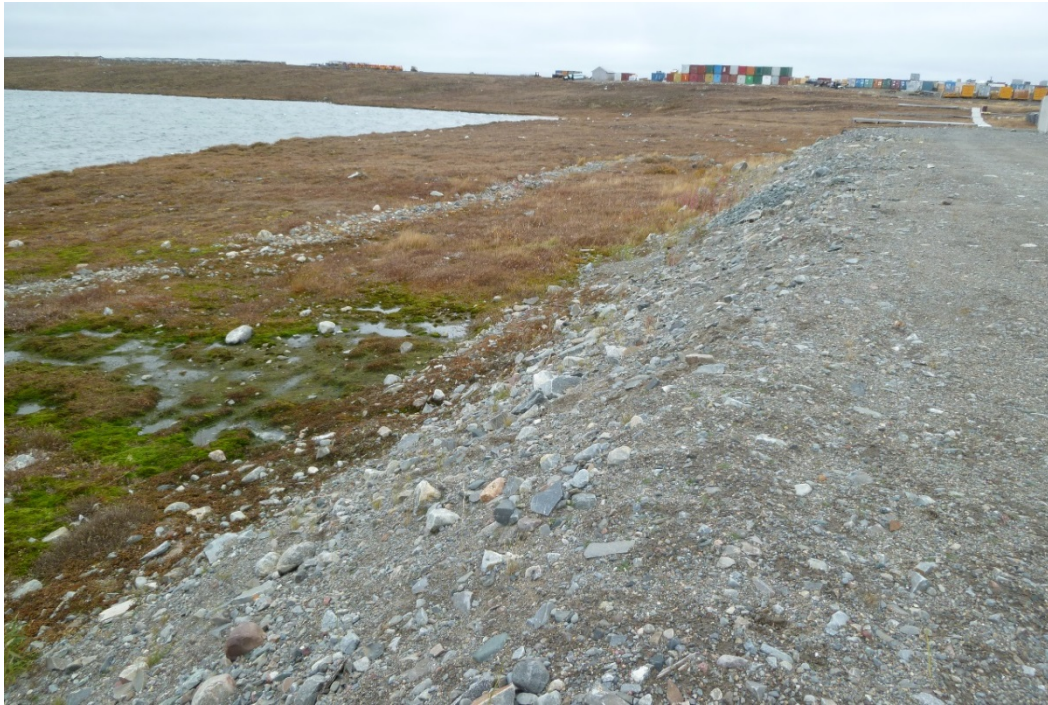
*Photograph 7: Exploration Camp Pad, Slope South of Camp Trailers, Looking Southwest (21 September 2017)*

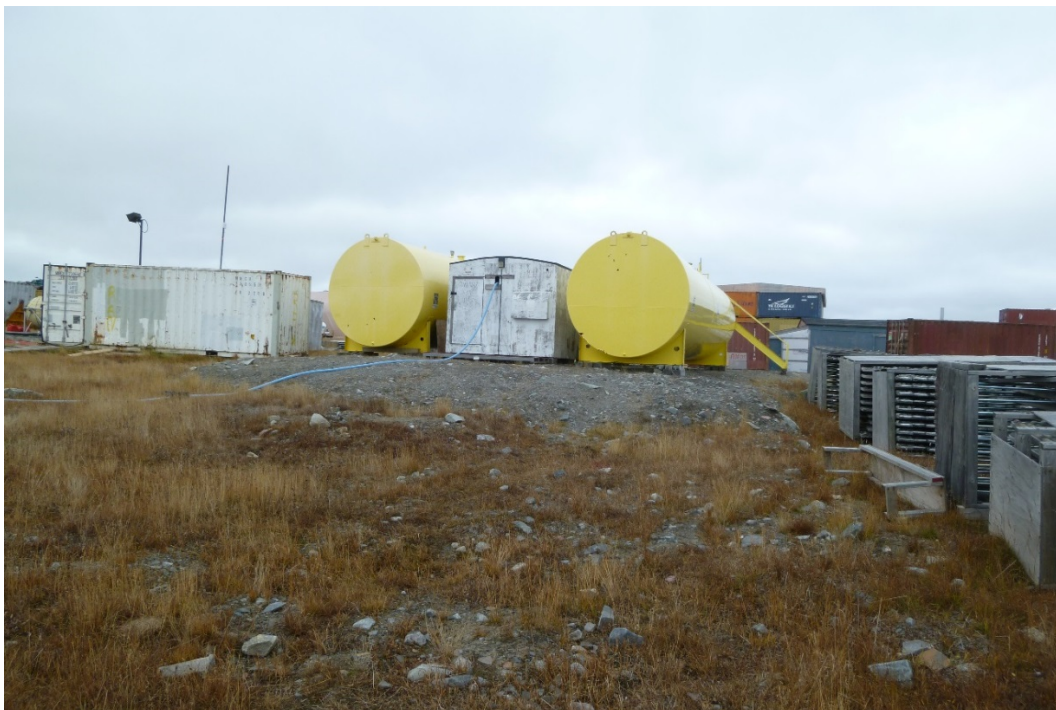
*Photograph 8: Exploration Camp Pad, Fuel Storage Tanks near Helicopter Pad (21 September 2017)*

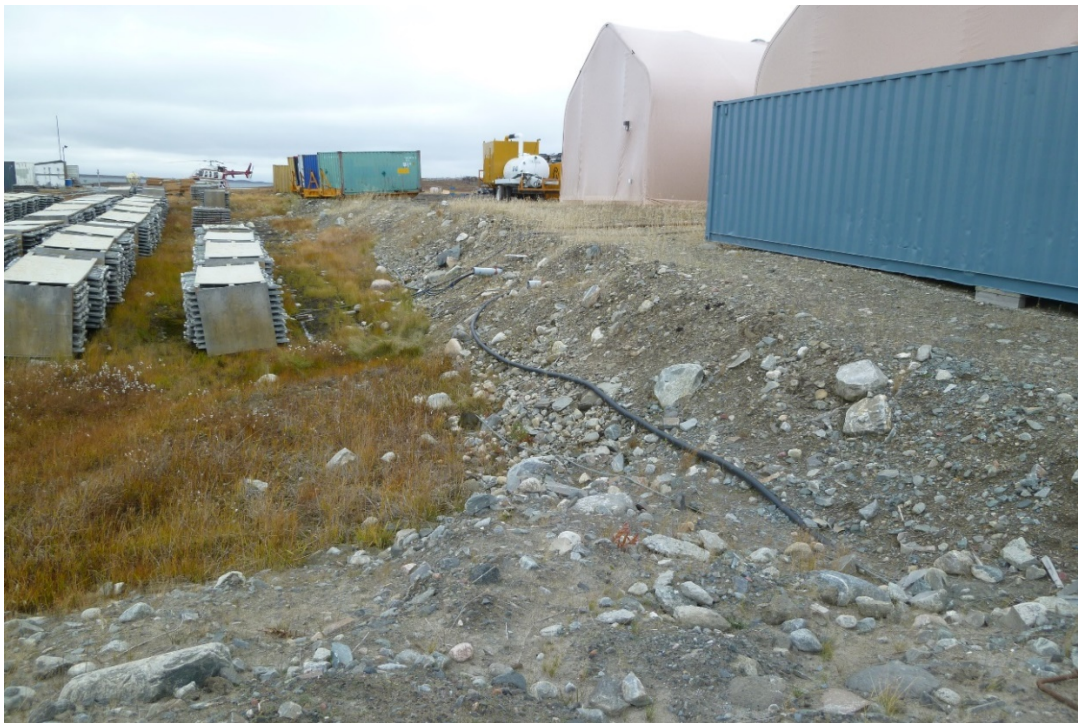
*Photograph 9: Exploration Camp Pad, Interior Slope Looking South (21 September 2017)*

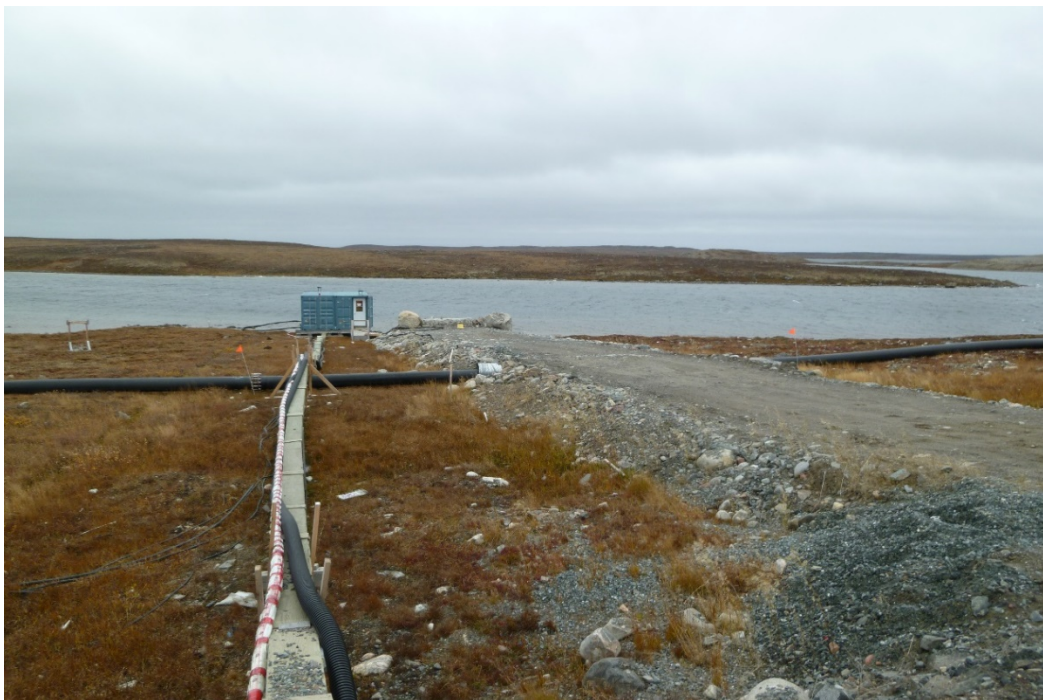
*Photograph 10: Exploration Camp Fresh Water Intake Access, Looking Northeast (21 September 2017)*

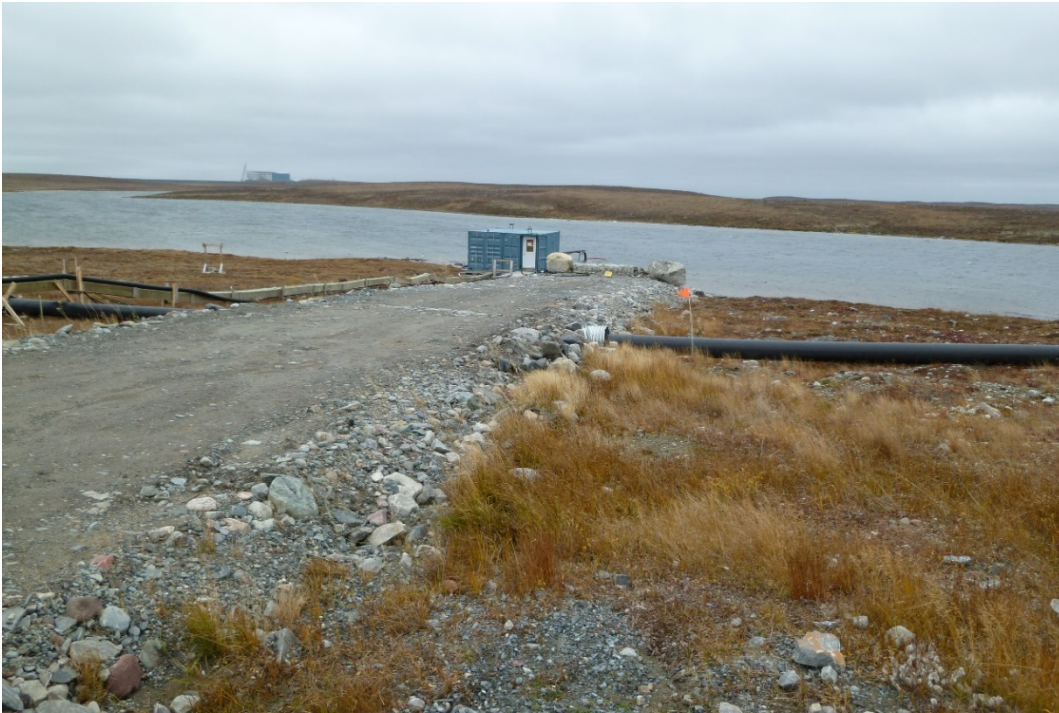
*Photograph 11: Exploration Camp Fresh Water Intake Access, Looking Northwest (21 September 2017)*

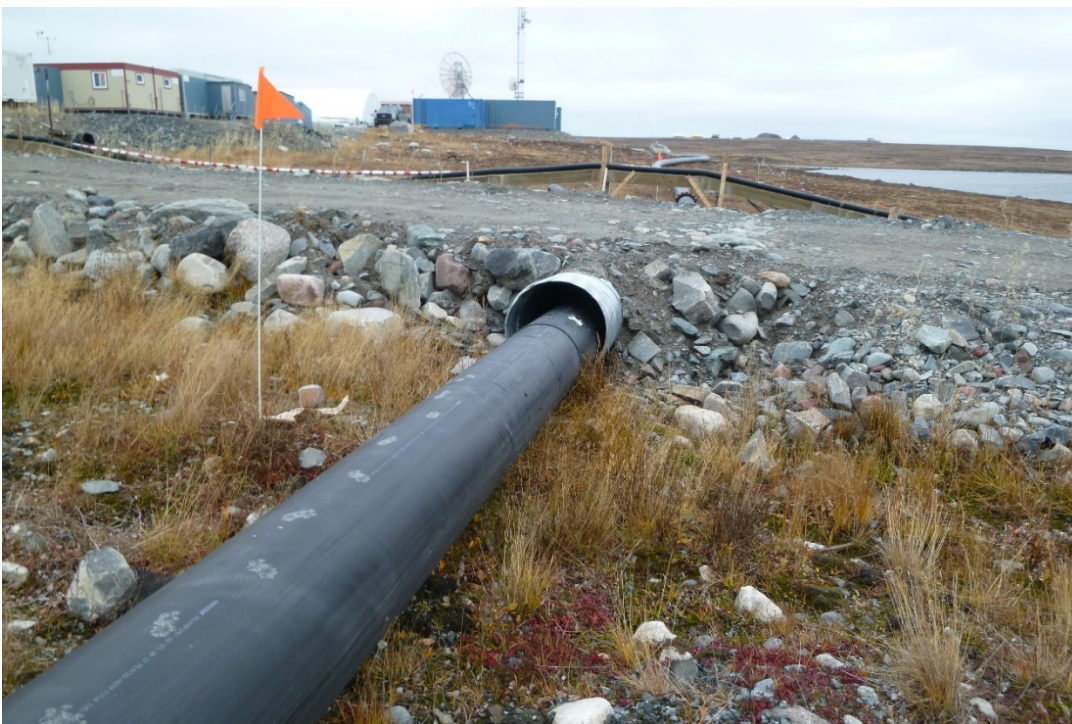
*Photograph 12: Exploration Camp Fresh Water Intake Access, Culvert for Pipe Crossing (21 September 2017)*

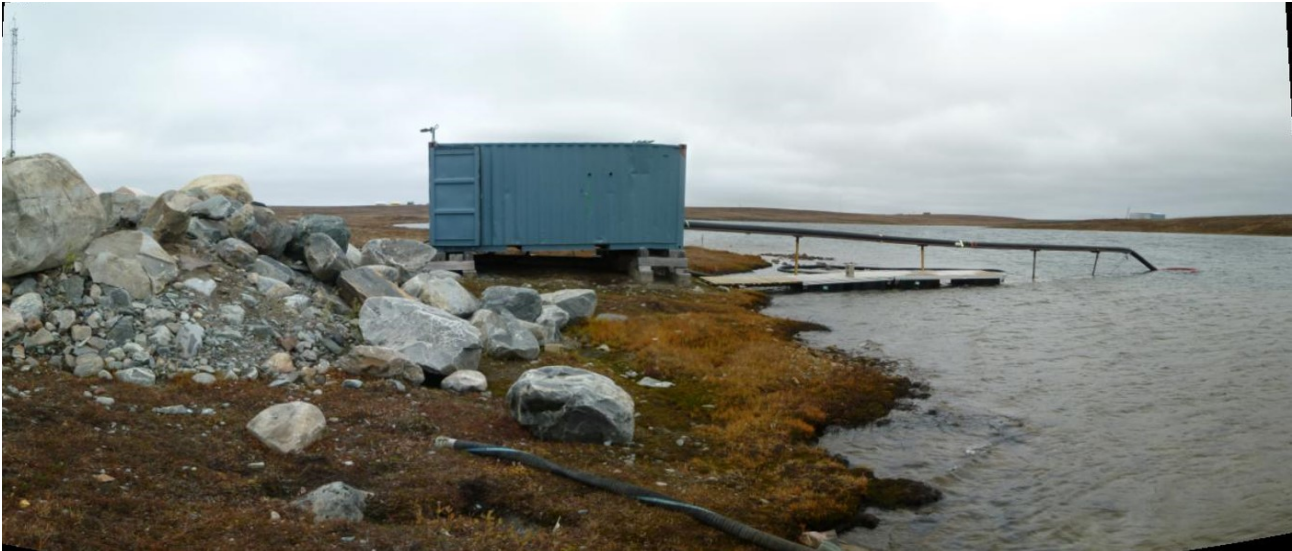
*Photograph 13: Exploration Camp Fresh Water Intake Pump House (21 September 2017)*

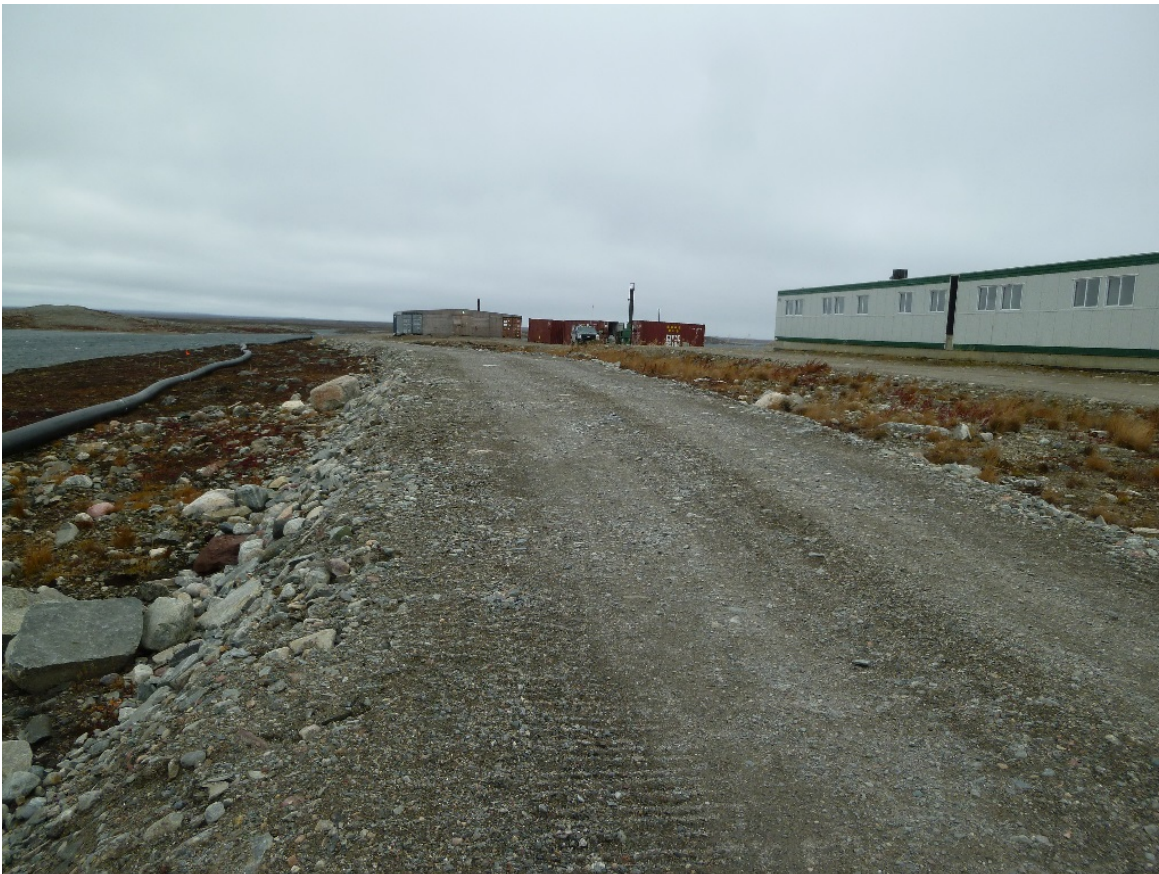
*Photograph 14: Exploration Camp Pad. Diffuser Access Road Adjacent to Camp Trailers, Looking Northeast (21 September 2017)*

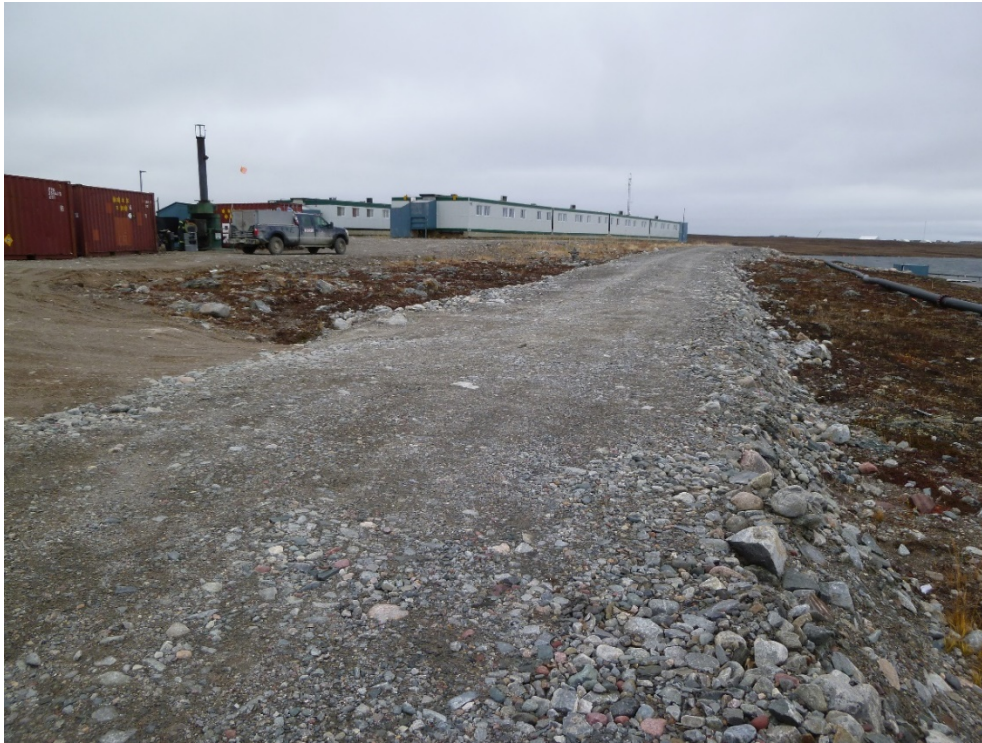
*Photograph 15: Exploration Camp Diffuser Access Road, near Camp, Looking Northwest (21 September 2017)*

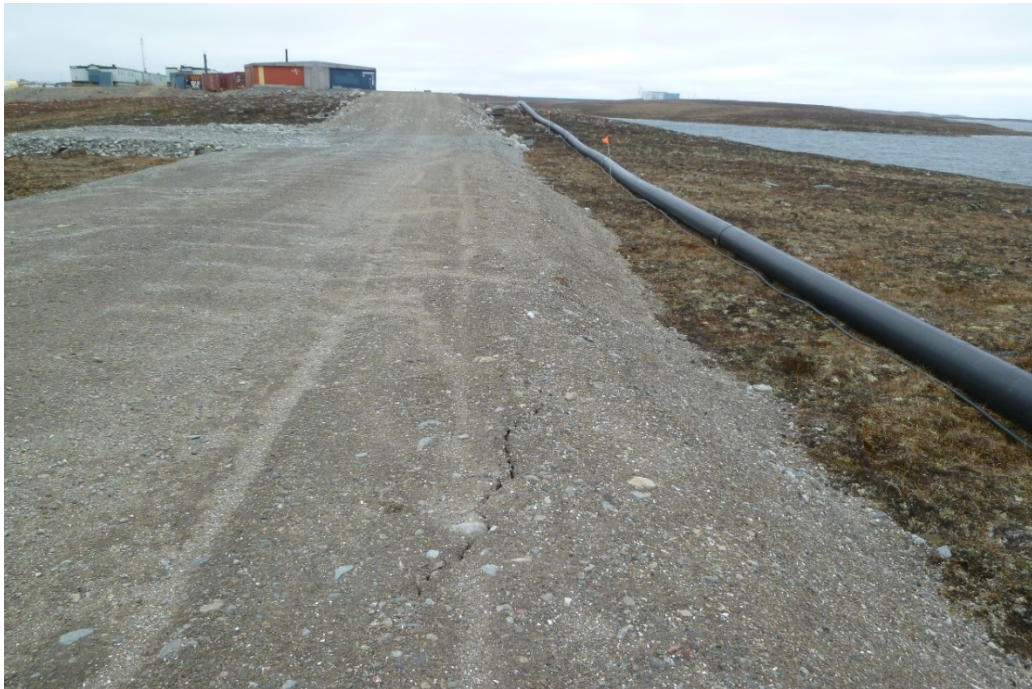
*Photograph 16: Exploration Camp Diffuser Access Road, Some Cracking along Slope, Looking Northwest (21 September 2017)*

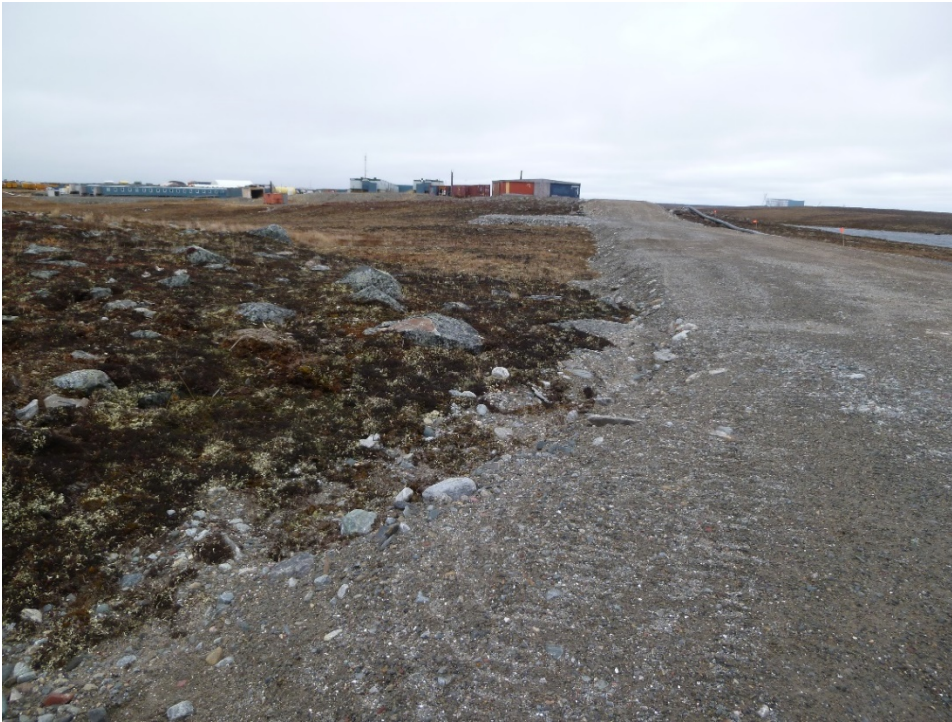
*Photograph 17: Exploration Camp Diffuser Access Road, Looking Northwest (21 September 2017)*

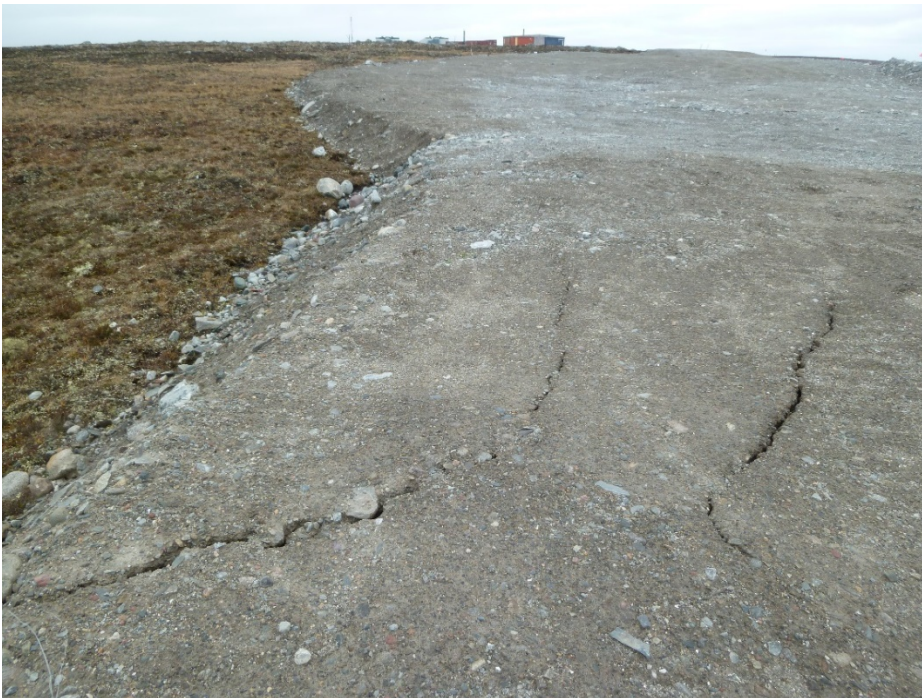
*Photograph 18: Exploration Camp Diffuser Access Road, cracking near Southeast end near Meliadine Lake (21 September 2017)*
