APPENDIX A6

Exploration Camp and Access Road

Meliadine All-Weather Access Road (AWAR) Inspection Photographs

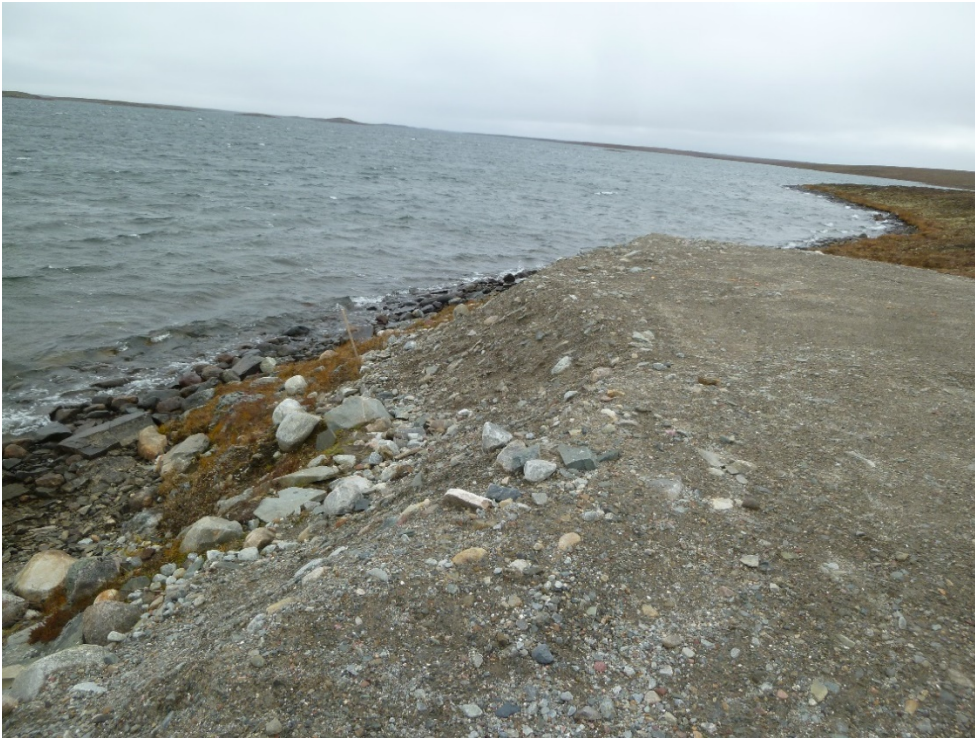
Photograph 19: Exploration Camp Diffuser Access Road, Adjacent to Meliadine Lake, Looking South (21 September 2017)

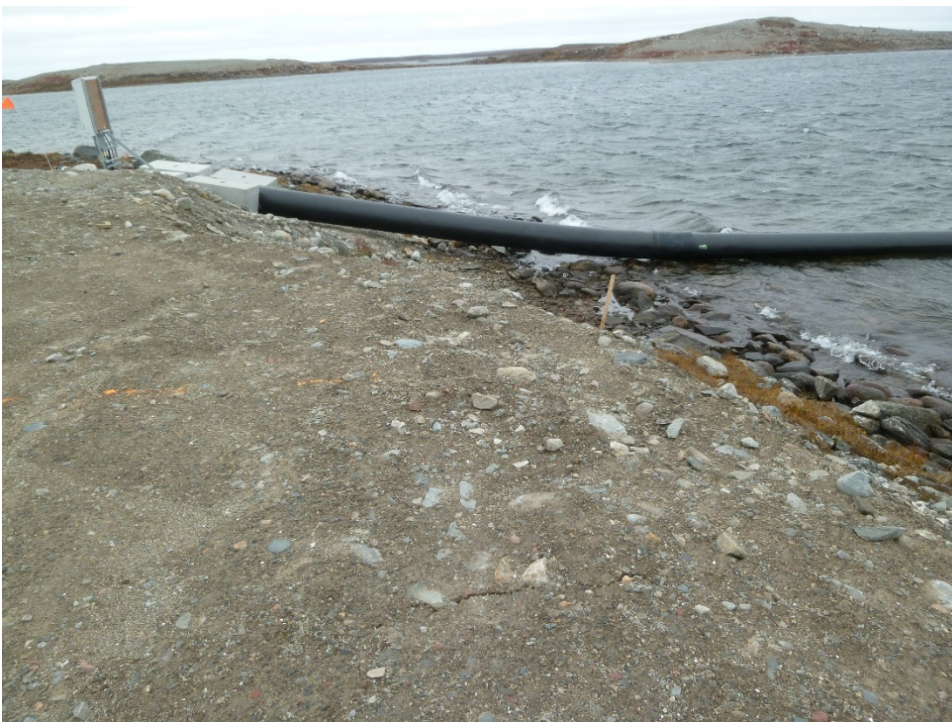
Photograph 20: Exploration Camp Diffuser Access Road, Adjacent to Meliadine Lake, Looking North (21 September 2017)

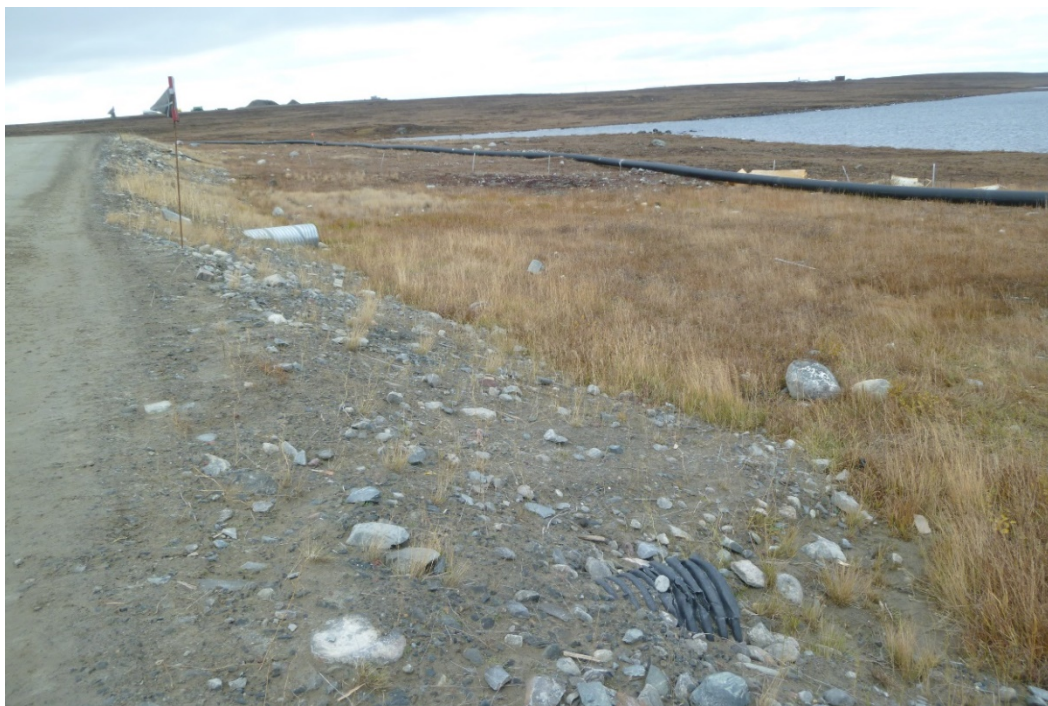
Photograph 21: Exploration Camp Access Road, Downstream ends of Culverts near Camp (black corrugated plastic and corrugated steel) (22 September 2017)

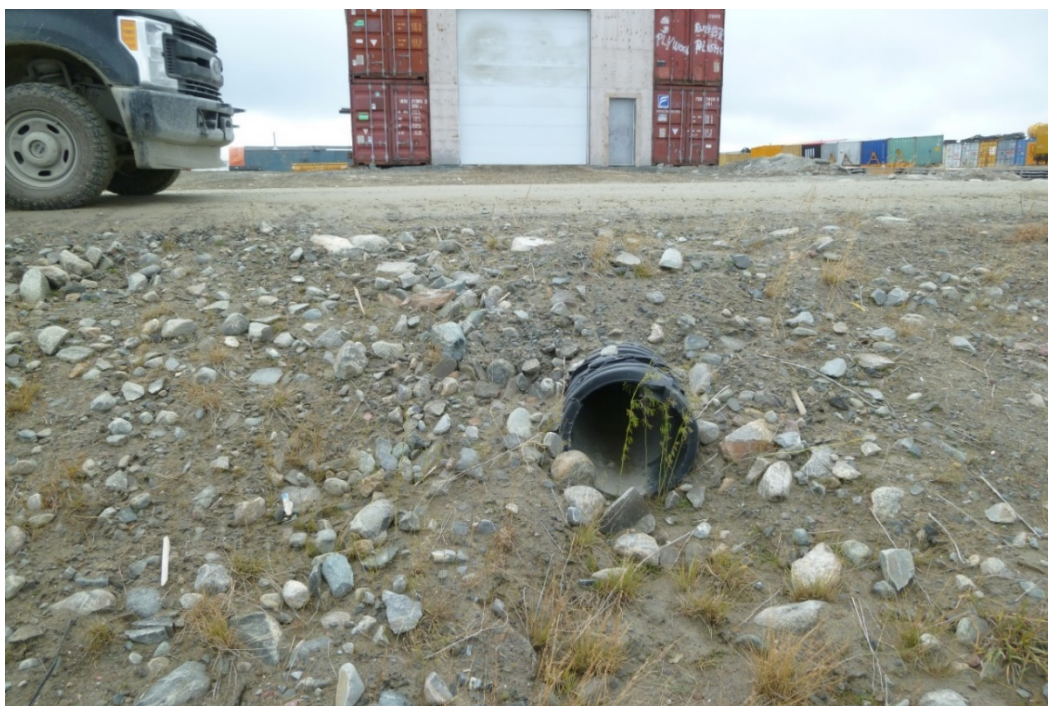
Photograph 22: Exploration Camp Access Road, Downstream end of Culvert near Camp (22 September 2017)

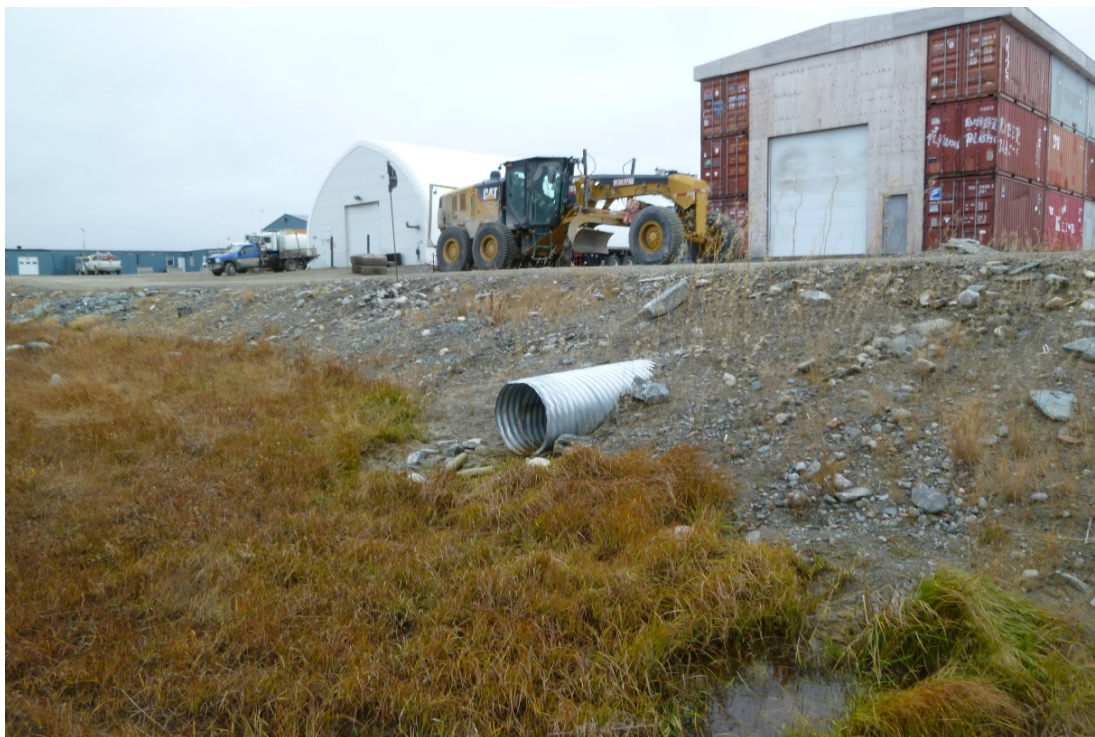
Photograph 23: Exploration Camp Access Road, Downstream end of Culvert near Camp (21 September 2017)

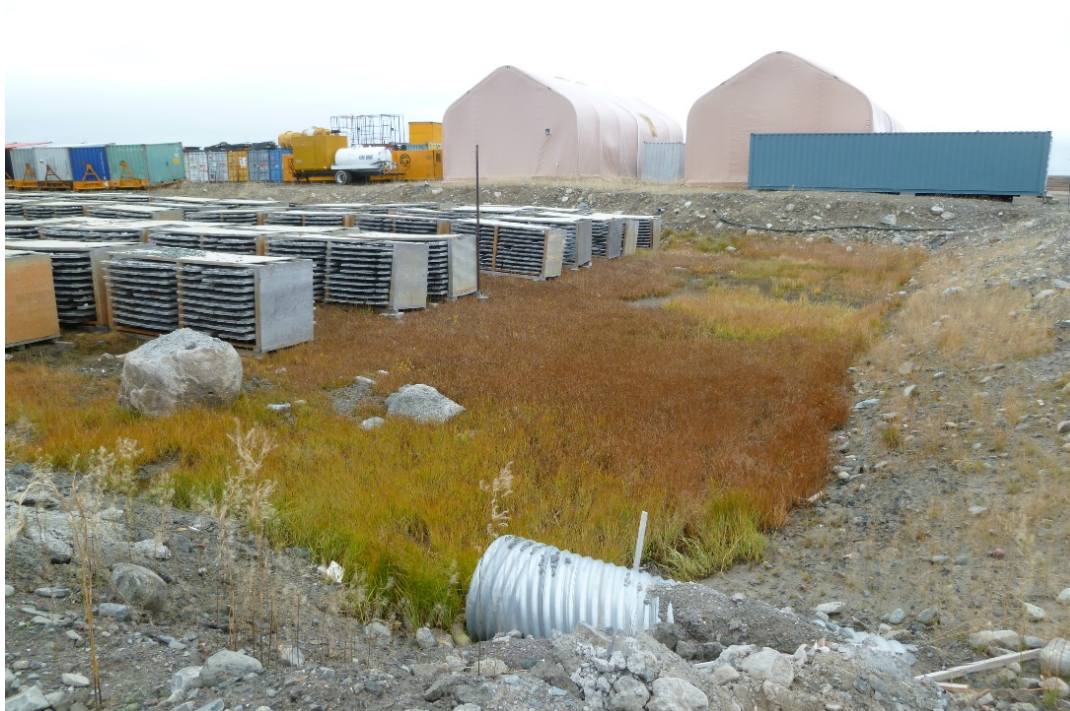
Photograph 24: Exploration Camp Access Road, Upstream end of Culvert near Camp (21 September 2017)

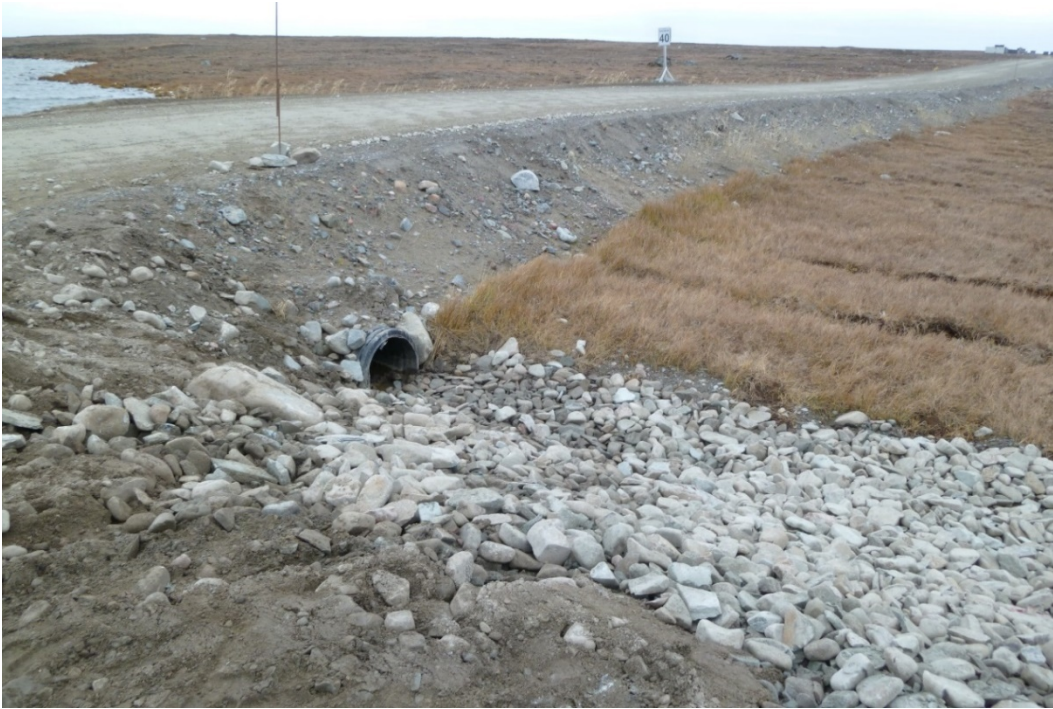
Photograph 25: Exploration Camp Access Road, Upstream end of Culvert near Fuel Storage (22 September 2017)

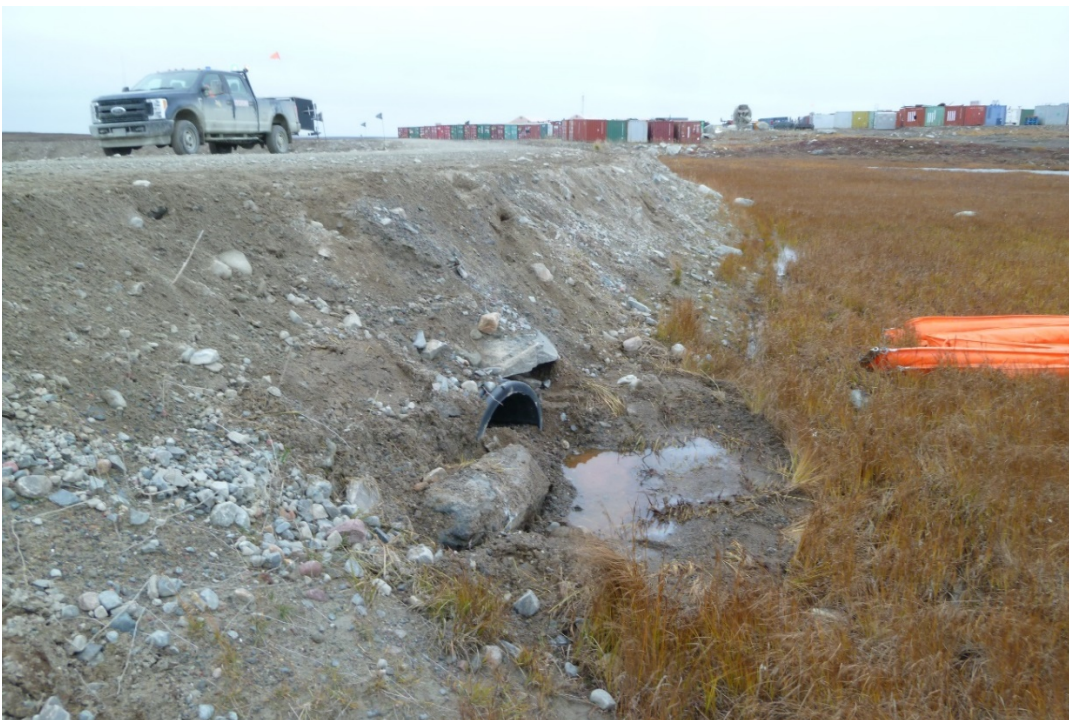
Photograph 26: Exploration Camp Access Road, Downstream end of Culver near Fuel Storage, Partially Blocked (21 September 2017)

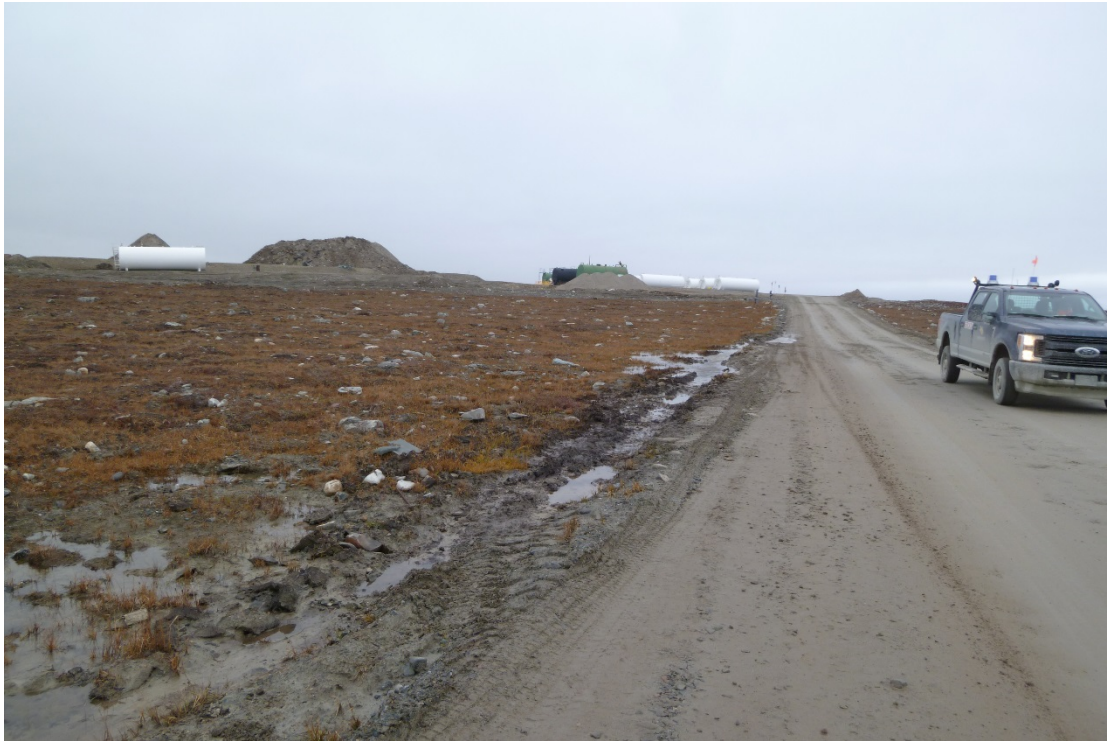
Photograph 27: Exploration Camp Access Road, Water Ponded Along East Edge of Road between Fuel Storage and Intersection with Main Road (21 September 2017)

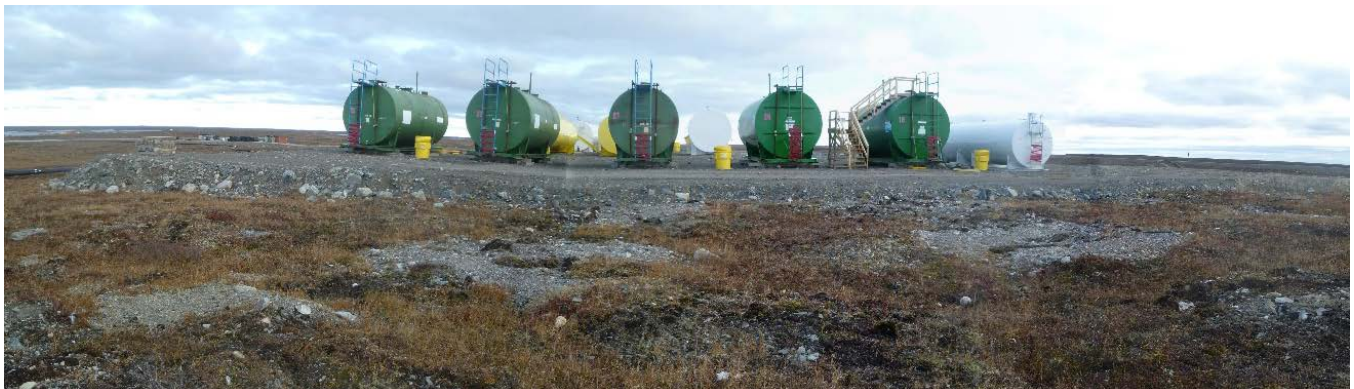
Photograph 28: Exploration Fuel Storage Pad, North Slope, Looking South (19 September 2017)

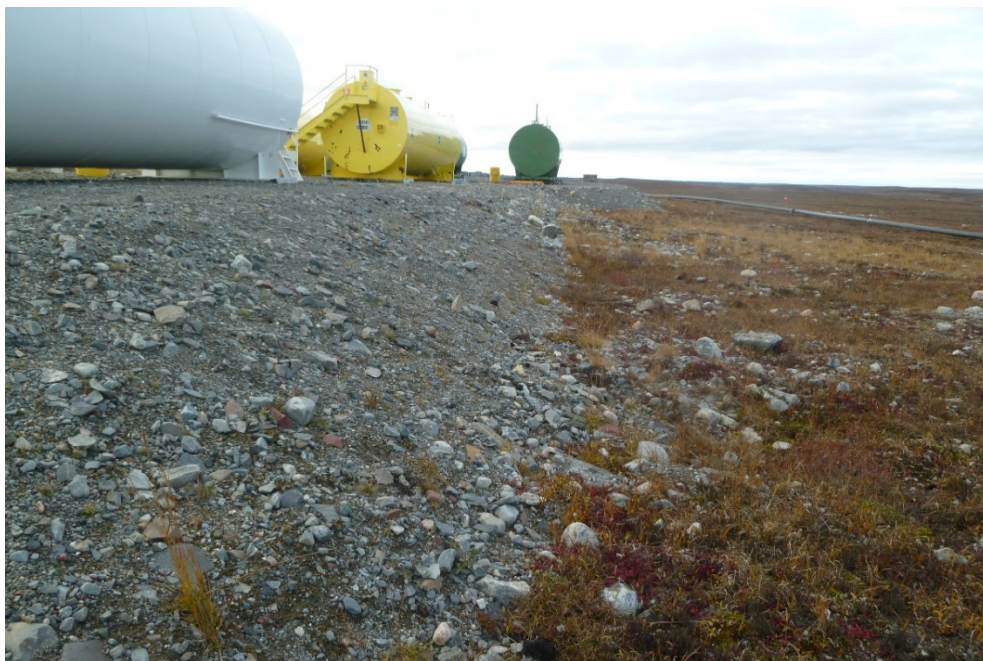
Photograph 29: Exploration Fuel Storage Pad, East Slope, Looking North (19 September 2017)

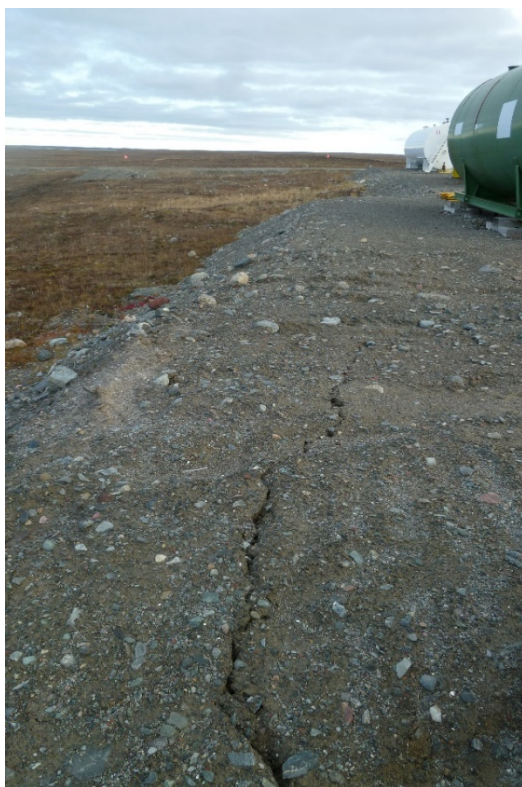
Photograph 30: Exploration Fuel Storage Pad, Cracking along Crest of East Slope, Looking South (19 September 2017)

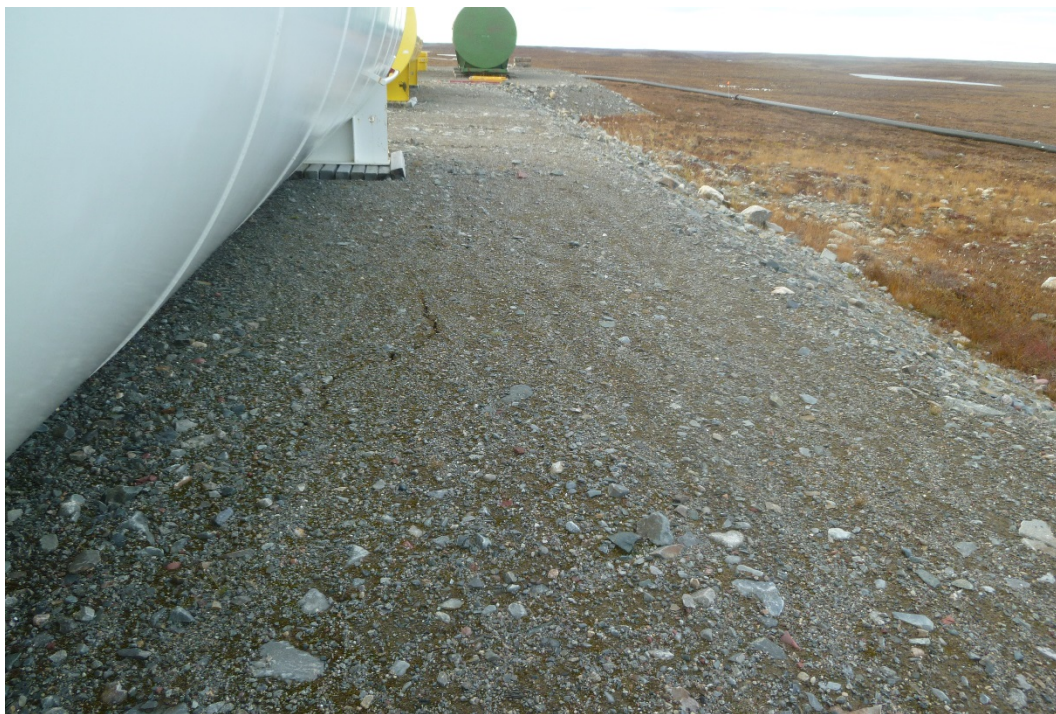
Photograph 31: Exploration Fuel Storage Pad, Minor Cracking near Crest of East Slope, Looking North (19 September 2017)

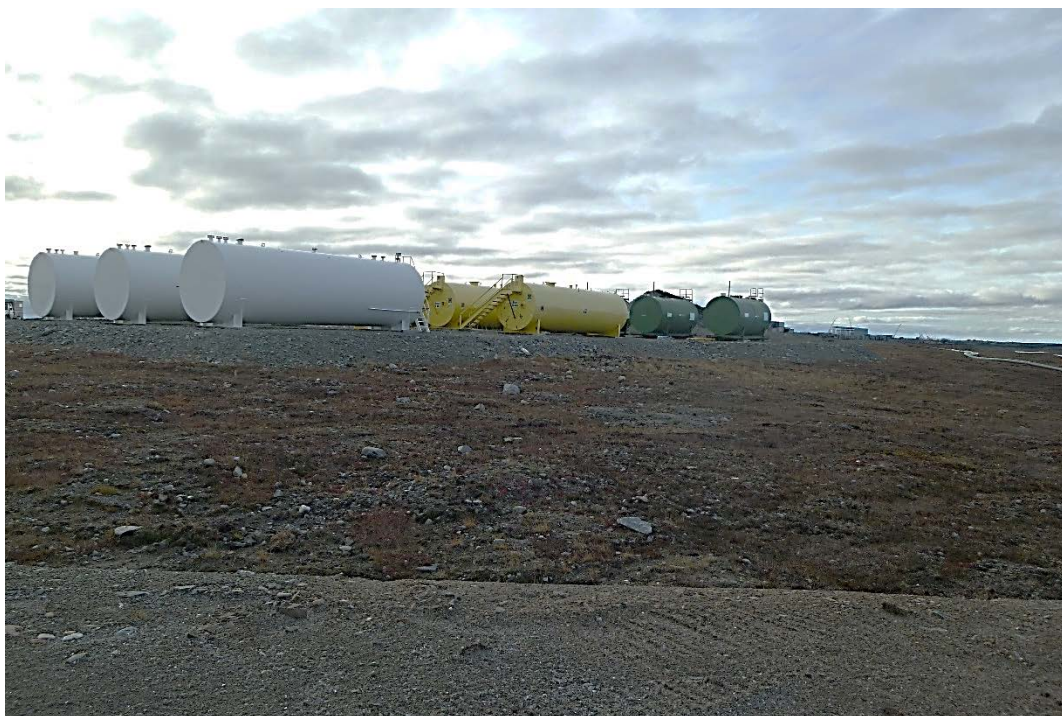
Photograph 32: Exploration Fuel Storage Pad, Looking Northwest (19 September 2017)

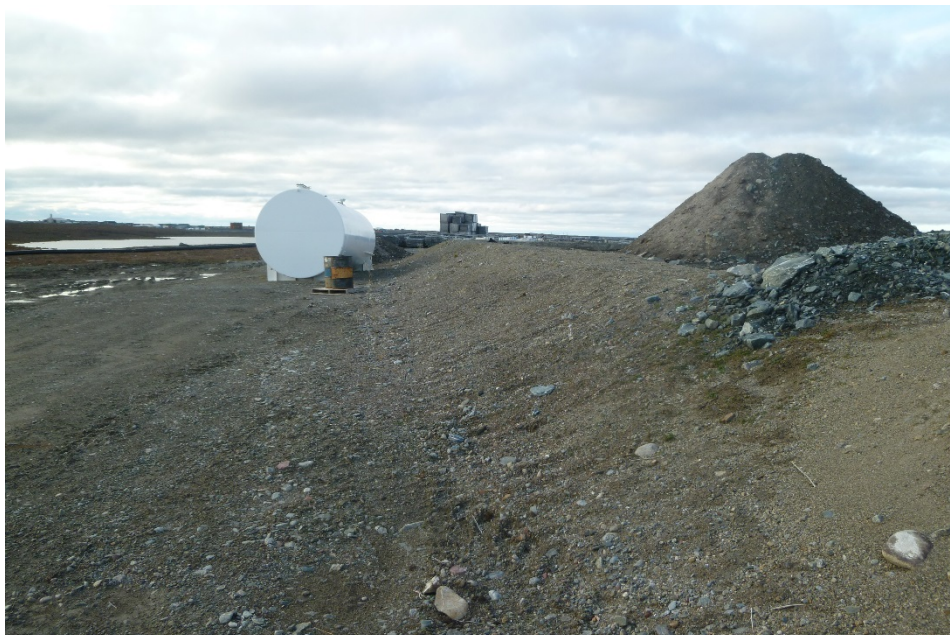
Photograph 33: Exploration Camp Landfarm, Downstream Face of West Slope, Looking Northwest (19 September 2017)

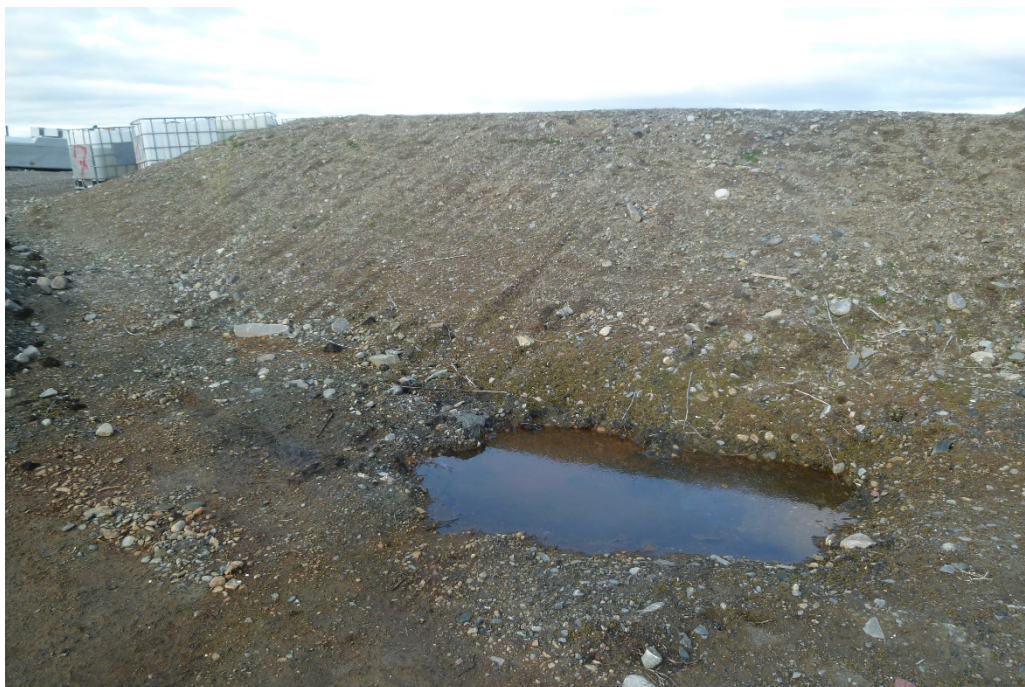
Photograph 34: Exploration Camp Landfarm, Small Pond of Water at Toe of Northeast Corner, Possible Seepage (19 September 2017)

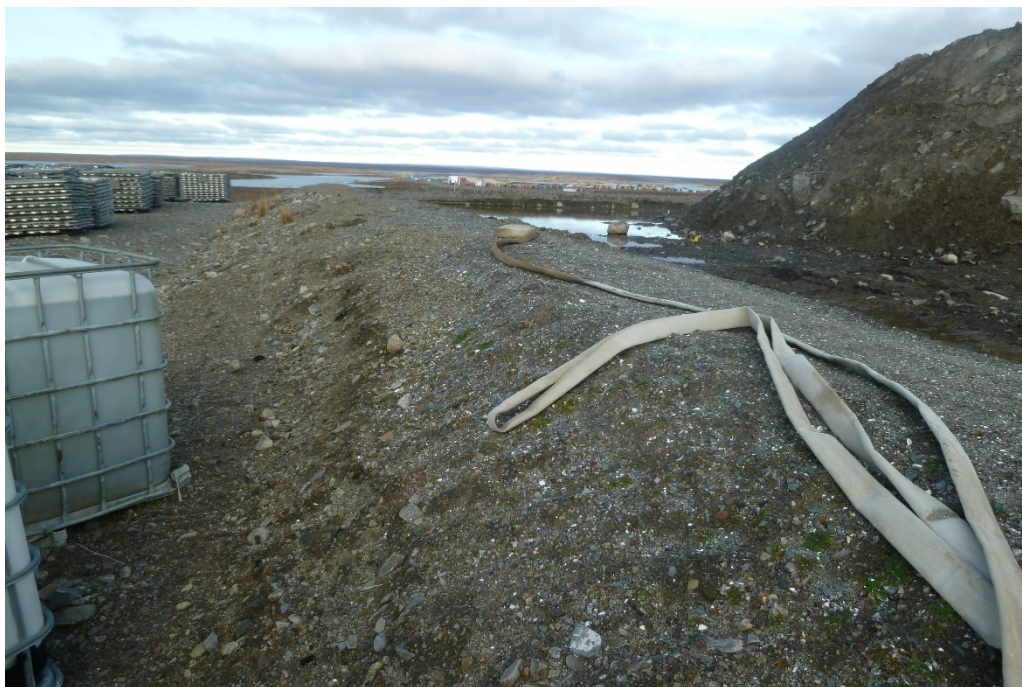
Photograph 35: Exploration Camp Landfarm, North Slope and Crest, Looking Northeast (19 September 2017)

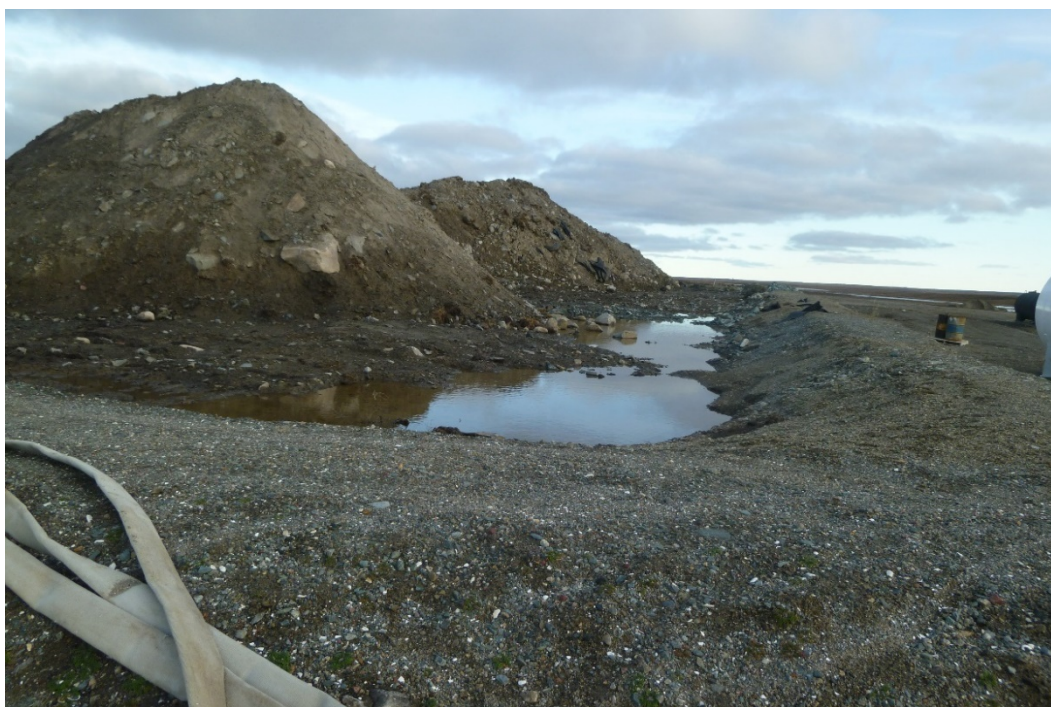
Photograph 36: Exploration Camp Landfarm, West Slope Crest, Looking Southeast. Water Poned within Landfarm (19 September 2017)

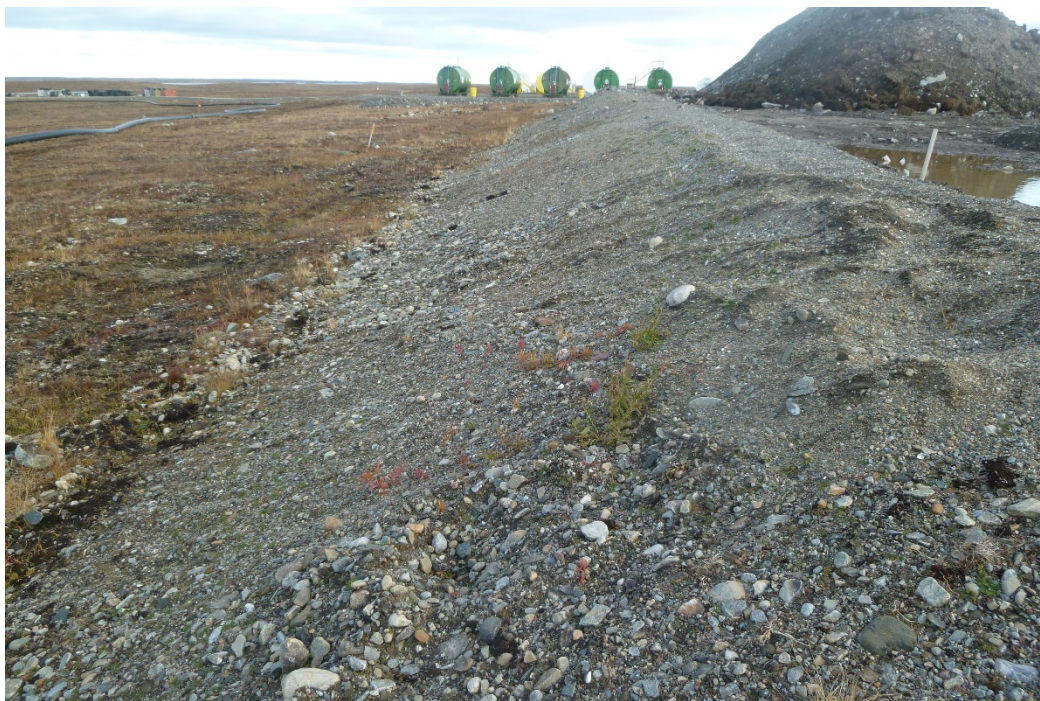
Photograph 37: Exploration Camp Landfarm, East Slope, Looking Southeast (19 September 2017)

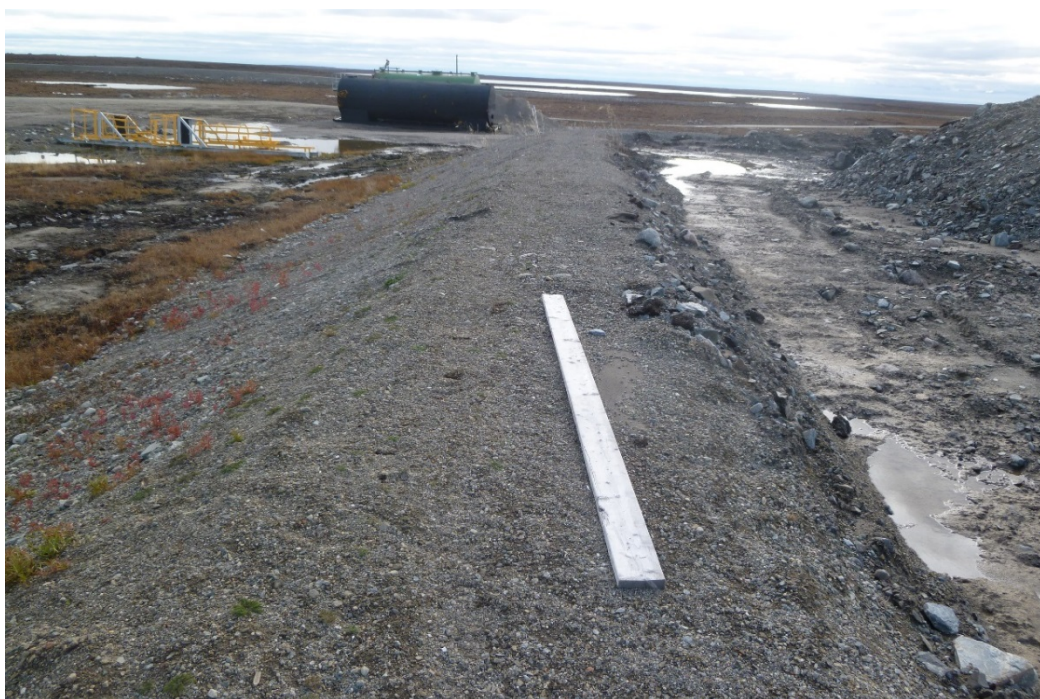
Photograph 38: Exploration Camp Landfarm, South Slope and Crest, Looking Southwest (19 September 2017)

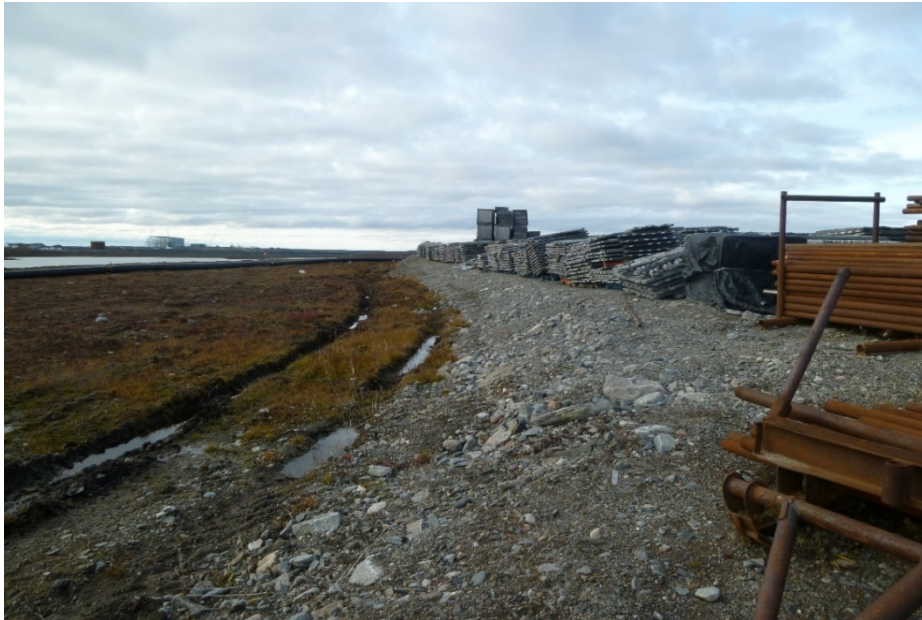
Photograph 39: Core Storage Pad, West Slope Looking North (19 September 2017)

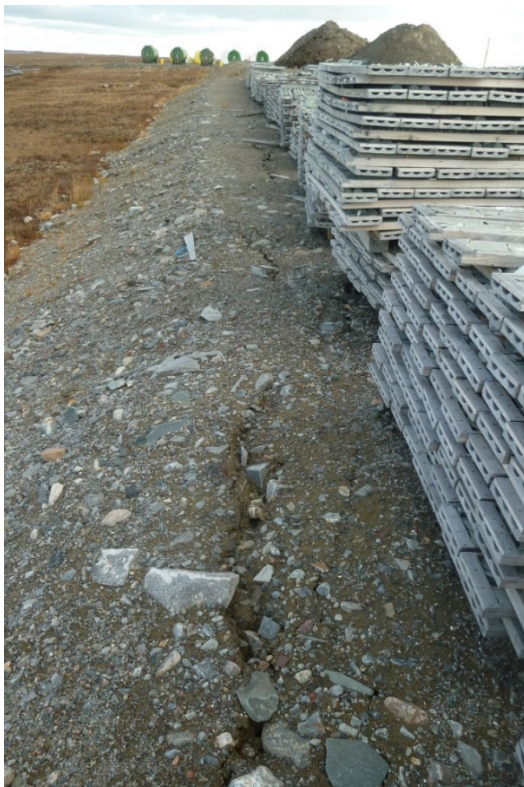
Photograph 40: Core Storage Pad, Cracking on Crest of East Slope, Looking South (19 September 2017)

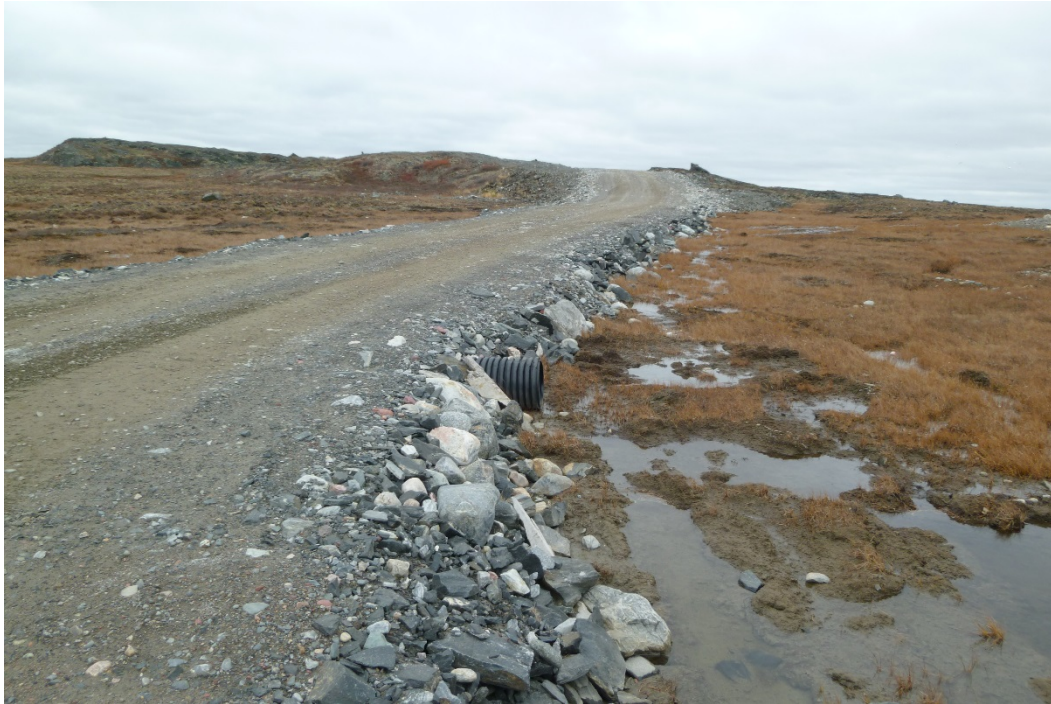
Photograph 1: At KM14.7, Access Road to B12 Quarry. Upstream End of 500 mm \varnothing Corrugated HDPE Culvert. Some Ponding Against Quarry Access Road and AWAR below Inlet of Culvert (20 September 2017)

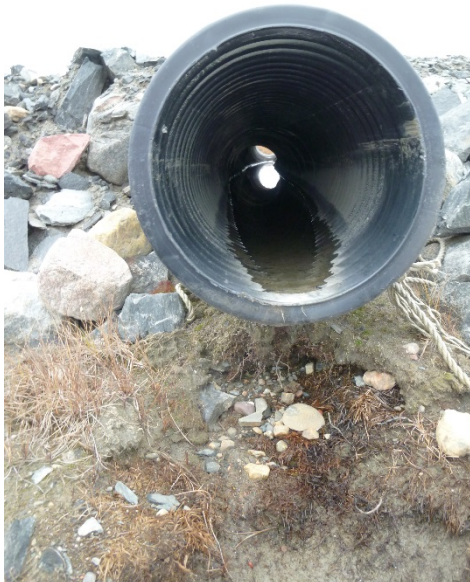
Photograph 2: View through Culvert Under Access Road to B12 Quarry at KM14.7, Some Dents, No Flow, Small Amount of Ponded Water Within Culvert (20 September 2017)

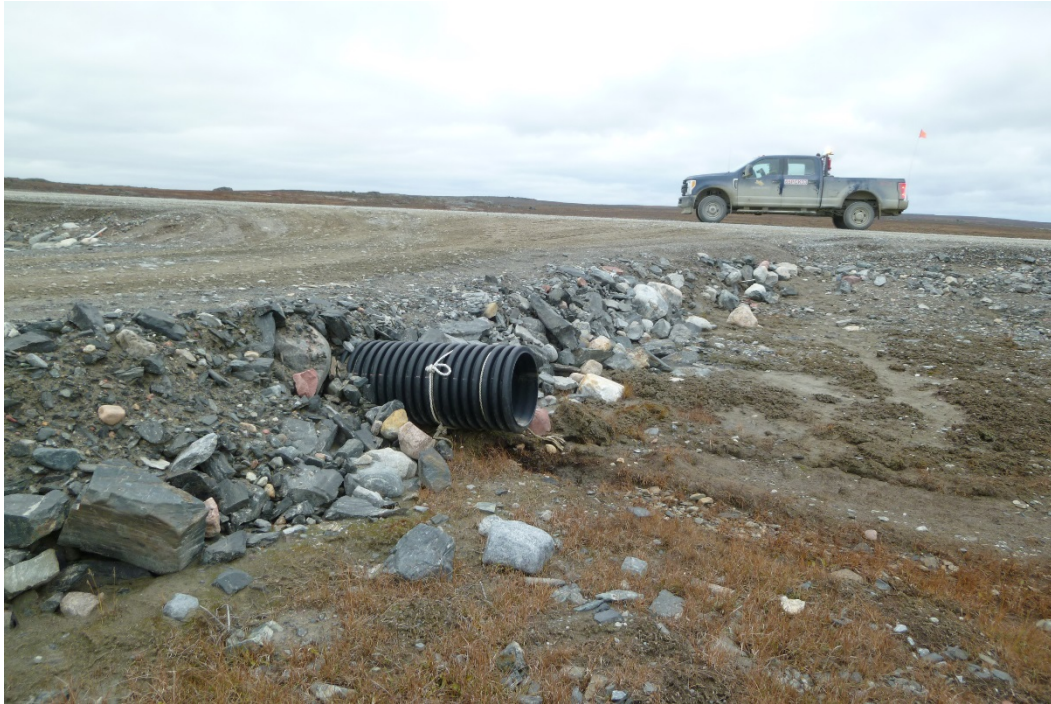
Photograph 3: Downstream End of Culvert through Access Road to B12 Quarry at KM14.7 (20 September 2017)

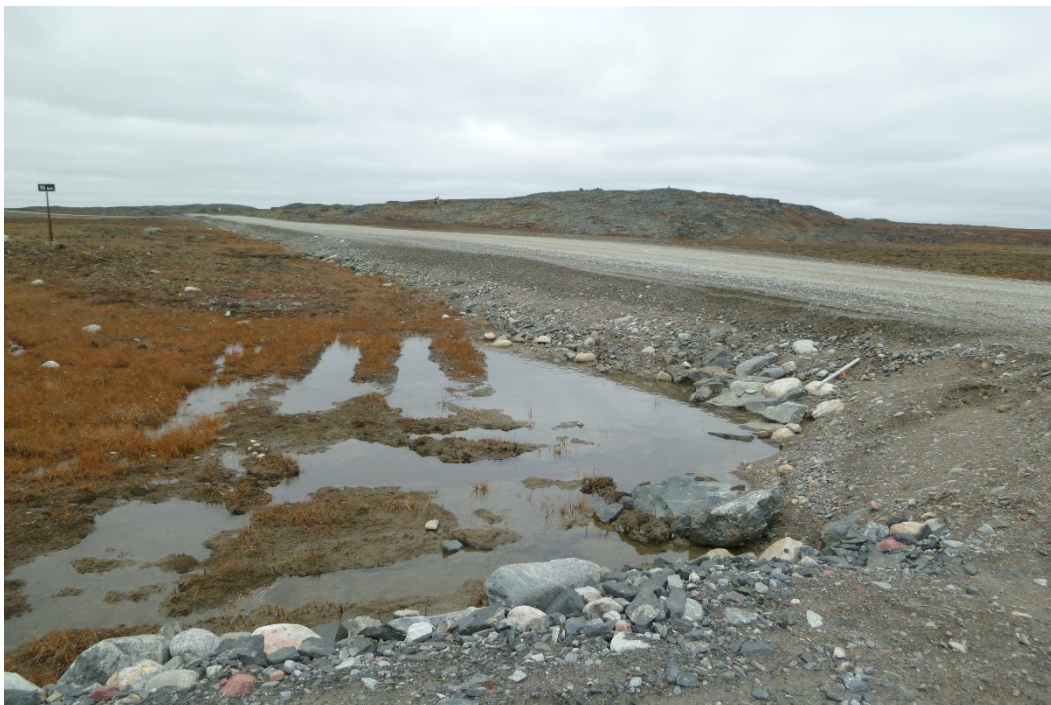
Photograph 4: Water Pooled Adjacent to AWAR and Access Road to B12 Quarry at KM14.7. Looking at AWAR from Quarry Access Road. (20 September 2017)
