APPENDIX B

Meliadine AWAR Inspection – 2017

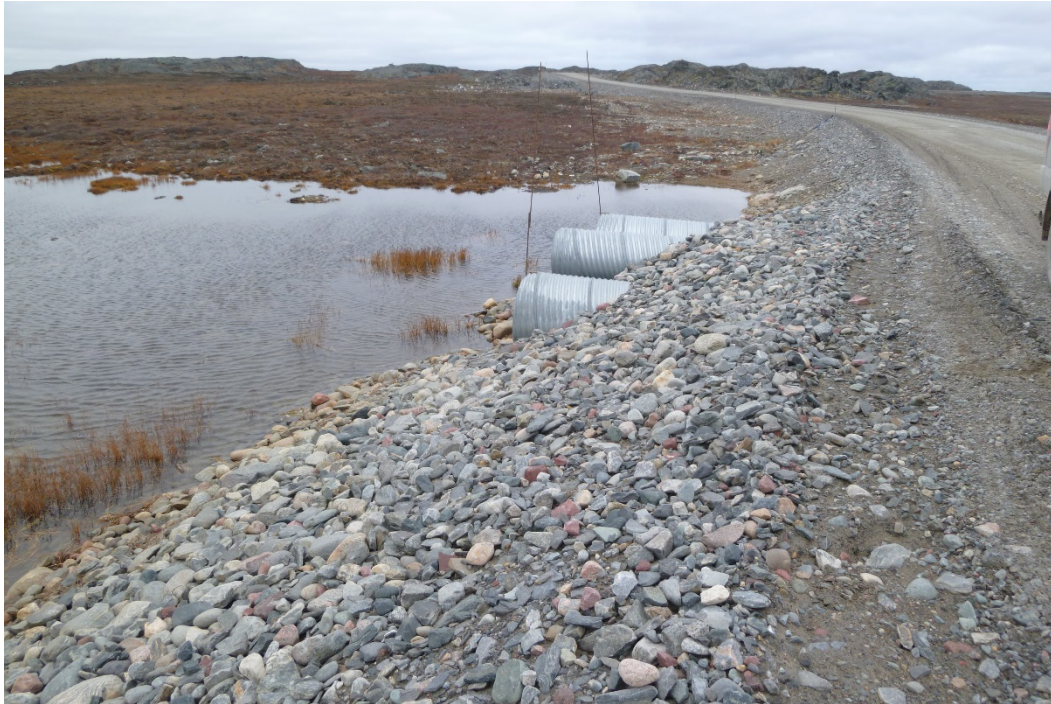
Photograph 5: KM16.3, Upstream Ends of 3 CSP Culverts from Front to Back of Photo: 1000 mm, 700 mm, and 1300 mm Ø Looking South (20 September 2017)

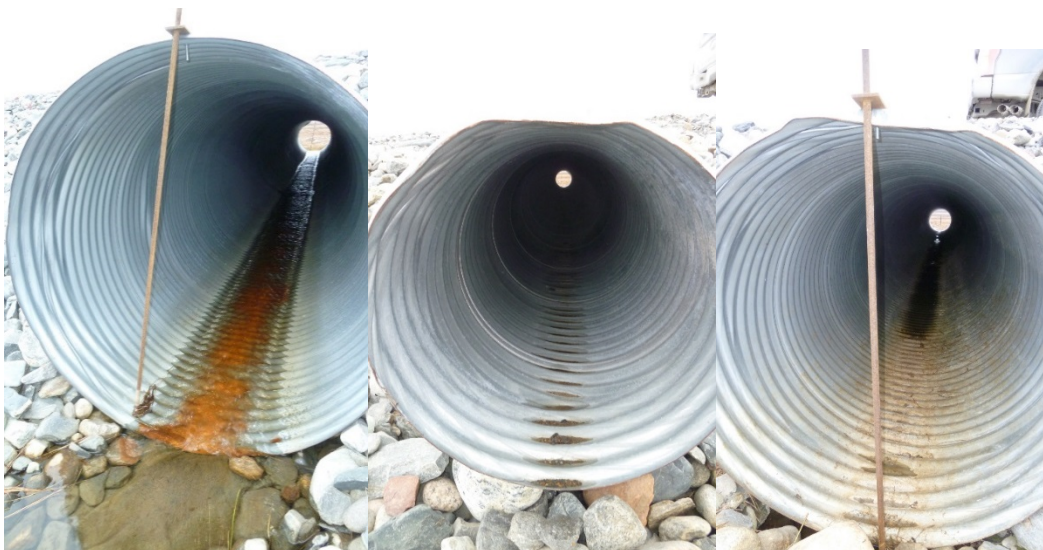
Photograph 6, 1 and 8: 3 CSP culverts at KM 16.3 from Upstream Looking Downstream. Good Condition, some Clear Flow in 1300 mm Ø Culvert. Good condition and no Flow for the 700 mm Ø (middle) and 1000 mm Ø (right) Culverts. (20 September 2017)

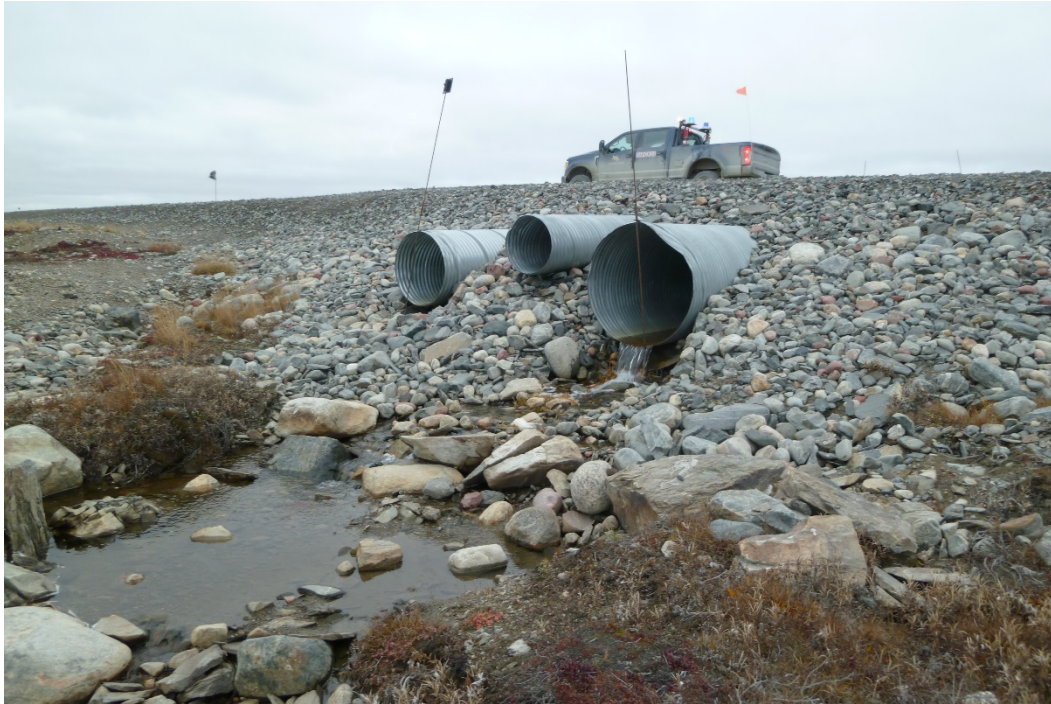
Photograph 9: Downstream Ends of Three CSP Culverts at KM16.3. Small Flow in 1300 Ø Culvert, Minor Deformation of End of Culvert. Small Erosion Visible at Outlet (20 September 2017)

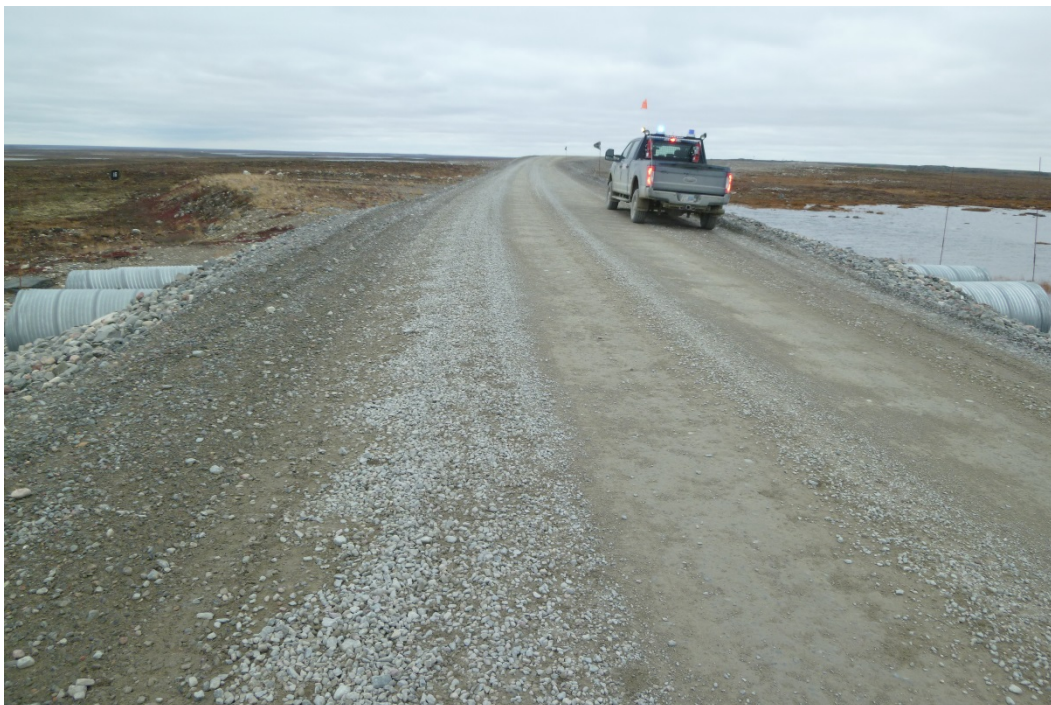
Photograph 10: Road Over 3 CSP Culverts, at KM16.3 Looking North (20 September 2017)

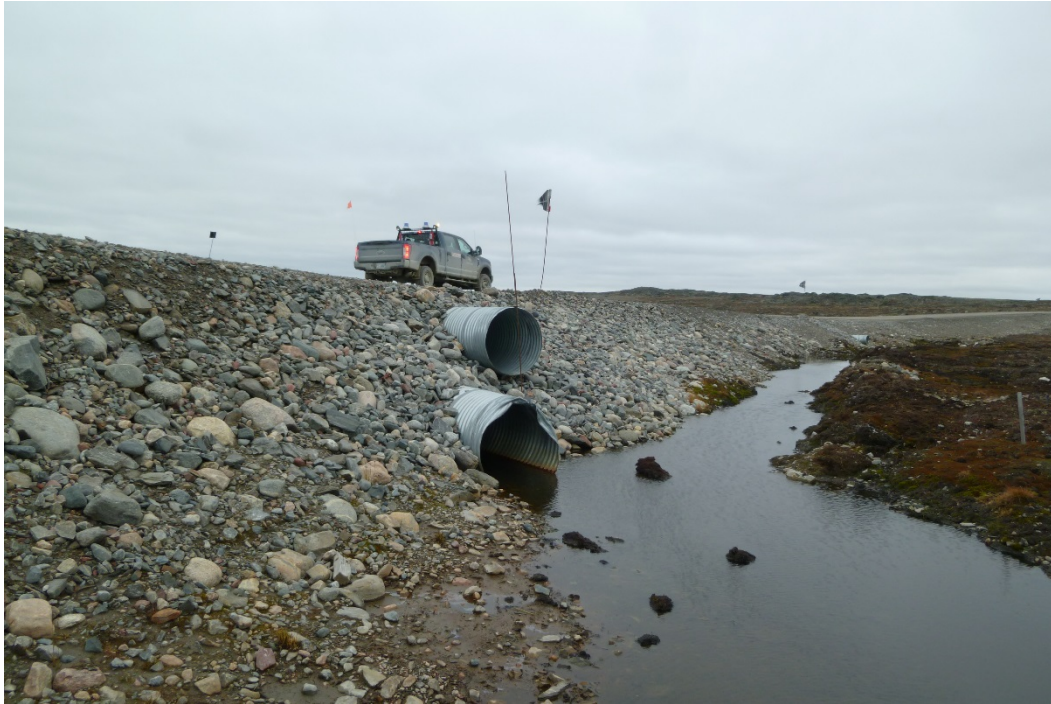
Photographs 11 to 14 were taken at KM18.1. There are 2 vertically offset, CSP culverts the upper culvert is 900 mm Ø and the lower culvert is 1000 mm Ø. Note that the road near KM18.1 would need to almost be flooded to reach inlet of 900 mm Ø culvert. If water management in this area is a problem, suggest installing second culvert at a lower elevation. A ditch on the upstream side hydraulically connects the culverts at KM18.1 to culvert at KM18.15.

Photograph 11: View of Upstream Ends of Two CSP Culverts at KM18.1, Upper is 900 mm Ø and the Lower is 1000 mm Ø, Looking North to Single 600 mm Ø CSP at KM18.15 in Background of Photo. Cover Over Upper (900 mm Ø) Culvert is Thin on Upstream Side (20 September 2017)

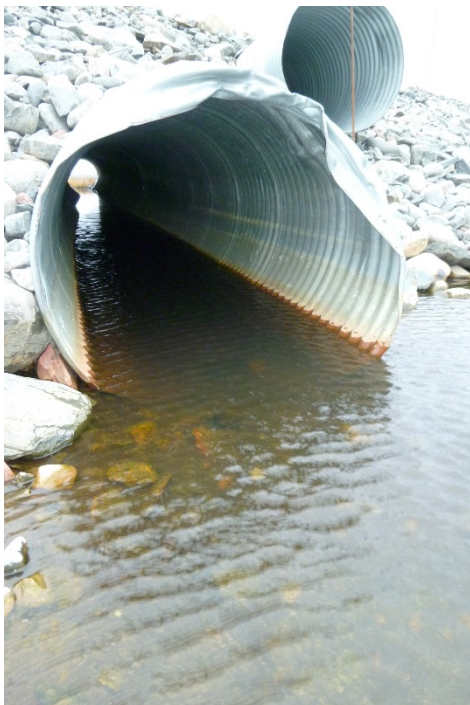
Photograph 12: View Through 1000 mm Ø CSP Culvert at KM18.1 From Upstream Side. Some Damage to Inlet of Culvert (20 September 2017)

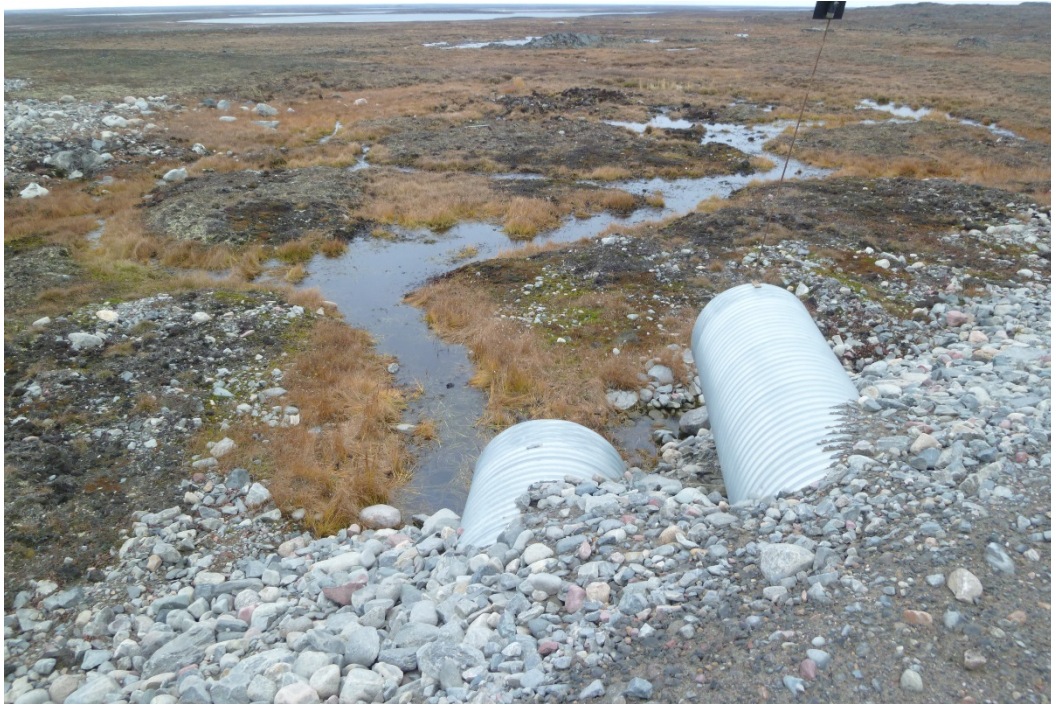
Photograph 13: Downstream View of Two CSP Culverts at KM 18.1 (20 September 2017)

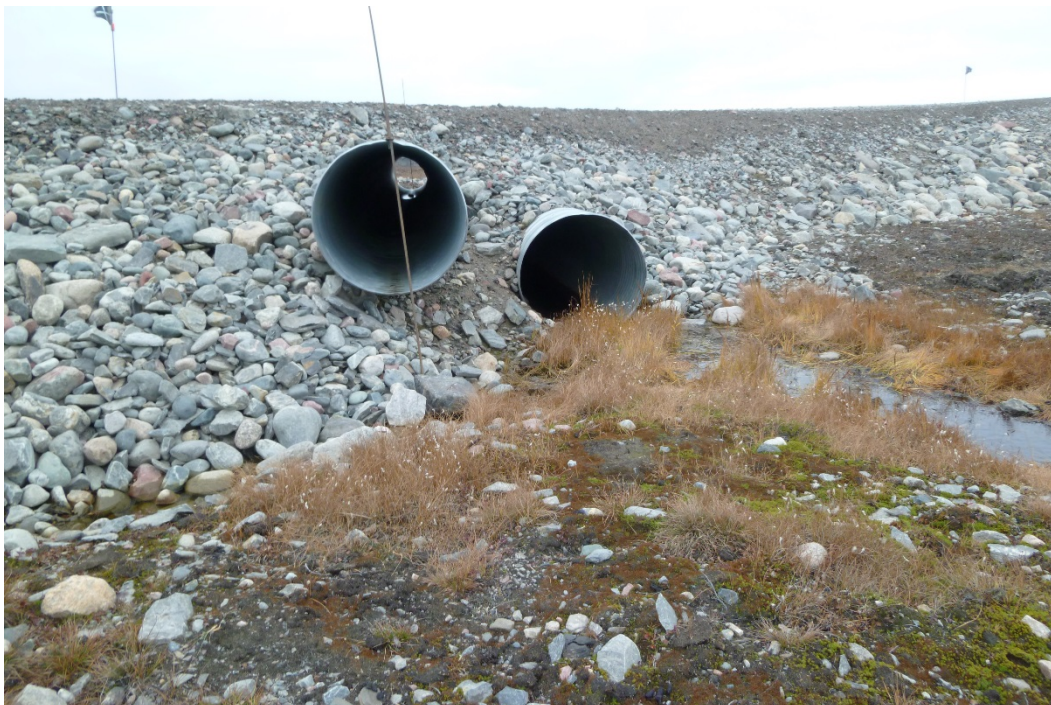
Photograph 14: Downstream Ends of the Two CSP Culverts at KM 18.1 (20 September 2017)

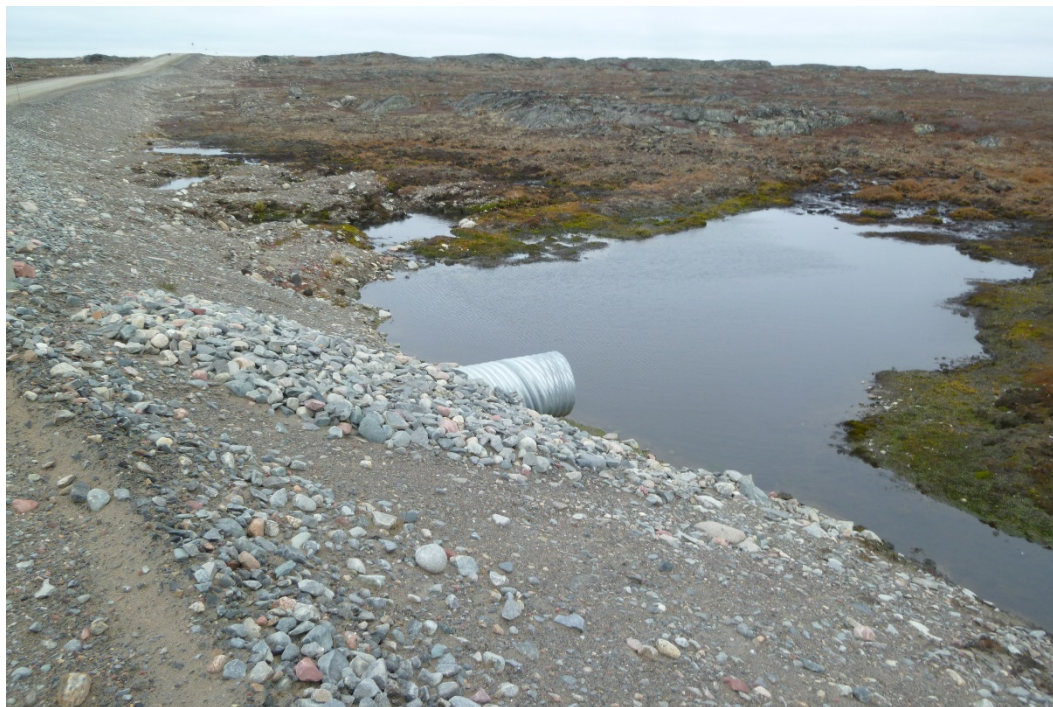
Photograph 15: Upstream End of 600 mm Ø CSP Culvert at KM18.15 (20 September 2017)

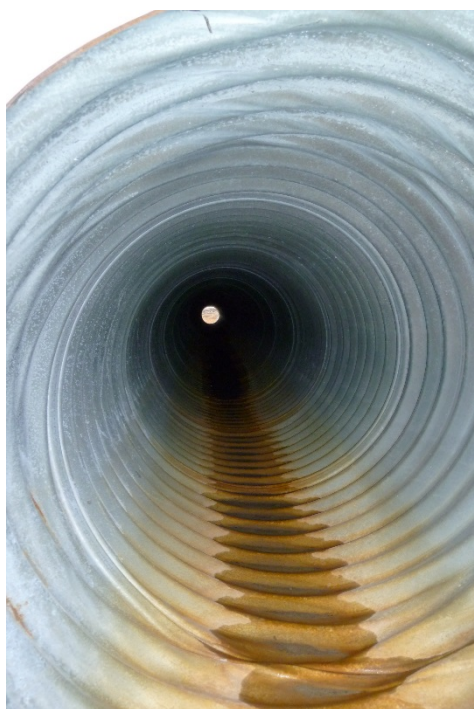
Photograph 16: View through 600 mm Ø CSP Culvert at KM18.15 from Upstream end (20 September 2017)

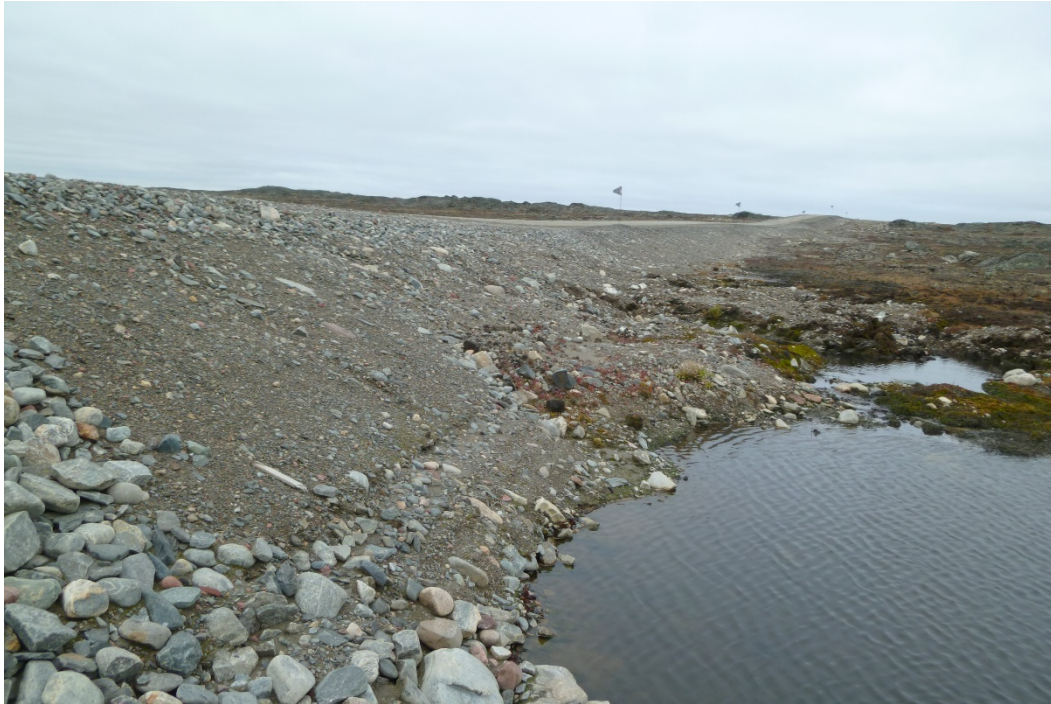
Photograph 17: View of The Road Embankment North of Upstream End Of 600 Mm Ø CSP Culvert at KM18.15. Some Erosion Observed on Embankment (20 September 2017)

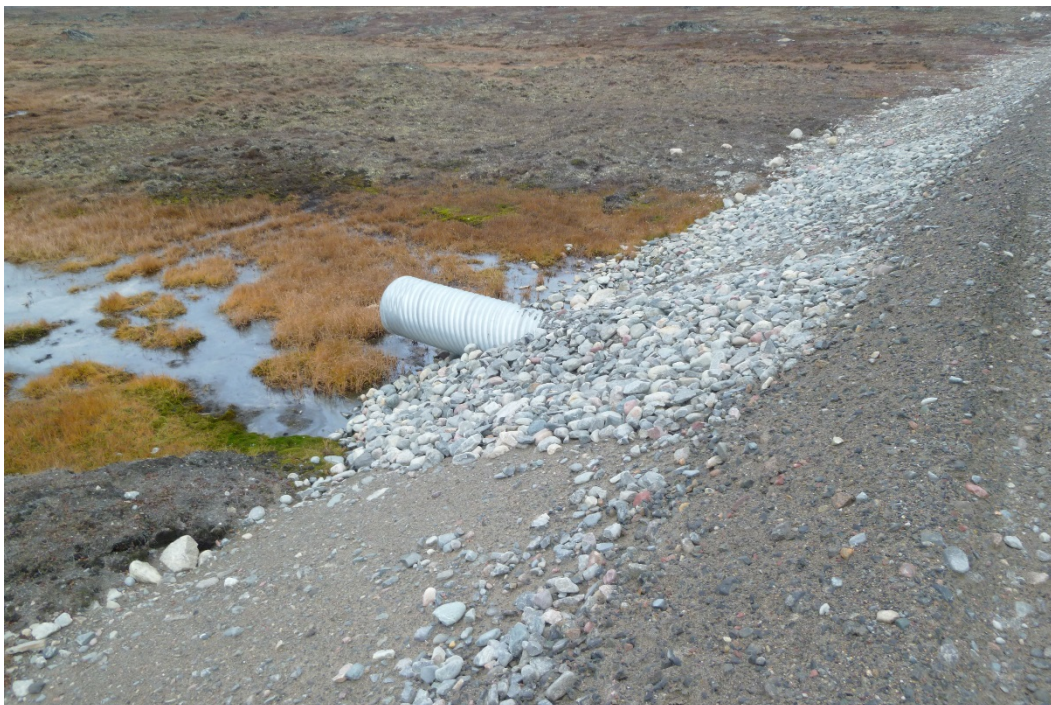
Photograph 18: Downstream End of 600 mm Ø CSP Culvert at KM18.15 (20 September 2017)

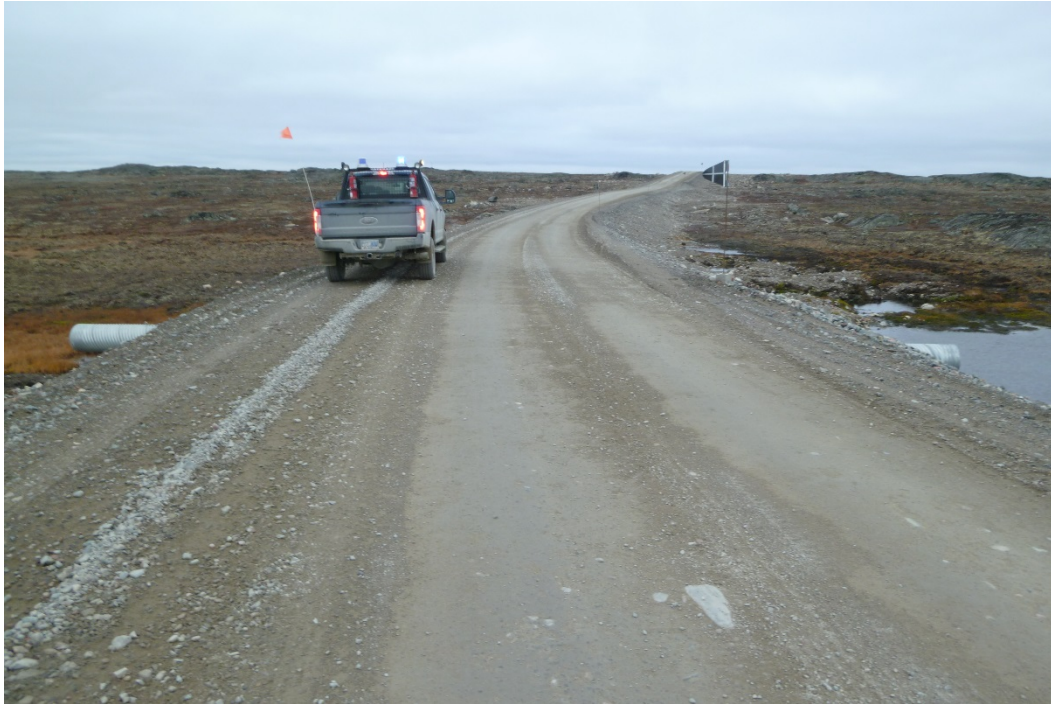
Photograph 19: Road Surface Looking North from 600 mm Ø CSP Culvert at KM18.15 (20 September 2017).

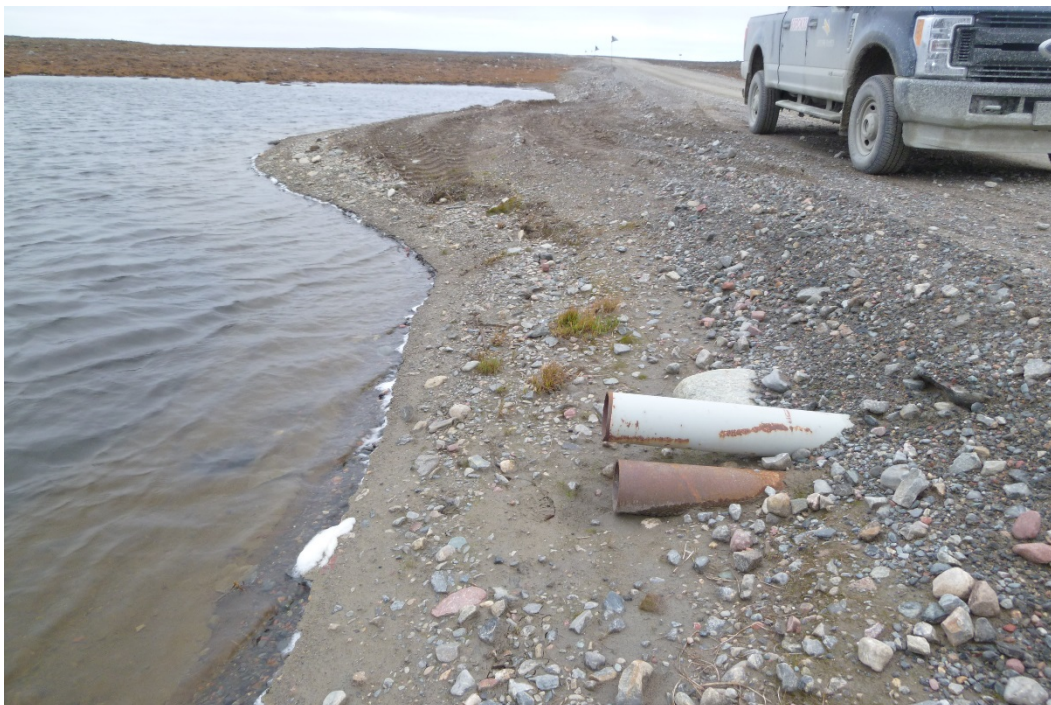
Photograph 20: KM21.7, View of the Upstream Ends of Pipes (20 September 2017)

Photographs 20 to 23 were taken at KM21.7. There are two 170 mm outside Ø pipes, vertically offset. AEM inspections note water ponding at or over road in this area during freshet. There is evidence of high water surrounding the area, the capacity of the pipes may be inadequate, or pipes could have been frozen/blocked causing water to backup.

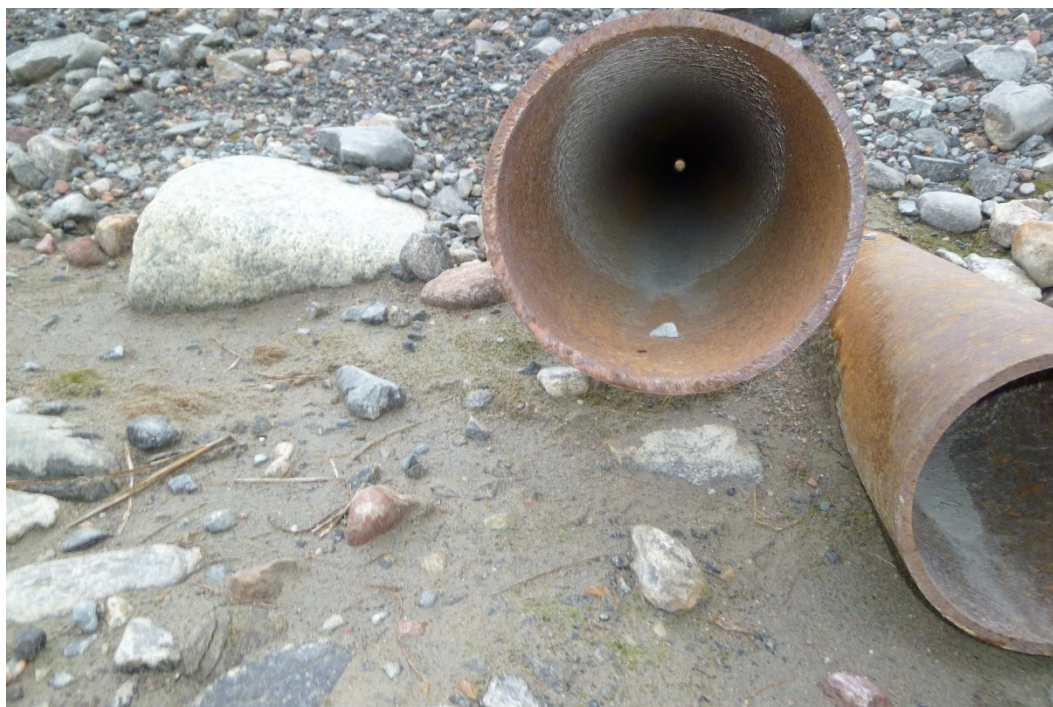
Photograph 21: Looking through Upper Pipe at KM21.7 (20 September 2017)

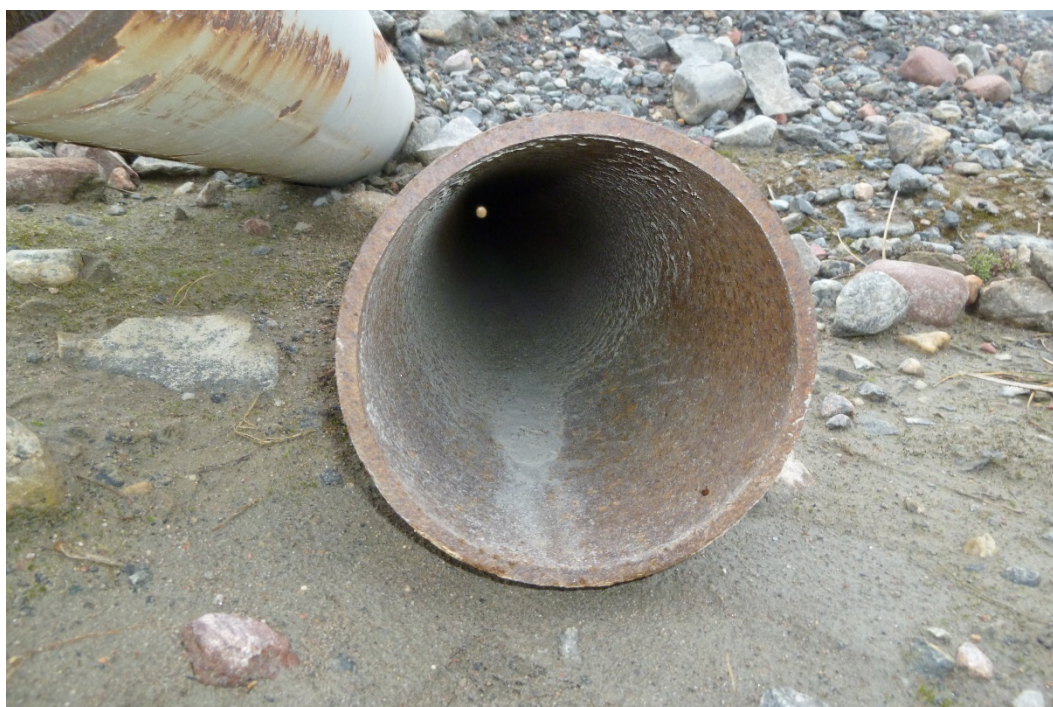
Photograph 22: Looking through Lower Pipe at KM21.7 (20 September 2017)

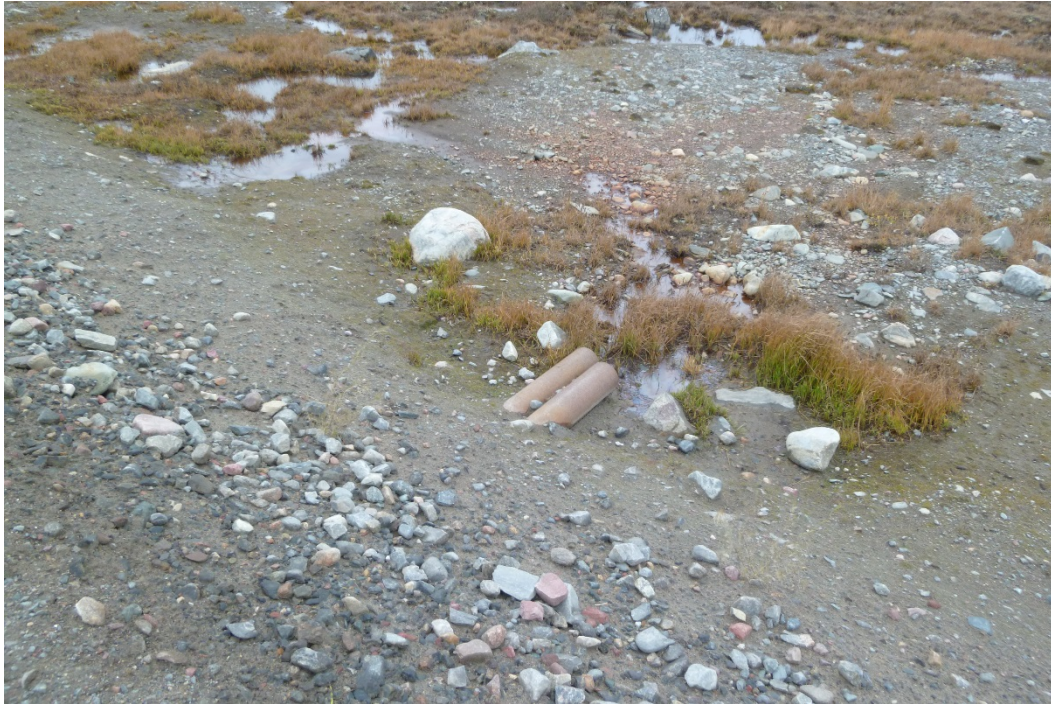
Photograph 23: Downstream View of the Pipes at KM21.7 (20 September 2017)

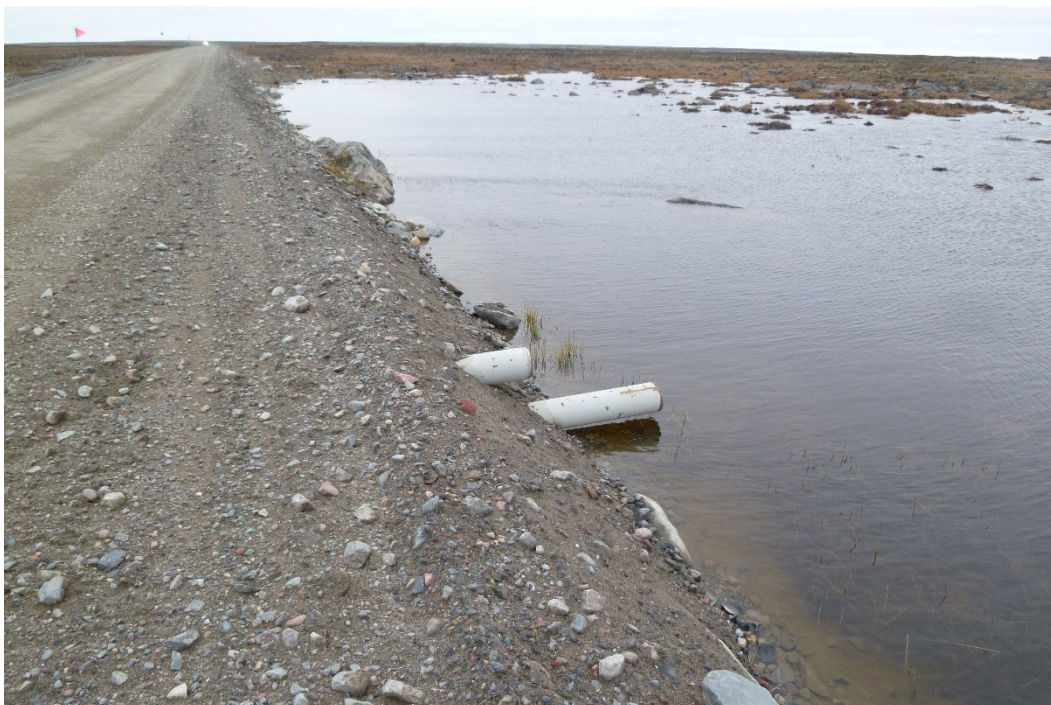
Photograph 24: KM22.3, There are Two Steel Pipes Vertically Offset, 160 Mm Ø. Looking at Upstream Ends. Inlets are Elevated, Could Be Installed at a Lower Elevation to Reduce Poned Water Along Road (20 September 2017)

Photographs 24 26 through 98 were taken at KM22.3. There are two steel pipes vertically offset, 160 mm Ø. Both pipes were clear with no flow. AEM inspection reports note water ponding at or over road in this area during freshet. The capacity of the pipes may be inadequate, or pipes could have been frozen/blocked causing water to backup.

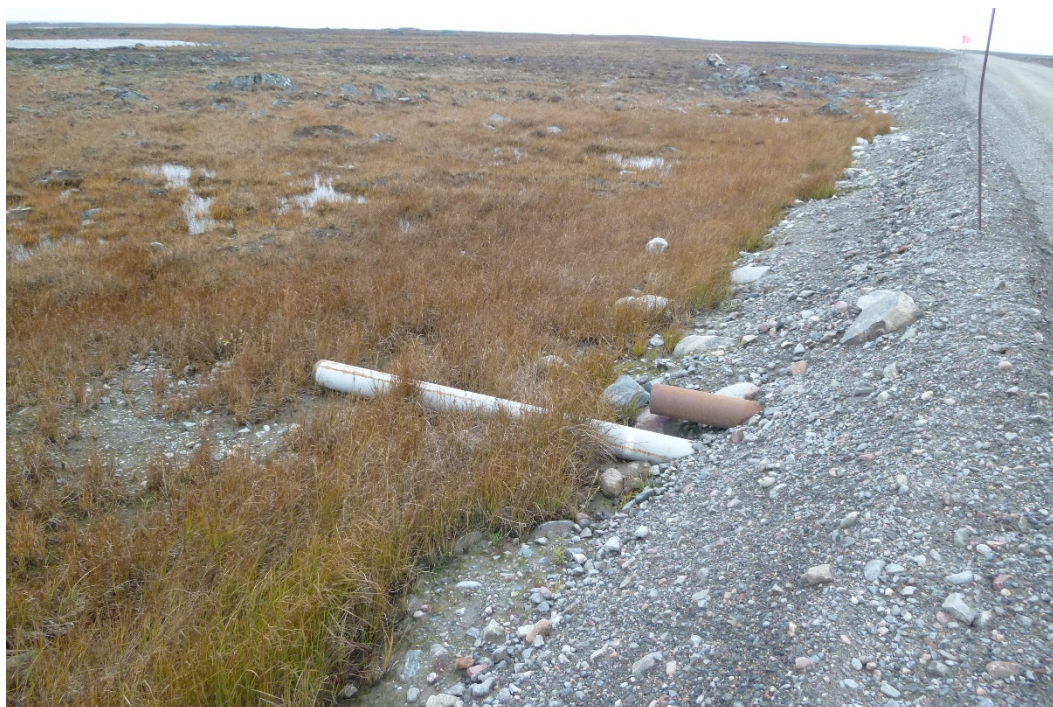
Photograph 25: Downstream End of Pipes at KM22.3 (20 September 2017)

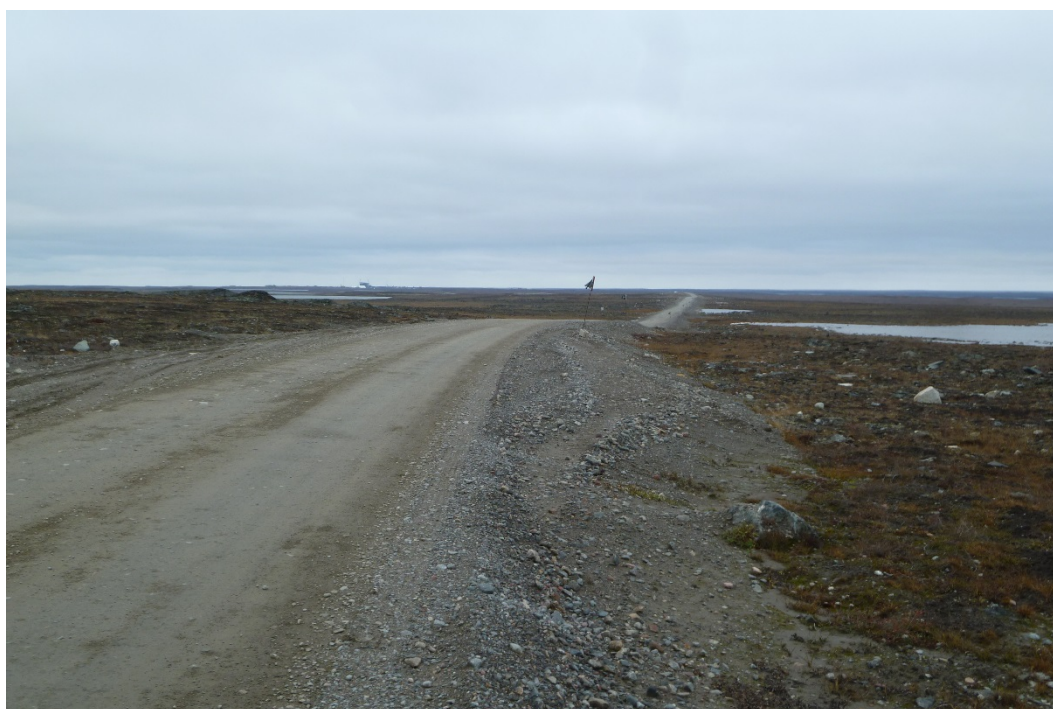
Photograph 26: Road Surface North of The Steel Pipes at KM22.3 Looking North (20 September 2017)

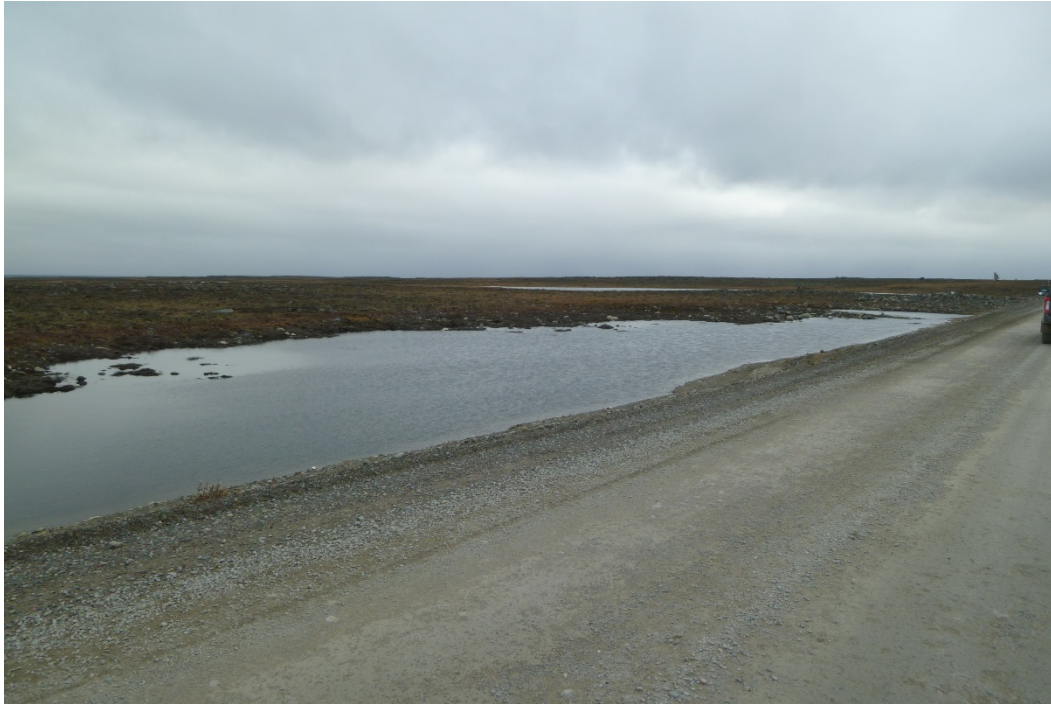
Photographs 27 to 29 were taken at KM22.7. Ponded water, no culvert.

Photograph 27: Ponded Water on East Side of the Road Near KM22.7 (22 September 2017)

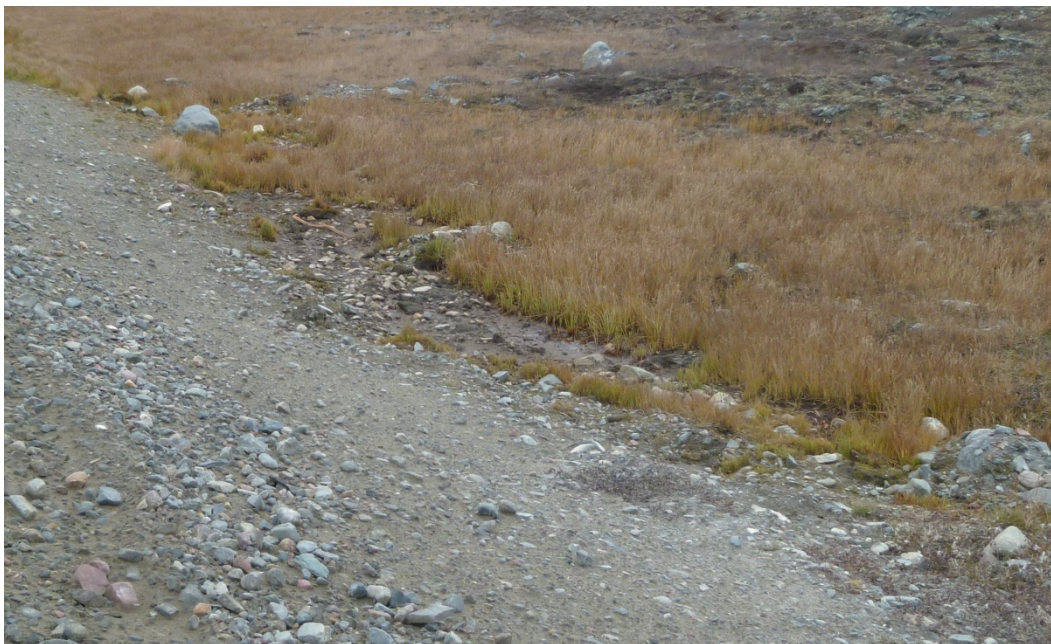
Photograph 28: Wet Ground on West side of Road Indicating Possible Seepage through Road Near KM22.7 (22 September 2017)

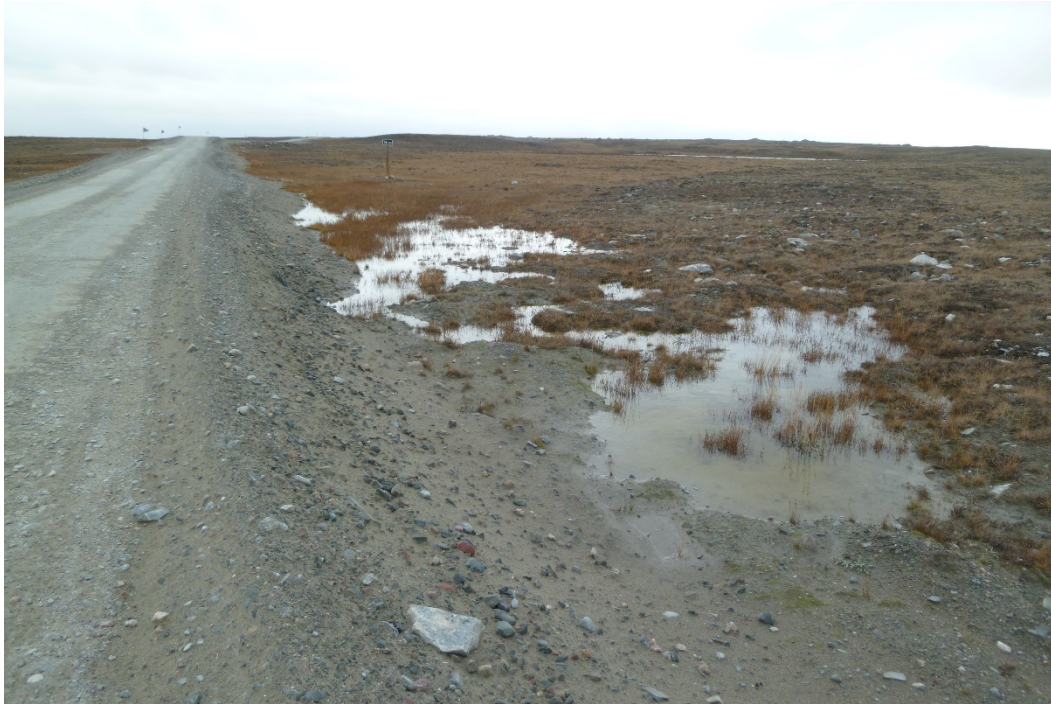
Photographs 29 through 32 were taken at KM25.8. HDPE corrugated 600 mm Ø culvert. Minor flow, some gravel in the base of the culvert and minor dents. Erosion observed on road embankment.

Photograph 29: Upstream end of HDPE Corrugated 600 mm Ø Culvert at KM25.8 (22 September 2017)

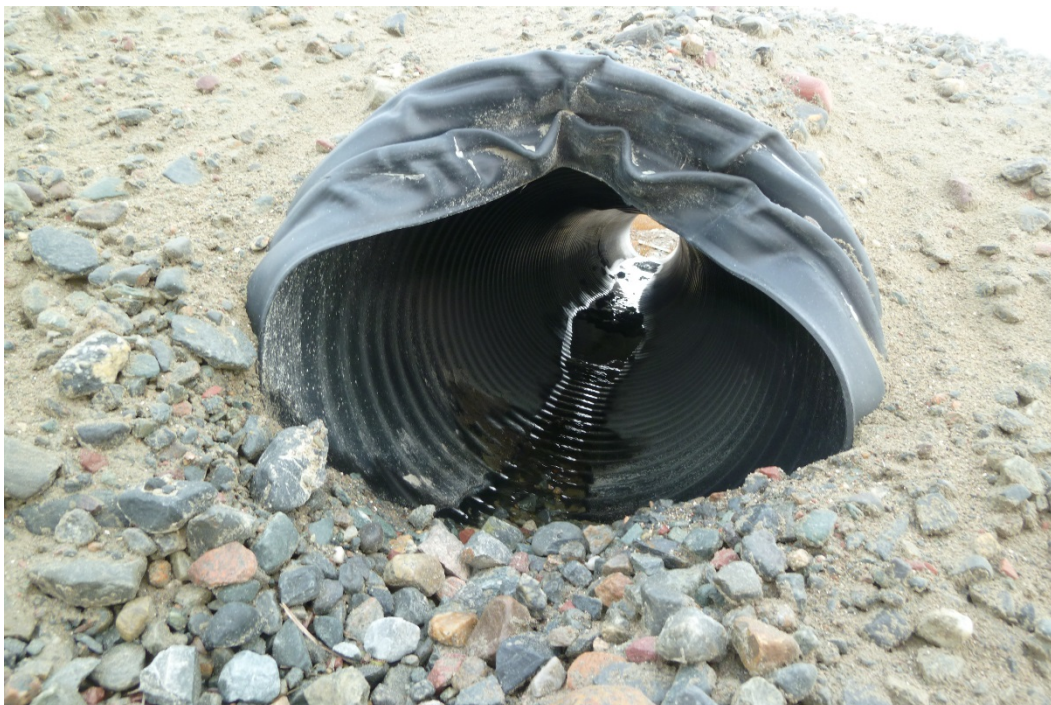
Photograph 30: Looking at the Inlet of the Culvert from Upstream to Downstream, 600 mm Ø HDPE, at KM25.8 (22 September 2017)
