2018 Annual Geotechnical Inspection

Meliadine Gold Project, Rankin Inlet, Nunavut

Golder Associates Ltd.

Reference No. 18105719-002-R-Rev0-3000

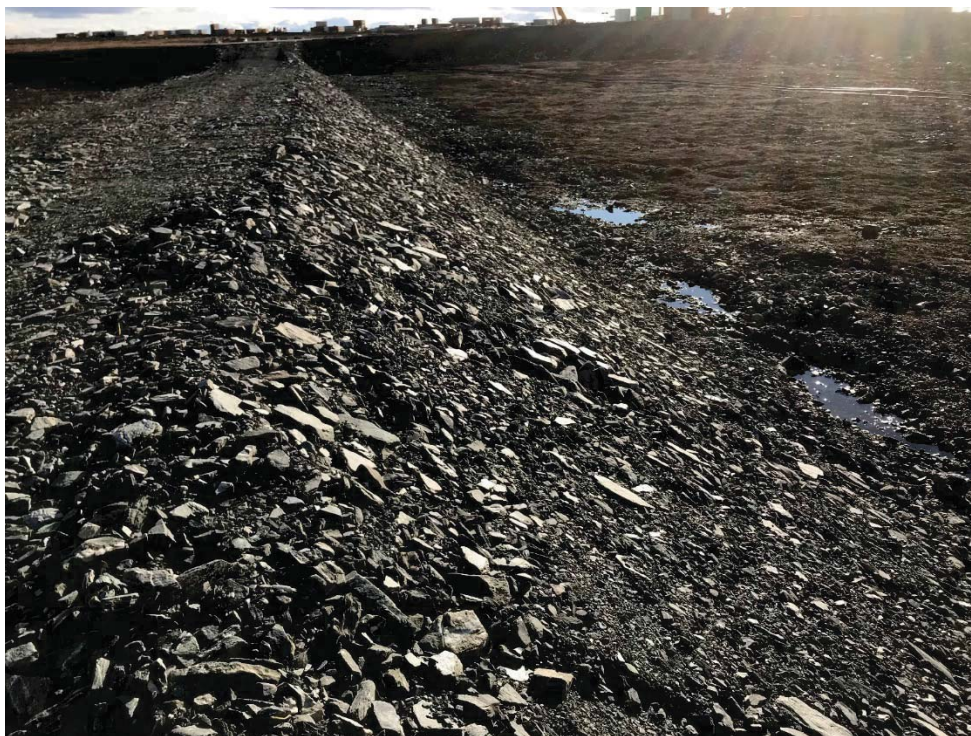
Photograph 3: DP1-A, North Slope Looking Southwest, Minor Slumping that was not observed during 2017 inspection (12 September 2018)

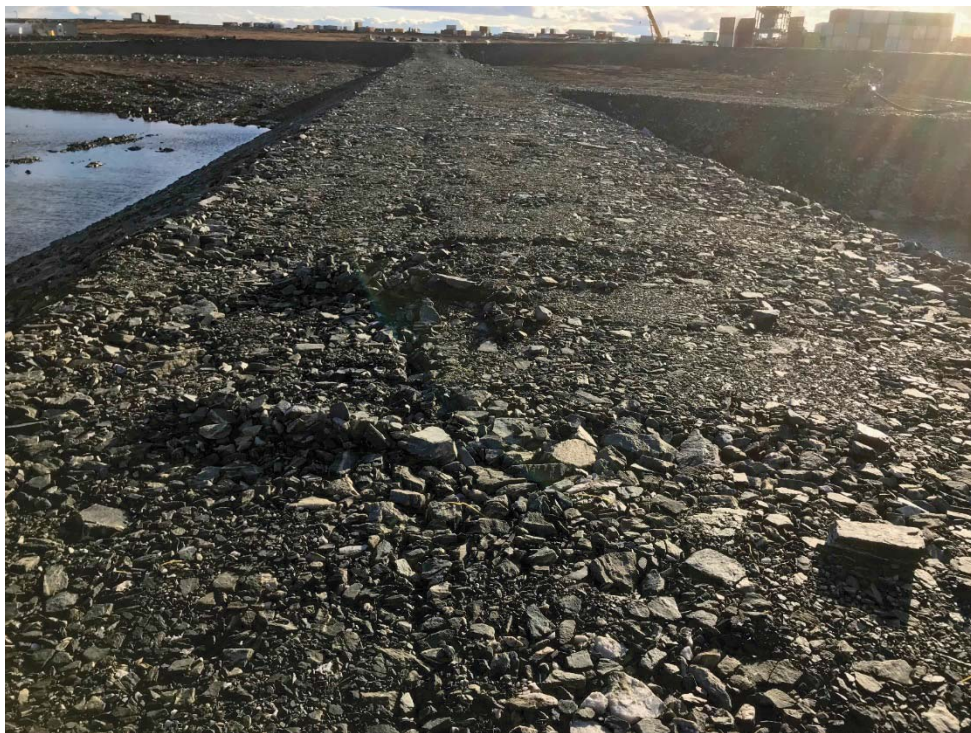
Photograph 4: DP1-A, Cracking Observed on Crest, Similar Condition to 2017 (12 September 2018)

- Cracks and areas of settlement in the containment pond dikes should be filled and/or recontoured to close the cracks and reduce the potential for infiltration and erosion. (M)

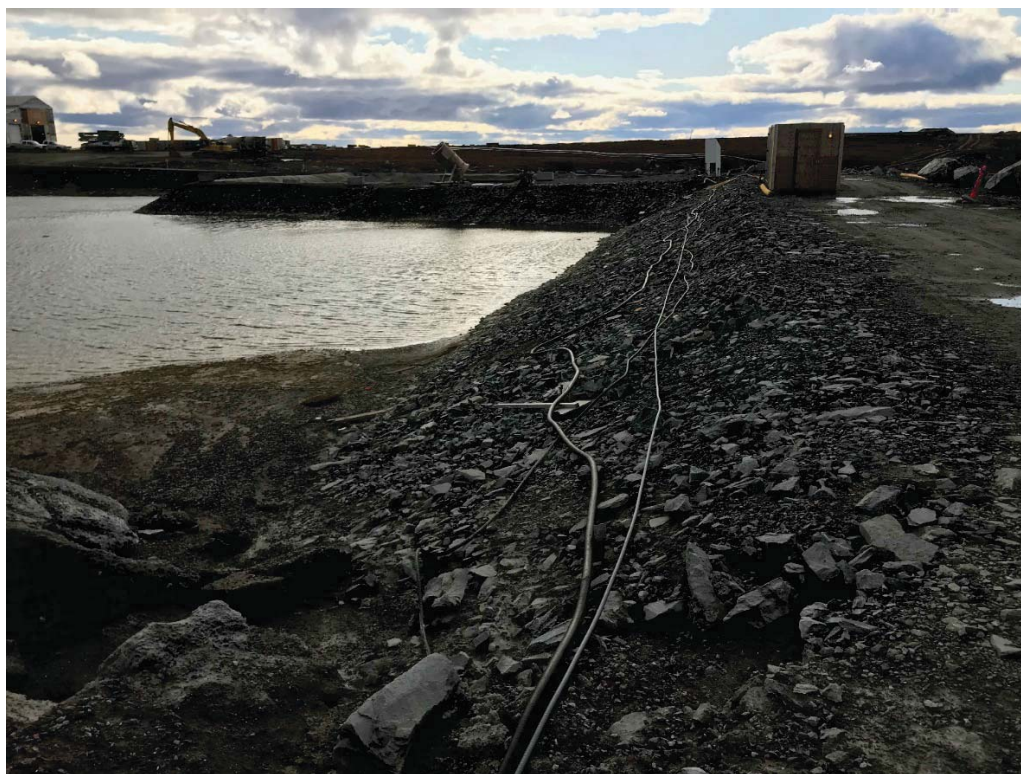
Photograph 10: DP1-B, Upstream Slope from Jetty 2 Looking East toward Snow Melt Management Pond, Minor Erosion on Slope (12 September 2018)

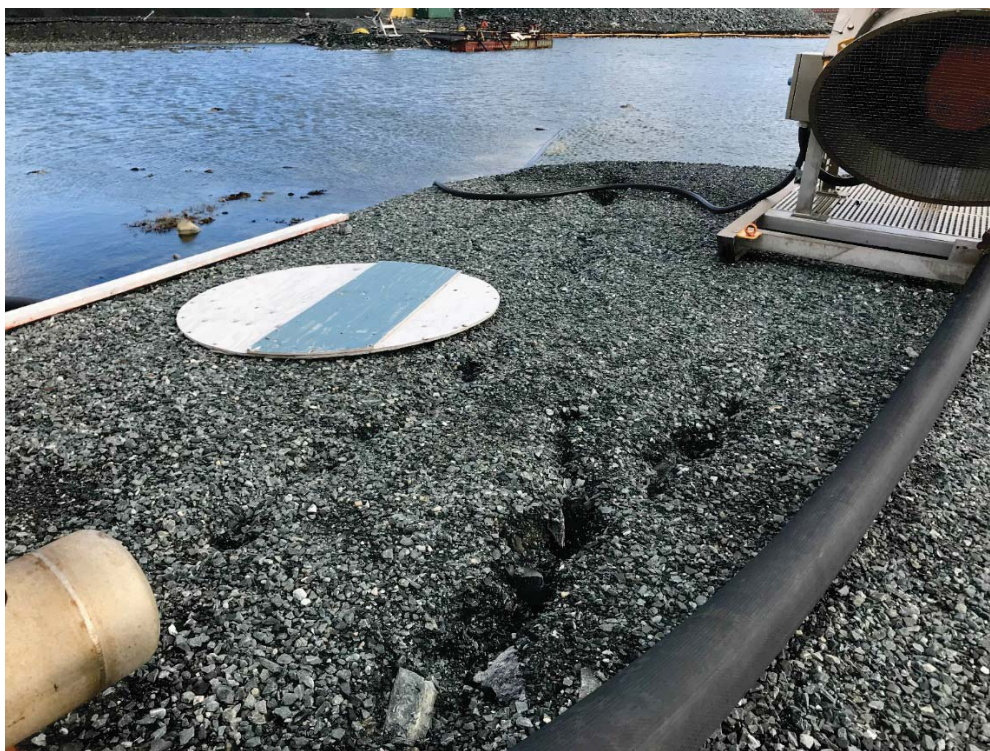
Photograph 12: DP1-B, Cracking on Crest of Jetty 2 has Increased Slightly from 2017. No cracking observed at Jetty 3 or Jetty 4 during inspection (12 September 2018)

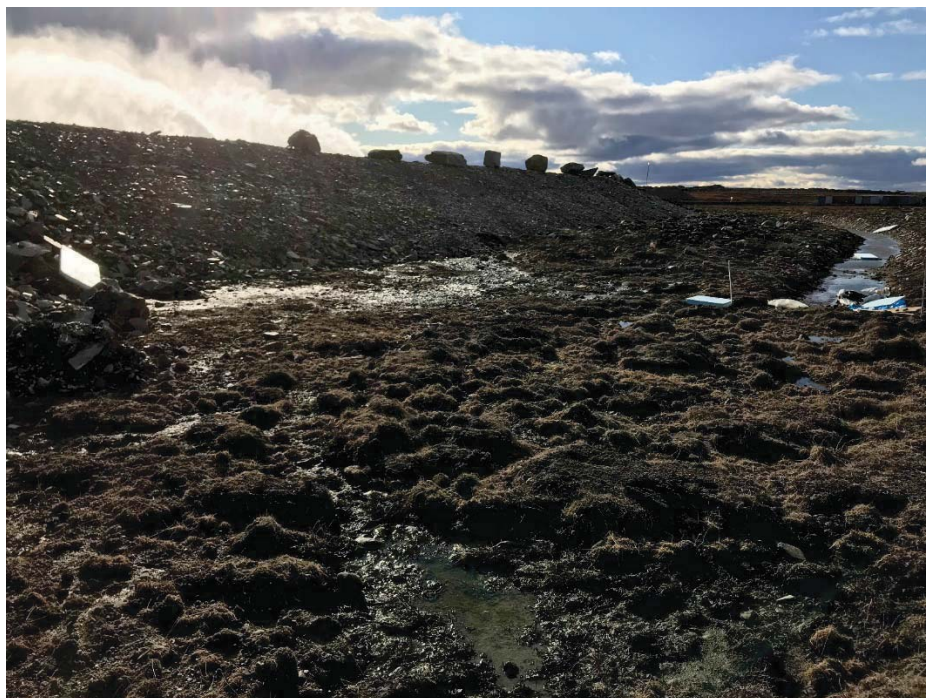
Photograph 13: DP1-B, Downstream Slope near Station 0+300, Looking West. Minor Seepage from Downstream Toe, Similar to 2017, Entering Collection Channel to Right of Photograph (12 September 2018)

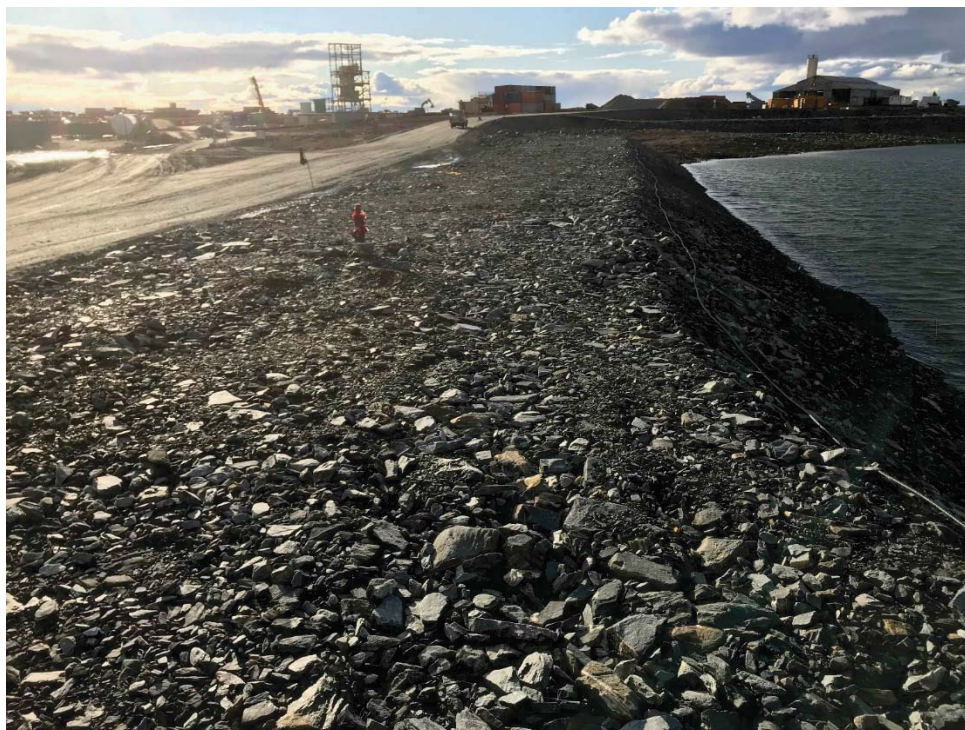
Photograph 26: DP2-A, Upstream Slope near Station 0+65, Signs of Minor Slumping at Crest, Looking West. Signs of Slumping at Crest were not Observed in 2017 (12 September 2018)

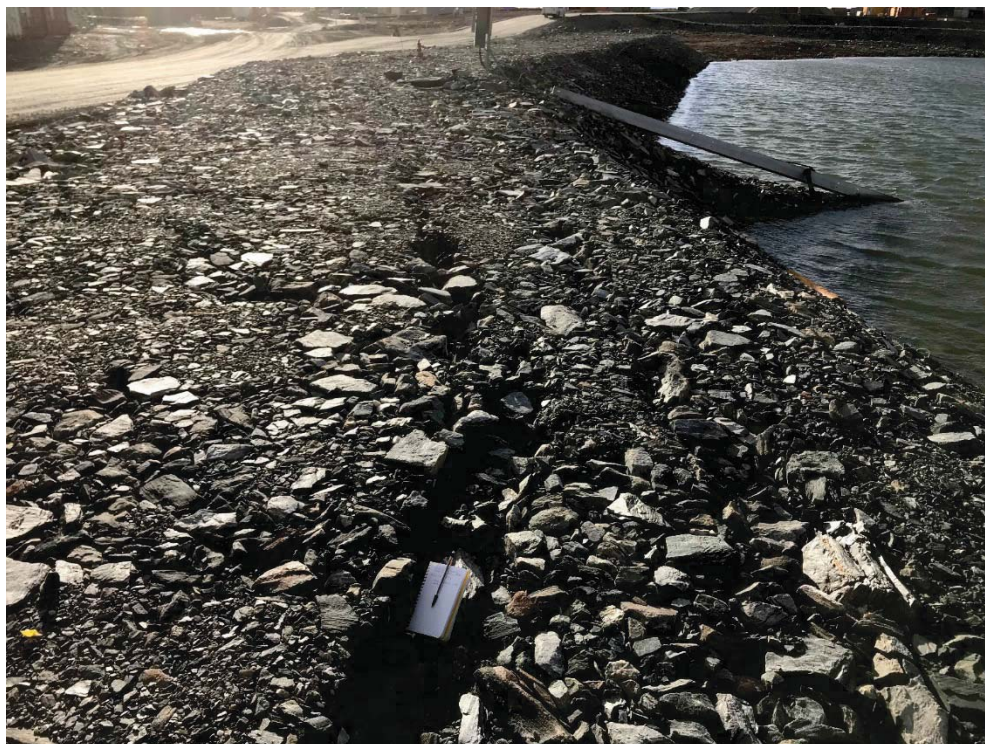
Photograph 27: DP2-A, Cracking near Station 0+100, looking West. (12 September 2018)

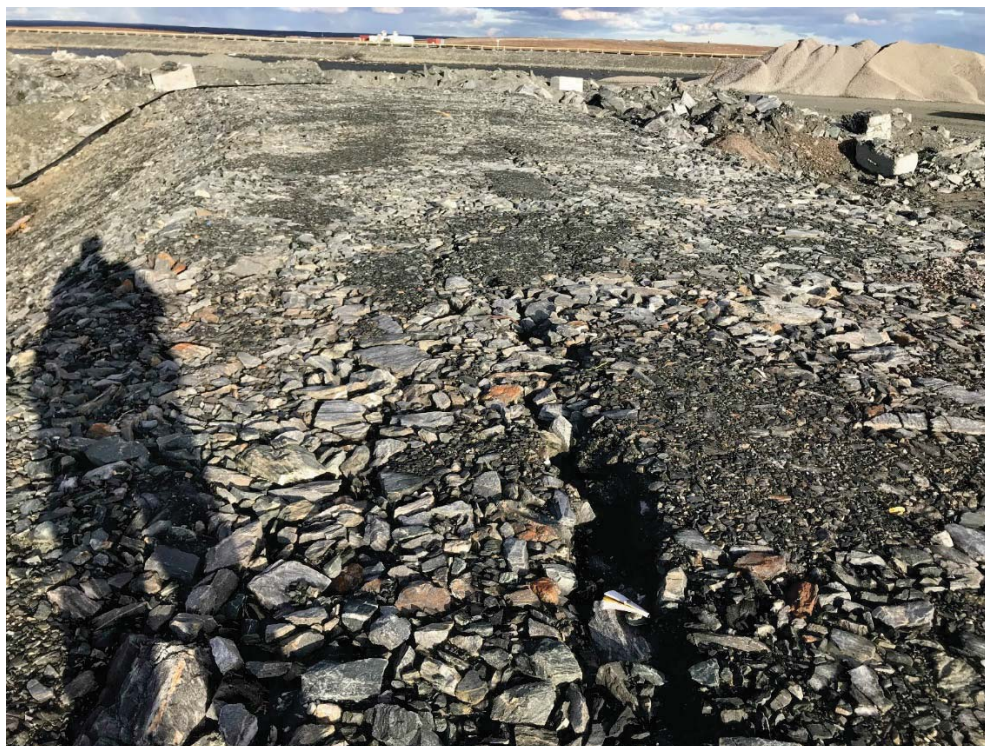
Photograph 28: DP2-A, Cracking near Station 0+100, looking East. The Length of the Cracking in This Area of the Dike was Similar to 2017, but the Cracks were Wider and Deeper (12 September 2018)

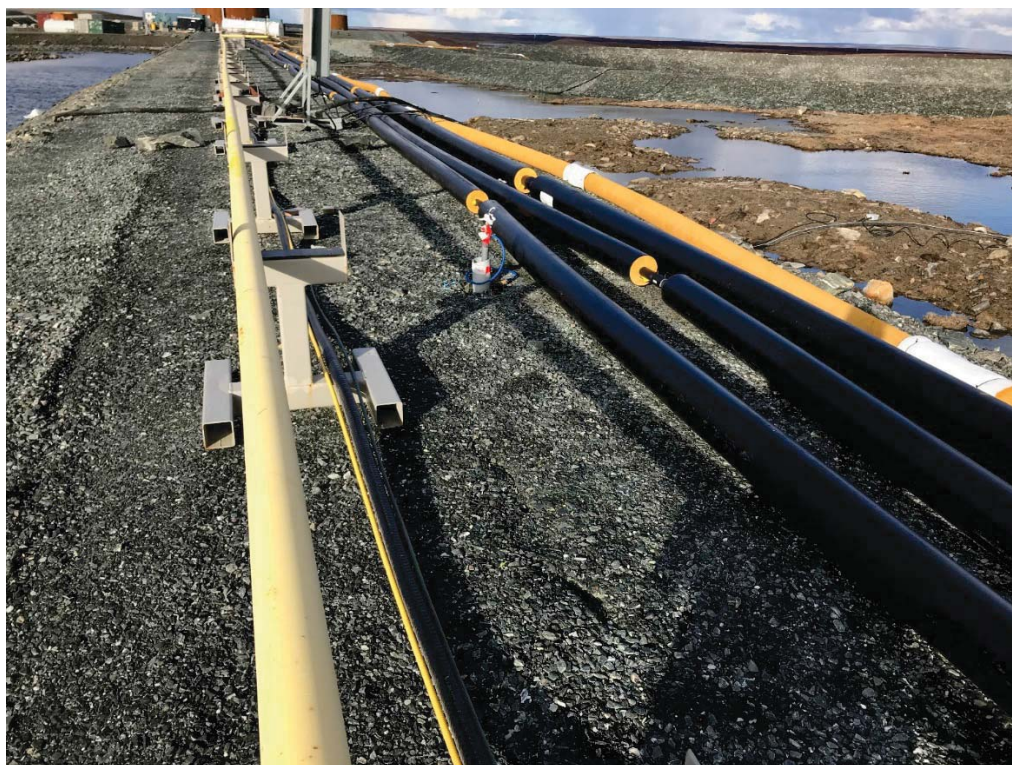
Photograph 32: DP3-A, Cracking on the Crest near Station 0+150, Looking Southwest. Cracking was Slightly Wider and Deeper than in 2017 (12 September 2018)

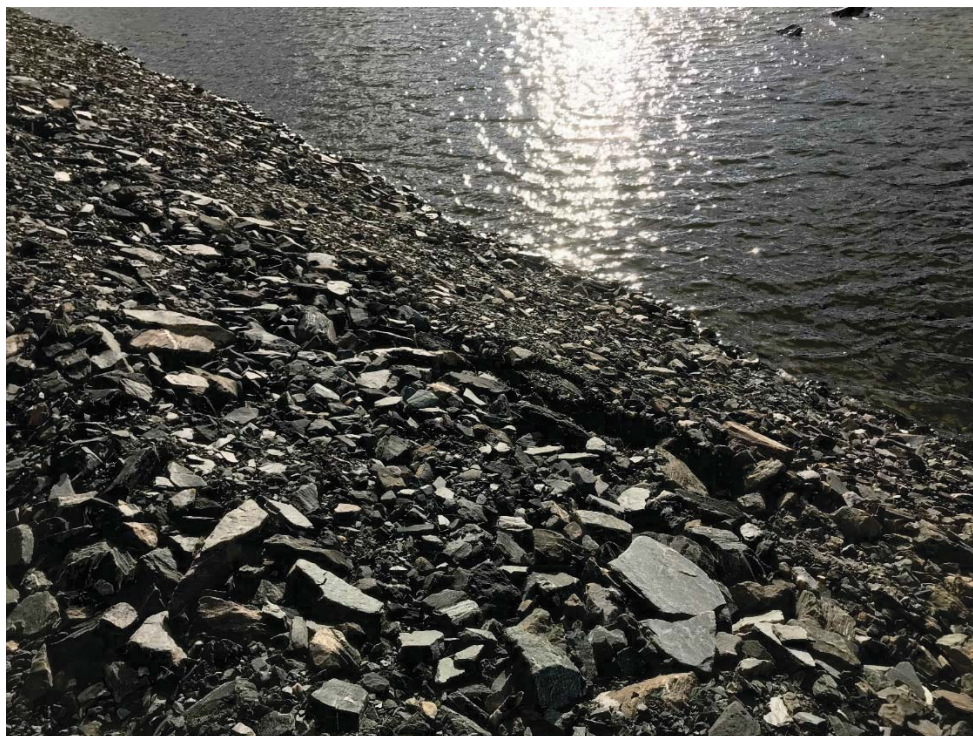
Photograph 33: DP3-A, Cracking on the Upstream Slope near Station 0+150 that was not Observed in 2017 (12 September 2018)

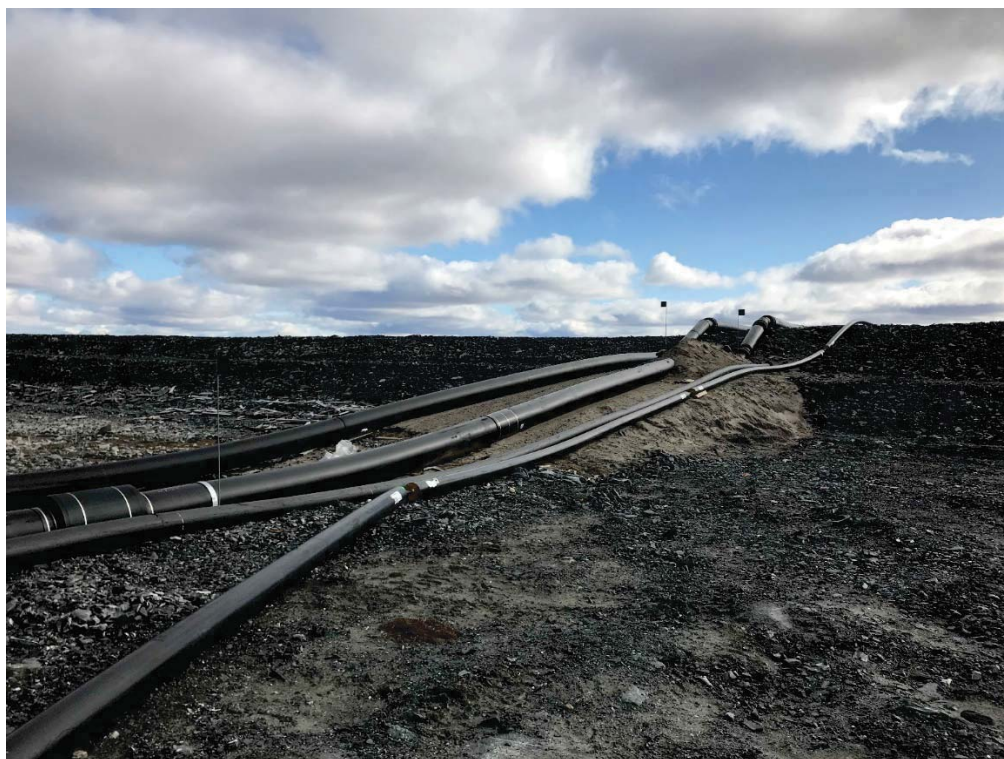
Photograph 2: D-CP1, Water Pipeline Ramp Upstream of Dike Near Station 1+140, Looking South. Some Minor Erosion Observed that was not Observed in 2017 (12 September 2018)

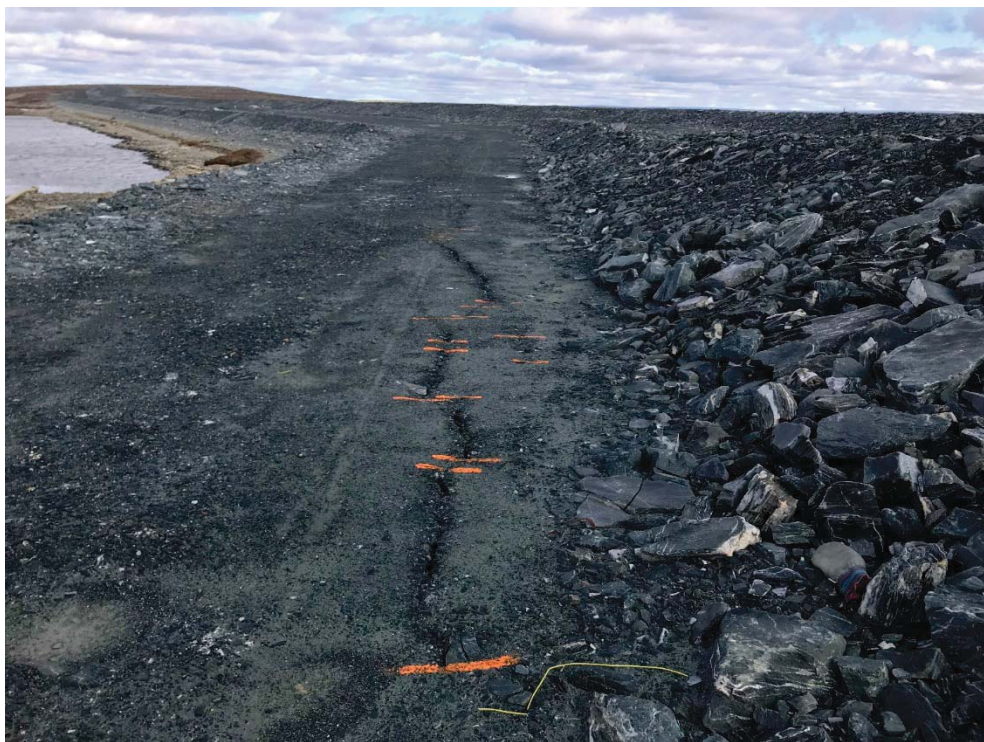
Photograph 4: D-CP1, Cracking on Upstream Bench Crest Near Station 1+150, Looking Northeast. Length of Cracking had Increased Slightly from 2017 Observations and Minor Increase in the Widths of the Cracks (12 September 2018)

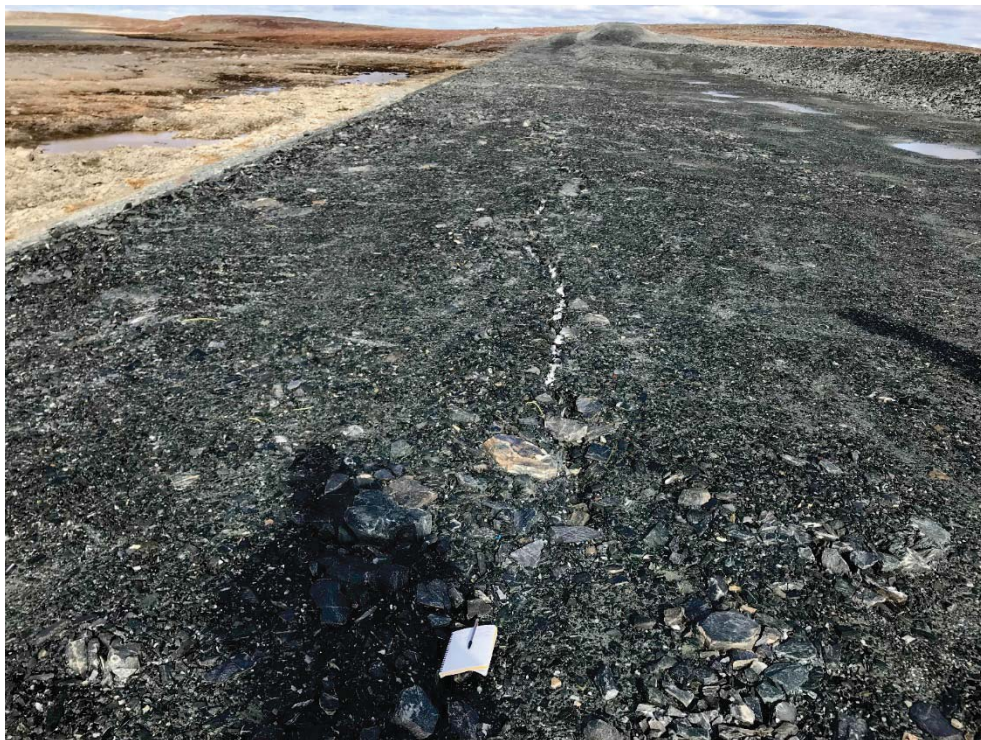
Photograph 9: D-CP1, Cracking on Upstream Bench Crest Near Station 1+450, Looking North. Similar Condition to 2017 (12 September 2018)

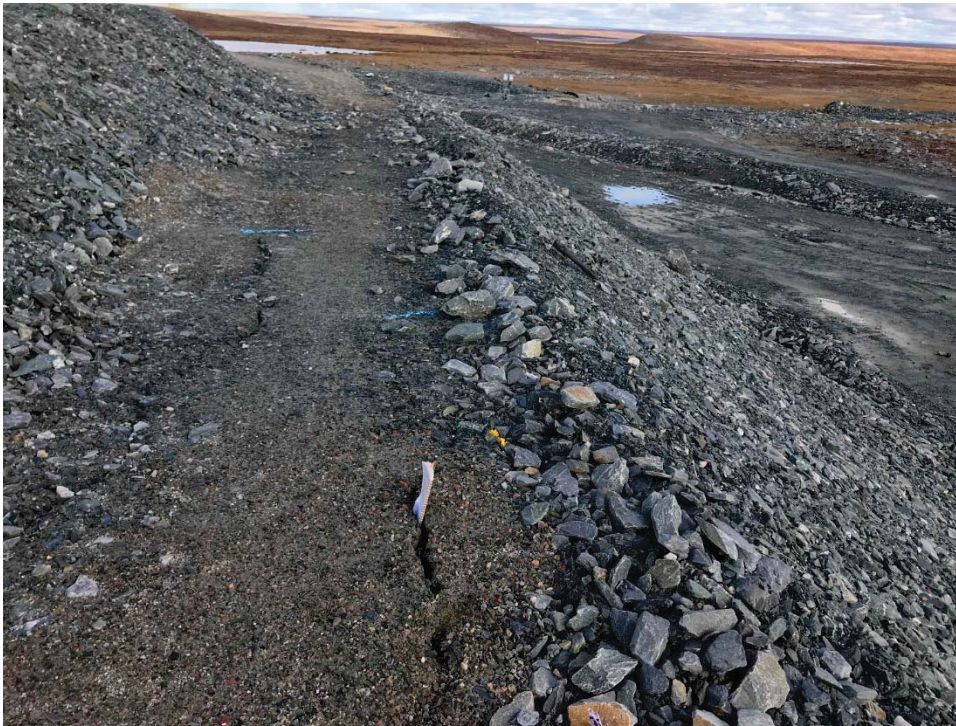
Photograph 19: D-CP1, Cracking on Downstream Bench Near Station 1+145, Looking Northeast. Cracks are Wider and Deeper Than in 2017 (12 September 2018)

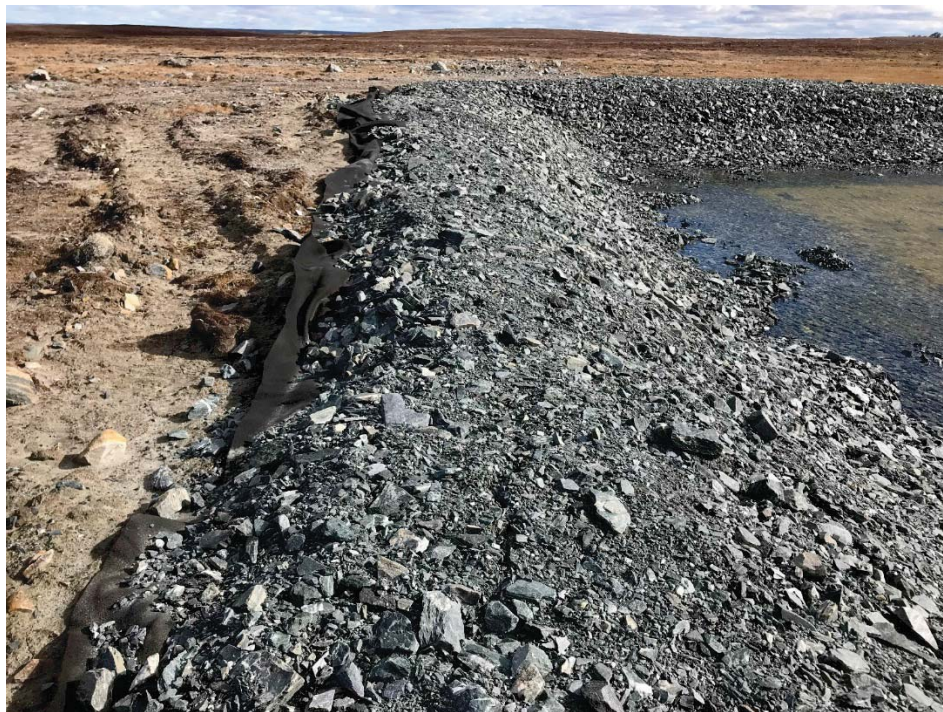
Photograph 26: D-CP1, Cracking/Slumping in North Side of Downstream Sump, Looking East. Similar Condition to 2017 (12 September 2018)

- Monitor the cracking observed in the D-CP1 downstream sump berms and adjacent to the downstream collection channel. Recontouring and/or compacting the areas of cracking to close the cracks will reduce the potential for water to infiltrate into the cracks leading to warming of the permafrost and additional thaw settlement and cracking. (M)

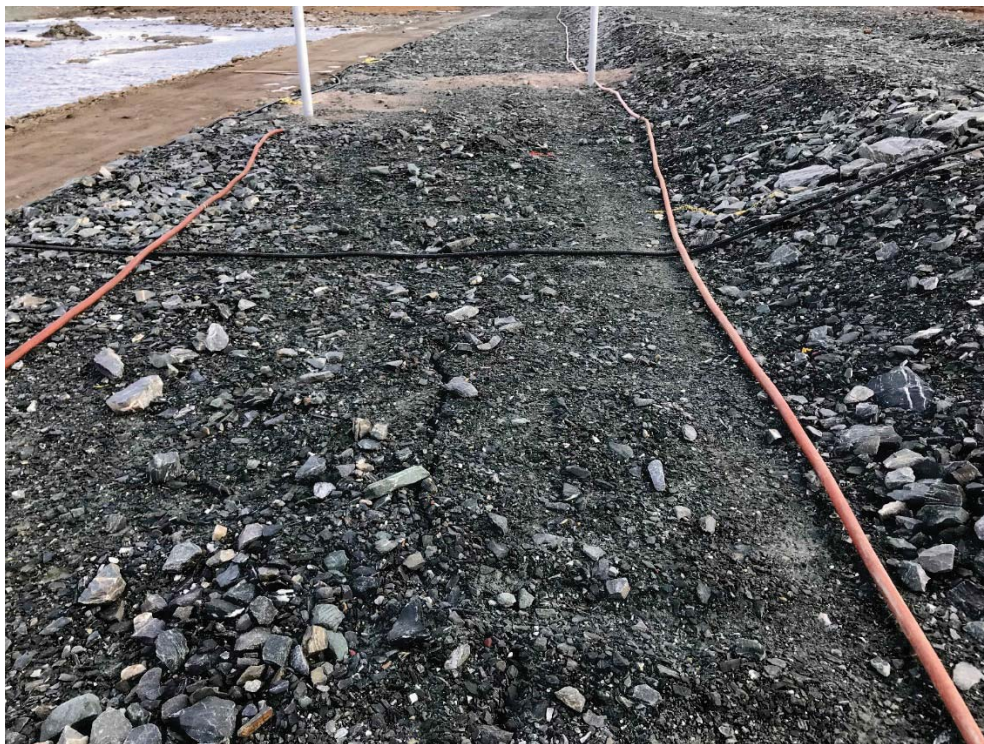
Photograph 34: D-CP5, Cracking on Upstream Bench Looking Northeast Near Station 1+180. This Cracking was not Observed in 2017 (12 September 2018)

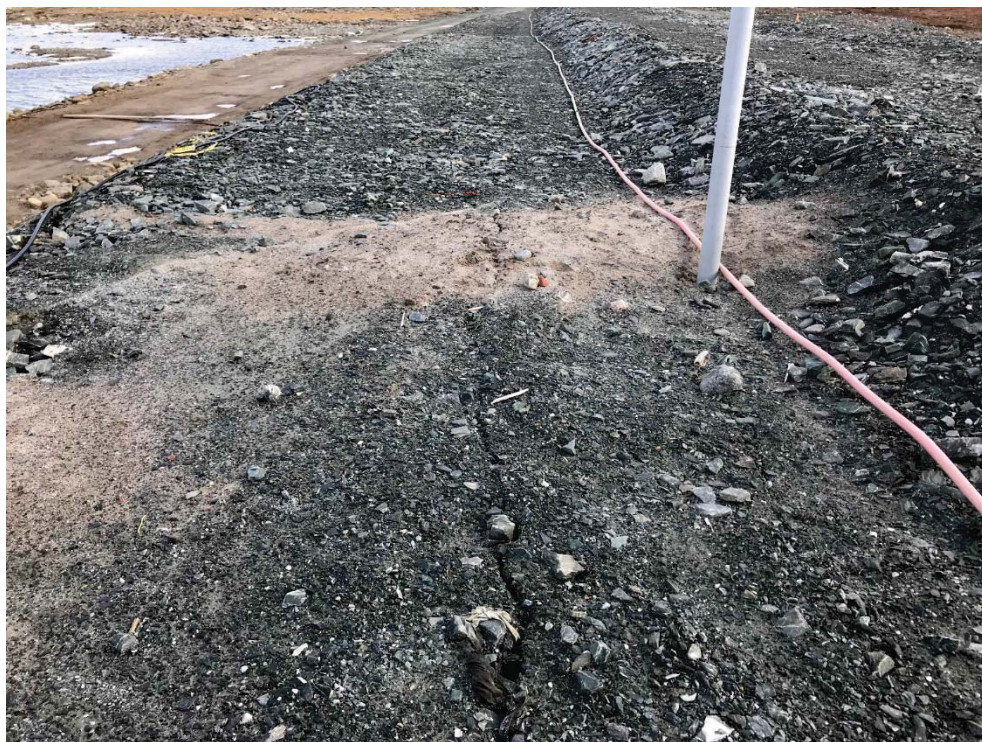
Photograph 35: D-CP5, Cracking on Upstream Bench Looking Northeast Near Station 1+185. This Cracking was not Observed in 2017 (12 September 2018)

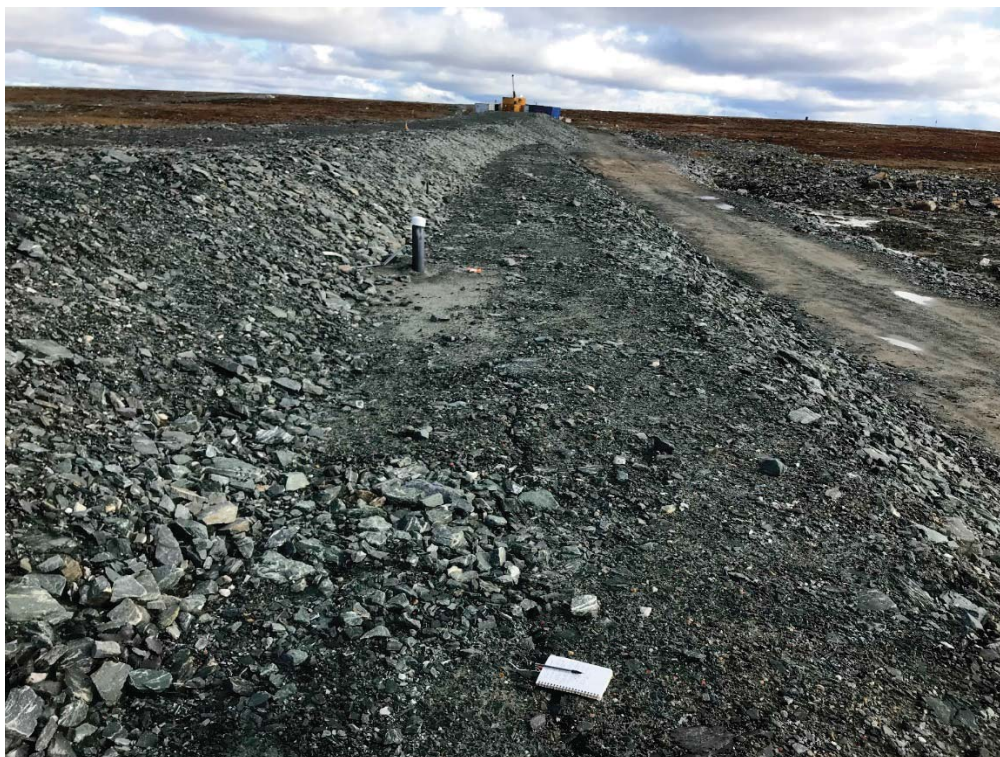
Photograph 40: D-CP5, Downstream Bench Cracking looking Northeast Near Station 1+180. Similar Condition to 2017 (12 September 2018)

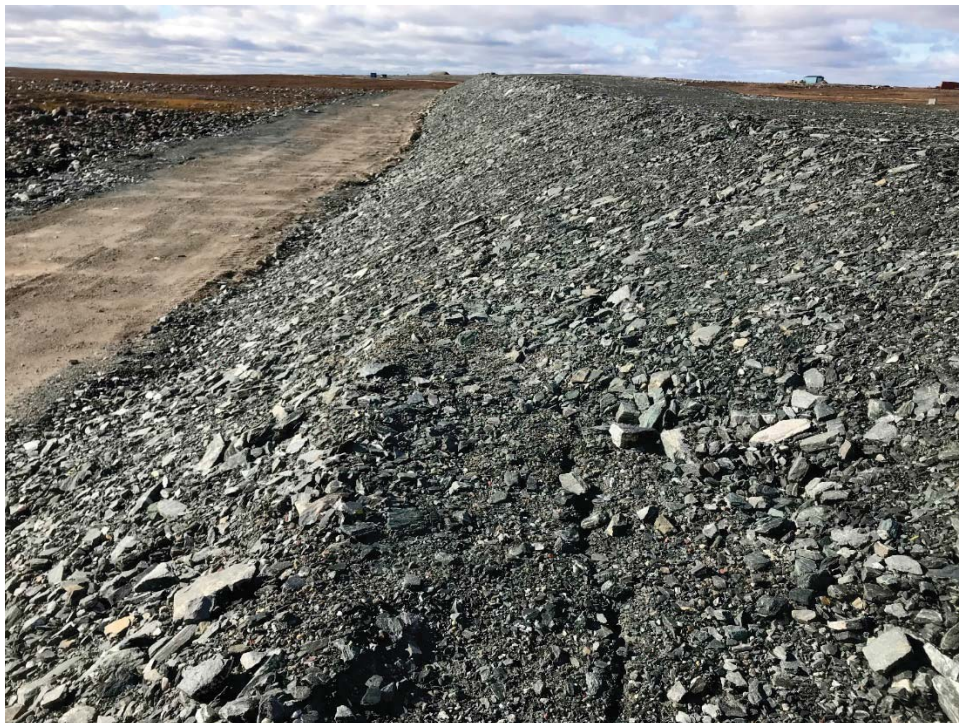
Photograph 41: D-CP5, Cracking in Downstream Slope Looking Southwest Near Station 1+175. This Cracking was not Observed in 2017 (12 September 2018)

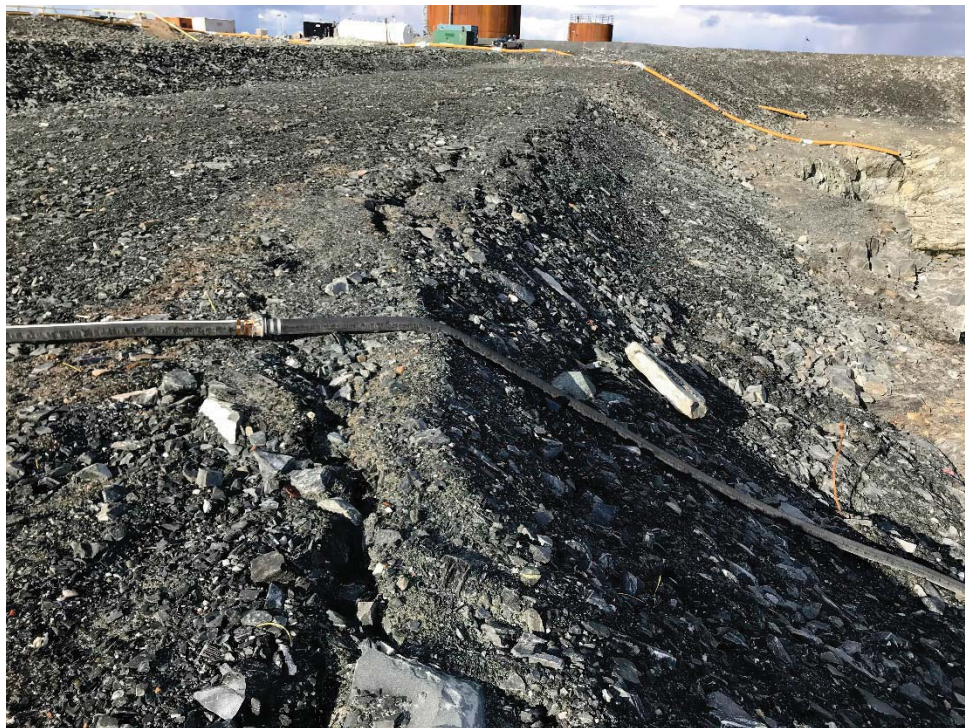
Photograph 46: Saline Pond, Cracking in Northwest Perimeter Berm Looking Southeast. Cracking and Slumping have Increased Slightly from 2017 (12 September 2018)

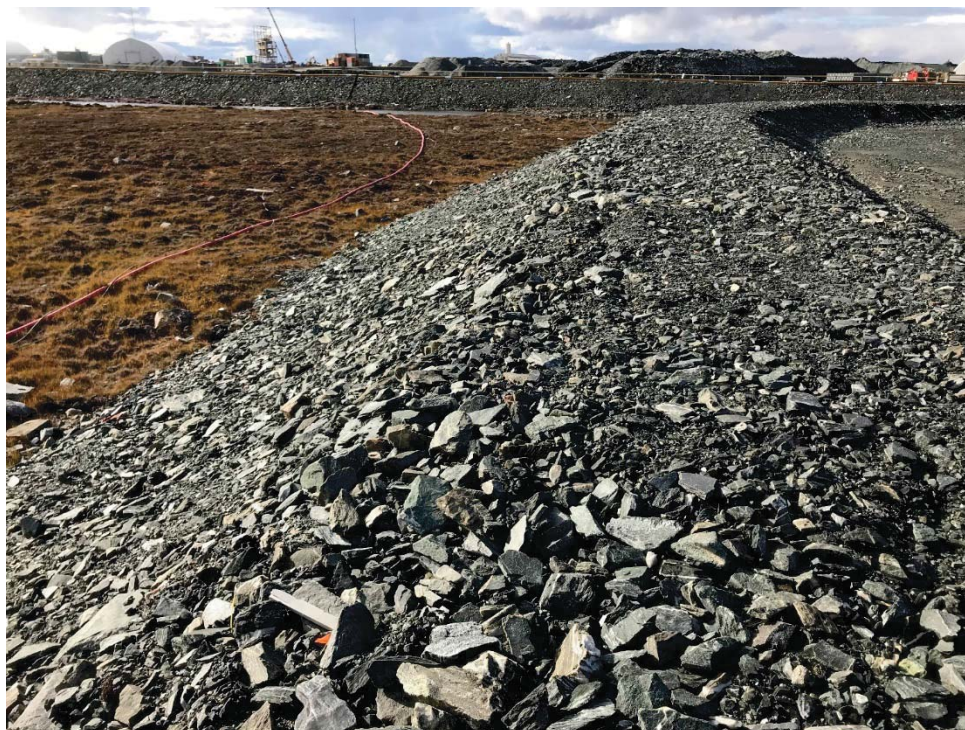
Photograph 47: Saline Pond, Southwest Perimeter Berm Looking Northwest, Cracking Along Downstream Crest. This Cracking was not Observed in 2017 (12 September 2018)

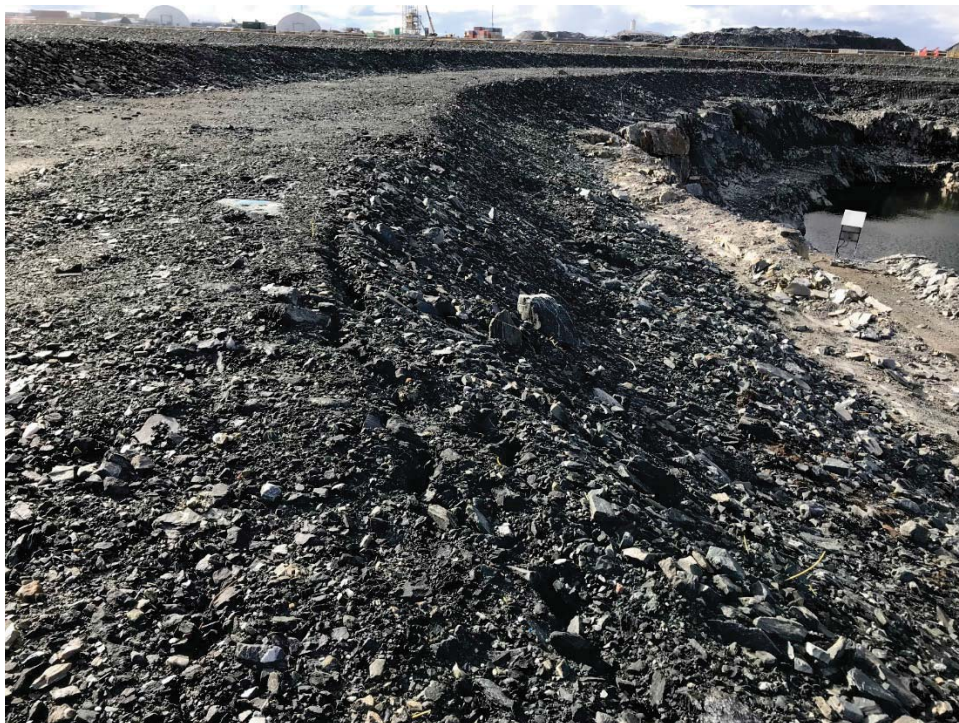
Photograph 48: Saline Pond, Southeast Perimeter Berm Cracking in Upstream Crest, Looking Northwest. This Cracking was not Observed in 2017 (12 September 2018)

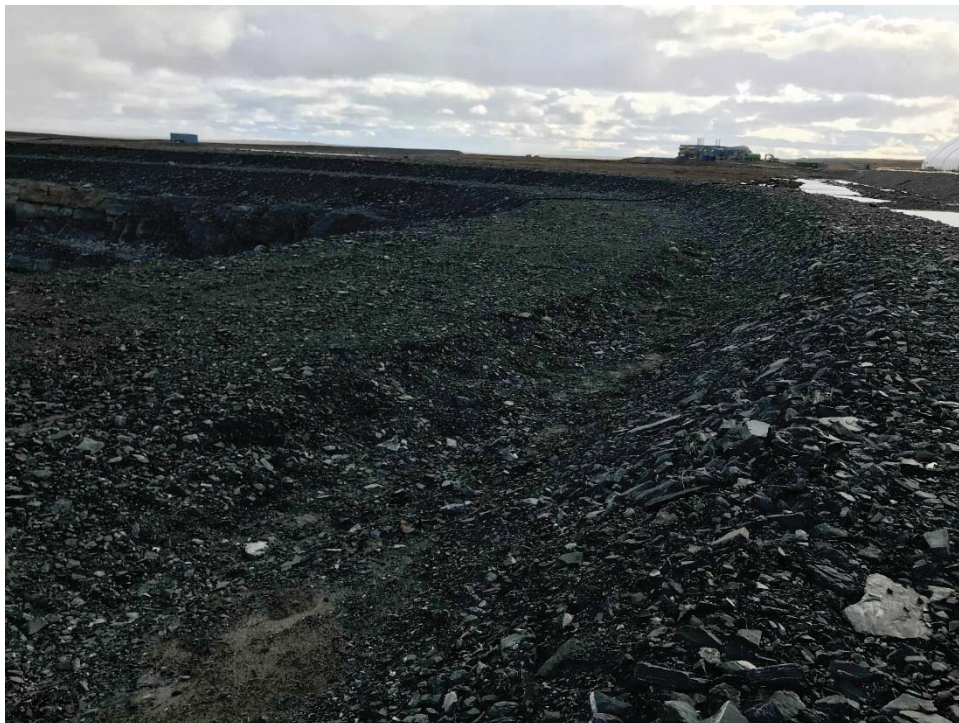
Photograph 49: Saline Pond, Area of Possible Settlement Identified During 2017 Inspection, Near Toe of Northwest Perimeter Berm, Looking Southwest. No Visible Change from 2017 (12 September 2018)

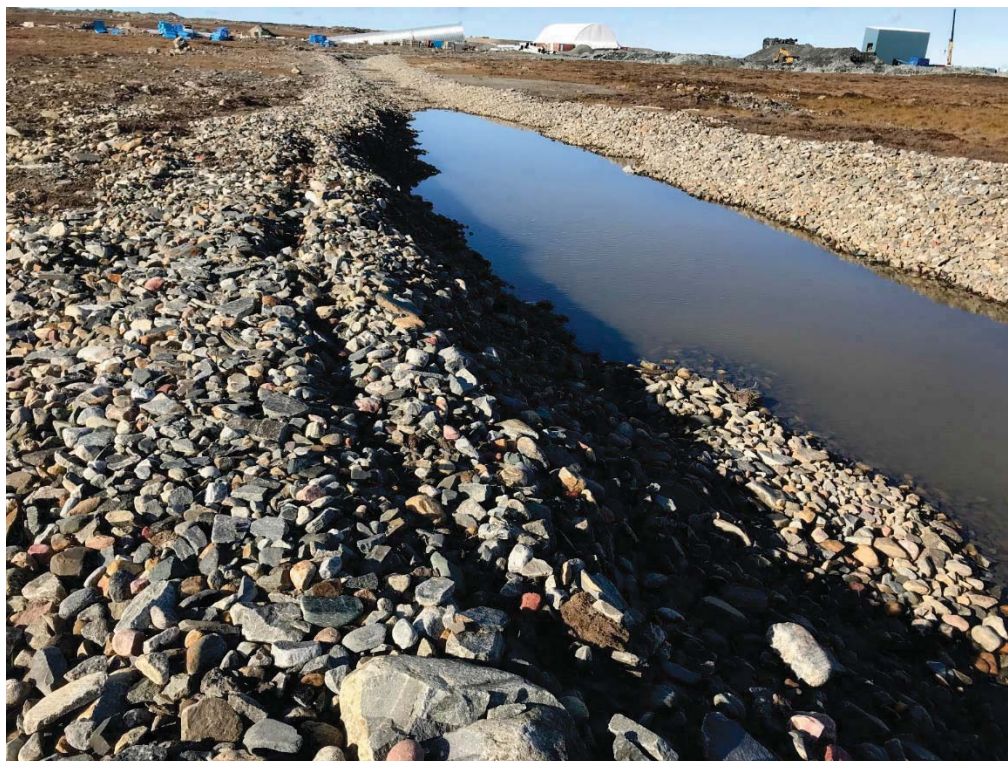
Photograph 52: Channel 1, Small Slump and Crack along the South Slope Crest About 30 m West from Outlet of Channel (13 September 2018)

- The cracking and sloughing along Channel 1 should be assessed to determine if the channel is too steep and riprap is sloughing over geotextile or if it is caused by thermal degradation of permafrost adjacent to the channel. If possible, the channel should be kept empty through the winter to promote freezing of the permafrost around the channel. (M)

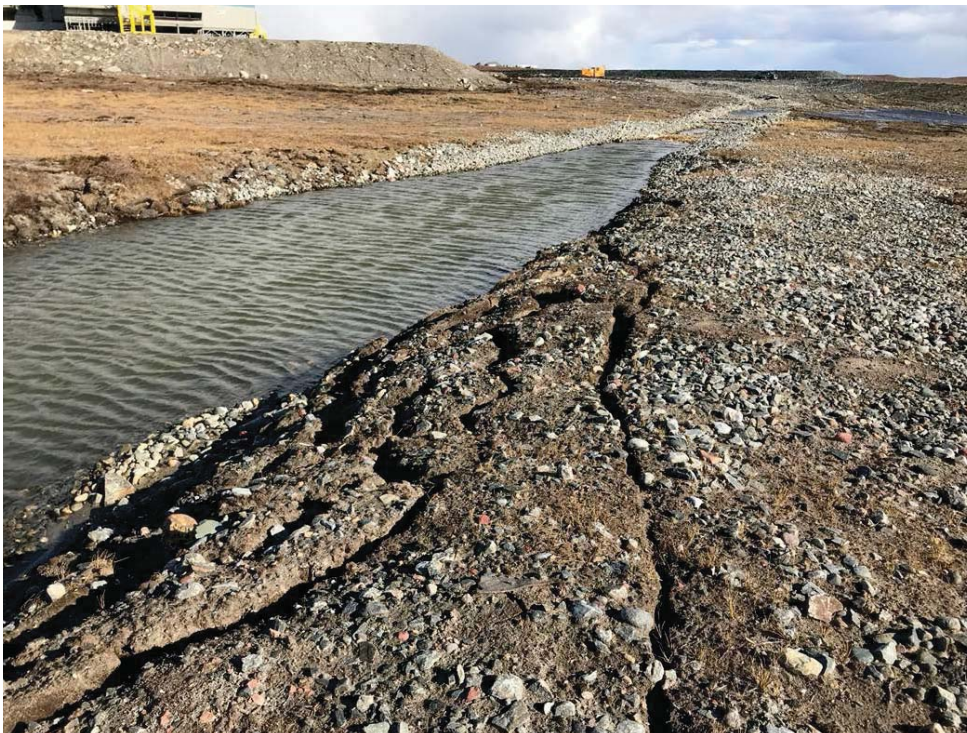
Photograph 71: Channel 5, Water Poned in Channel and Cracking Along South Slope of Trench Near Station 0+050, Looking Southwest. This Cracking was Not Observed in 2017 but Access to This Area was Limited due to Water Levels and Saturated Conditions in the Tundra (12 September 2018)

- Monitor the cracking adjacent to Channel 5. If cracking gets worse, recontouring and/or compacting the areas of cracking to close the cracks will reduce the potential for water to infiltrate into the cracks leading to warming of the permafrost and additional thaw settlement and cracking. (M)

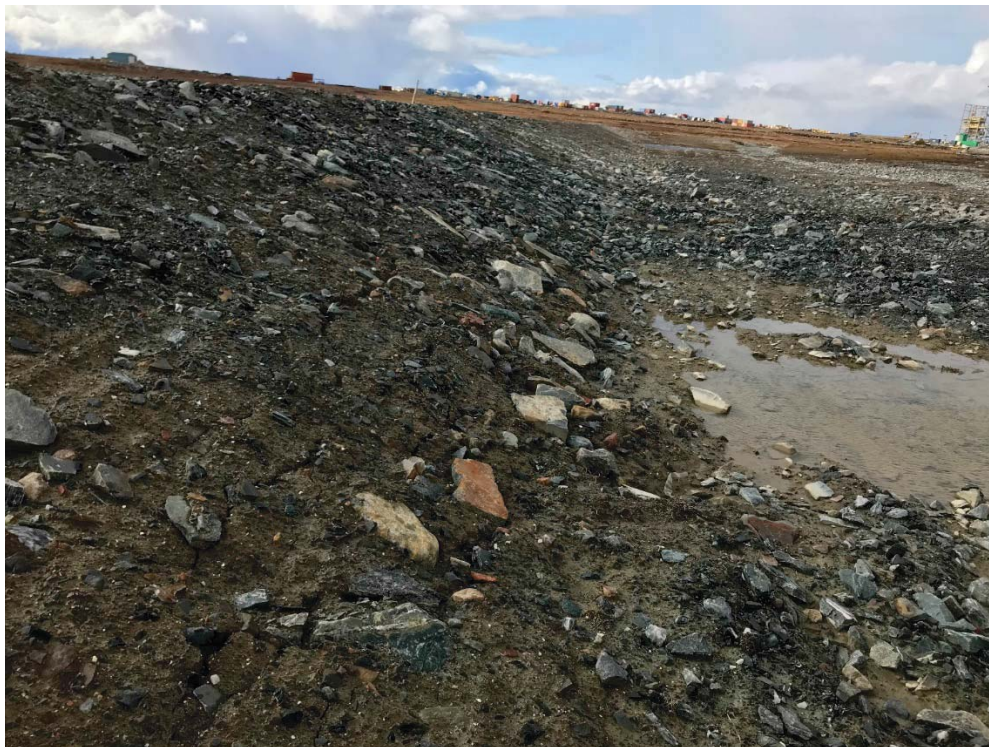
Photograph 76: Berm 3, Upstream Slope, Some Cracking Near Station 0+280, Looking North. This Cracking was Not Observed in 2017 (12 September 2018)

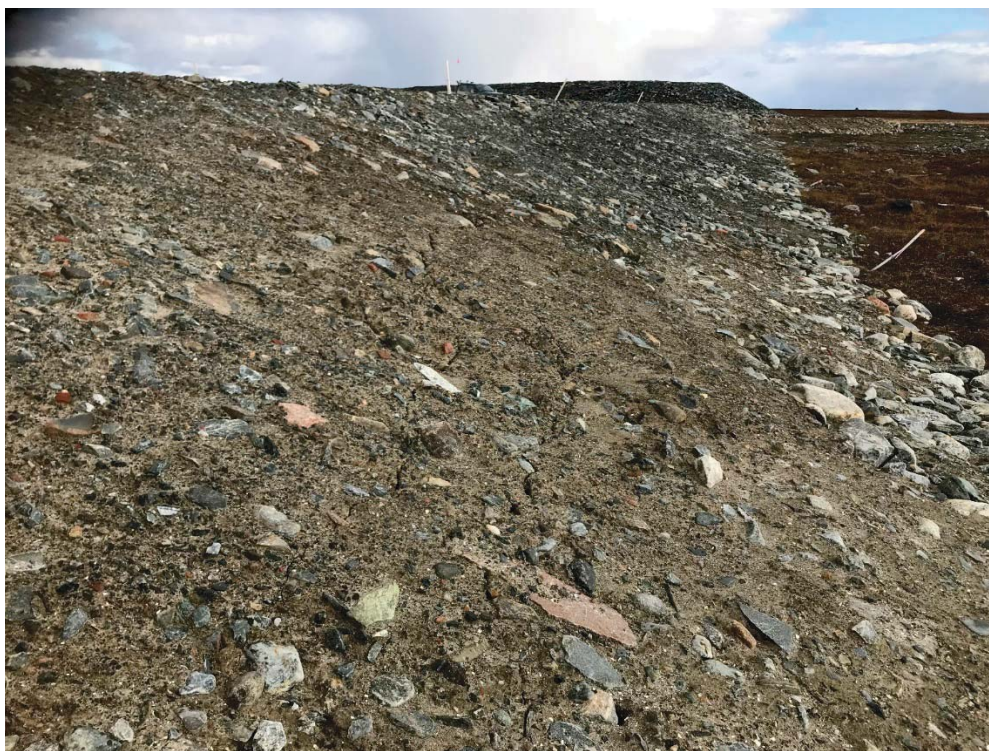
Photograph 77: Berm 3, Downstream Slope, Some Cracking Near Station 0+280, Looking North. Cracking was not Observed in 2017 (12 September 2018)

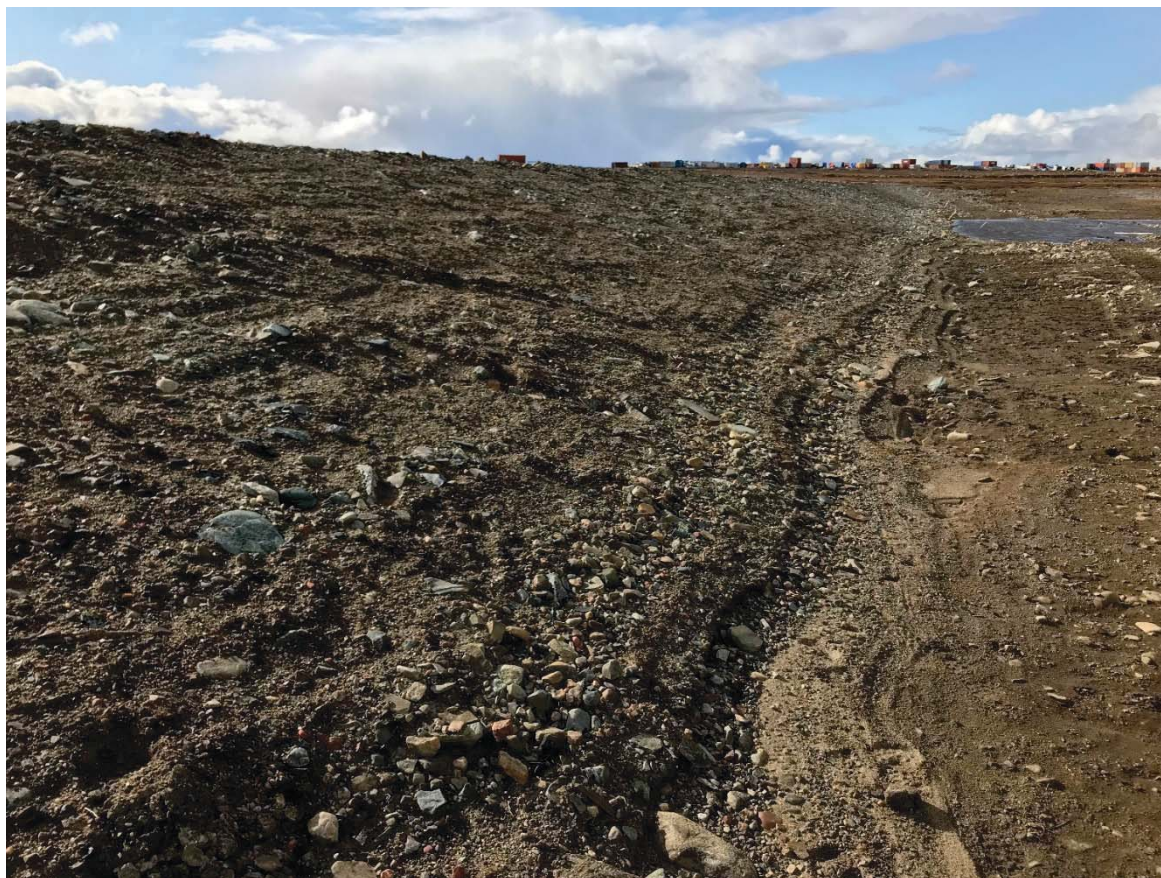
Photograph 78: Berm 3, Upstream Slope, Erosion at Toe and Along Slope from Previous High Water Mark, Near Station 0+230, Looking Northwest (12 September 2018)
