APPENDIX A-3

Site Roads, Culverts, and
Tiriganiaq and Wesmeg Areas

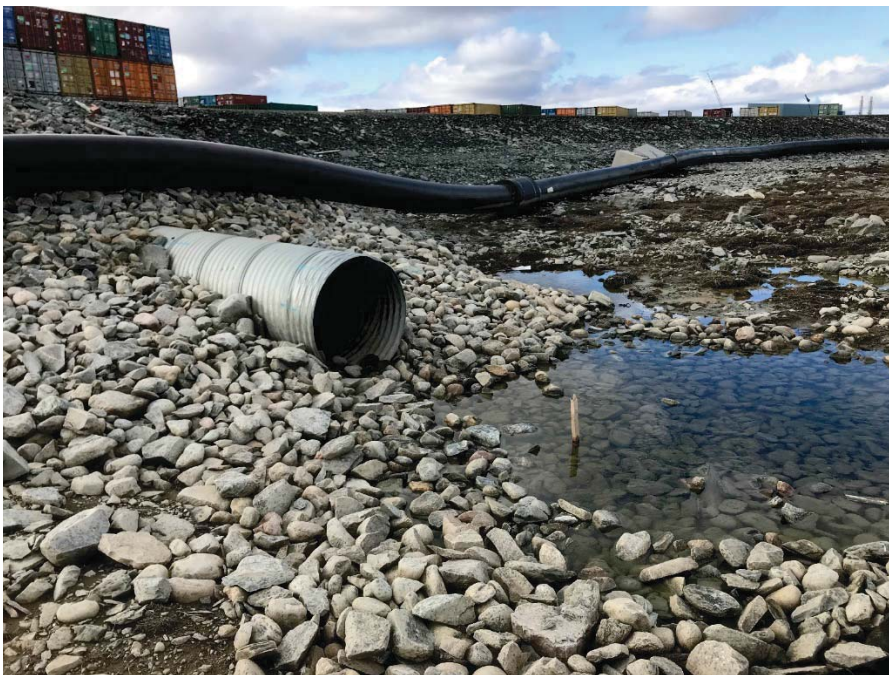
Photograph 11: Culvert #4, Damage to Upstream End of Culvert. Similar to 2017 (12 September 2018)

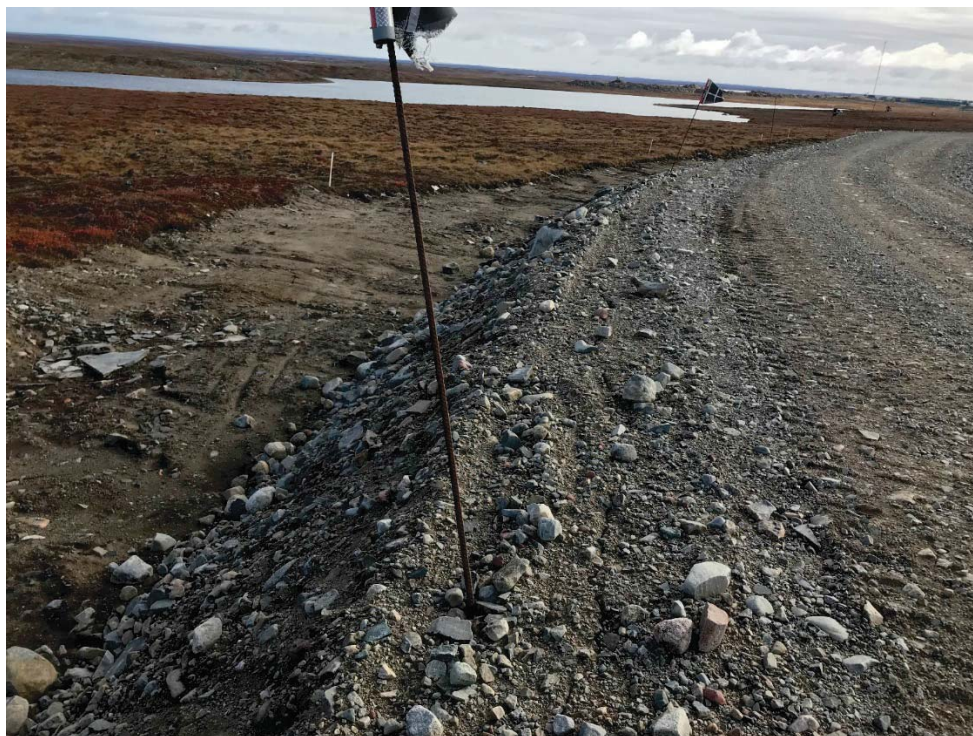
Photograph 20: Emulsion Plant Access Road, Looking Southeast from Mid-Point of Road Near Emulsion Esker. Disturbed Tundra on East Side of Road that Could Pond Water and Cause Thermal Degradation of the Permafrost. (14 September 2018)

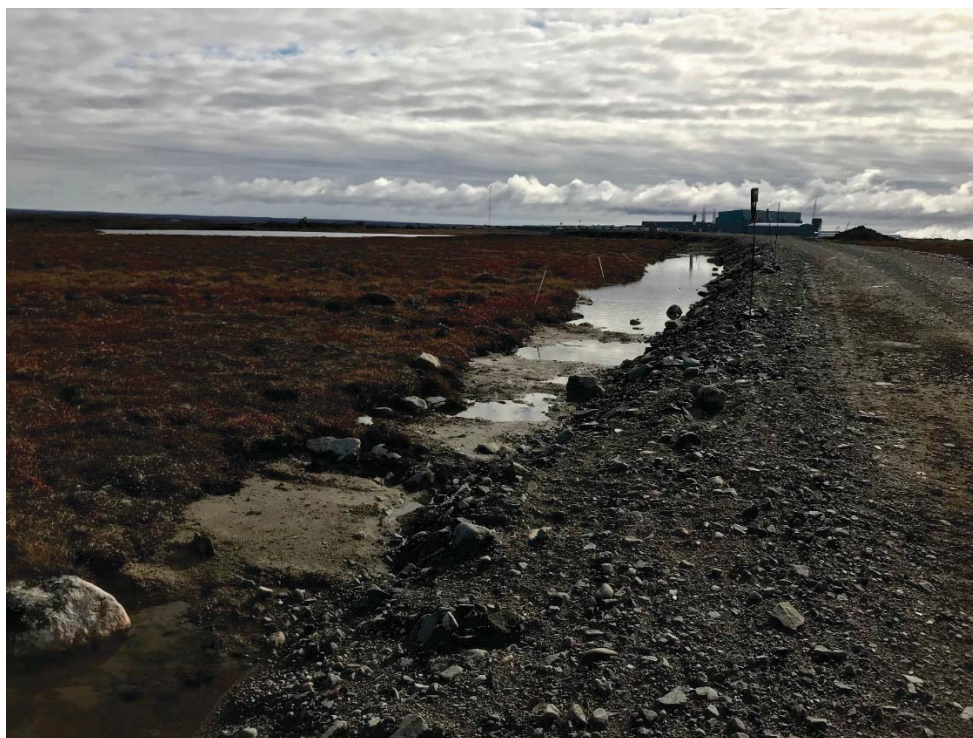
Photograph 21: Emulsion Plant Access Road, Looking Southeast from Near Dino Access Gate, Some Minor Cracking in Road Crest (14 September 2018)

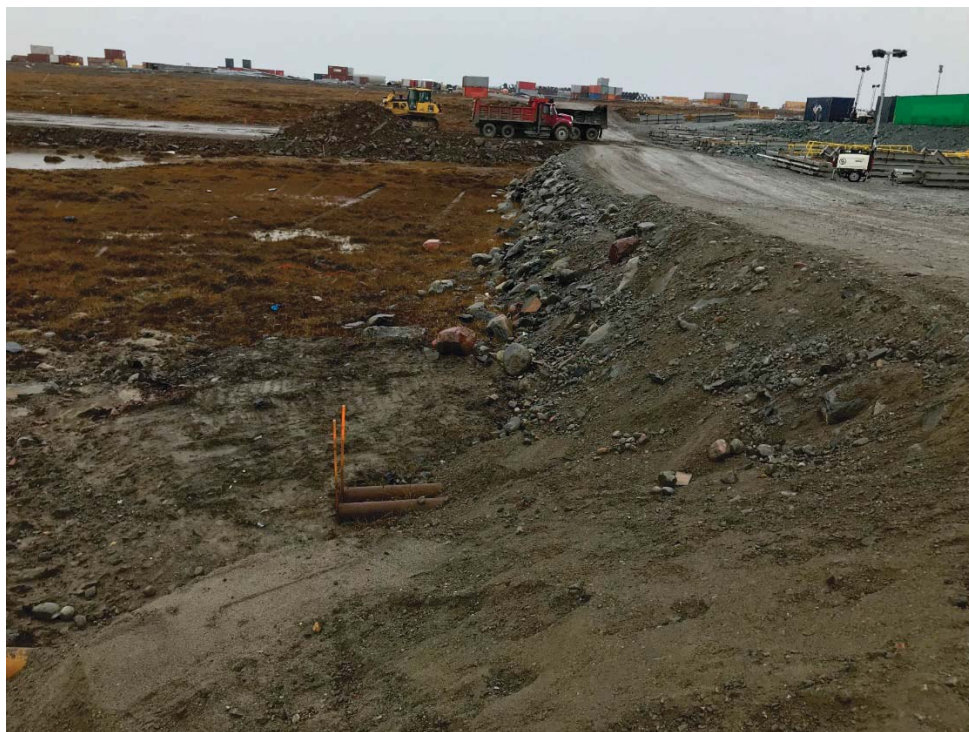
Photograph 22: Emulsion Plant Access Road, Looking Southeast Approximately Half Way Between Access Gate and Emulsion Plant Pad. Water is Ponding Adjacent to the Road Which Could Lead to Permafrost Degradation if Left (14 September 2018)

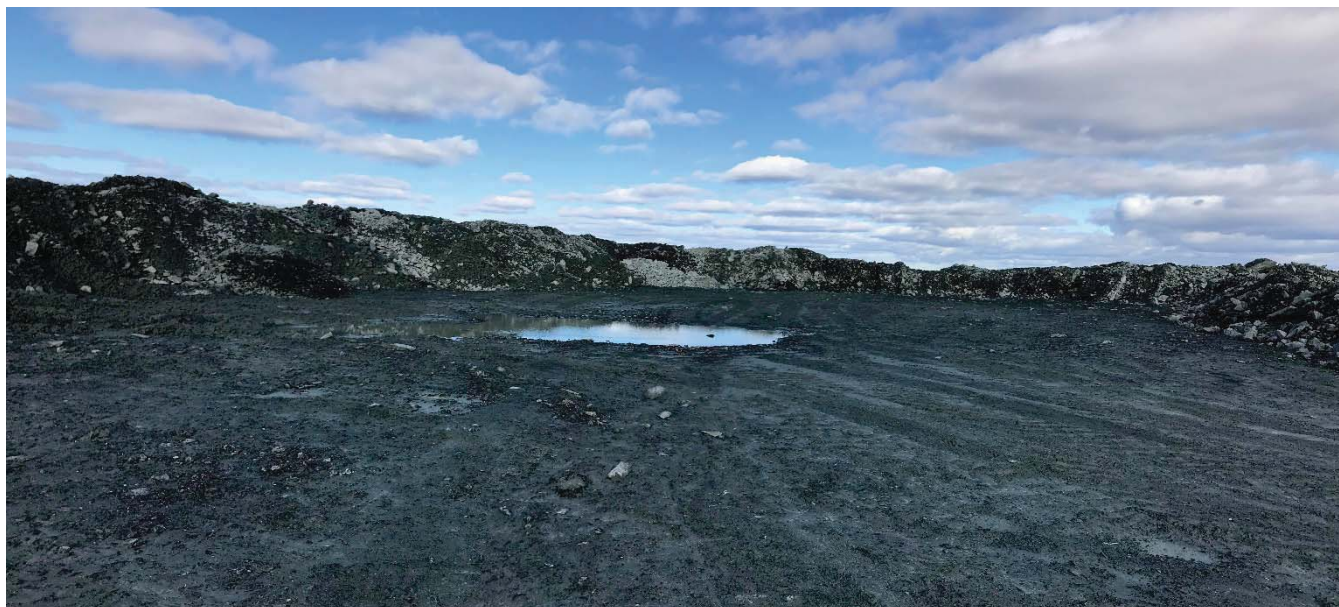
Photograph 4: Cracking in the High Grade Stockpile, Similar to 2017 (14 September 2018)

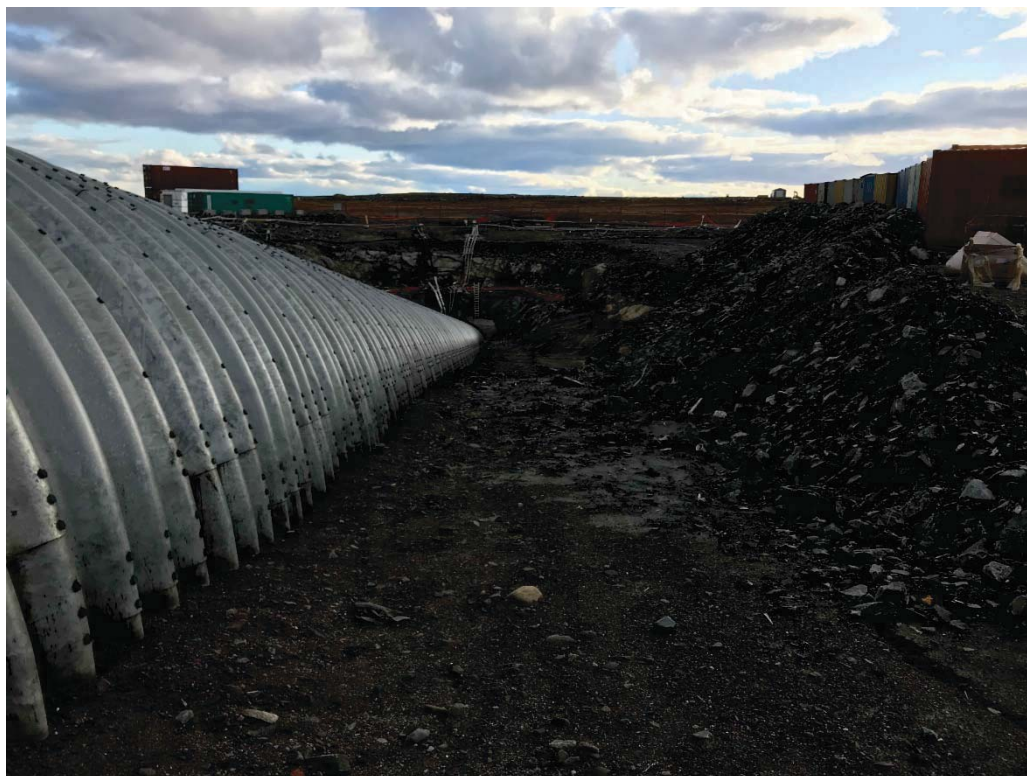
Photograph 12: Portal No. 1, View Down East Side, Looking South. Minor Erosion on Surface of Backfill (12 September 2018)

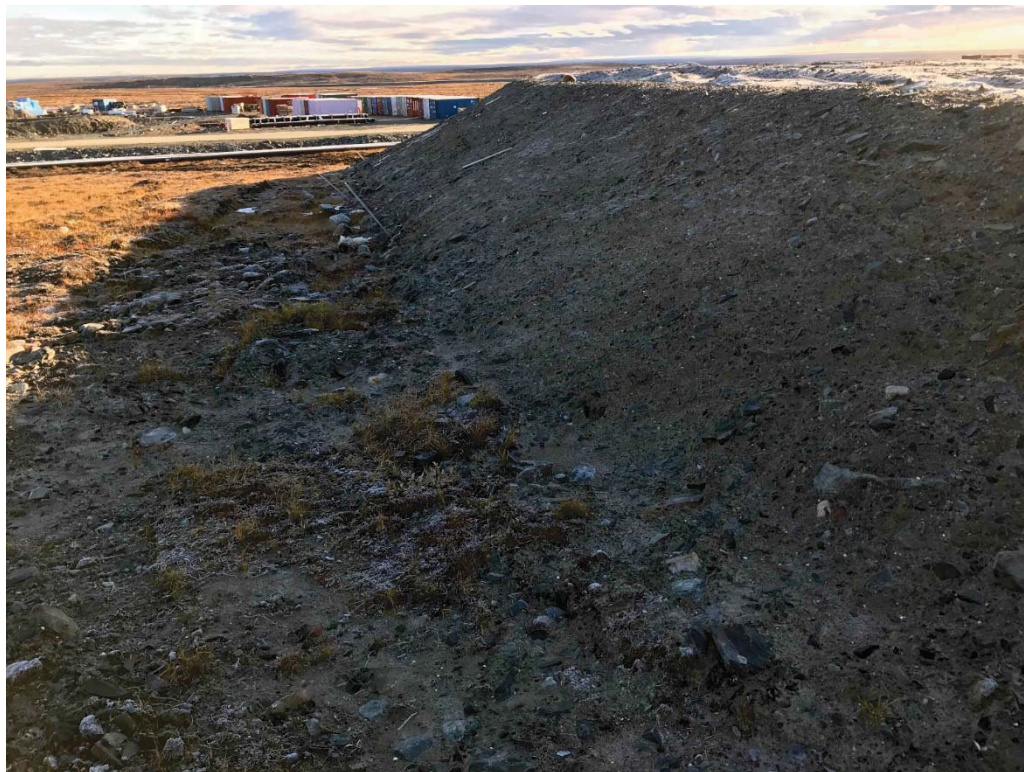
Photograph 22: Exploration Landfill, Cracking on Downstream Slope at the Northwest Corner (13 September 2018)

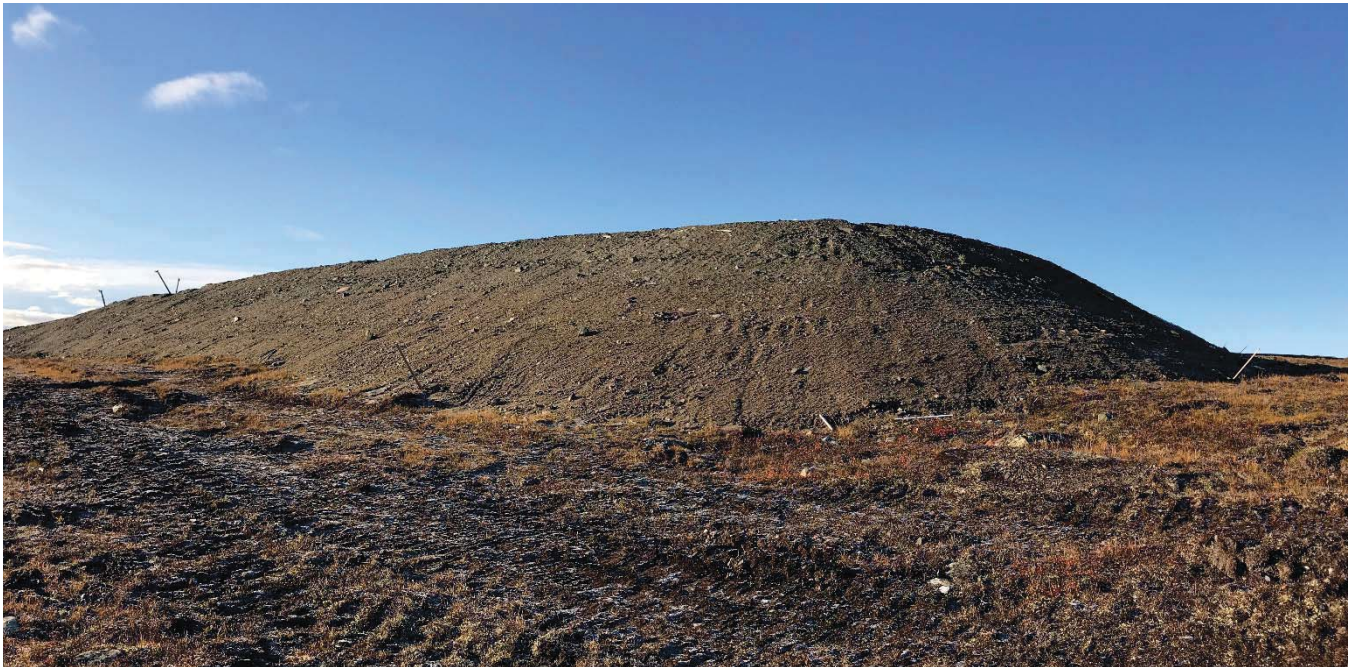
Photograph 24: Exploration Landfill, Cracking on North Slope (13 September 2018)

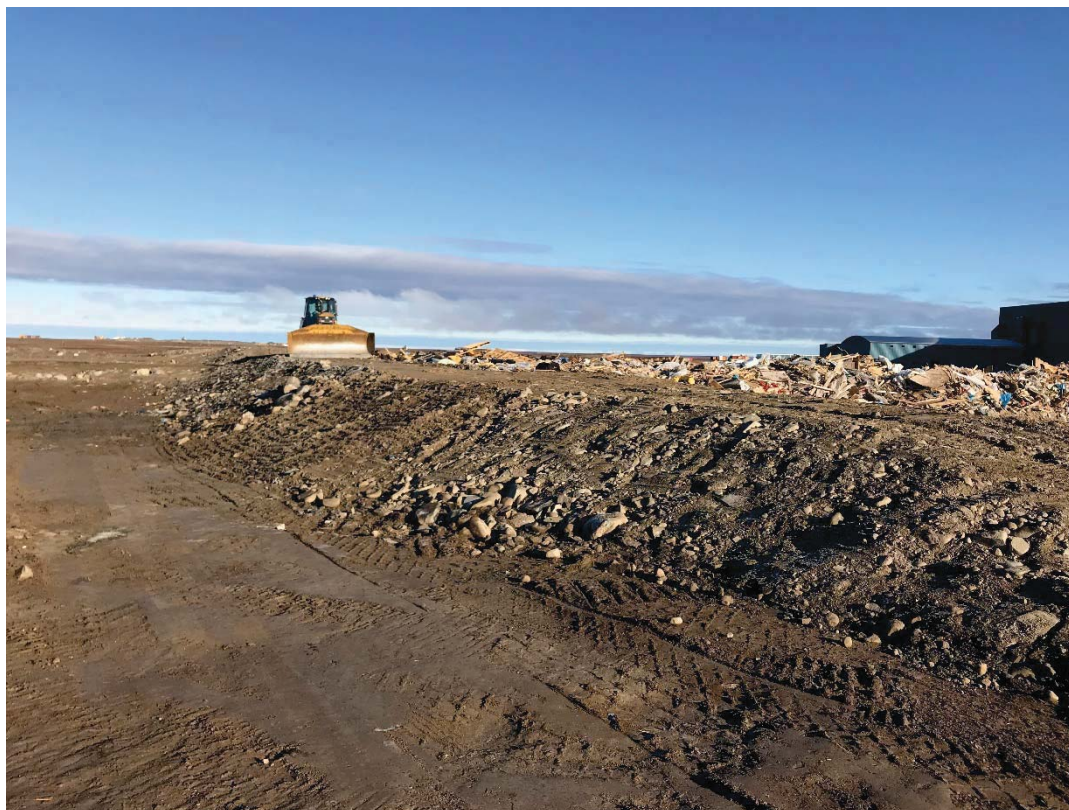
Photograph 30: Operations Landfill, North and East Slopes from Northeast Corner, Looking South. Some Water Pooled at Toe of Slope (13 September 2018)

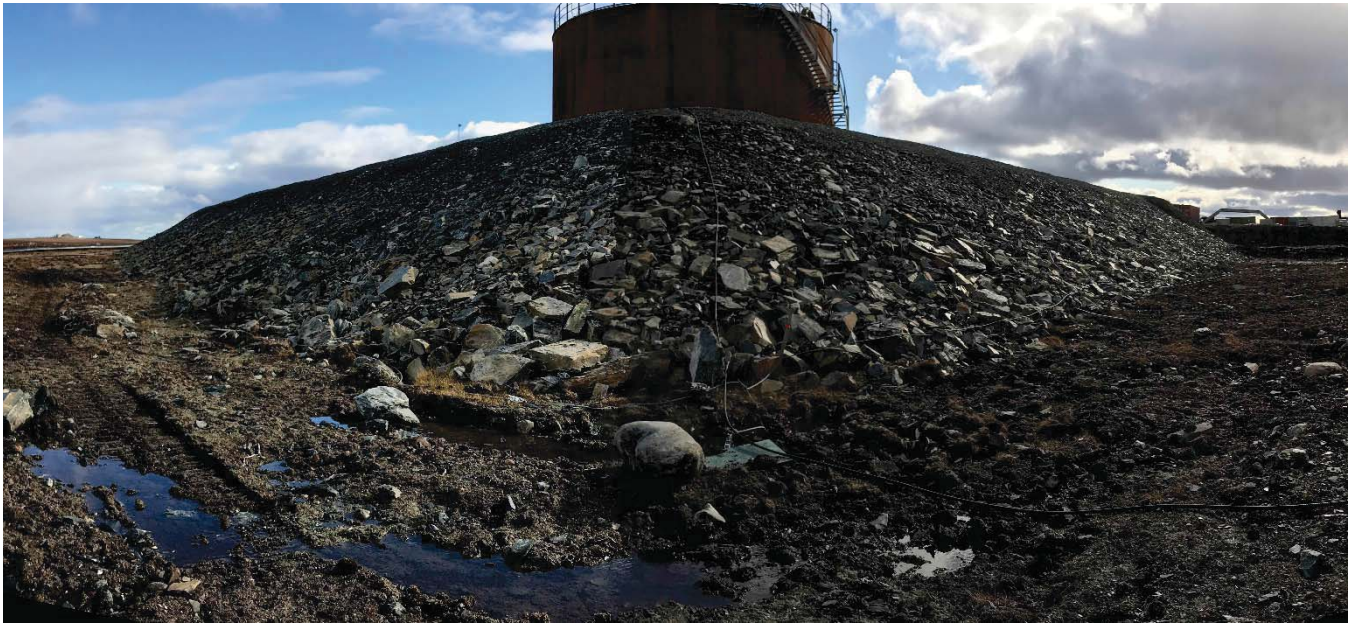
Photograph 34: Operations Landfill Expansion, Northeast Slope from the Southeast Corner of the New Landfill Expansion. Slopes of New Expansion are Steeper than Original Landfill Slopes (13 September 2018)

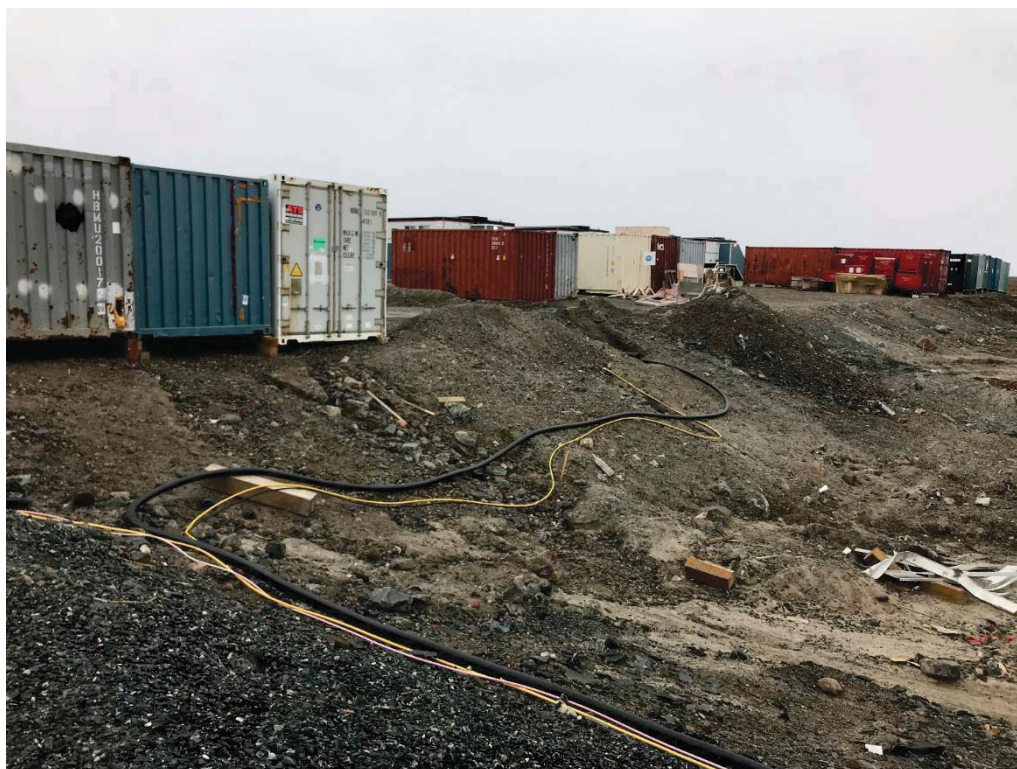
Photograph 41: Erosion of North Slope of Main Camp/Industrial Pad, Looking East. (11 September 2018)

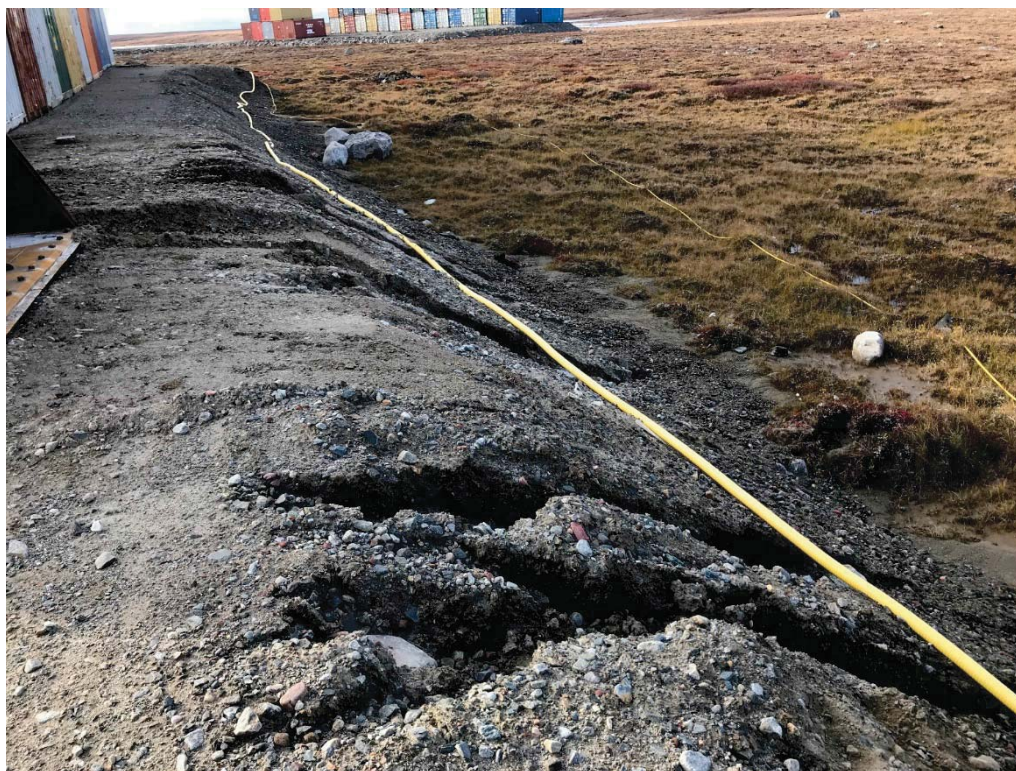
Photograph 53: Emulsion Plant Pad, Erosion and Cracking on East Slope, Looking North. (14 September 2018)

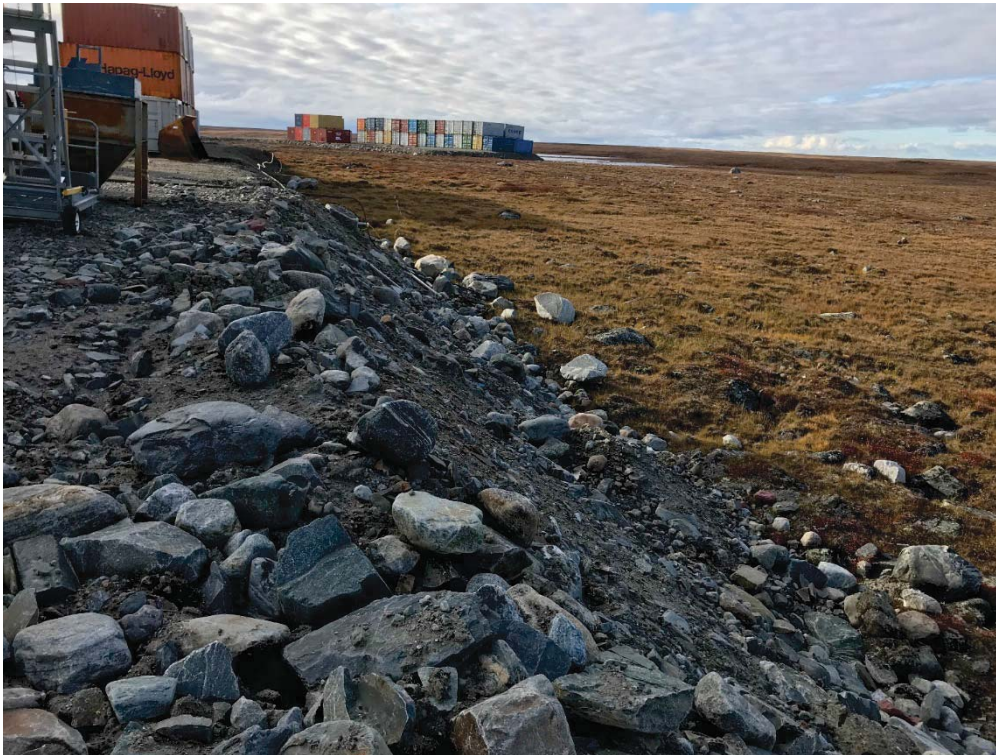
Photograph 54: Emulsion Plant Pad, Erosion and Cracking on East Slope, Looking South. (14 September 2018)

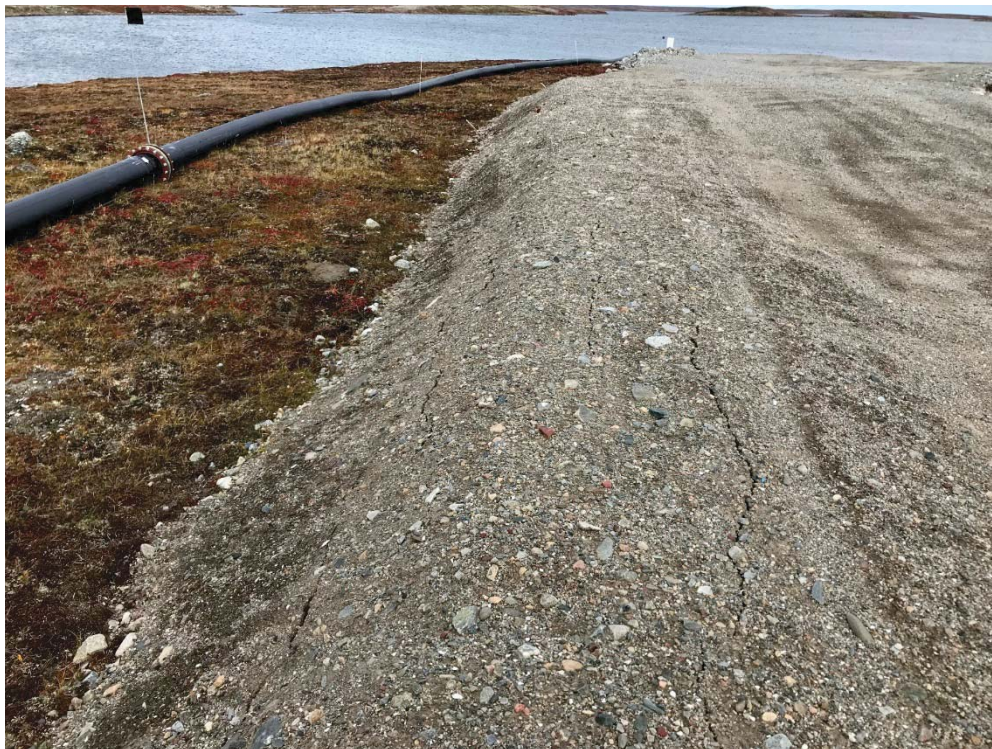
**Photograph 18: Exploration Camp Diffuser Access Road, Cracking on South Side of Road, Looking West
(10 September 2018)**

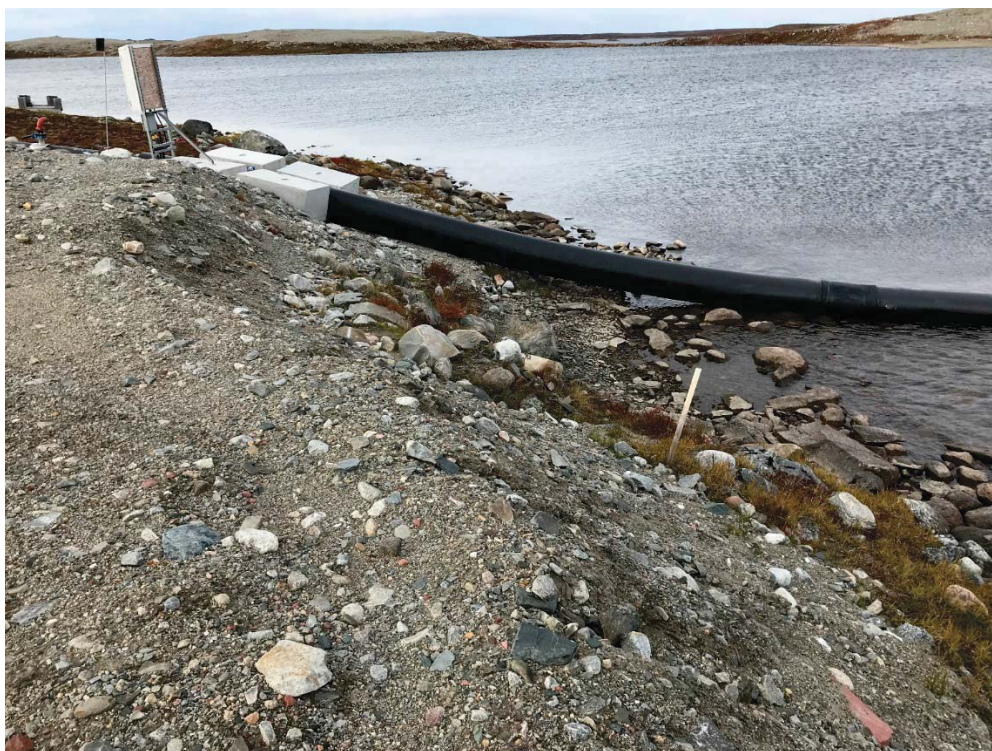
Photograph 19: Exploration Camp Diffuser Access Road, Minor Cracking on North Side of Road, Looking East (10 September 2018)

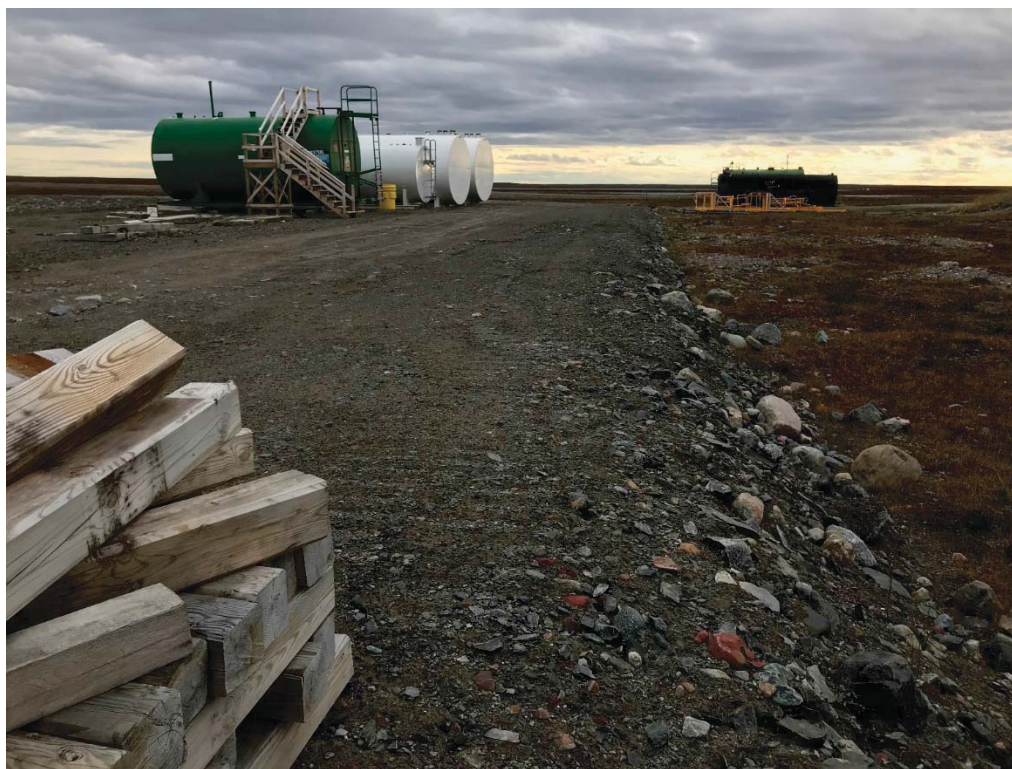
Photograph 39: Exploration Camp Fuel Storage, Minor Cracking in Fuel Storage Area Pad (10 September 2018)
