APPENDIX B

All Weather Access Road
Photographs

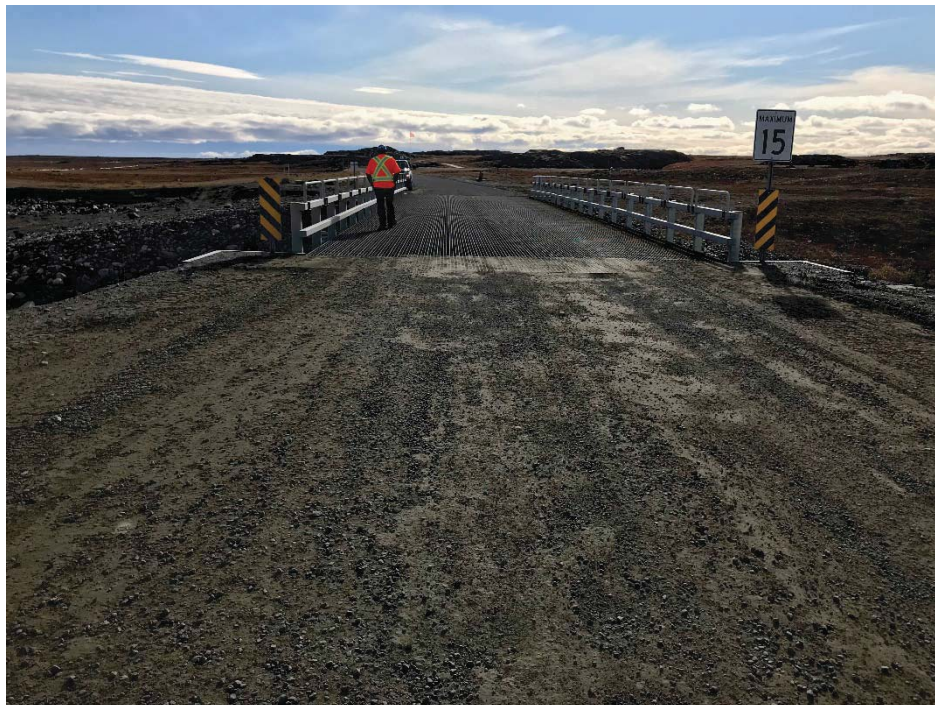
Photographs 1 to 5 were taken at KM6.0 of the Char River Bridge. Some finer grained material observed on downstream side of Left (north) Abutment, should be monitored for signs of erosion.

Photograph 1: Char River Bridge at KM6.0 Looking South (13 September 2018)

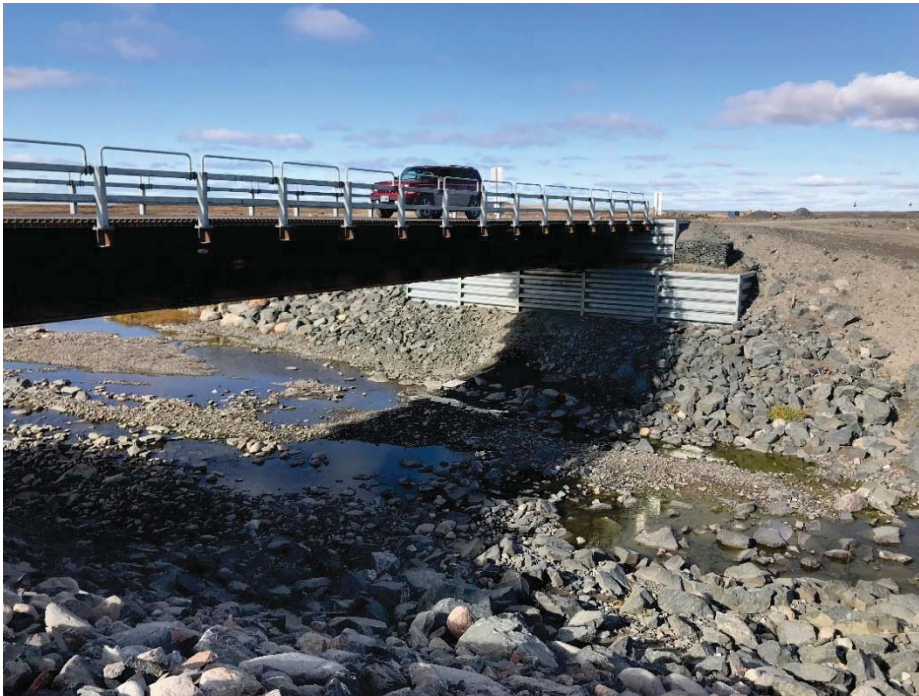
Photograph 5: Char River Bridge, downstream side of left (north) abutment, taken from the downstream side of the right (south) abutment. Finer grained material observed over coarse rockfill. (13 September 2018)

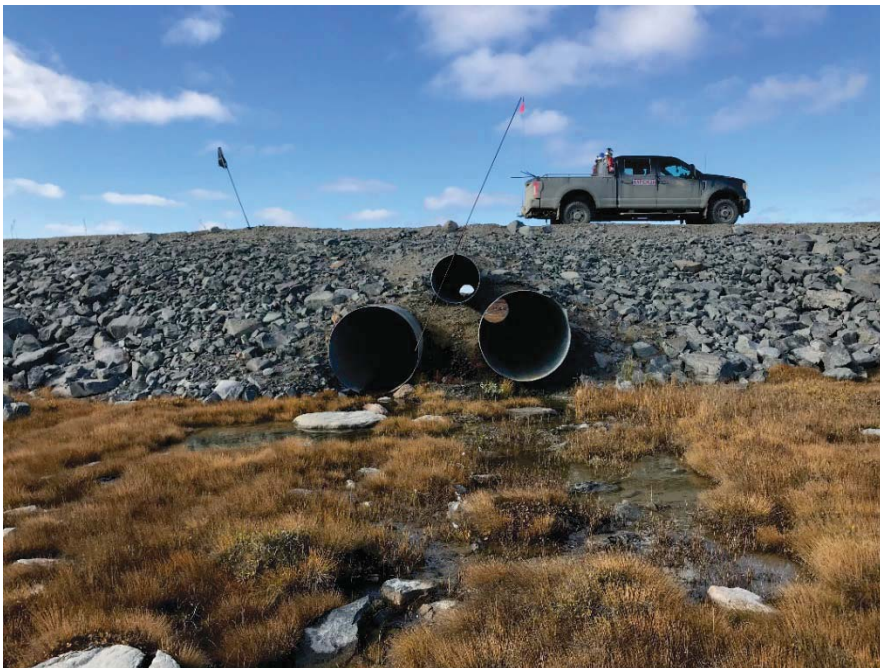
Photograph 6: At KM6.2, Downstream ends of 3 CSP culverts. Lower two culverts are 1300 mm \varnothing , upper culvert is 700 mm \varnothing . All are in good condition. Small erosion between culverts, consider adding armouring (13 September 2018)

Photographs 6 to 8 were taken at KM6.2 where there are 3 CSP culverts. The culverts are in good condition. Some minor erosion on the embankment between the culverts, consider additional armouring.

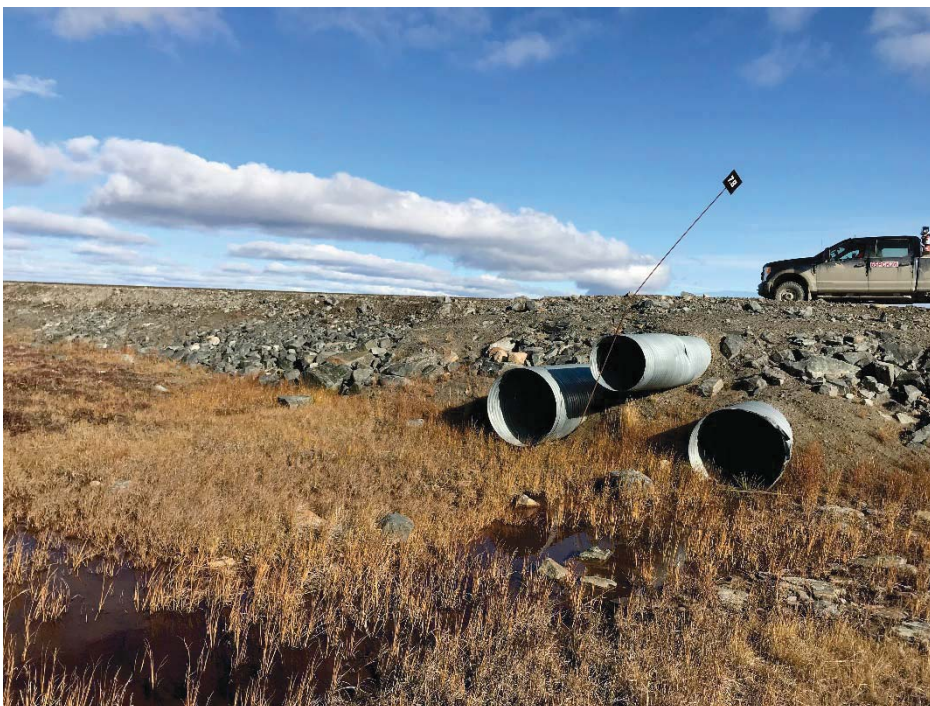
Photographs 9 to 12 were taken at KM7.0 where there are 3 CSP culverts. There is minor damage to the upstream ends of two of the culverts. Some exposed sand on embankments, additional armoring should be considered.

Photograph 10: Upstream ends of 3 CSP culverts at KM7.0. Minor damage to the upper and lower right culverts. Some exposed sand around the culvert inlets, additional armoring should be considered (13 September 2018)

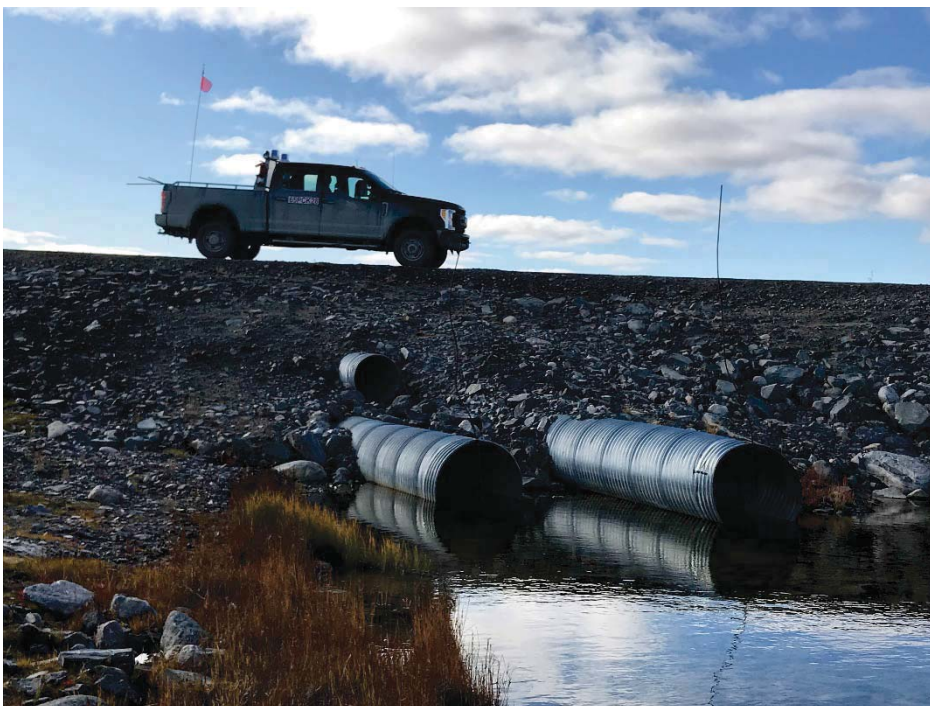
Photographs 17 to 22 were taken at KM7.4 where there are 3 CSP culverts. The inlet of one of the culverts has been partially crushed, possibly by boulders rolling down the embankment. Finer grained material surrounds the inlet and outlet which should be monitored for signs of erosion. Also extending the outlet of the upper culvert should be considered to reduce the chance of erosion.

Photograph 17: At KM7.4, upstream ends of 3 CSP culverts. Lower two culverts are 900 mm \varnothing (left) and 1000 mm \varnothing (right), and the upper culvert is 700 mm \varnothing . Inlet of the 900 mm has been damaged, (13 September 2018)

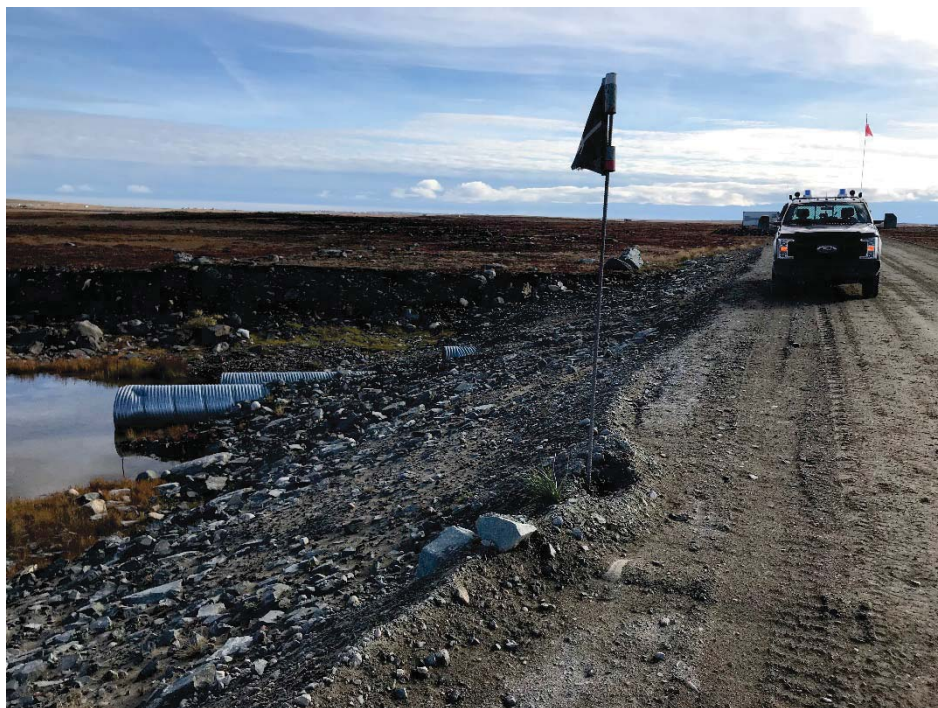
Photograph 19: Damaged upstream end of 900 mm culvert at KM7.4, similar to what was observed in 2017. It appears the damage may have been caused by boulders that rolled down the slope (13 September 2018)

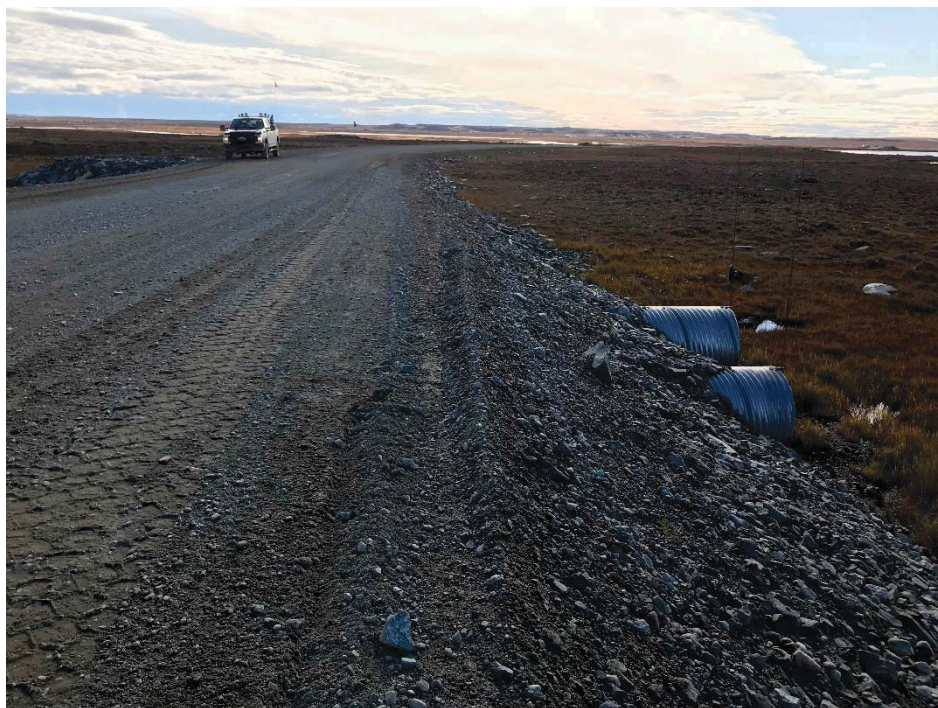
Photographs 31 to 35 were taken at KM9.1 where there are 2 CSP culverts, each 1000 mm in diameter. There is some minor deformation in the culverts under the road, no flow, water ponded below inverts.

Photograph 33: View through lower CSP culvert at KM9.1 from downstream to upstream. No observable change in deformation of culvert when compared to 2017 inspection (13 September 2018)

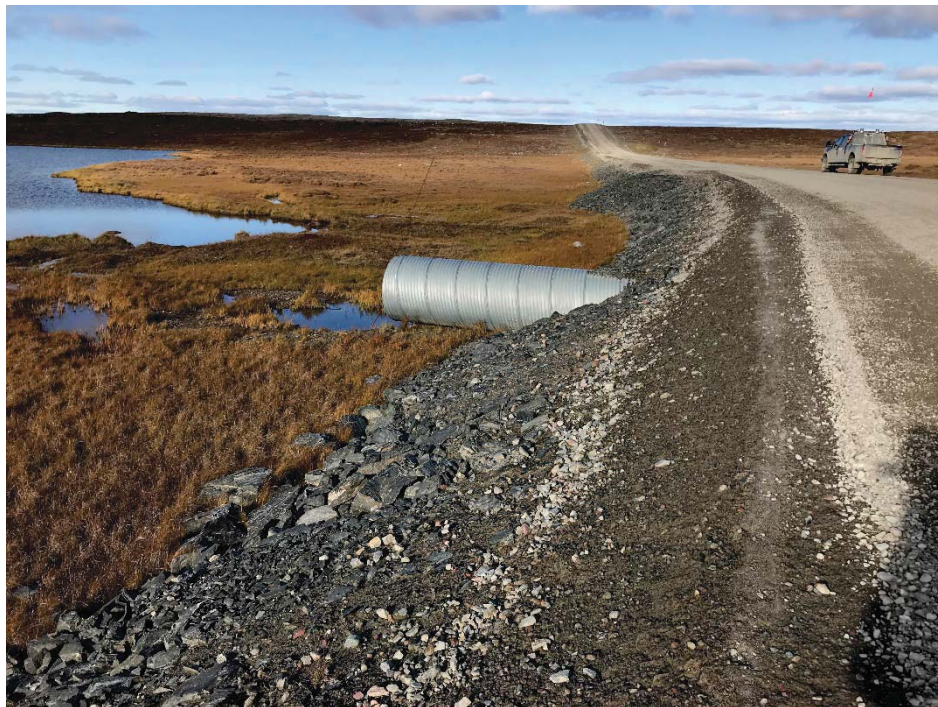
Photograph 36: At KM9.5, upstream end of a single 1300 mm ø CSP. Culvert inlet is elevated, allowing water to pond upstream. (13 September 2018)

Photographs 36 to 39 were taken at KM9.5 where there is a single CSP culvert. It is generally in good condition, there is a small deformation of the culvert under the road. The culvert inlet is elevated resulting in water ponding on the upstream side of the road. The ponded water extends approximately 100 m north and 50 m south of the culvert location.

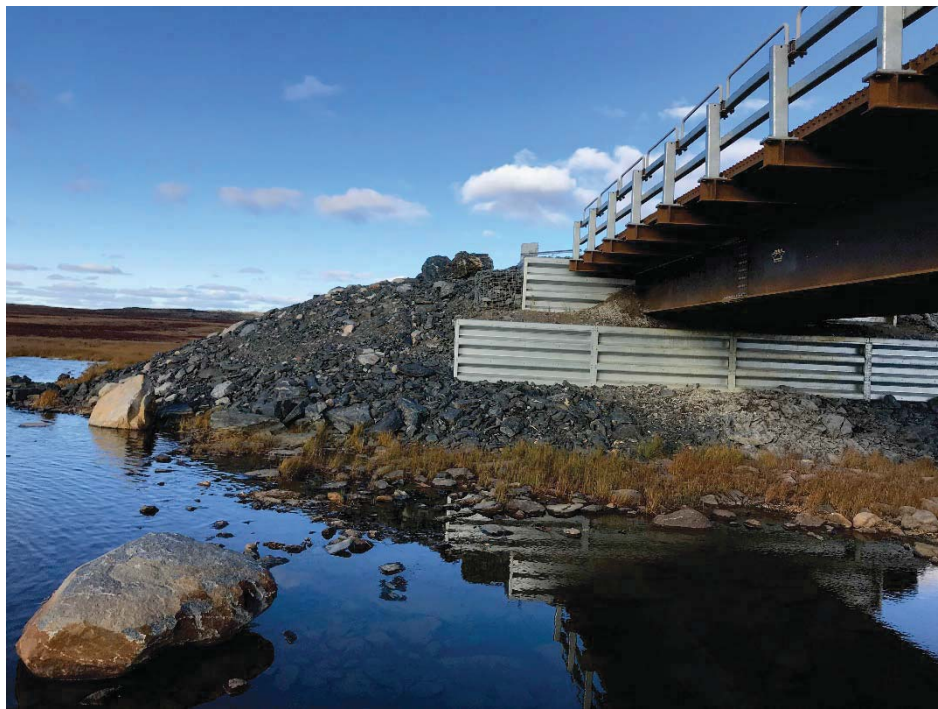
Photographs 40 to 47 taken of M-5 Bridge, at KM10.5. The bridge abutments are generally in good condition. No change to area previously noted as possible erosion. There is a damaged gabion on the downstream side of the Left (north) Abutment that should be replaced.

Photograph 41: M-5 Bridge at KM10.5, photo of damaged gabion on the downstream side of the Left (north) Abutment that should be replaced. (13 September 2018)

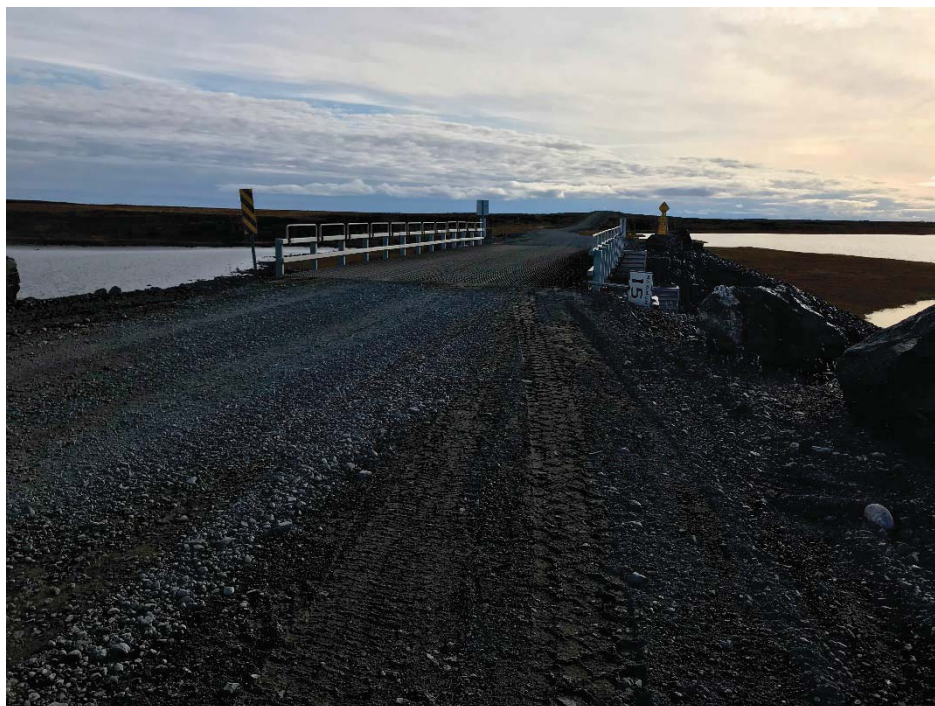
Photograph 45: M-5 Bridge at KM10.5 Right (south) Abutment, upstream side. Previously noted as area of possible erosion, no obvious change since 2016/2017, material may have been placed in this way during construction (13 September 2018)

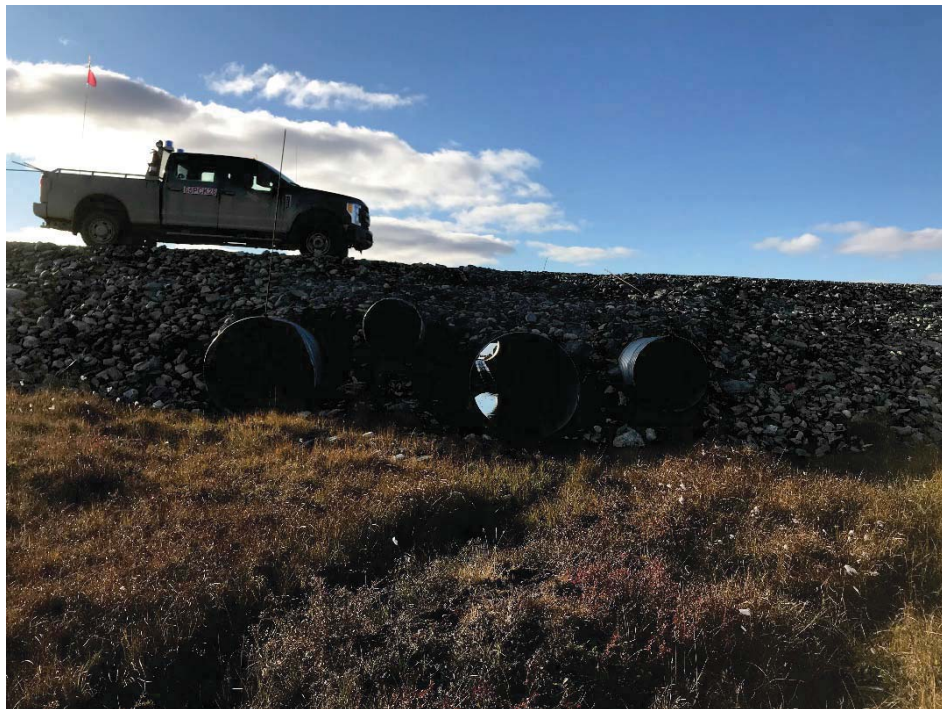
Photograph 48: Upstream ends of four CSP culverts at KM12.1. From left to right the diameters are 900 mm, 1300 mm, 700 mm, 1300 mm. Small dent in inlet of uppermost culvert (13 September 2018)

Photos 48 to 52 were taken along AWAR at KM12.1 where there are four CSP culverts. The embankments are generally in good condition. There is deformation of the culverts visible under the road.

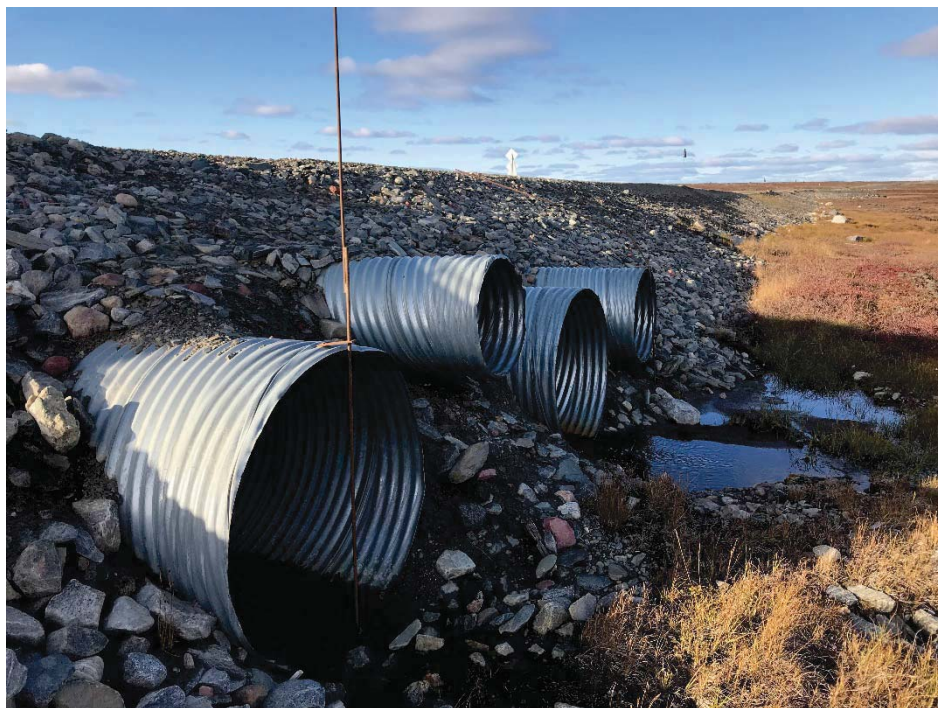
Photograph 49: Downstream ends of four CSP culverts at KM12.1. Small flow observed through the lowest culvert (second from right in the photograph). Visible deformation of the culverts under the road (13 September 2018)

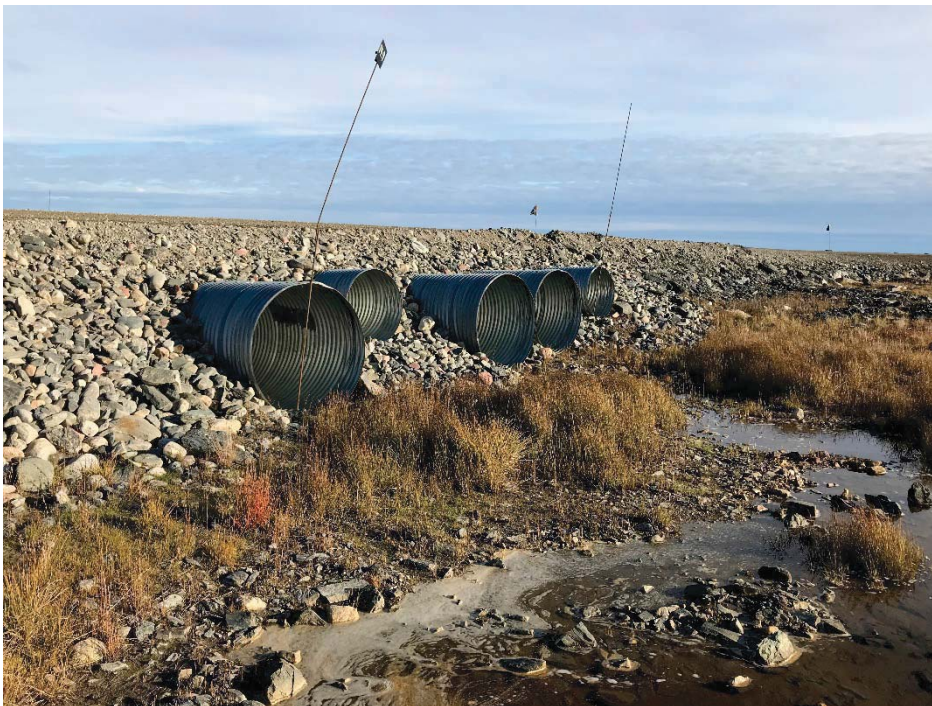
Photos 55 to 58 were taken along AWAR at KM13.5. Five CSP culverts are installed at this location, three of 1300 mm \varnothing and two of 900 mm \varnothing . The inverts of the 900 mm culverts are elevated higher than the inverts of the 1300 mm culverts. Minor deformation of the culverts noted under the road, embankments are generally in good condition.

Photograph 55: At KM13.5, upstream ends of 5 CSP Culverts (3×1300 mm \varnothing ; 2×900mm \varnothing). The 900 mm culverts are vertically elevated. Minor deformation of the culverts under the road (13 September 2018)

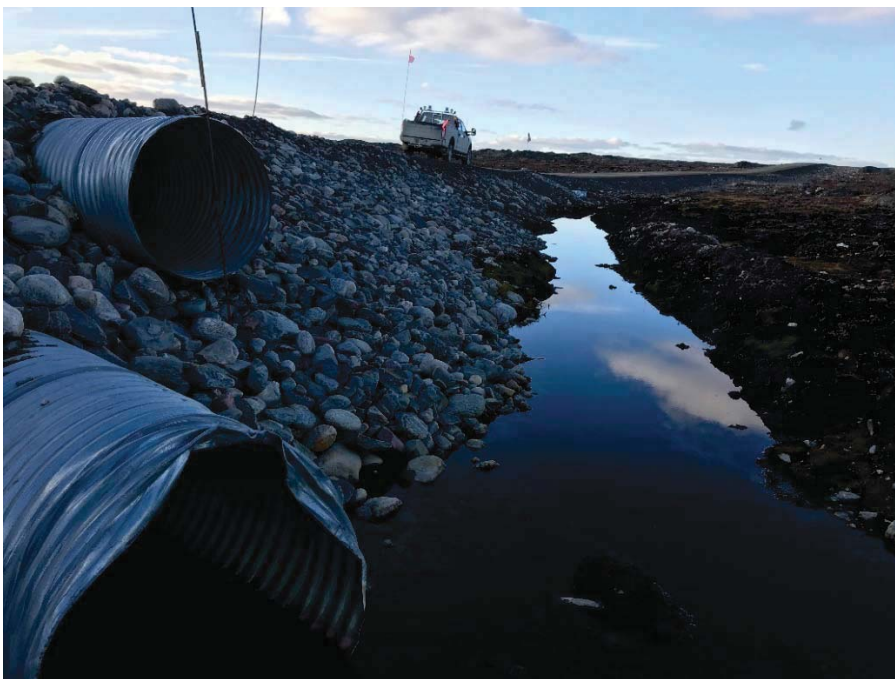
Photograph 67: At KM18.1, upstream ends of two CSP culverts. Upper culvert is 900 mm Ø and the lower is 1000 mm Ø. Cover over upper (900 mm Ø) culvert is thin on upstream side (13 September 2018)

Photographs 67 to 70 were taken at KM18.1. There are 2 vertically offset, CSP culverts the upper culvert is 900 mm Ø and the lower culvert is 1000 mm Ø. Note that the road near KM18.1 would need to almost be flooded to reach inlet of 900 mm Ø culvert. If water management in this area is a problem, suggest lowering the culvert or installing another culvert at a lower elevation. Some damage was observed on the inlet of the lower culvert, embankment is generally in good condition. A ditch on the upstream side hydraulically connects the culverts at KM18.1 to culvert at KM18.15.

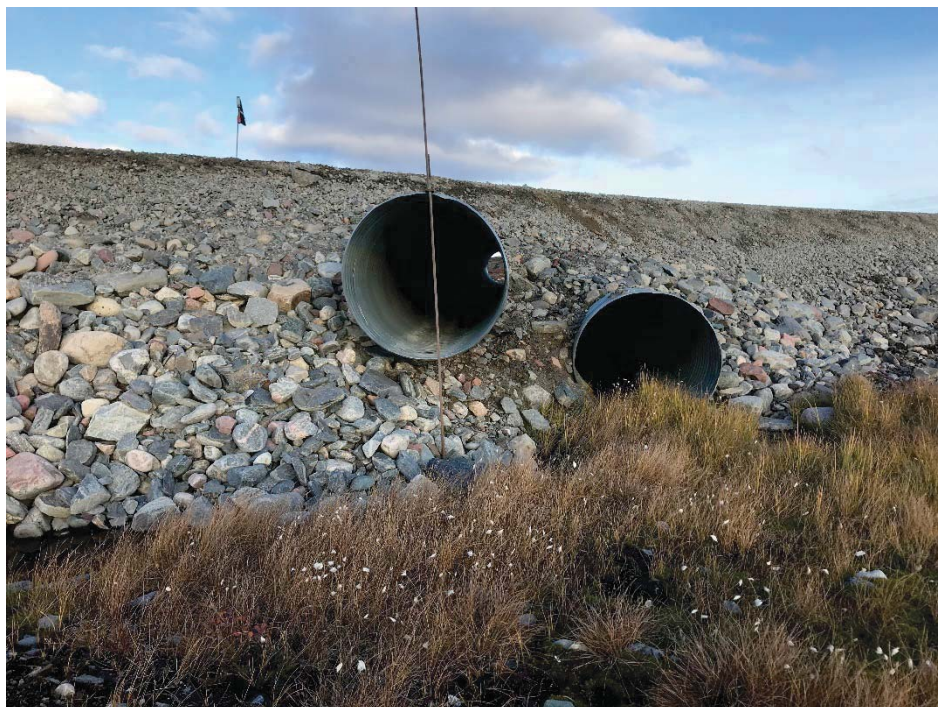
Photograph 68: Damage to the inlet of the lower (1000 mm Ø) CSP culvert at KM18.1. View north along the AWAR road embankment, slope looks good, but water ponded along road. Culvert at KM18.15 visible in background (13 September 2018)

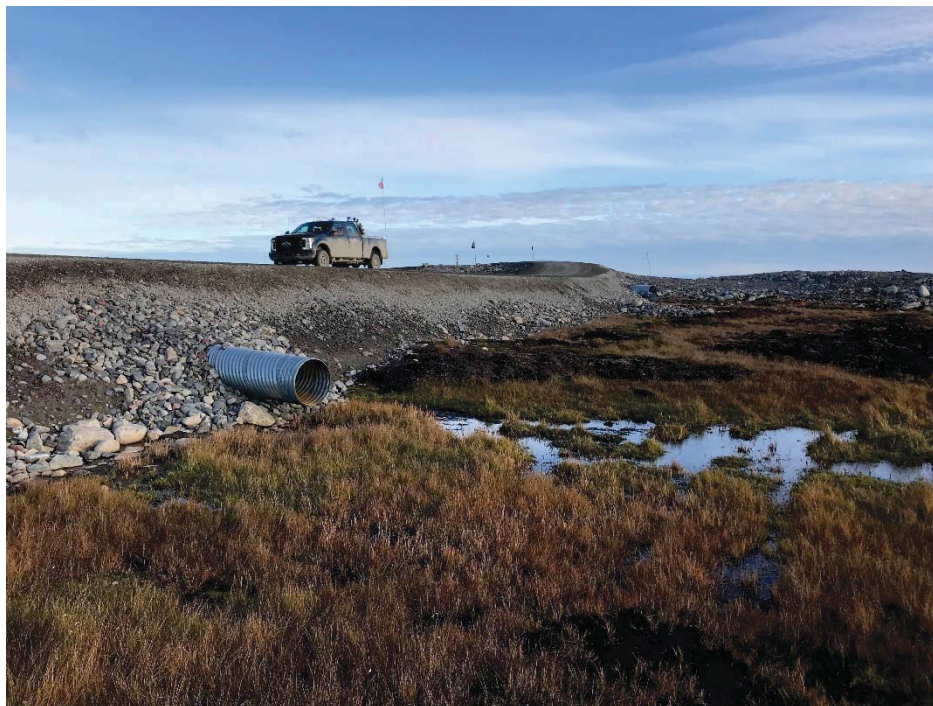
Photograph 71: Upstream end of a 600 mm Ø CSP Culvert at KM18.15. Water ponding below inlet. (13 September 2018)

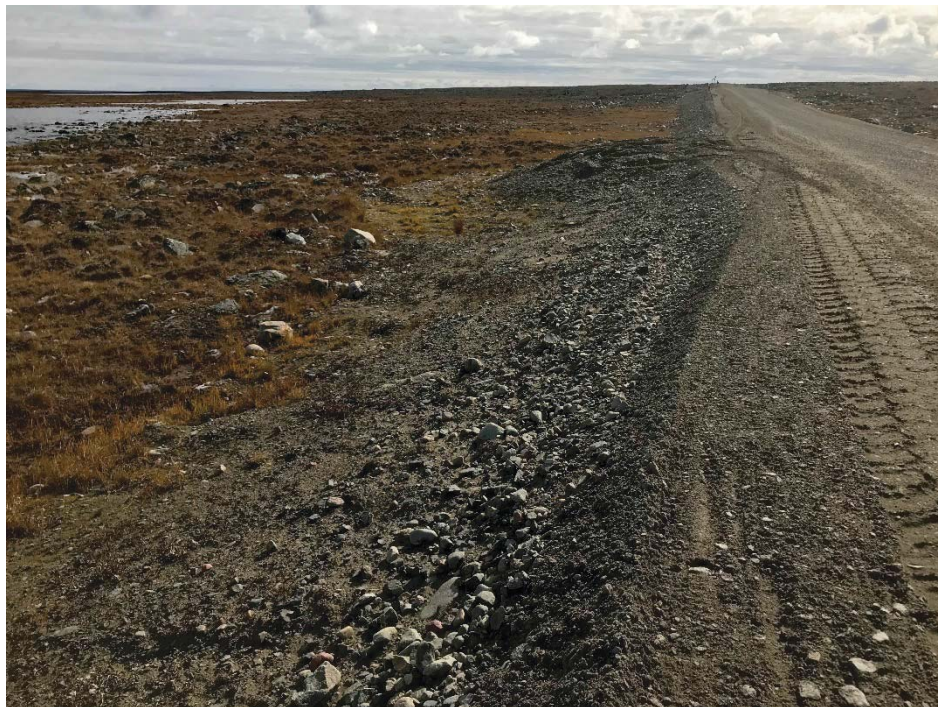
Photograph 78: At KM21.2 where water is ponding on the west side of the AWAR, looking north (14 September 2018)

Photographs 78 to 80 were taken at KM21.2 where water is ponding on the west side of the AWAR. There are no culverts present at this location. Water flowed over the road at this location during freshet. A straw log has been placed on the east side of the road to manage erosion. It is recommended that a culvert be installed at this location.

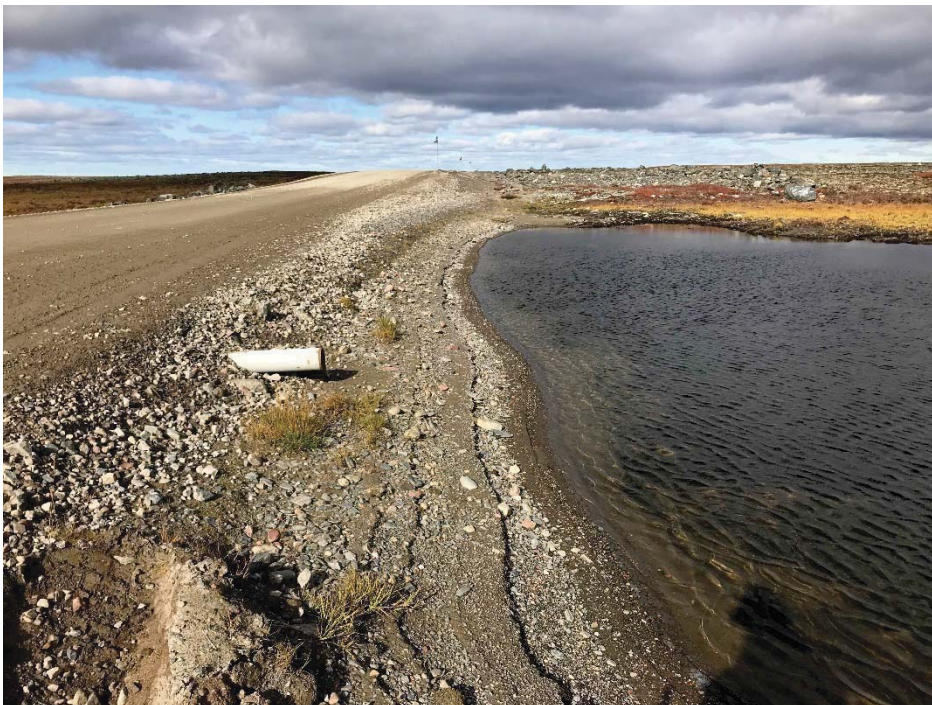
Photographs 81 to 84 were taken at KM21.7. There are two 170 mm outside \varnothing pipes, vertically offset. Mine personnel reports that the road was excavated at this location this spring to allow water to drain. The capacity of the pipes may be inadequate, or pipes could have been frozen/blocked causing water to backup. Installation of larger diameter culvert should be considered at this location.

Photograph 81: At KM21.7, view of the upstream ends of two steel pipes, each with an outside diameter of 170 mm. Water is ponded year-round at this location. Mine personnel reported that during freshet it was necessary to excavate the road at this location to let the water drain (14 September 2018)

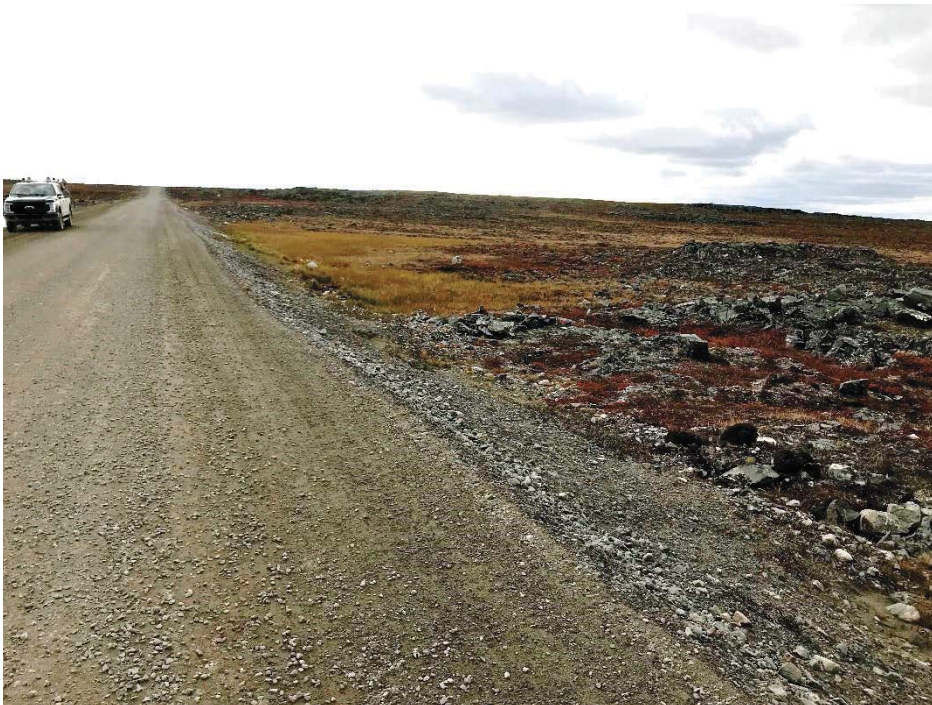
Photographs 89 and 90 were taken at KM22.7 where water is ponded on the east side of the road. Wet soil was observed on the west side of the road indicating seepage through the road. There is no culvert at this location. Consider installation of culvert.

Photograph 89: Ponded water on the east side of the AWAR near KM22.7. No culvert at this location (14 September 2018)

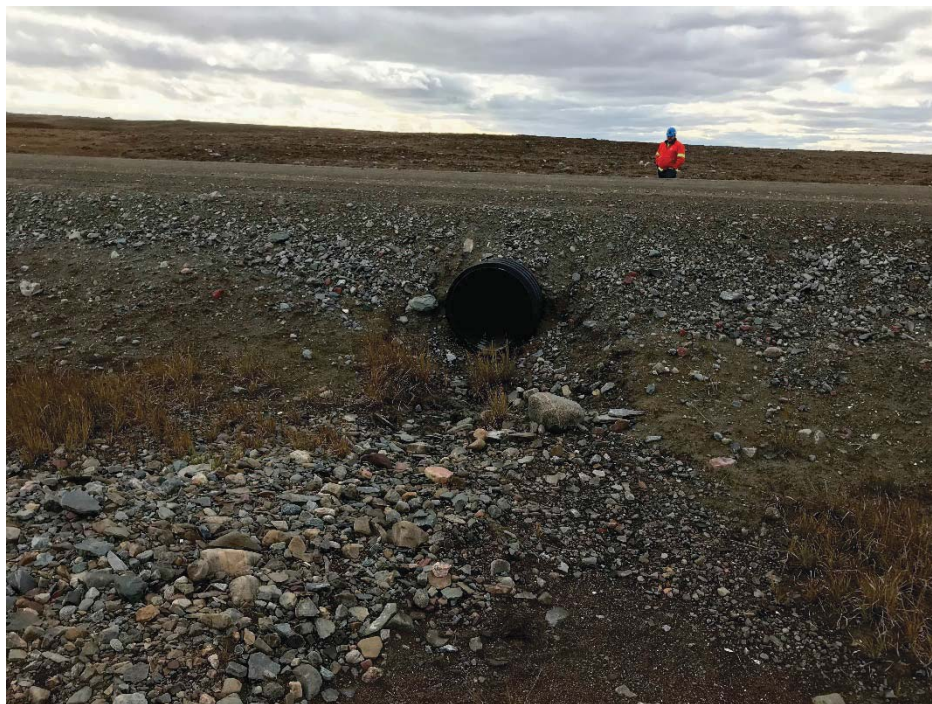
Photographs 91 through 93 were taken at KM25.8 where there is a single HDPE corrugated 600 mm Ø culvert. Some damage and granular material partially blocking the inlet of the culvert. Culvert should be cleaned out to re-establish capacity.

Photograph 91: Damaged upstream end of corrugated 600 mm Ø HDPE culvert at KM25.8. Inlet is partially blocked and should be cleaned out. (14 September 2018)

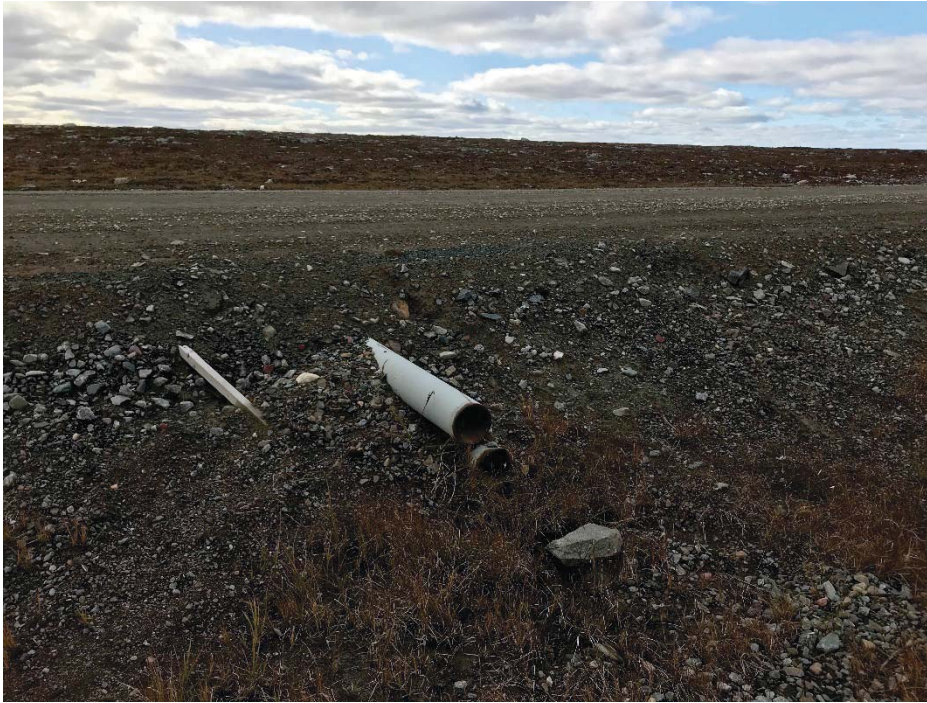
Photograph 94: Upstream ends of two 160 mm Ø steel pipes at KM26.2. The lower pipe is bent upwards and should be replaced. The inlets are elevated close to road surface and nearly covered by road fill, consider lowering and extending (14 September 2018)

Photographs 94 and 95 were taken at KM26.2 where there are 2 vertically offset, 160 mm Ø steel pipes. The lower pipe is bent upwards. The Inlets are elevated close to the road surface elevation and are nearly covered by road fill. Replacing the bent pipe and lowering and extending the inlets should be considered.

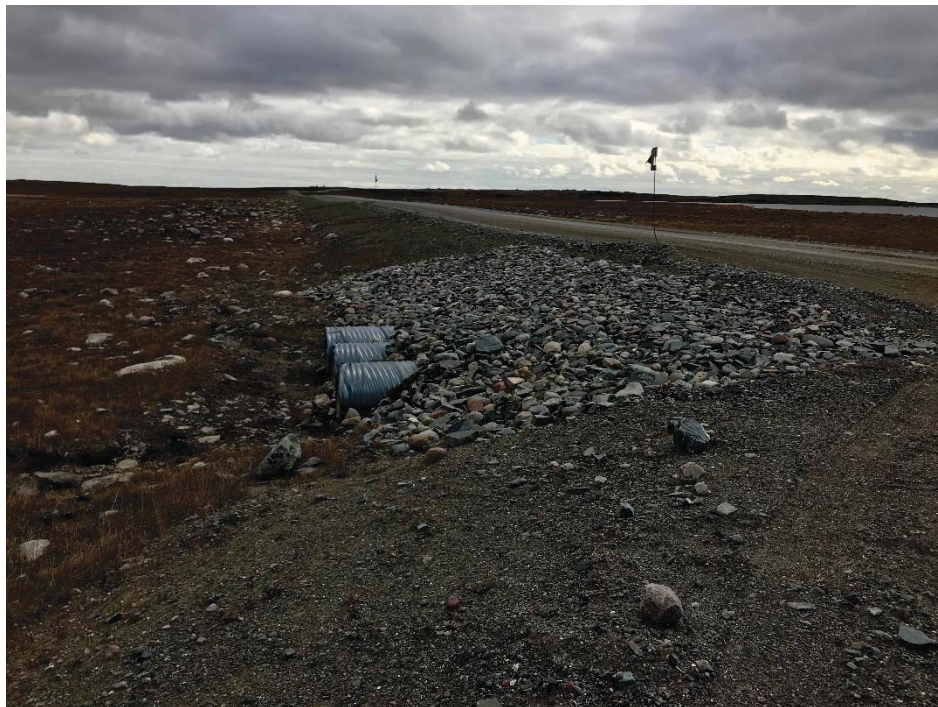
Photograph 96: Upstream ends of three 700mm Ø CSP culverts at KM26.5. Minor sediment buildup in the bottom of the culverts shouldn't substantially influence flows, monitor. (14 September 2018)

Photographs 96 through 100 are at KM26.5 where there are three 700mm Ø CSP culverts installed at about equal elevation. Small dents in culverts, minor deformation observed under the road. Minor sediment buildup observed in the culverts, riprap and embankments are in good condition.

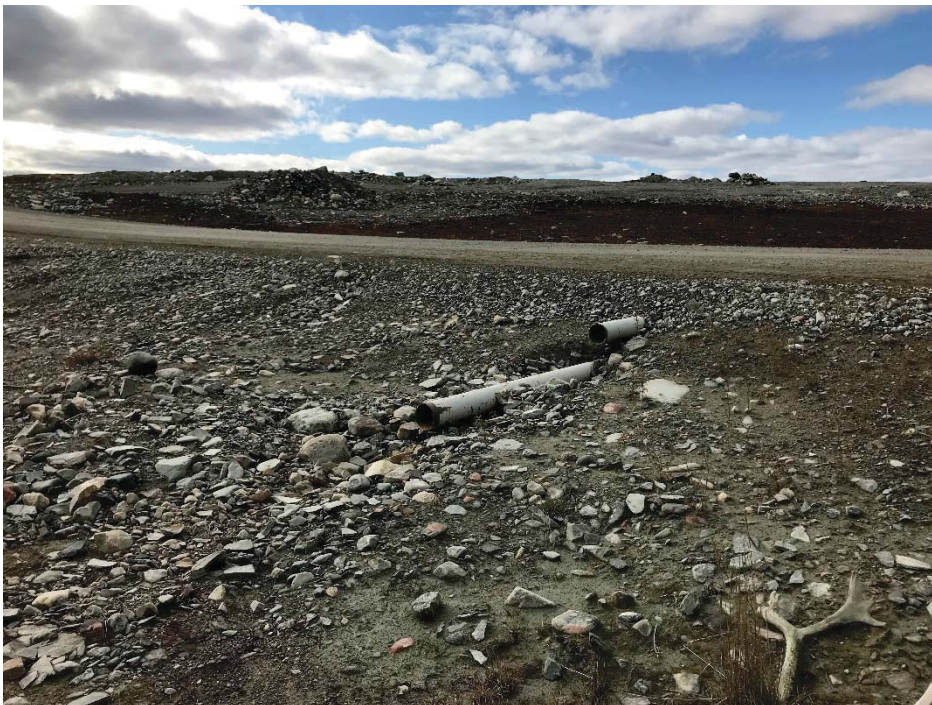
Photographs 101 through 104 are at KM26.8 where there are two 160mm Ø steel pipes installed, vertically offset. The inlet of the lower pipe was covered by new road fill placed in 2018. The culvert should be extended or replaced. There is some erosion evident below the outlets of both pipes.

Photograph 101: At KM26.8, upstream ends of two vertically offset 160mm Ø steel pipes. The inlet of the lower pipe has been covered during placement of new road fill, should be extended. (14 September 2018).

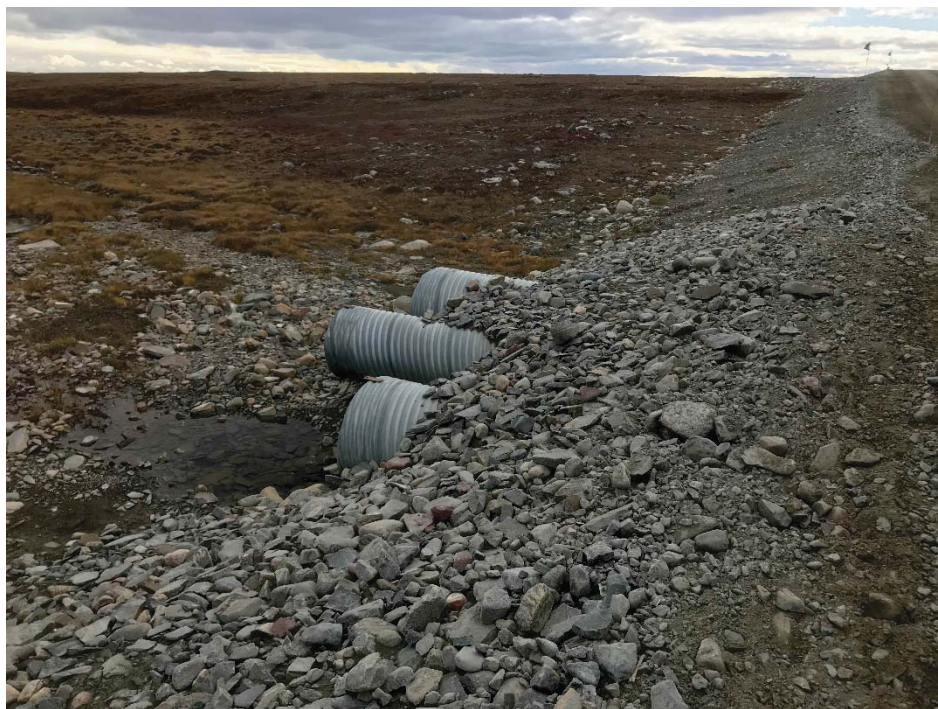
Photographs 105 through 108 are at KM27.1 where there are 3 CSP culverts installed: 900 mm, 700 mm, and 1000 mm ø. Some minor sloughing of riprap observed around the culvert inlets. Some erosion/deposition observed under culvert outlets. Otherwise embankment slope is generally in good condition.

Photograph 105: At KM 27.1, upstream ends of three CSP culverts. Some minor sloughing of riprap observed around culvert inlets. (14 September 2018)

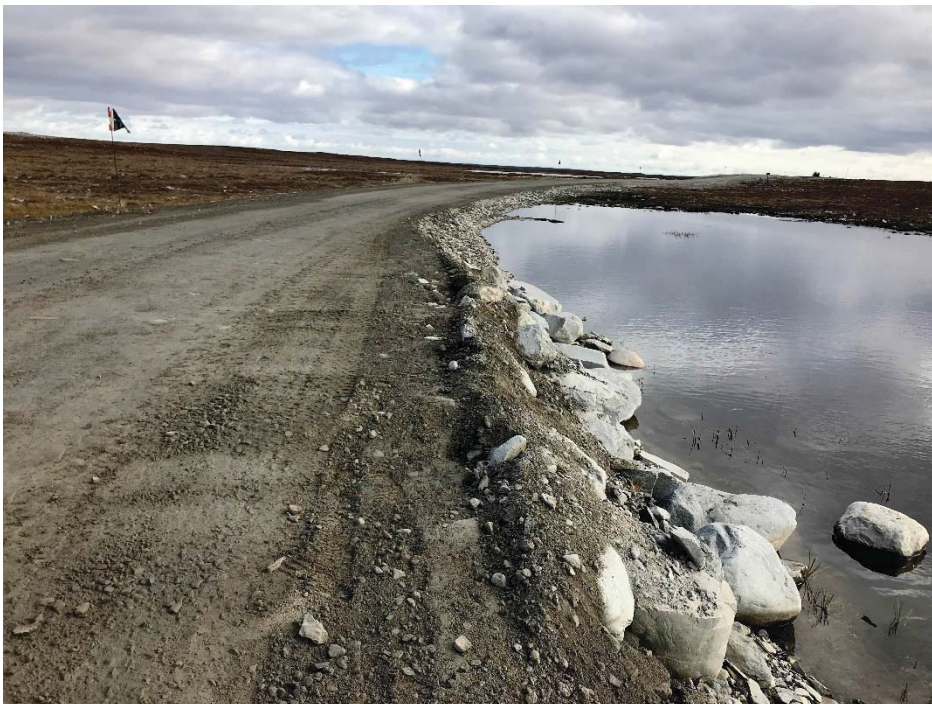
Photographs 111 through 114 are at KM29.6 where a single 500 mm Ø corrugated HDPE culvert is installed. Ponding water observed on the west side of road. Culvert inlet is partially blocked by road fill and riprap and is elevated above level of ponded water. Move riprap from in front of inlet and recommend lowering culvert invert to reduce ponding adjacent to road.

Photograph 111: At KM29.6, upstream end of single 500 mm Ø corrugated HDPE culvert. Inlet to the culvert is partially blocked by riprap and road fill and is elevated above ponded water at this location. Remove riprap, clean out culvert and recommend lowering invert. (14 September 2018).
