CLIENT  
AGNICO-EAGLE MINES LIMITED  
MELIADINE GOLD PROJECT  
NUNAVUT

CONSULTANT  
GOLDER

PROJECT  
Meliadine Gold Project  
Rankin Inlet, Nunavut

**Itivia Fuel Storage, Laydown, and  
By-Pass Road Photographs**

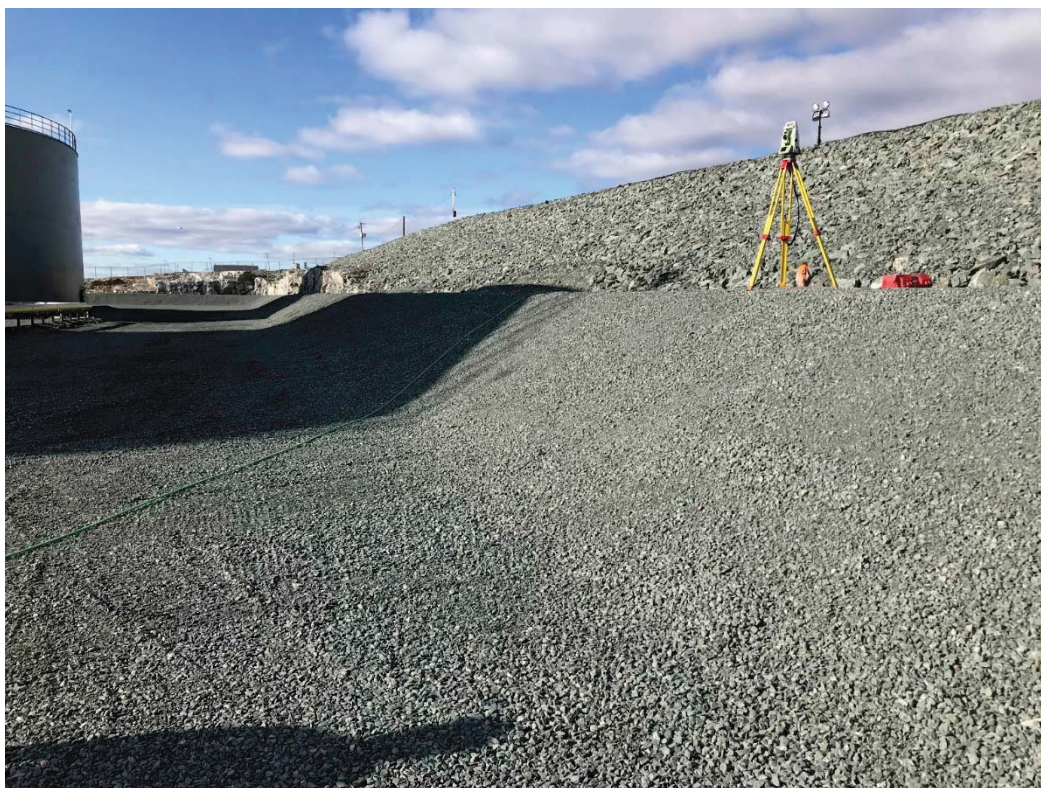
**Photograph 7: Itivia Fuel and Laydown Area, Overview of Interior of Fuel Storage Area, Looking Northeast from Southwest Corner. (14 September 2018).**

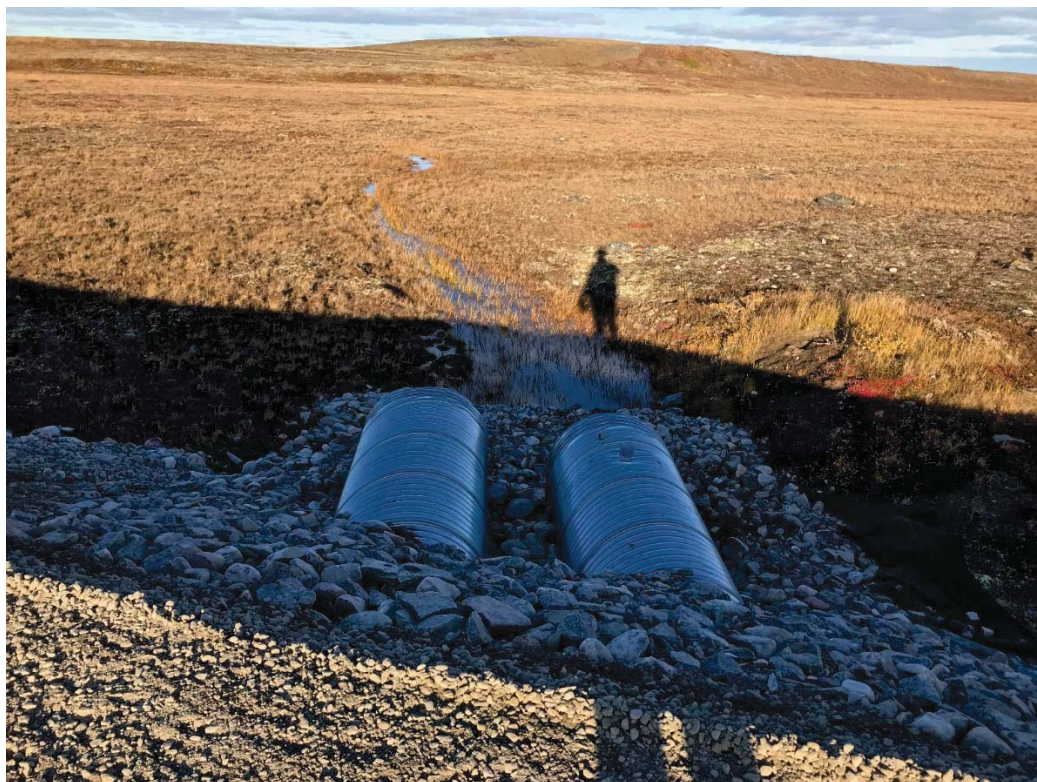
**Photograph 40: Culvert C11b-1 Outlet and Downstream Drainage Channel, Looking Southeast (14 September 2018)**

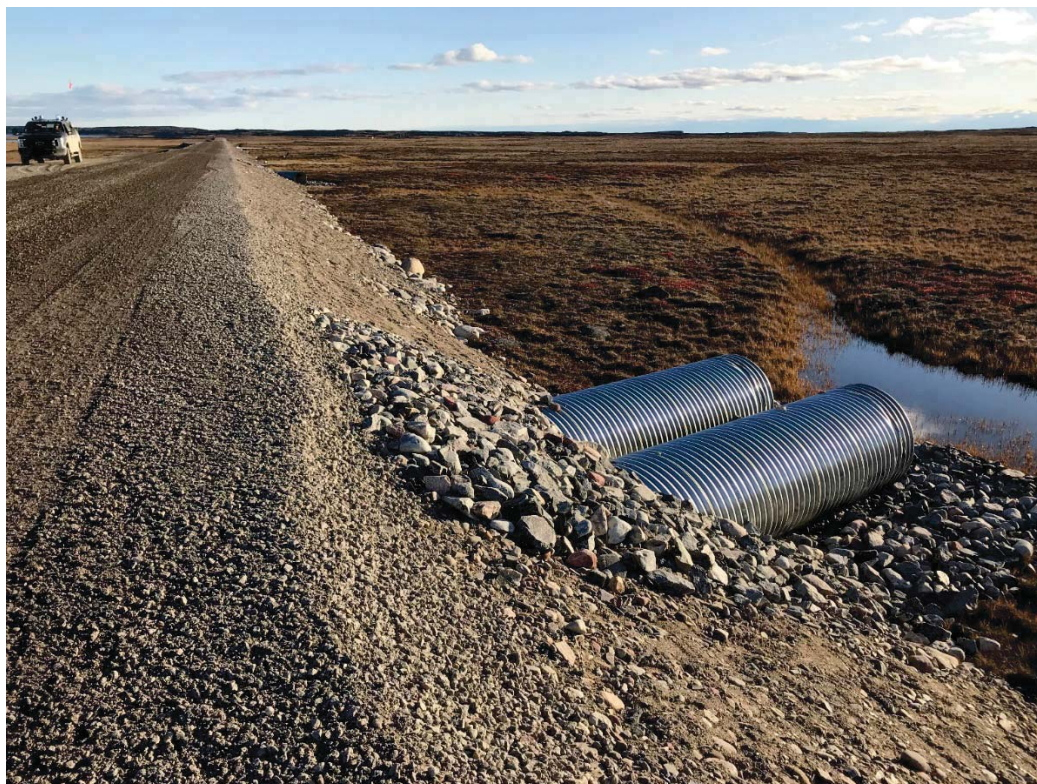
**Photograph 41: Inlets and Upstream Drainage Channel for Culvert C11c, Looking East (14 September 2018)**

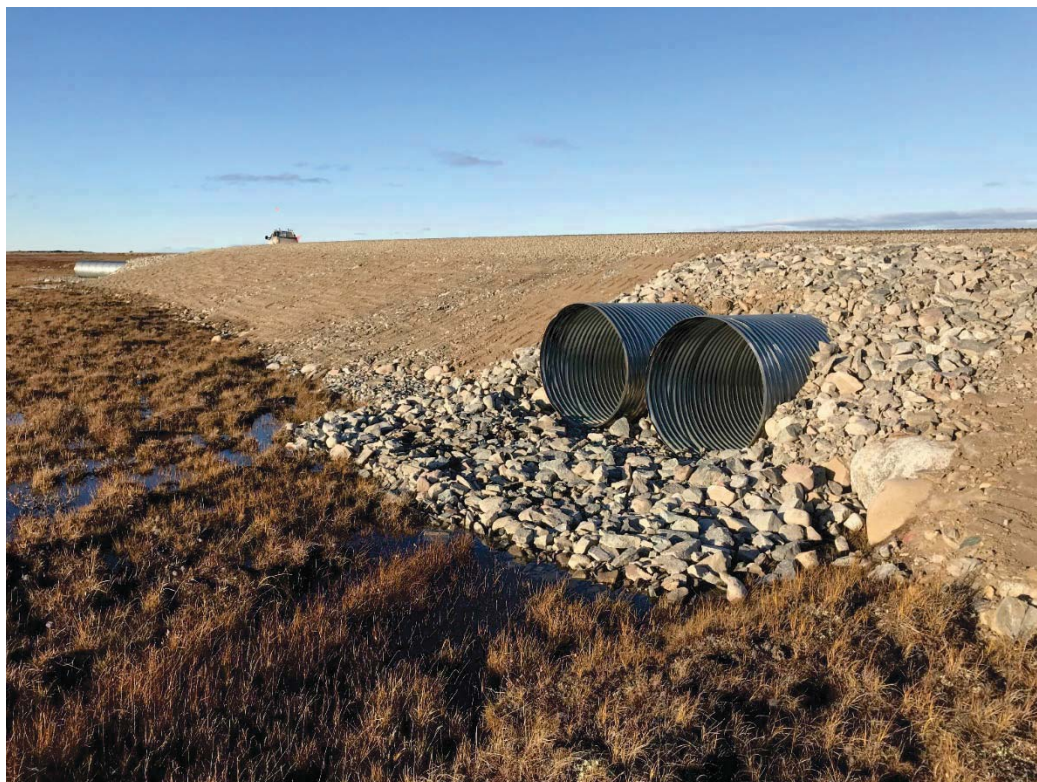
**Photograph 42: Outlets and Downstream Drainage for Culvert 11c, Looking South (14 September 2018)**

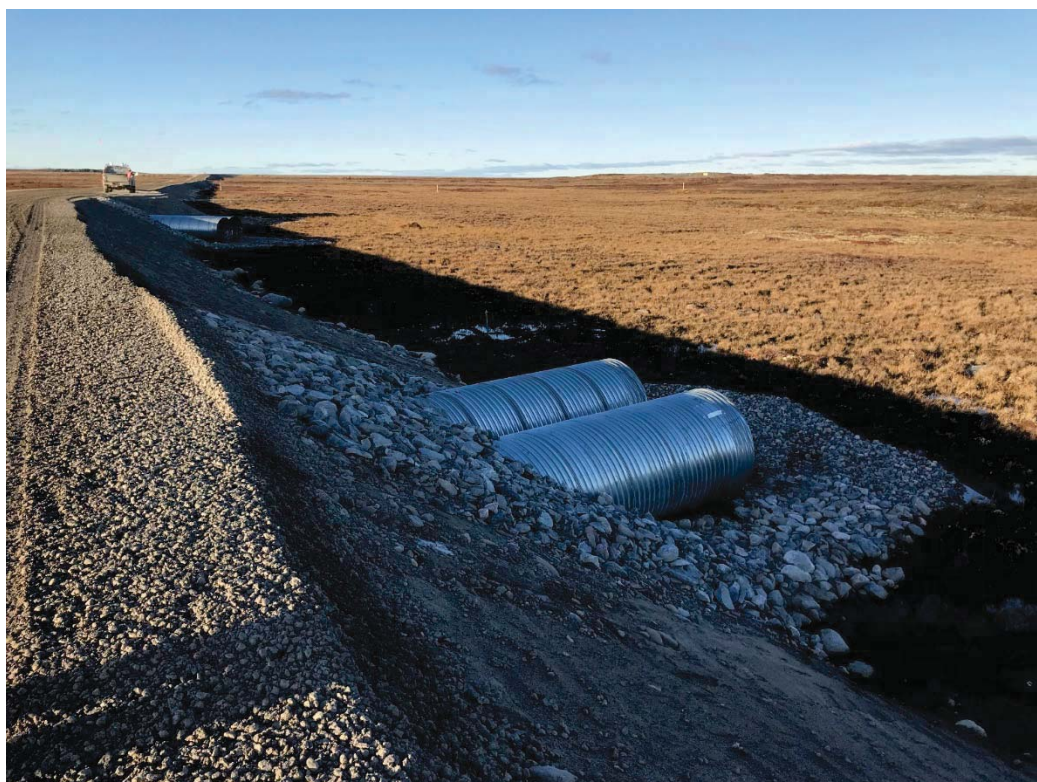
**Photograph 43: Culvert 12a Inlet, Looking North (14 September 2018)**

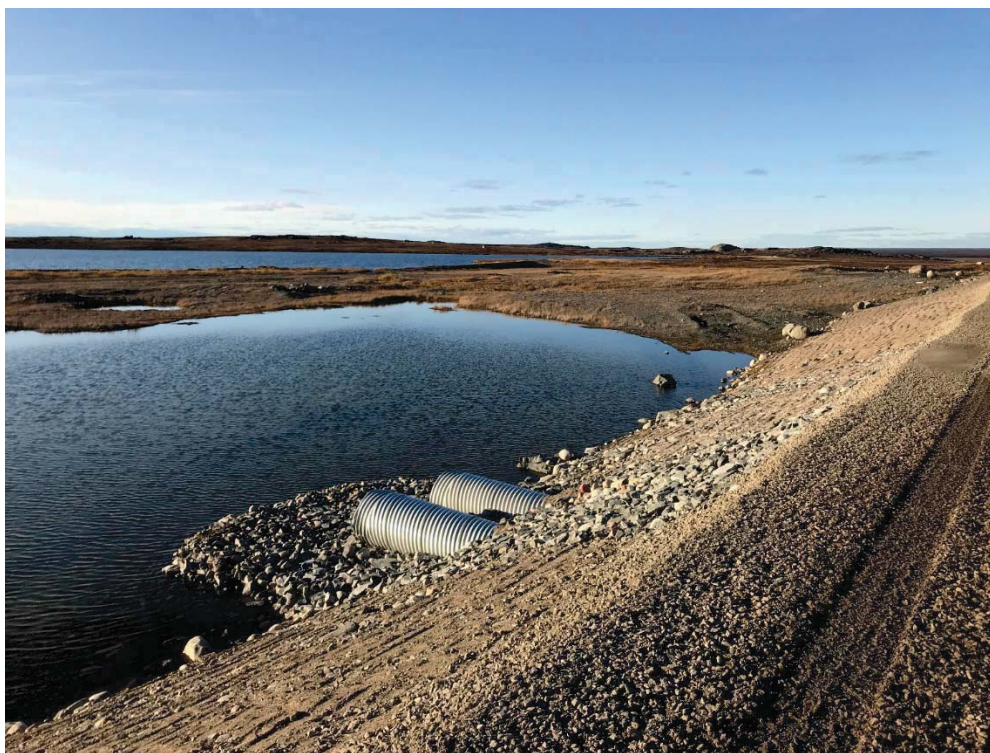
**Photograph 47: Culvert 13 Inlets, Ponded Water Upstream and Below the Culvert Inverts, Looking East (14 September 2018)**

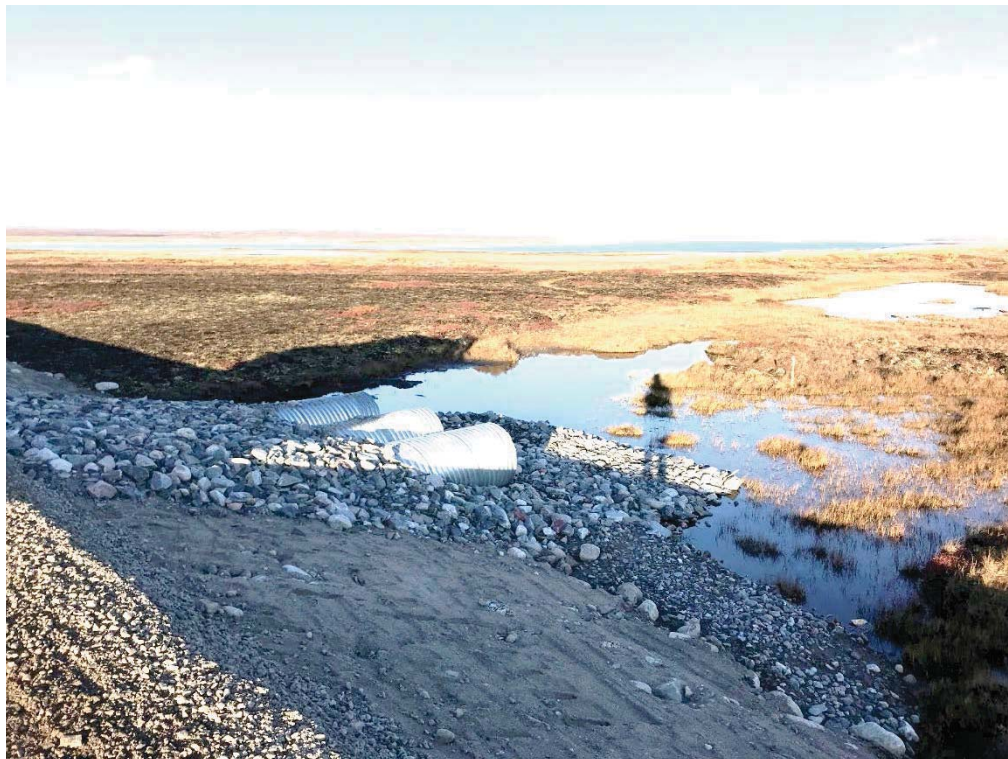
**Photograph 48: Culvert 13 Outlets, Ponded Water Observed Downstream Below the Culvert Inverts and Against the Road Embankment Toe, Looking Northwest (14 September 2018)**
