Appendix F-3

Reportable spills and follow up reports

Follow Up Report – January 31st 2018 Sewage Spill #18-027

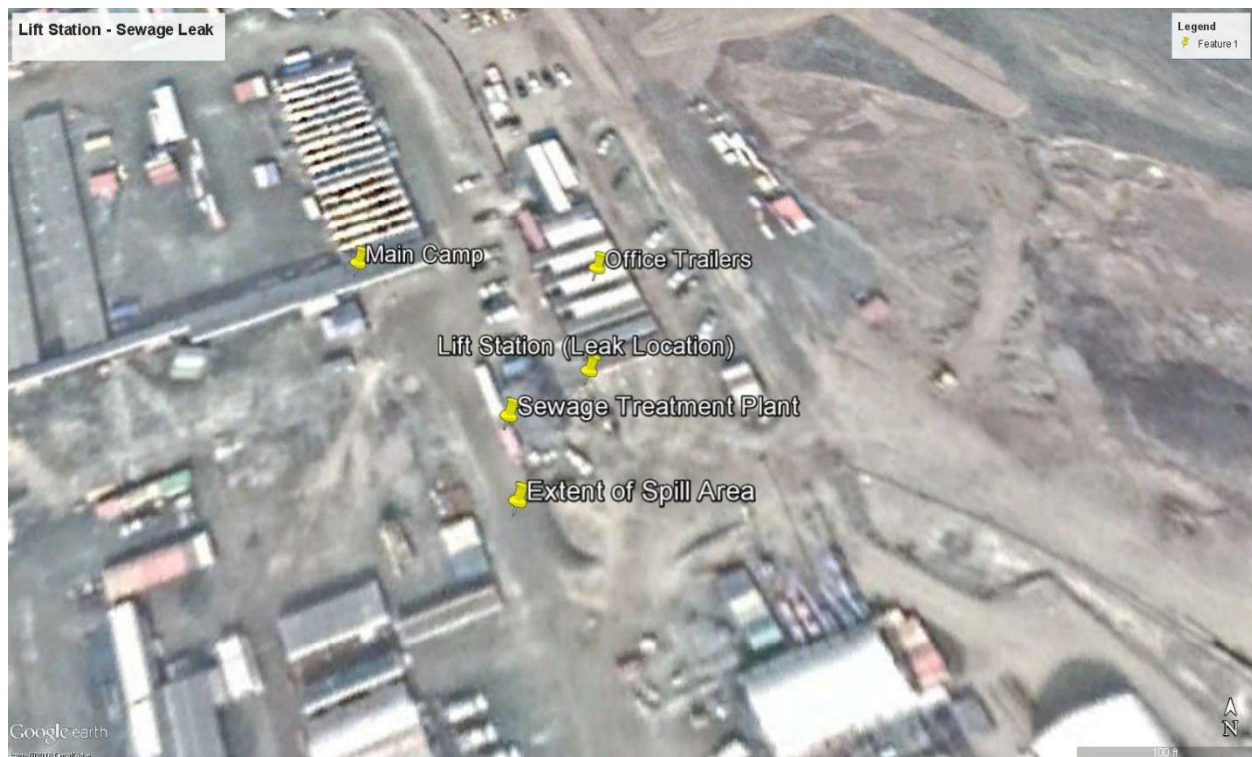
Figure 1: View from above – Main Camp: Location of lift station piping (source of leak) and spill area.

A rubber joint on the sewage treatment plant piping failed. The equipment failure was likely due to the material fatiguing in frigid temperatures.

The spill froze to the immediate area and was excavated and disposed of appropriately. The joint has been replaced with a mechanical joint made of more suitable material. A third party review of the system was completed and recommendations have been provided to Agnico Eagle for implementation in order to improve the performance of the STP.

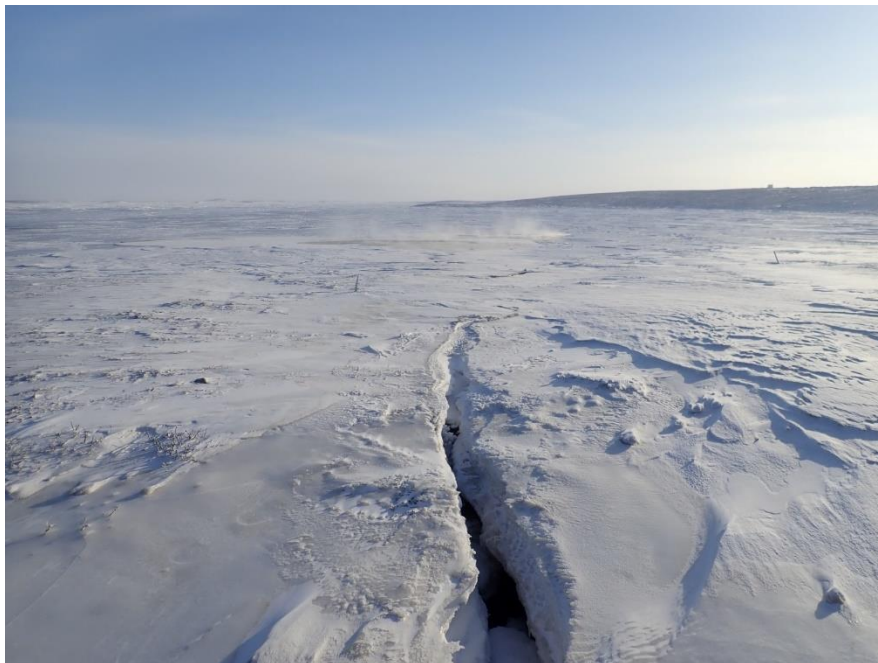
Picture 1: Channel formed by release water flowing through ice into Meliadine Lake.

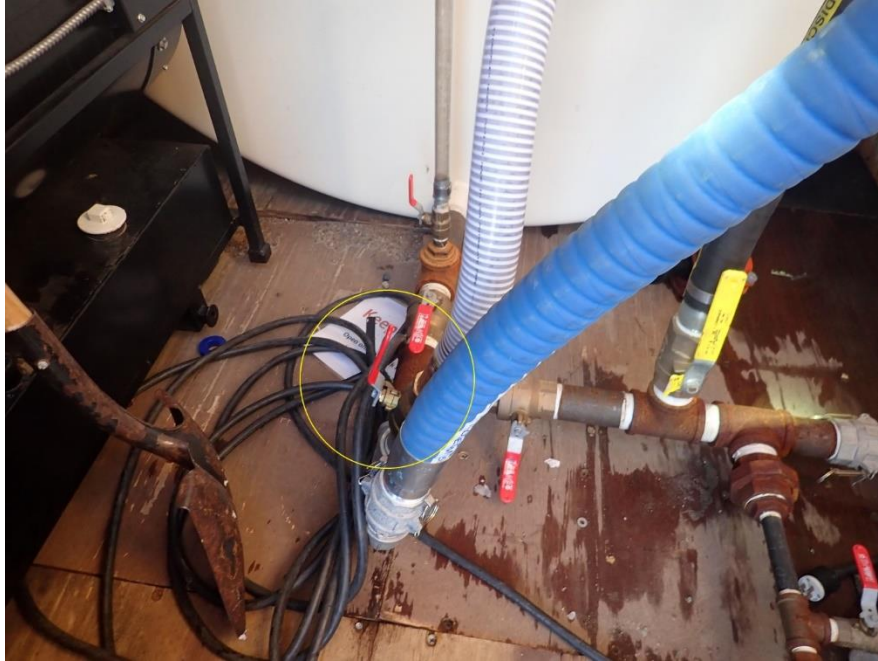
Picture 2: Release valve left open causing the spill.

Investigation into the release was inconclusive. However, it is believed that a water truck operator failed to close the release valve after transferring water to a truck.

The release was deemed to be caused by human error. The release valve is now fitted with a locking mechanism. A supervisor now keeps a register to record which operator is in possession of the key.

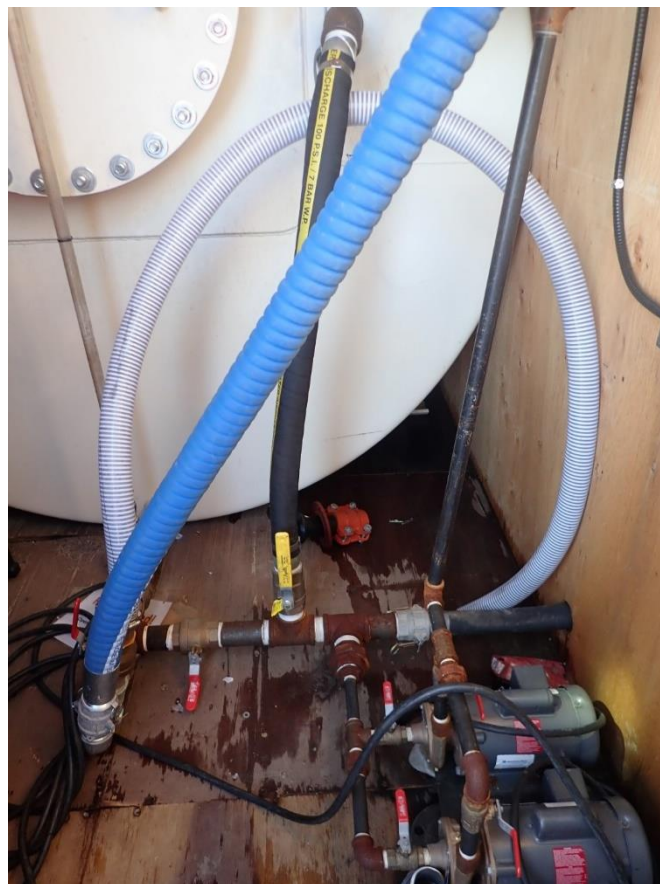
Picture 3: Discharge hose connected to retention tank release valve.

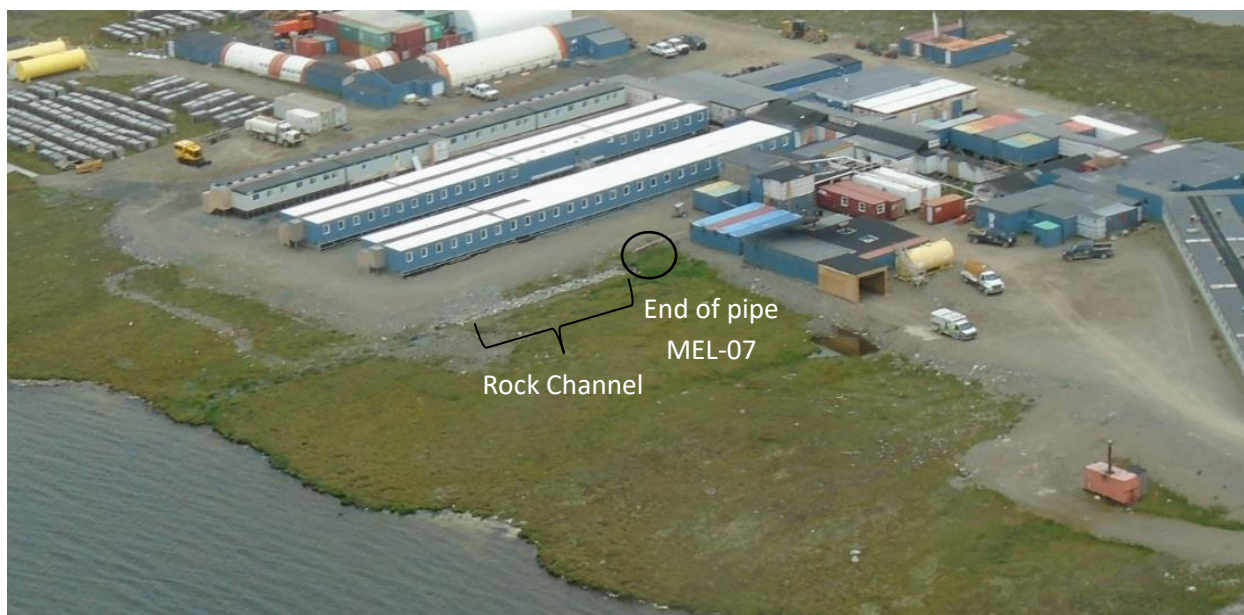
The MEL-07 effluent discharges to land at a location situated approximately 65 m from the ordinary high water mark of Meliadine Lake (see Figure 1). Once the effluent reaches the end of the pipe, it travels along a rock channel intended to reduce the flow and prevent erosion. The effluent will then follow the rock channel to Meliadine Lake. It is expected that with the extreme cold temperatures on February 2nd, and the fact that the effluent discharges to land first, the bacteria would likely not have survived.

Figure 1: View from above - MEL-07 discharge configuration with rock channel and flow path to Meliadine Lake

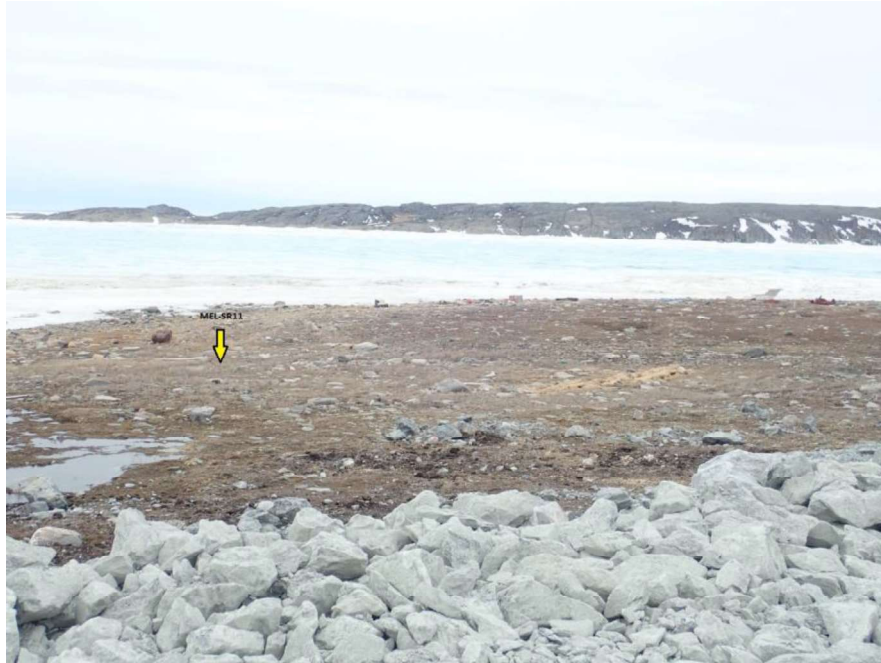
Picture 1: Sampling location between access road and Melvin Bay.

Run-off was caused by snow melting inside and outside the site disturbance area. A sediment trap was created using gravel and straw logs prior to the run-off event being sampled. The sediment traps were not effective enough to reduce TSS below acceptable levels. Improving the snow management plan and following the procedure will help reduce run-off volumes in the future.

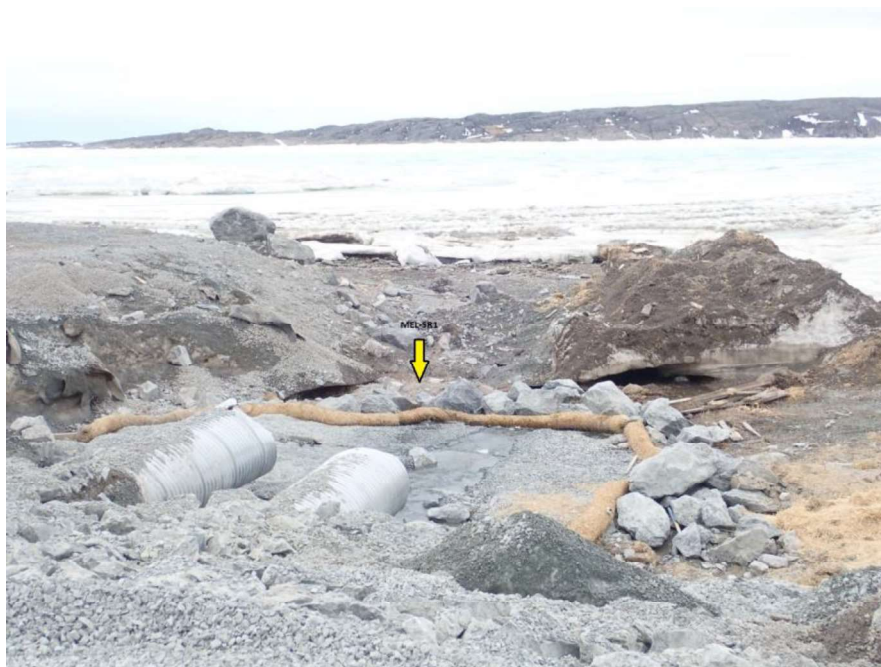
Picture 2: Sample location immediately after sediment controls at culvert.

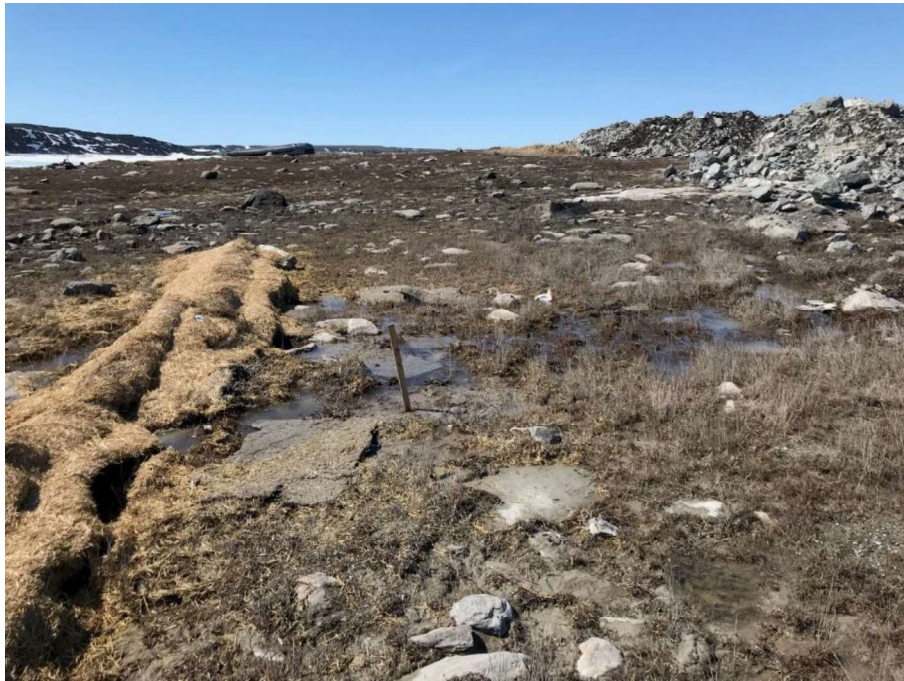
Picture 1: Straw log sediment trap between Bypass Road entrance at Itivia and Melvin Bay.

Run-off was caused by snow melting inside and outside the site disturbance area. A sediment trap was created using straw logs prior to the run-off event being sampled. The sediment traps were not effective enough to reduce TSS below acceptable levels. Improving the snow management plan and following the procedure will help reduce run-off volumes in the future.

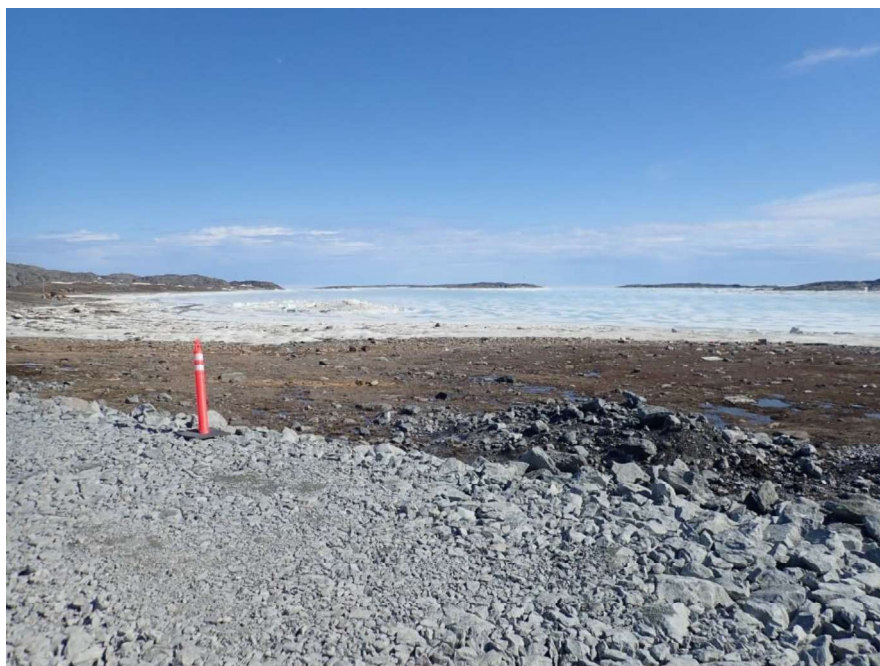
Picture 2: Run-off area from Bypass Road entrance at Itivia to Melvin Bay.

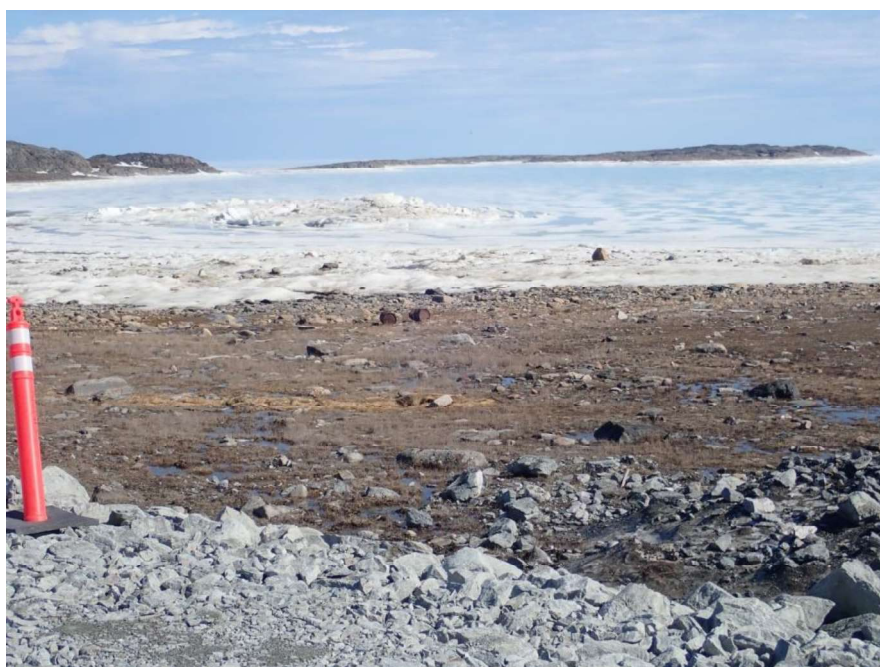
Picture 3: Run-off area from Bypass Road entrance at Itivia to Melvin Bay.

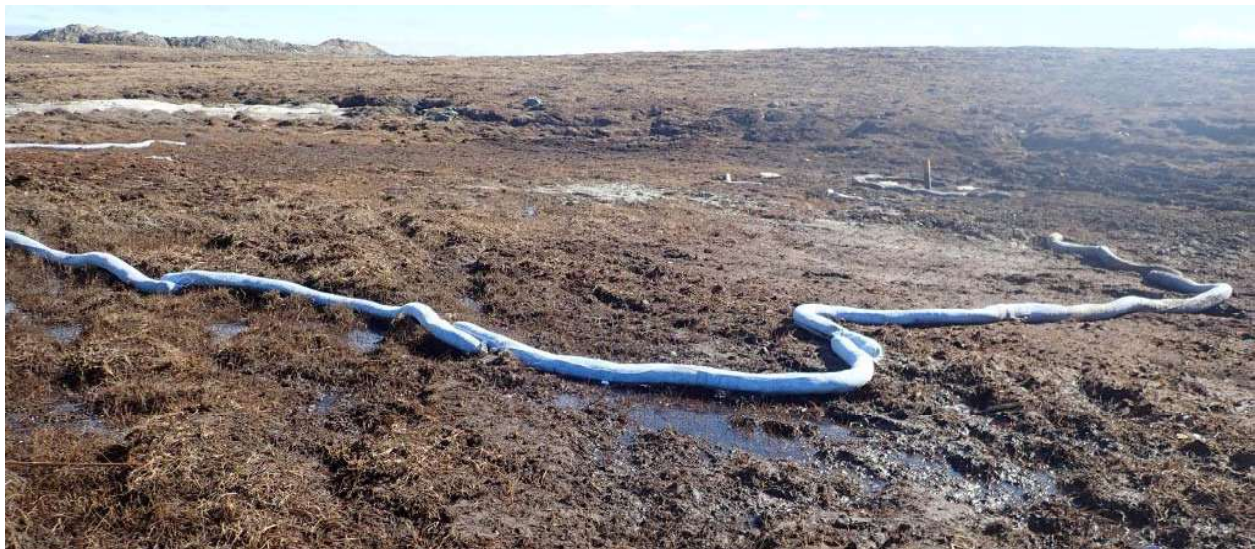
Drilling activities have been underway near Lake B8 and a small drip from a hydraulic hose in the drilling shack was observed when the drill was being demobilized from the location. The hose was dripping for an unknown duration, however, maintenance and a hose change was conducted approximately 3-weeks prior to the spill report. Lake B8 is a non-fish bearing lake. Despite B8 being non-fish bearing lake, it remains a non-contact water body as part of Meliadine's Water Management Plan until the dike D-CP4 is constructed and B8 becomes containment pond CP4. At present moment, the impact to B8 is expected to be minimal; however, ongoing spill clean-up and observations are planned as snow and ice thaws at this location (GPS UTM 83 Z015: 539096.07, 6988864.61, 1006.40).

Figure 1: Booms placed downstream of spill location.

The drill will be inspected and repaired prior to starting at the next location and better secondary containment to be sought to reduce risks from hose drips.

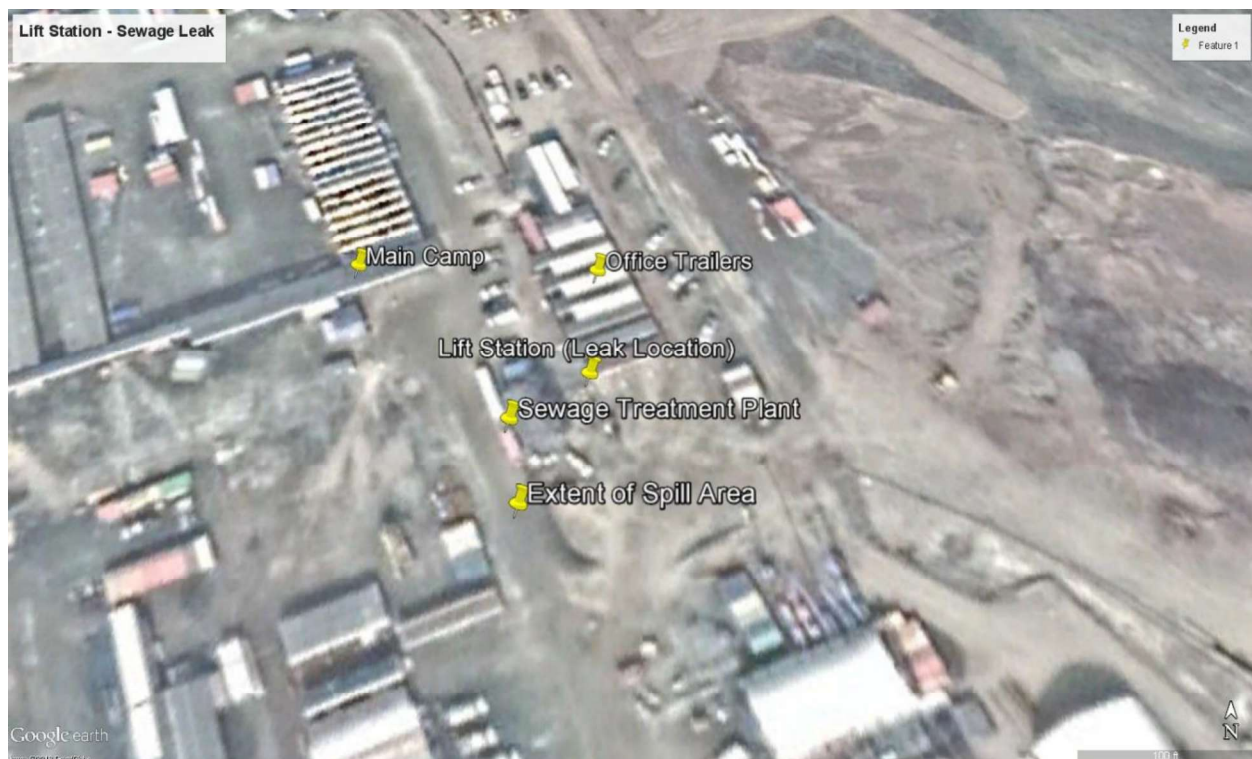
Figure 1: View from above – Main Camp: Location of lift station piping (source of leak) and spill area.

The building housing the STP sunk into the ground due to thawing ground conditions causing the discharge line to disconnect from the lift station.

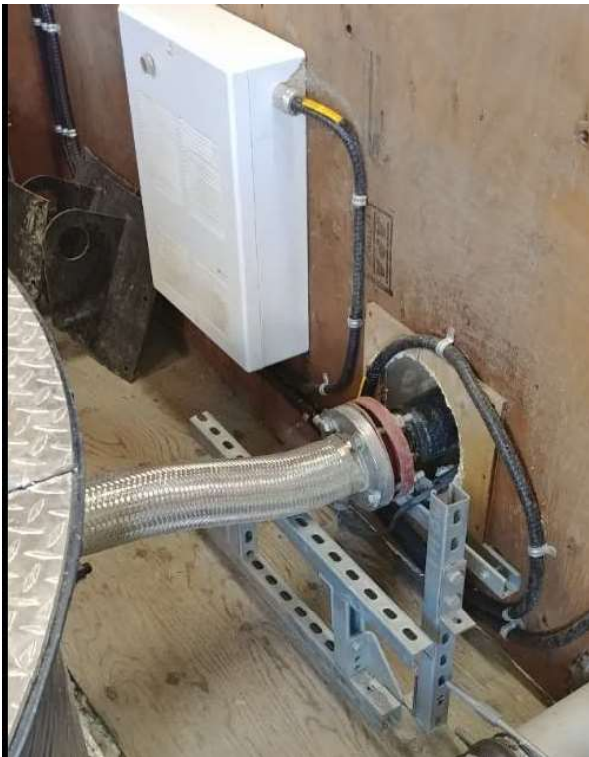
Figure 1: Newly installed flexible hose.

Daily inspections were conducted at the lift station prior to receiving new parts to be installed. New flexible piping has been installed to prevent re-occurrence. Figures 1 and 2 show the flexible pipe installed and insulation of the piping that continues outside, respectively.

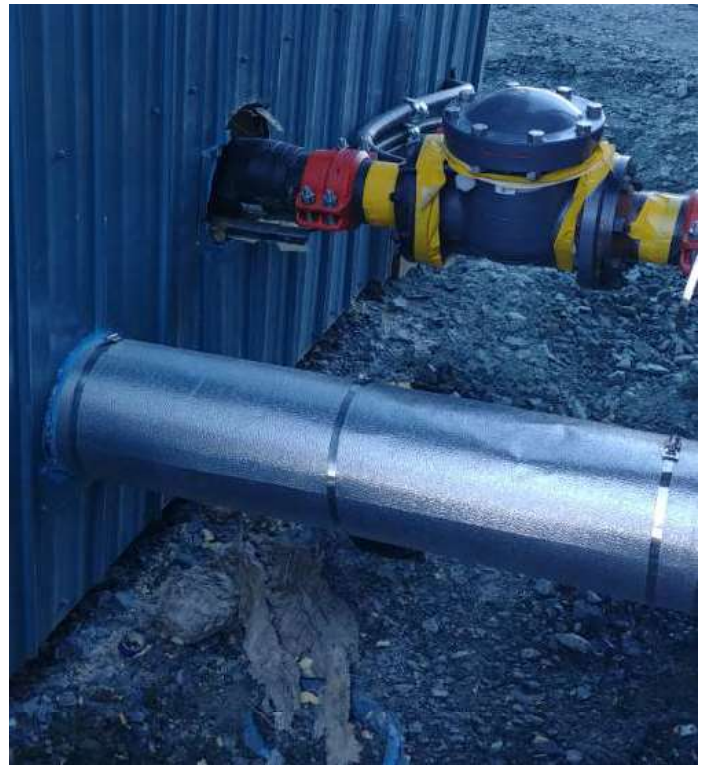
Figure 2: Insulated piping outside the MSB sewage lift station.

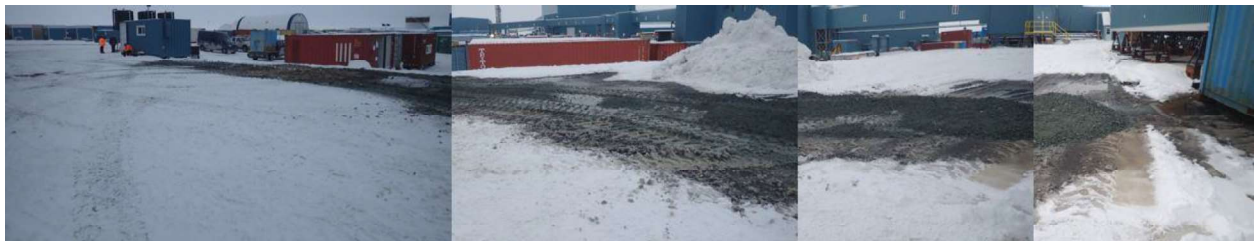
An investigation was completed and the cause of the spill was determined to be a failed pump, which lead to an overflow of the effluent storage tank. A new pump is being brought in on a rush order to replace the broken one. The system's circuitry will be reconfigured so that when one pump fails, the other will remain operating. An alarm horn will be added to warn of high levels in the storage tank, and will send a signal advising central control.

Photo 1: Panorama showing the extent of the affected area.

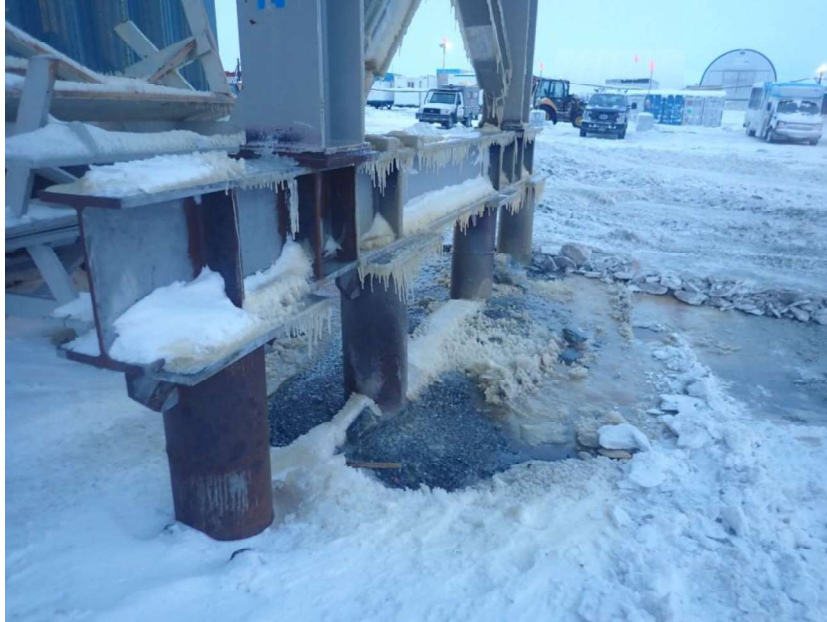
The release occurred due to the failure of an expansion joint in the boiler recirculation system. The cause of the failed component is unknown. The expansion joint was replaced and the system inspected for leaks.

Figure 1: Water from boiler recirculation system flowing to ground.
