Appendix 6 : 2020 Annual Geotechnical Inspection Report

# **2020** Annual Geotechnical Inspection Meliadine Gold Project, Rankin Inlet, Nunavut

## **Agnico Eagle Mines Limited**

FEBRUARY 2021 ISSUED FOR USE

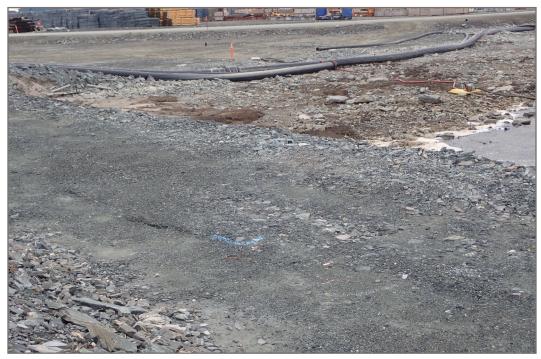
- Overall, the dike appeared stable, with no significant geotechnical concerns identified.
- Minor cracking and small settlement were observed along portions of the upstream and downstream crest (e.g., Photos 5 and 7, Appendix B). The largest cracks were up to 3 cm wide. The cracking was less prevalent than observed in August 2019.

Photo 7: Dike D-CP1 - Upstream crest—similar condition to 2019.

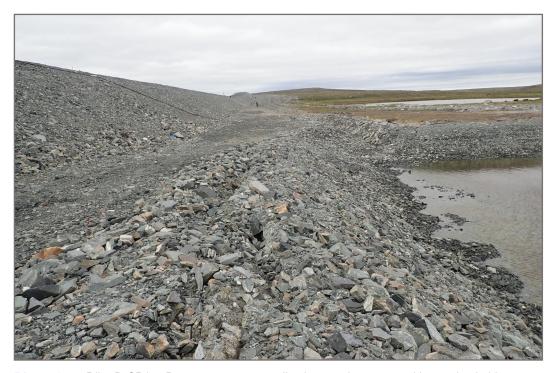
Photo 8: Dike D-CP1 - Downstream water collection pond, some cracking and subsidence at the upstream crest of the pond .

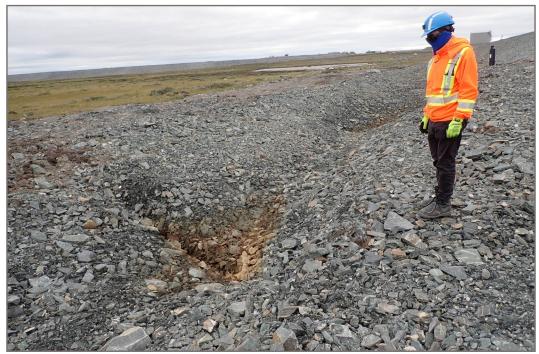
Photo 13: Dike D-CP1 - Subsidence in water collection channel, possibly caused by thaw of ice wedge below channel.

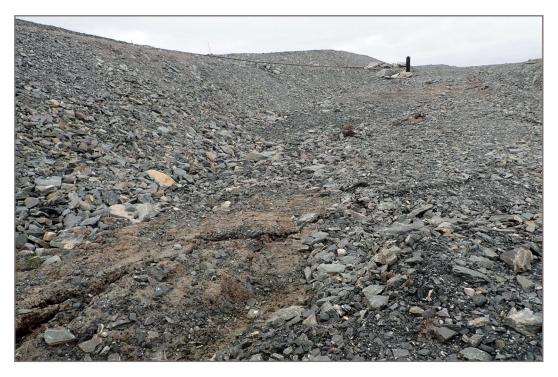
**Photo 14:** Dike D-CP1 - Subsidence and cracking between dike toe and water collection channel.

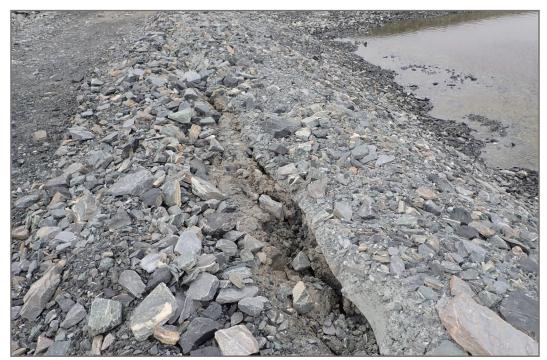
Photo 15: Dike D-CP1 - Subsidence and cracking at water collection pond downstream of the dike.

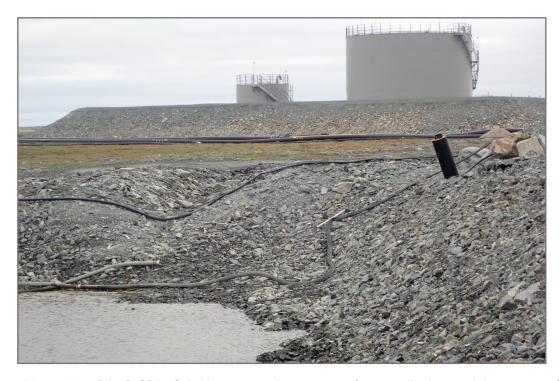
**Photo 16:** Dike D-CP1 - Subsidence at southeast corner of water collection pond downstream of the dike.

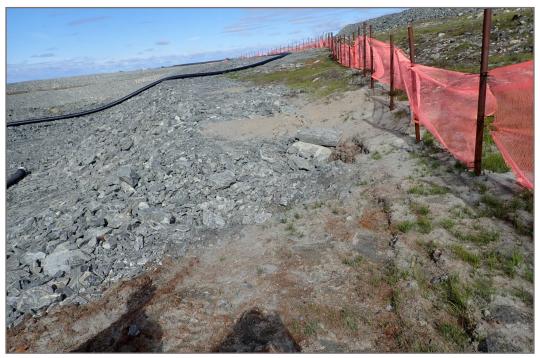
At the time of inspection CP4 was filled with water to Elevation 55.7 m. The slopes of the pond are a combination of overburden and bedrock. The overburden is covered with a layer of rockfill obtained from the pond excavation. No obvious signs of instability were observed in the bedrock or overburden slopes. Thaw settlement has occurred in the native ground above the overburden slope protection rockfill as shown in Photos 5, 6, 7, and 8, Appendix D. The settlement is up to 0.5 m deep. The settlement is like that observed in 2019. Thaw settlement has also occurred between the CP4 Berm and the overburden protection rockfill as shown in Photos 10, 11, and 12, Appendix D. It is visually estimated that the settlement is up to 0.6 m. The settlement is more continuous than observed in 2019.

**Photo 5:** Pond CP4 - Settlement and cracking above north slope.

Collection Pond CP4 and its associated infrastructure is performing adequately. Thaw settlement has occurred in the original ground above the pond rockfill slope protection, but the slopes appear to be stable. The thaw settlement is like that observed in 2019. The settlement and the impact on the pond should continue to be monitored to determine if any remedial action is required.

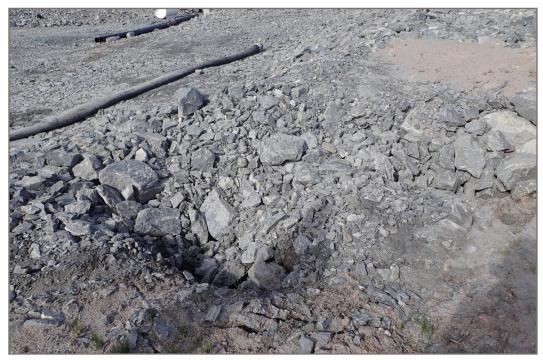
**Photo 6:** Pond CP4 - Small subsidence above north slope close to original ground contact.

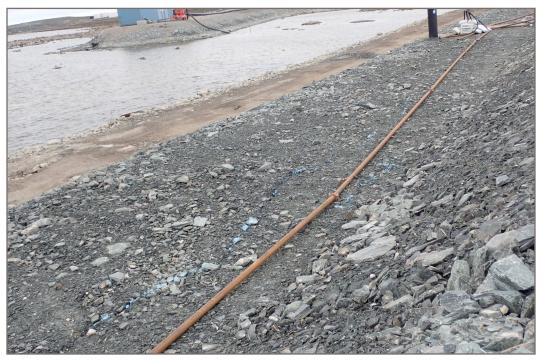
**Photo 8:** D-CP5 Dike - Crack on upstream shell, also observed in 2018 and 2019.

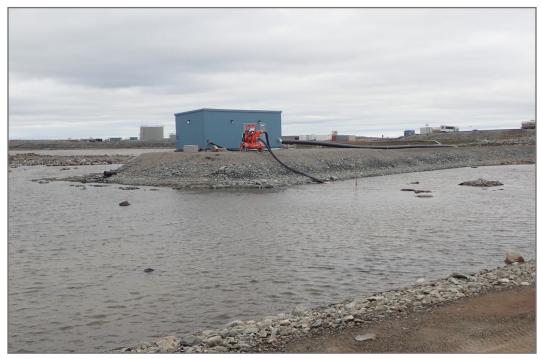
**Photo 9:** CP5 Jetty - looking towards the north east, erosion evident just above the water level.

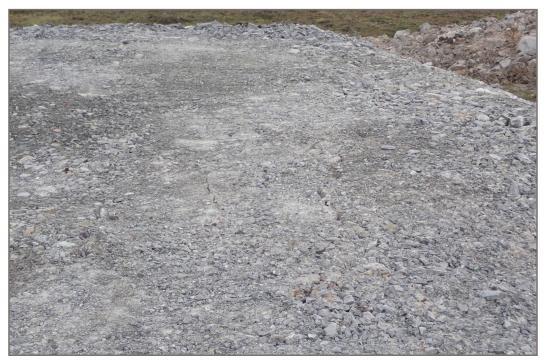
Photo 17: Berm CP6 - minor cracking in upstream/till cover.

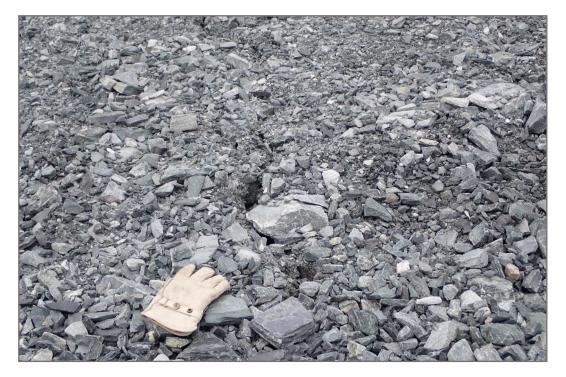
Photo 18: Berm CP6 - Cracking in rockfill berm cover.

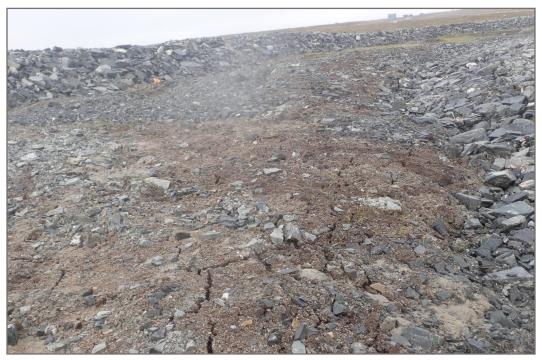
**Photo 18:** SP4 Saline Pond—Cracking in disturbed overburden above rockfill covered slope.

Saline Ponds 1, 3, and 4 are performing well. The settlement and cracking around Saline Ponds 1 and 4 should continue to be monitored.

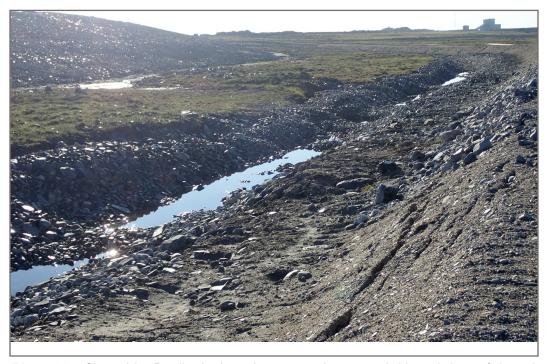
**Photo 12:** Channel 3 - Ponding in channel; appears to be some subsidence in base of channel resulting in rip settling and cracking in road side slope.

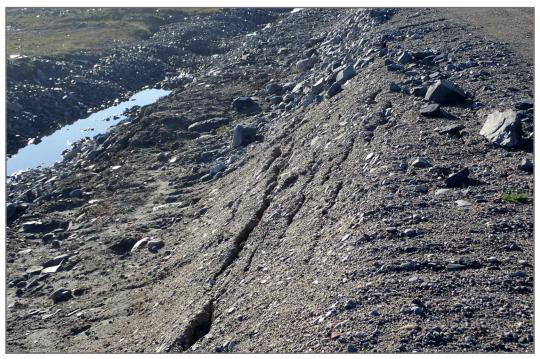
Photo 13: Channel 3 - Cracking in road side slope adjacent to channel.

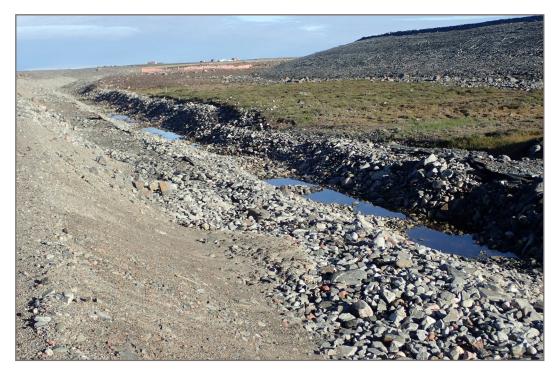
Photo 14: Channel 3 - Ponding in channel; appears to be some subsidence in base of channel resulting in rip settling and cracking in road side slope.. High points (less subsidence) resulting in ponding.

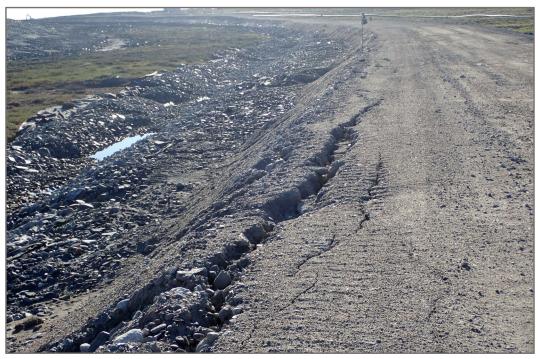
**Photo 15:** Channel 3 - Cracking in road side slopes.

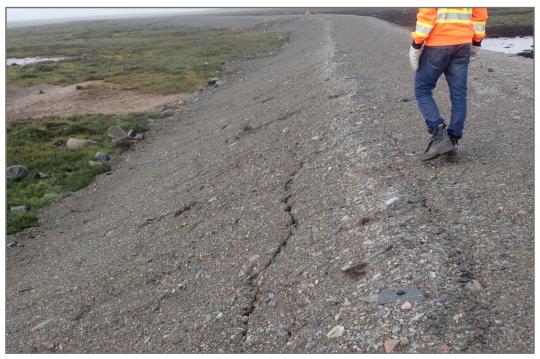
Photo 25: Berm 2—Cracking on side slope.

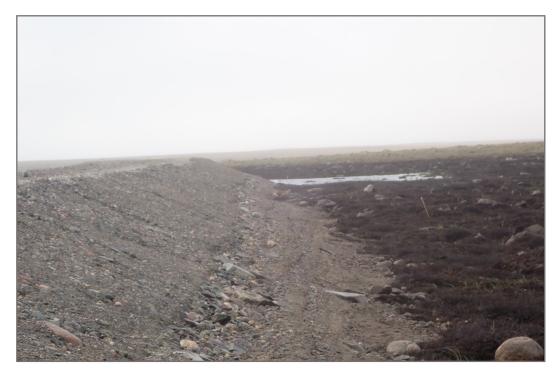
Photo 26: Channel 2—Minor surface erosion along berm from ponded water.

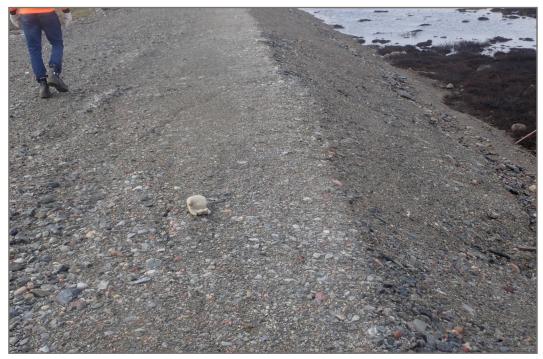
Photo 27: Berm 2—Minor cracking on berm crest.

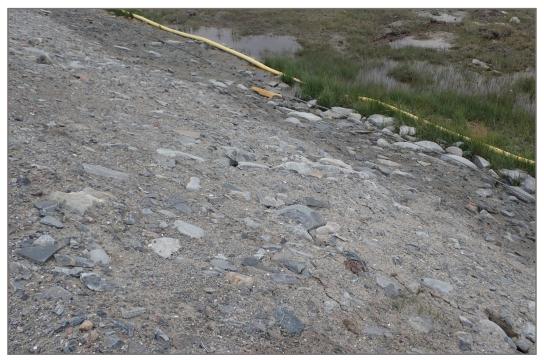
Photo 29: Berm 3—Minor cracking in berm.

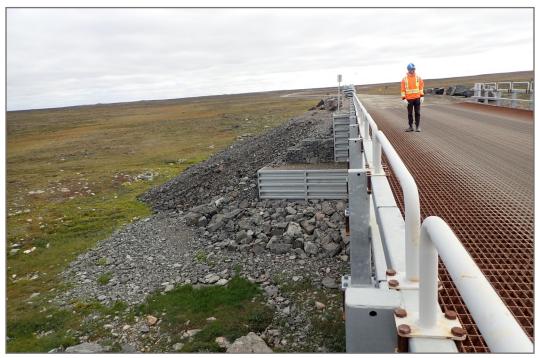
Photo 8: Culvert km 7.4—Damage to culvert inlet
