APPENDIX 15 2024 REPORTABLE SPILLS

Re: Follow-up Report Spill #2024-001 – Release of 150 L of Sewage at the Meliadine Gold Mine

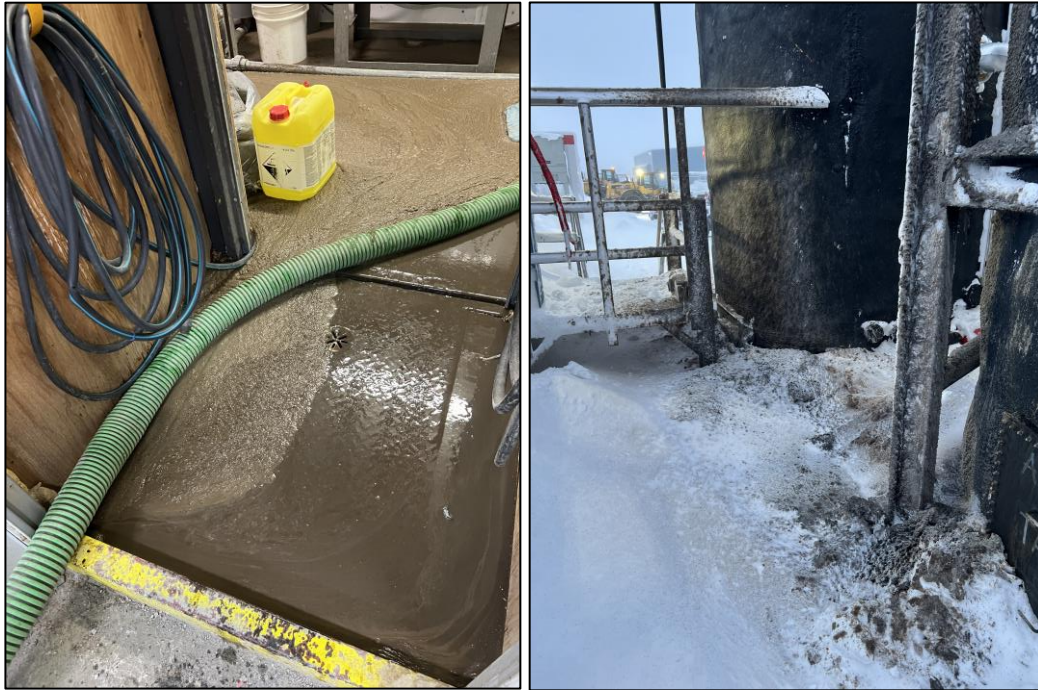
January 14th, 2024 – 50 L Sewage (#2024-017)

Photos 5 and 6: Sewage spill location.

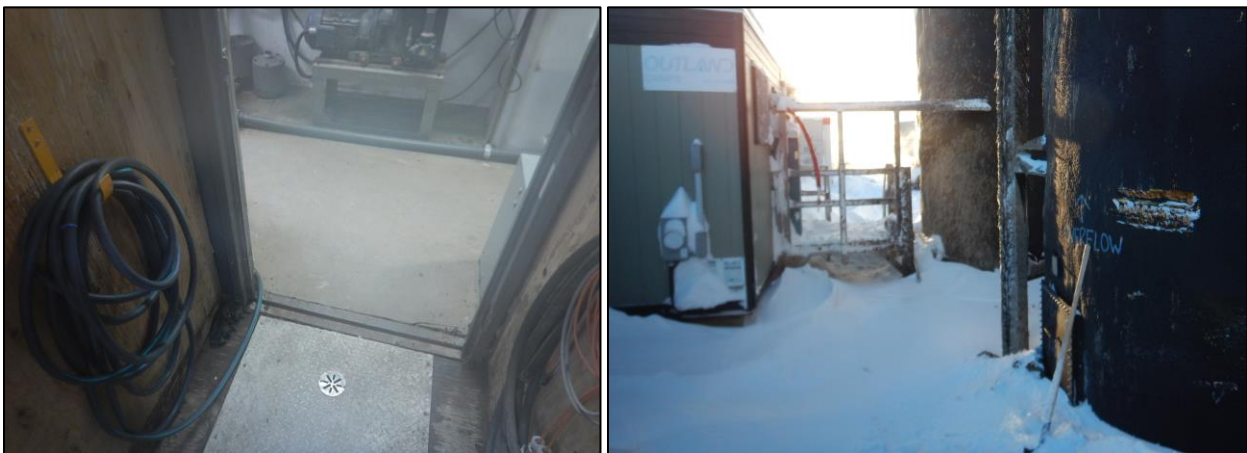
Photos 7 and 8: Spill location post remediation.

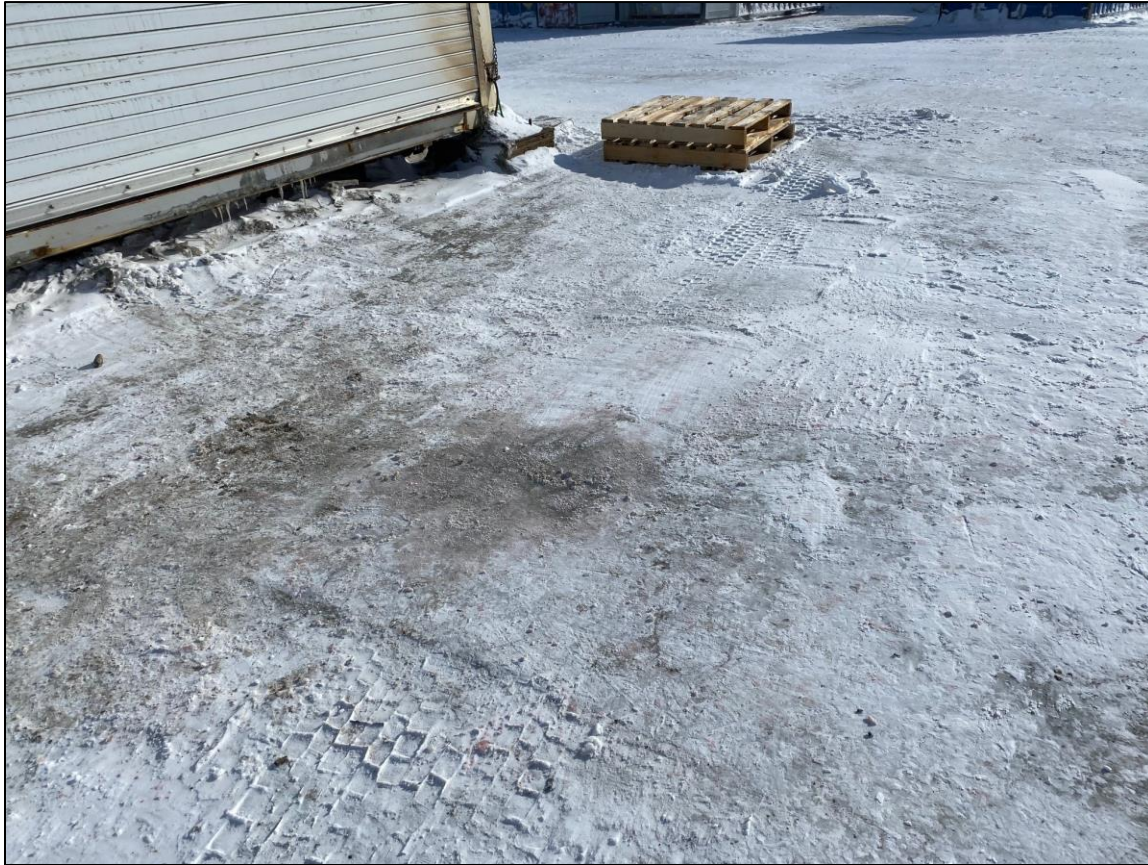
Photo 1: Spill location post remediation. (An initial spill photo is not available since the spill was cleaned up before any photos were taken.)

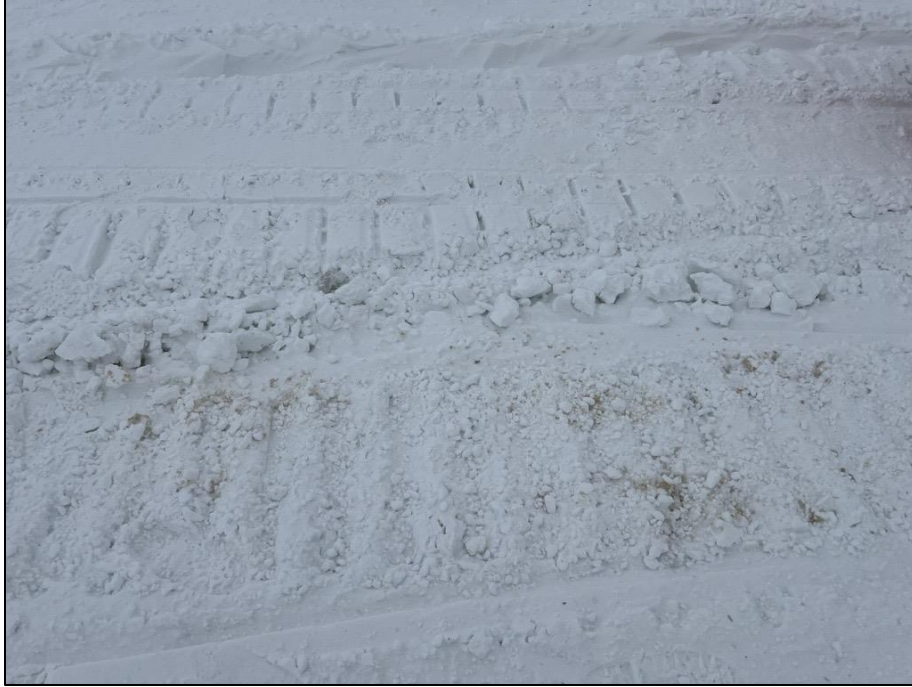
Photo 1: Spill location along the dozer path.

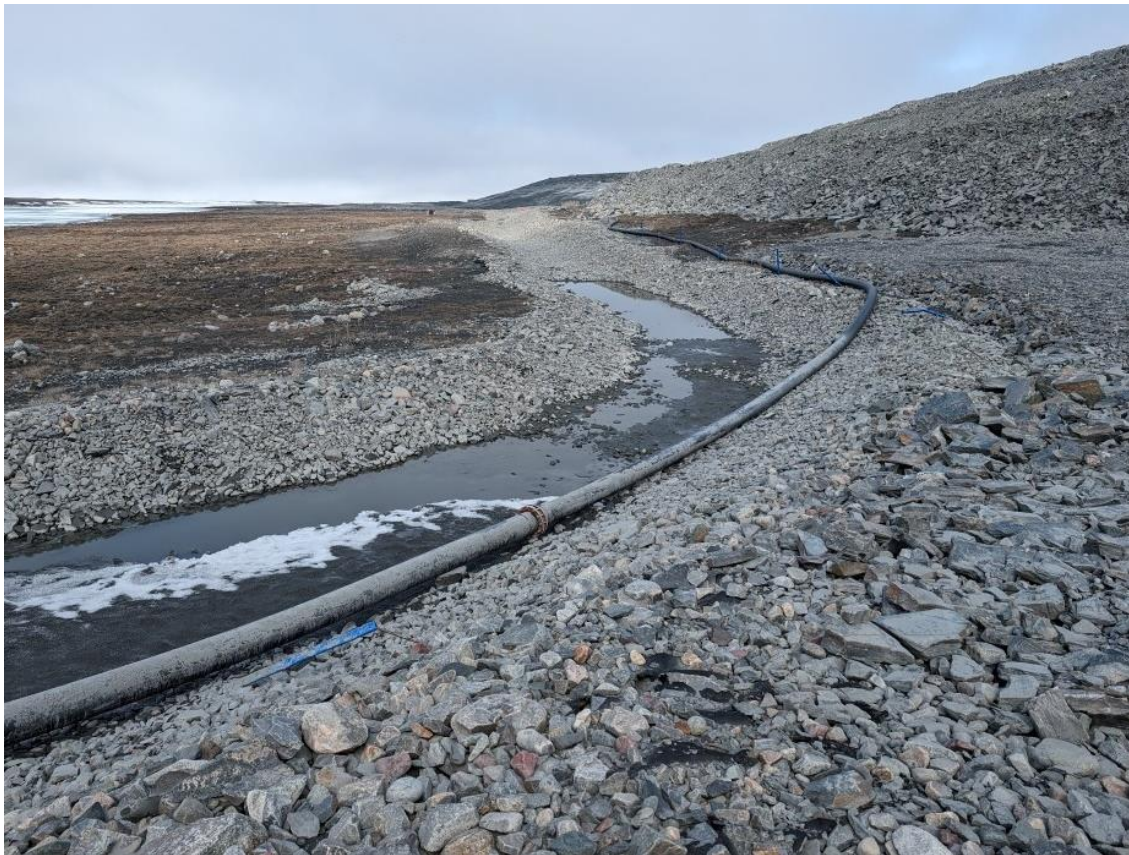
Photo 2: Overflow location on May 22nd, 2024 (day after the event).

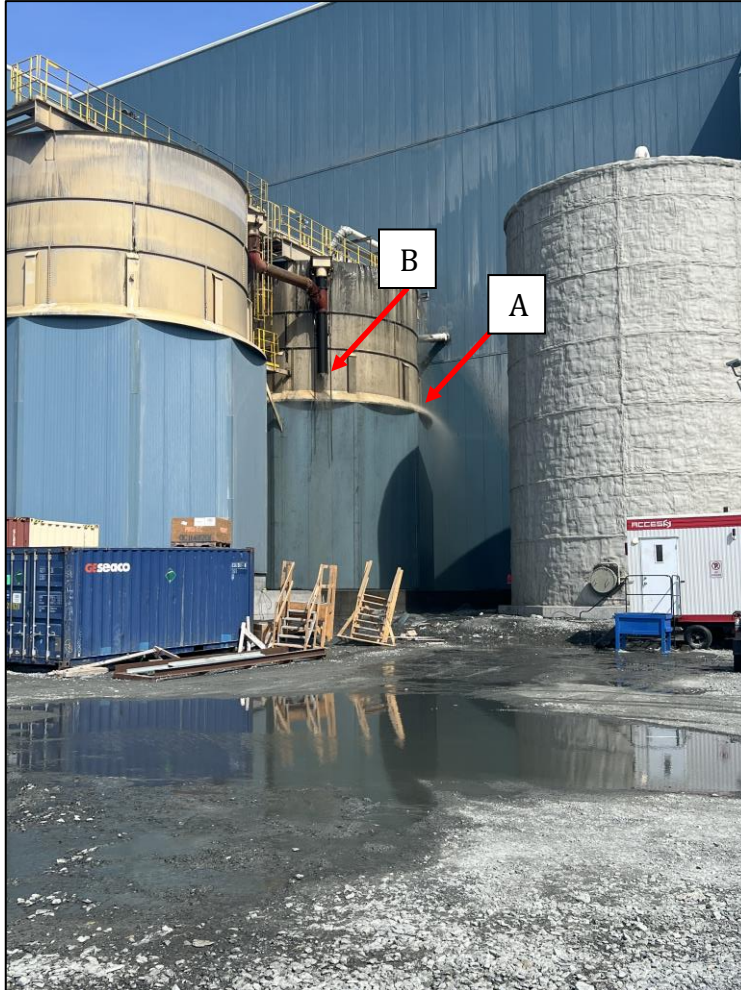
Photo 1: Thickener process water spill location. Arrow A indicates the shape of the tank resulting in overflow being deflected over the containment berm wall. Arrow B indicates the secondary overflow launder pipe that did not extend fully into the containment berm.

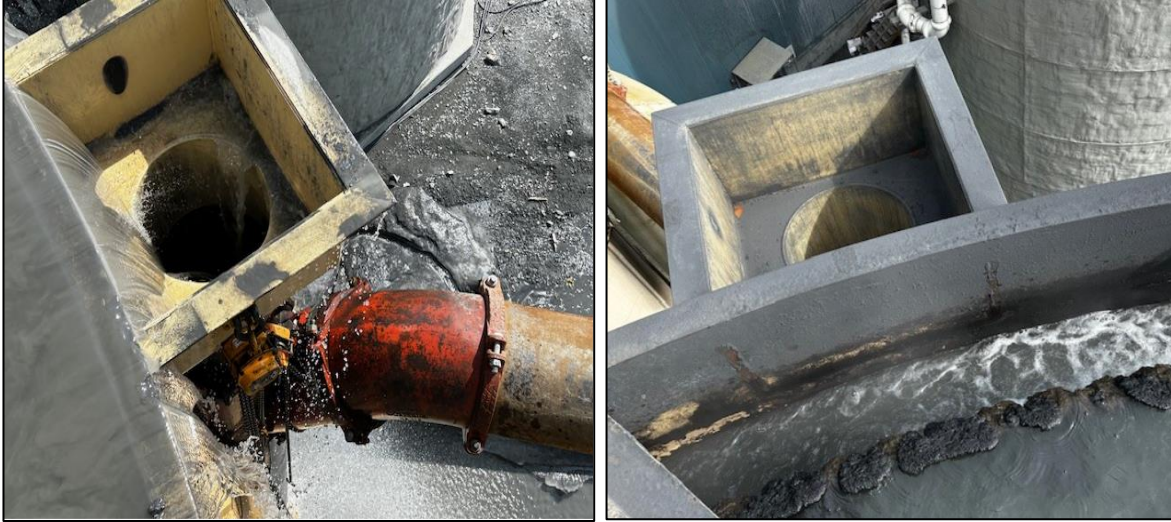
Photo 2: Secondary overflow collection pipe was ineffective in capturing overflow as the tank wall blocked the flow of water into the collection pipe. Photos of both tanks are shown prior to corrective actions being implemented.

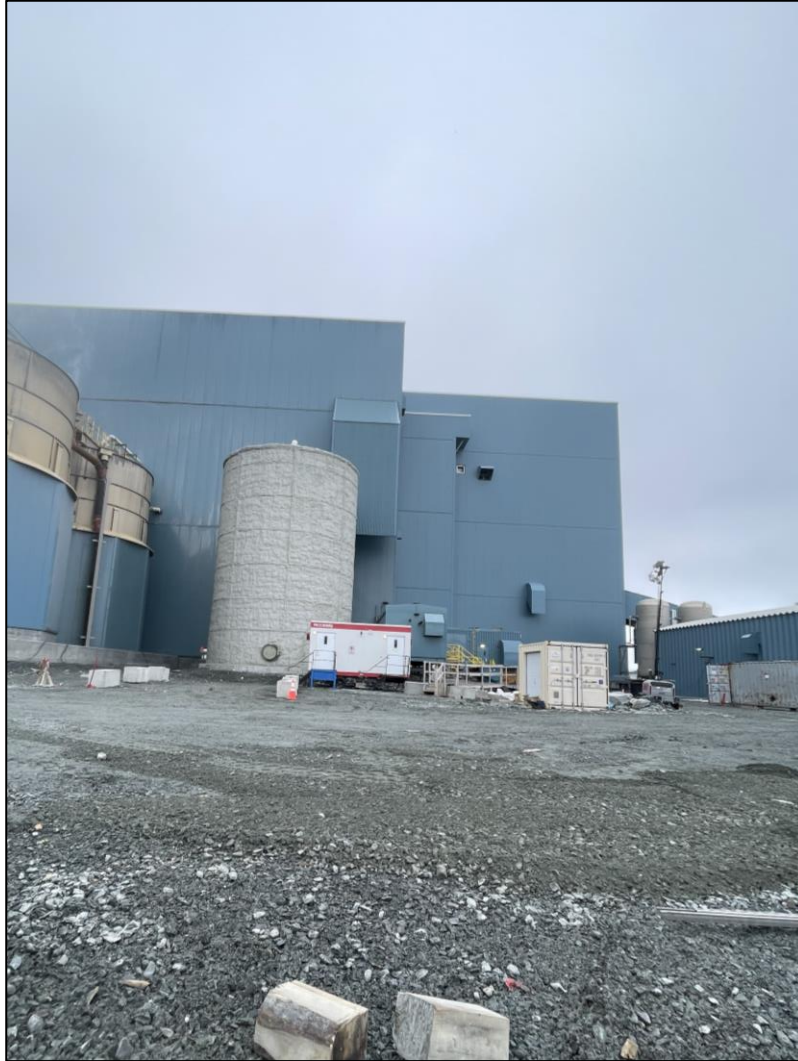
Photo 3: Spill location post remediation.

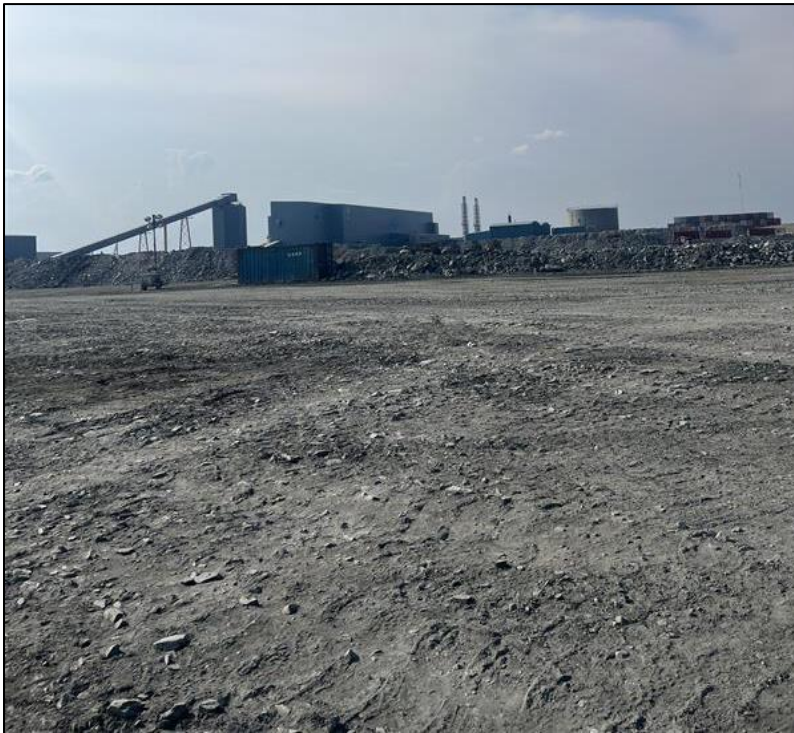
Photo 2: Hydraulic oil spill location post remediation.

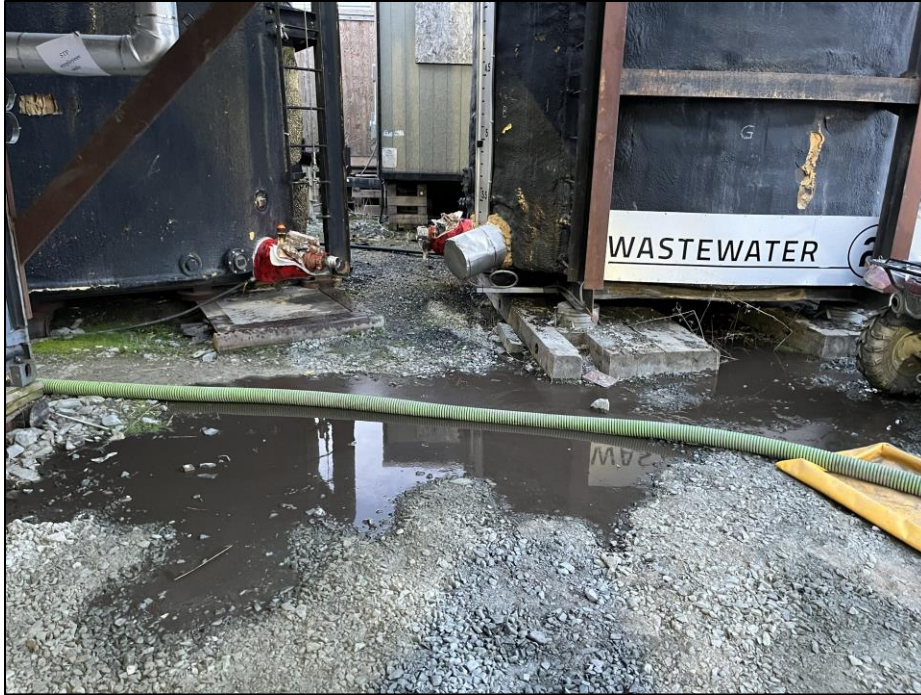
Photo 1: Sewage spill location.

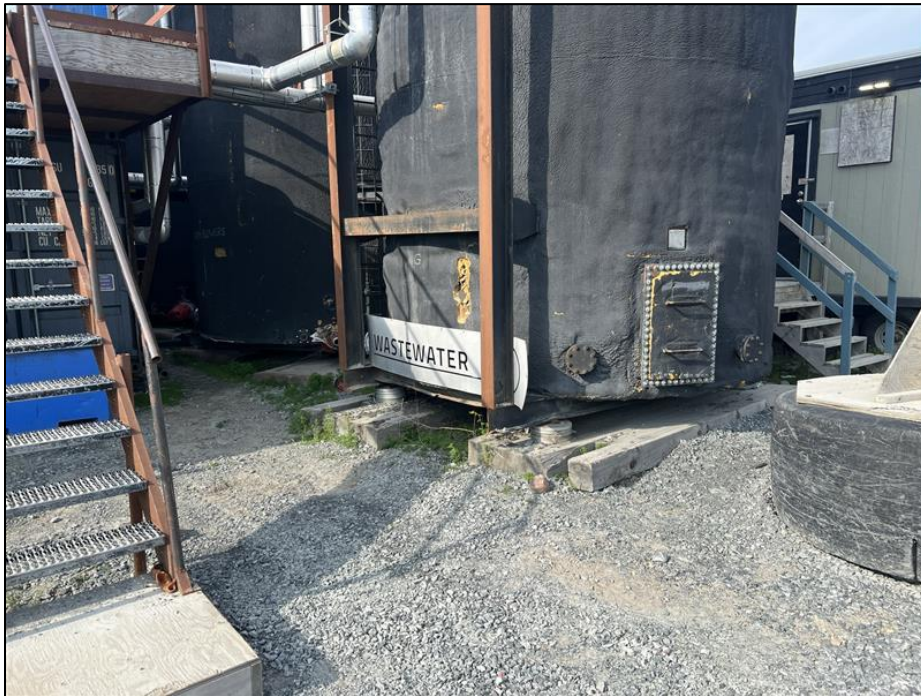
Photo 2: Sewage spill location post remediation.

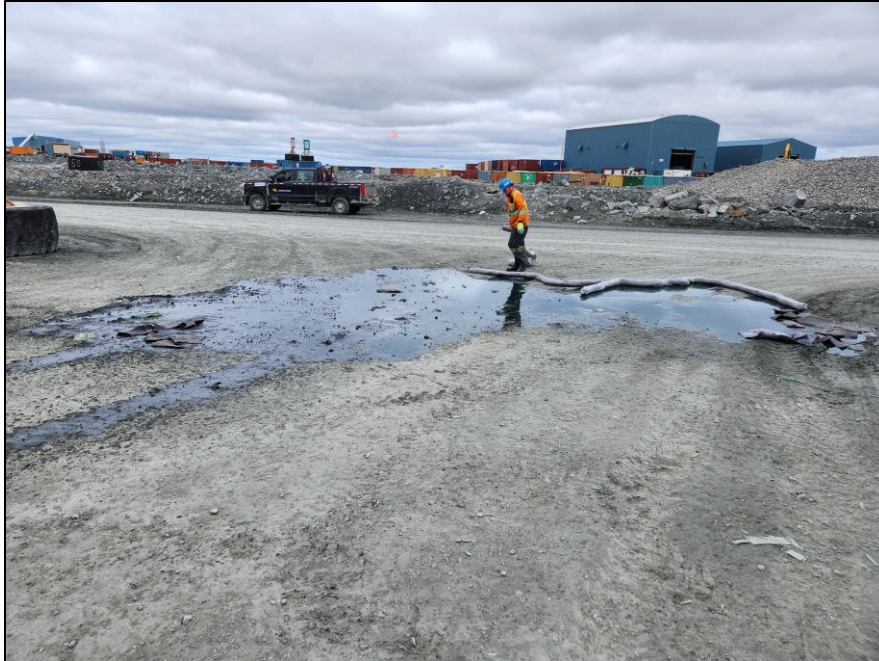
Photo 1: Spill location.

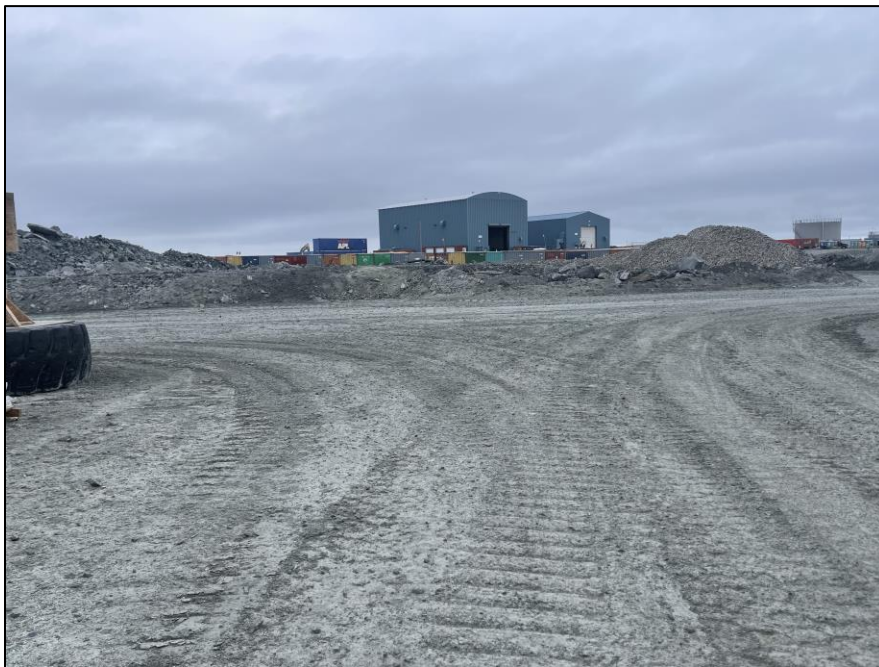
Photo 2: Spill location post remediation.

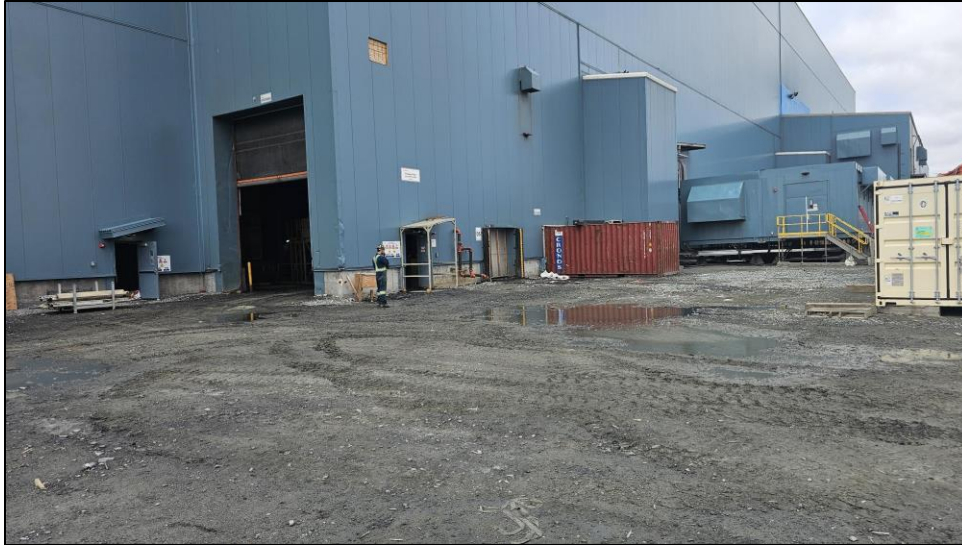
Photo 1: Process water spill location.

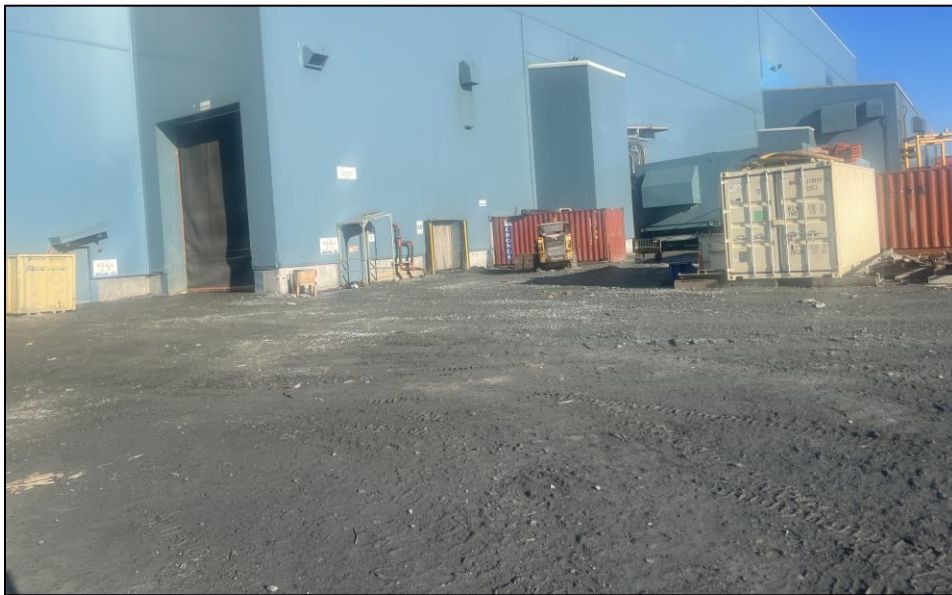
Photo 2: Spill location post remediation.

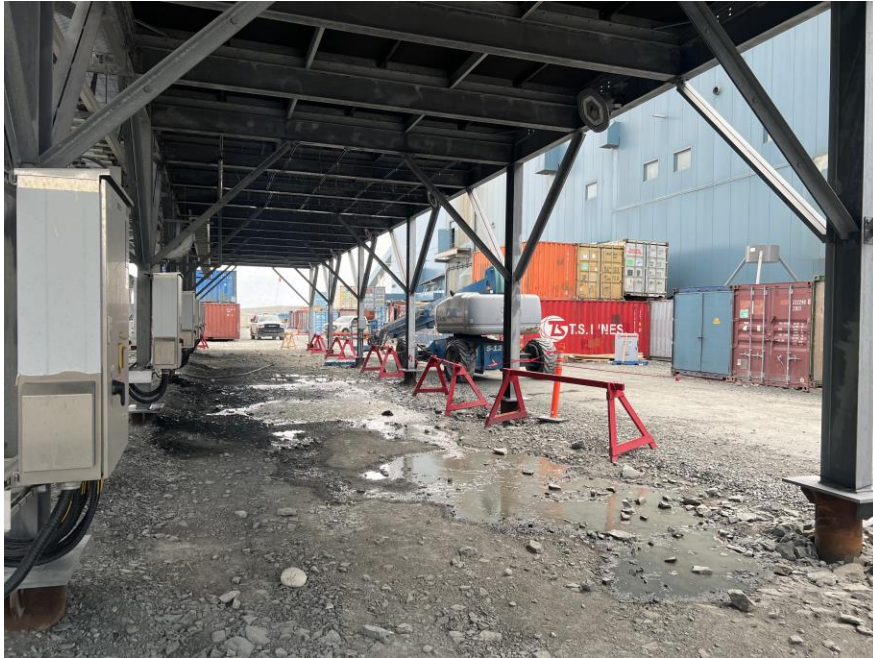
Photo 1: Spill location during the incident.

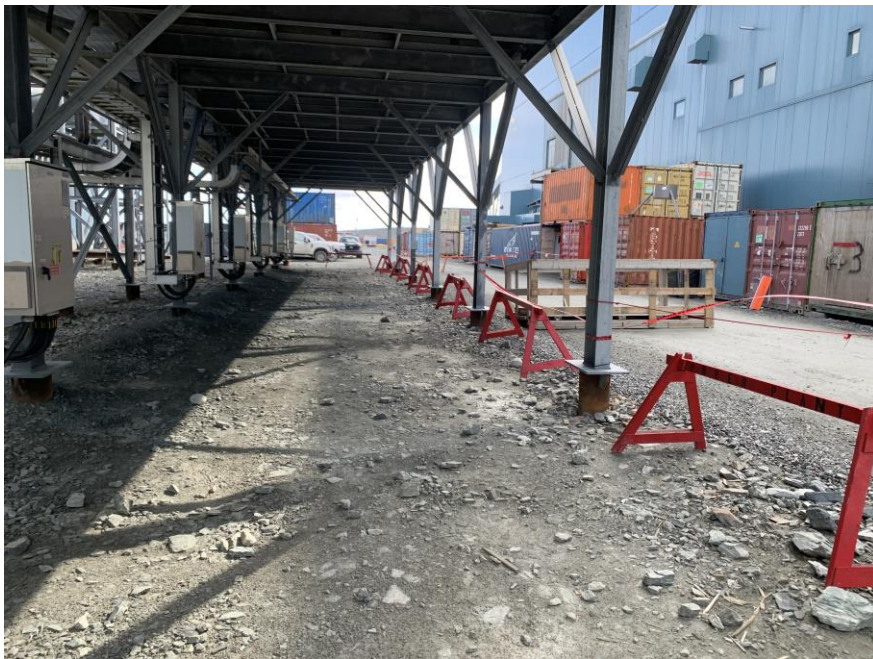
Photo 2: Spill location post remediation.

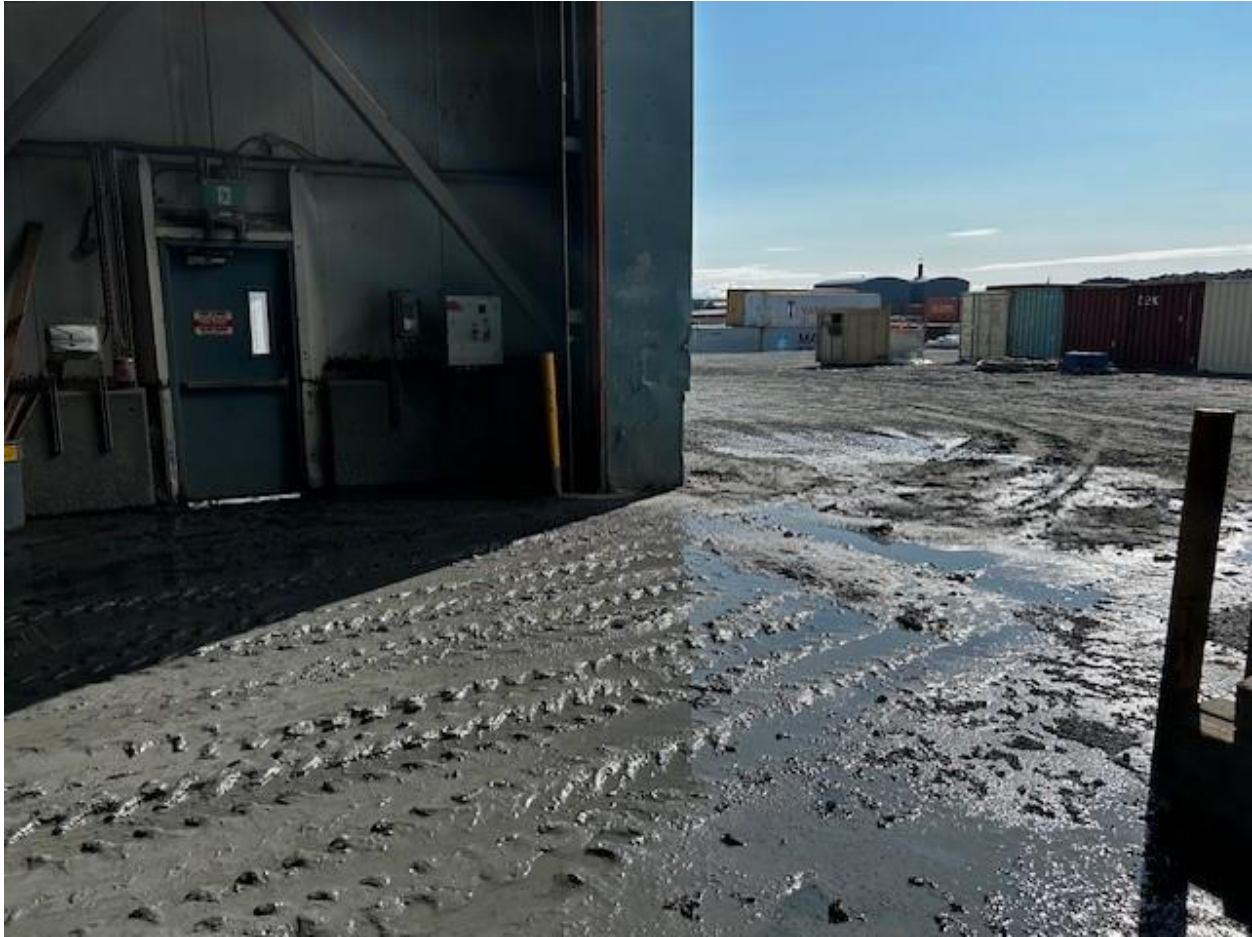
Photo 1: Spill location during the incident.

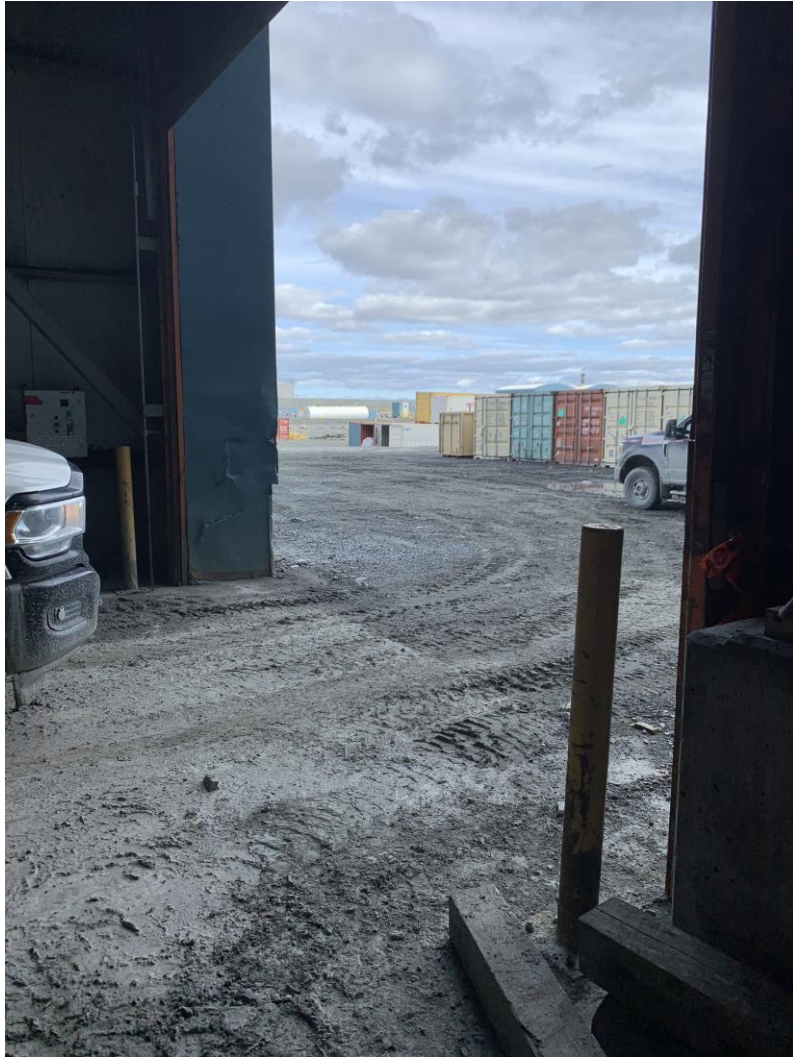
Photo 2: Spill location post clean-up.

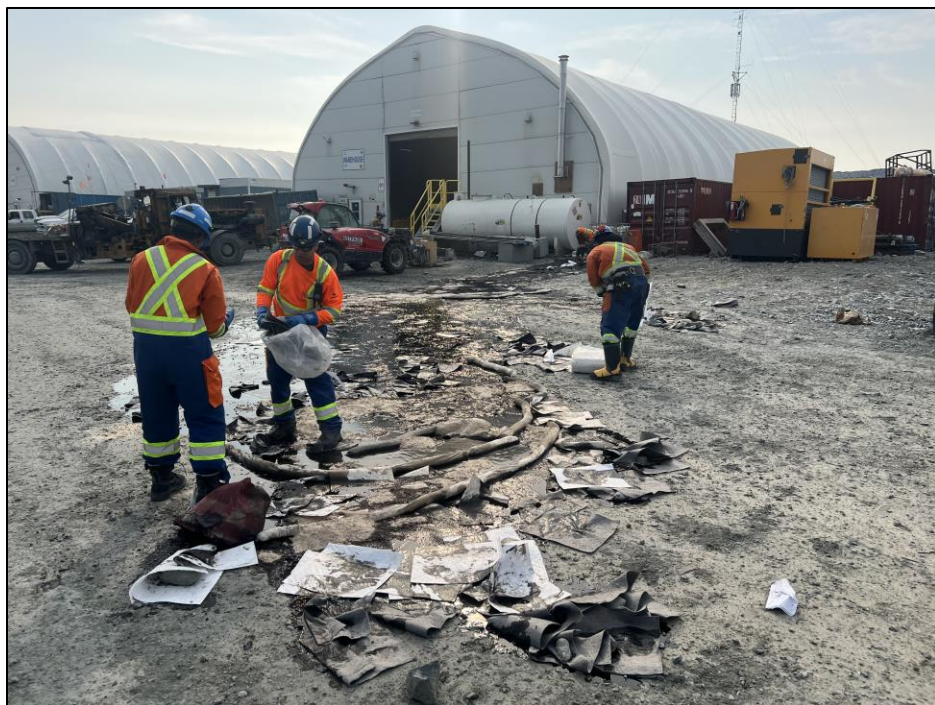
Photo 1: Waste oil spill location at Dome 3, Portal 1.

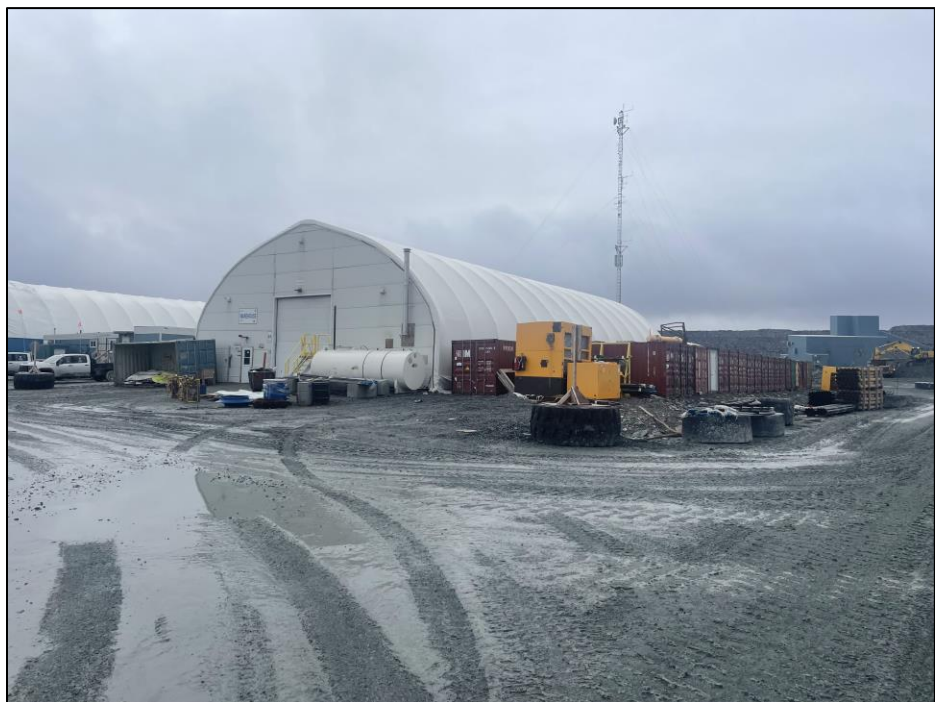
Photo 2: Waste oil spill location post remediation.

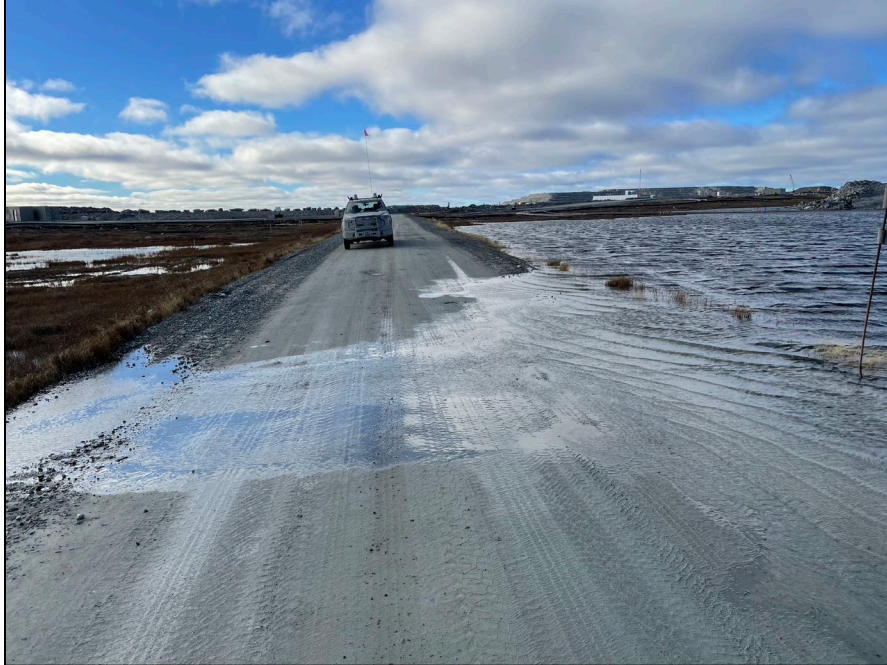
Photo 1: Location of the runoff event.

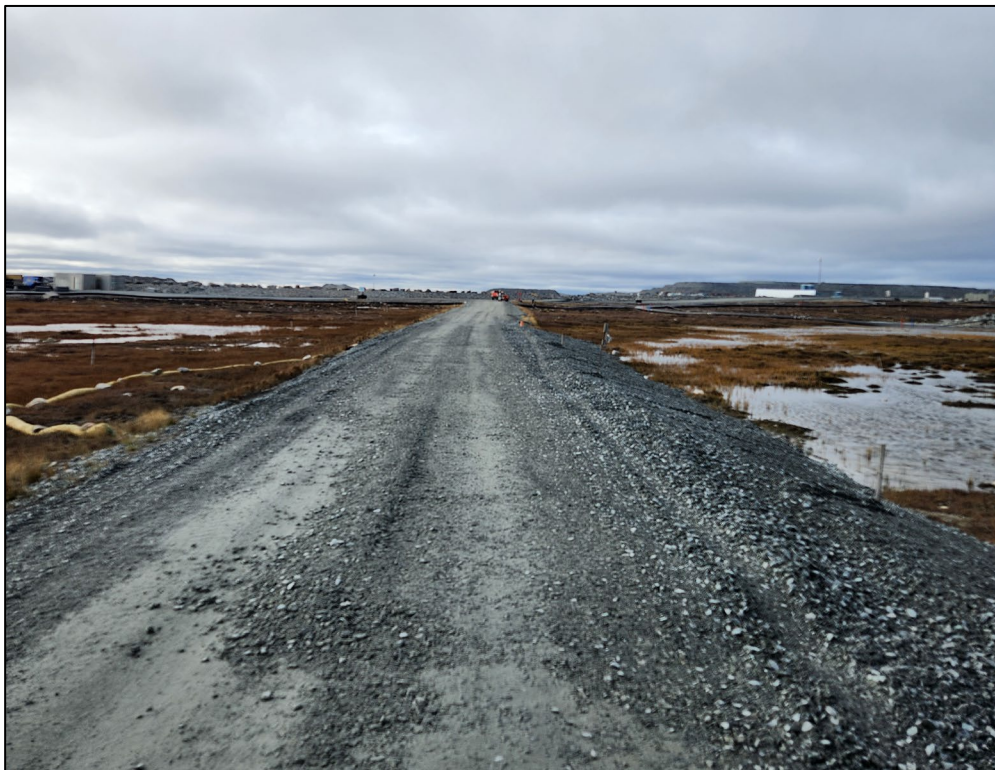
Photo 2: Location of the runoff event after the and corrective actions.

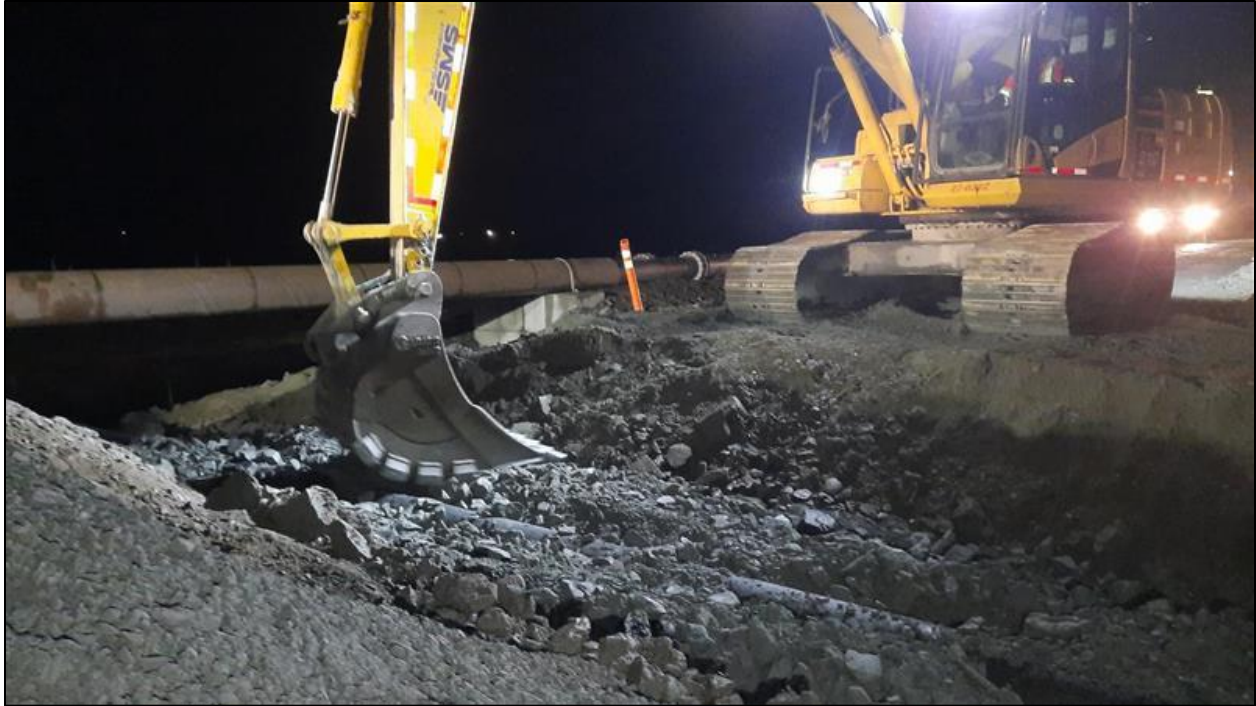
Photo 1: Trench being excavated for installation of temporary HDPE drainage pipe.

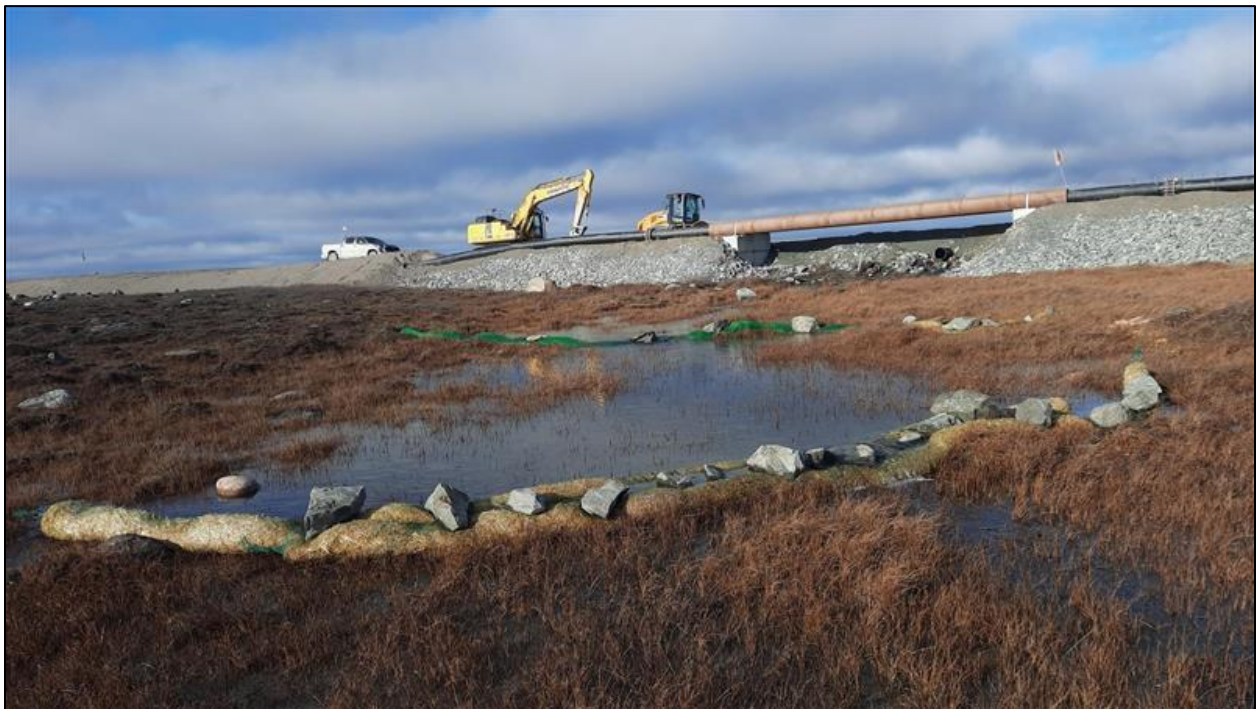
Photo 2: Downstream sediment controls.

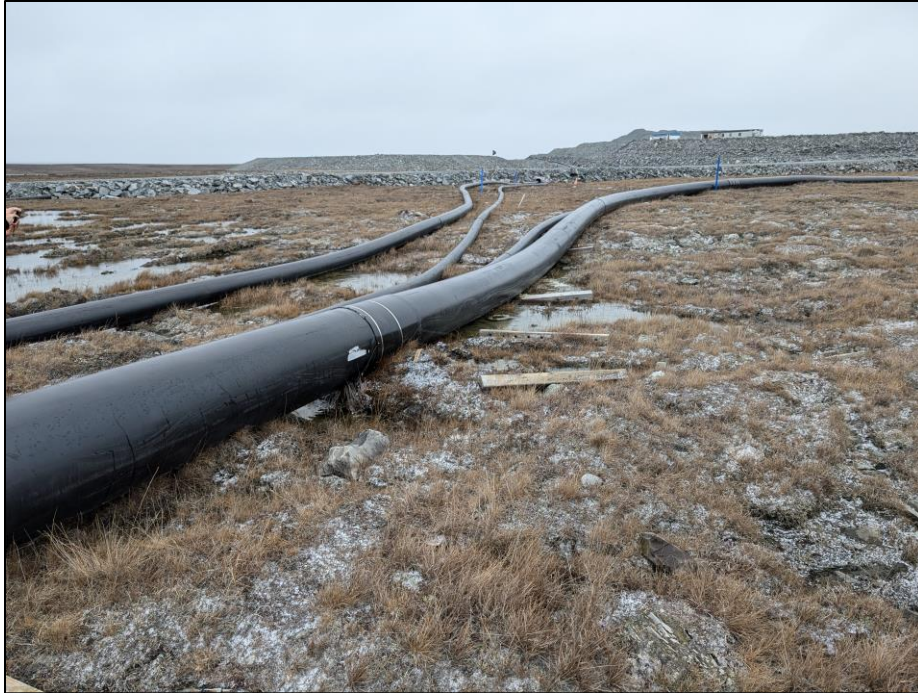
Photo 1: Location of leaking sleeve and treated water release.

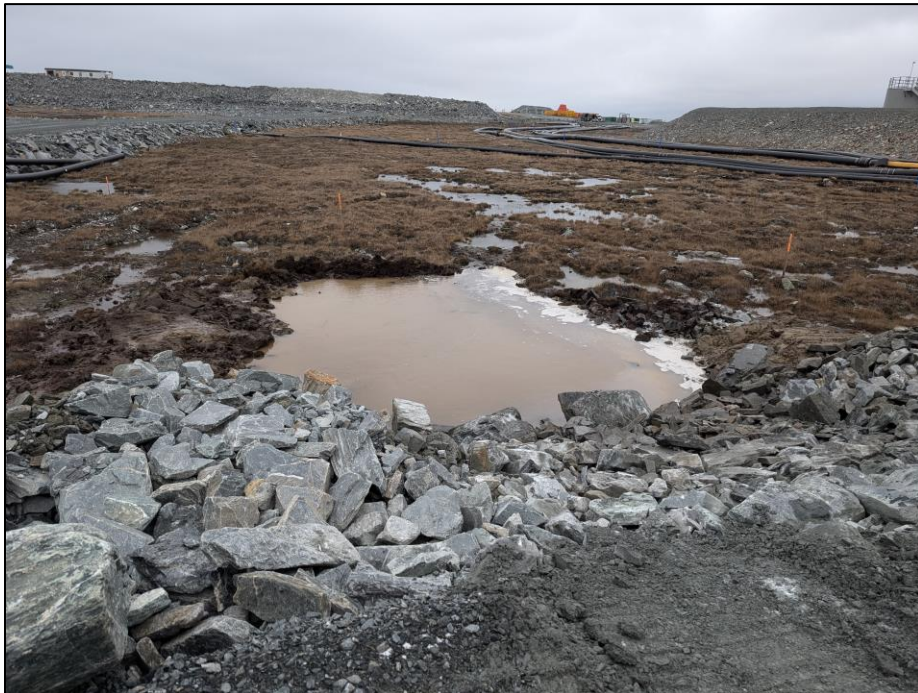
Photo 2: Sump excavated to collect the treated water.

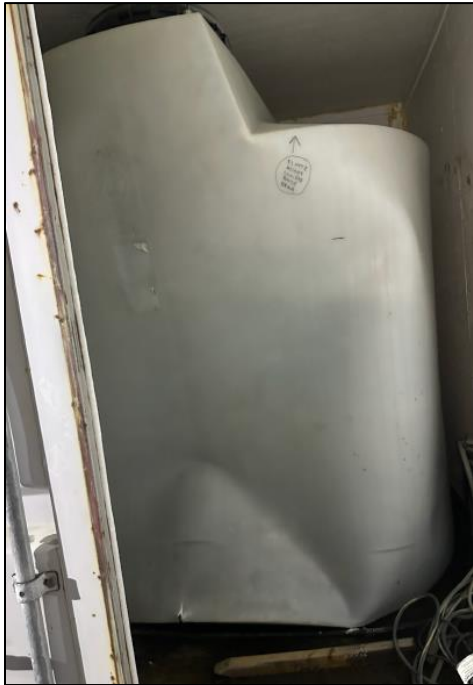
Photo 2: Sewage tank failure

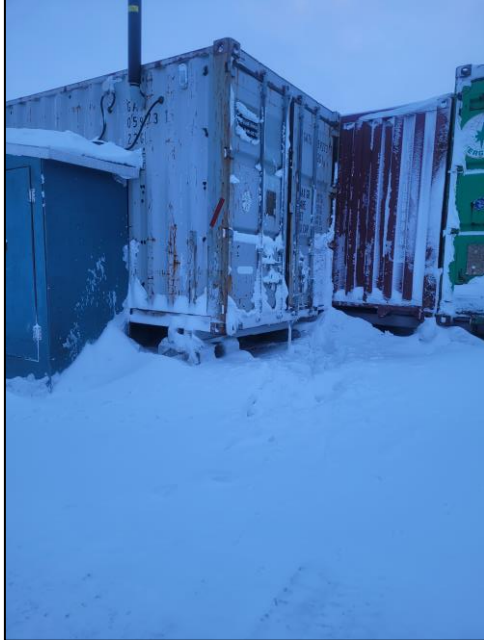
Photo 3: Spill location post remediation.
