PHOTOGRAPHS

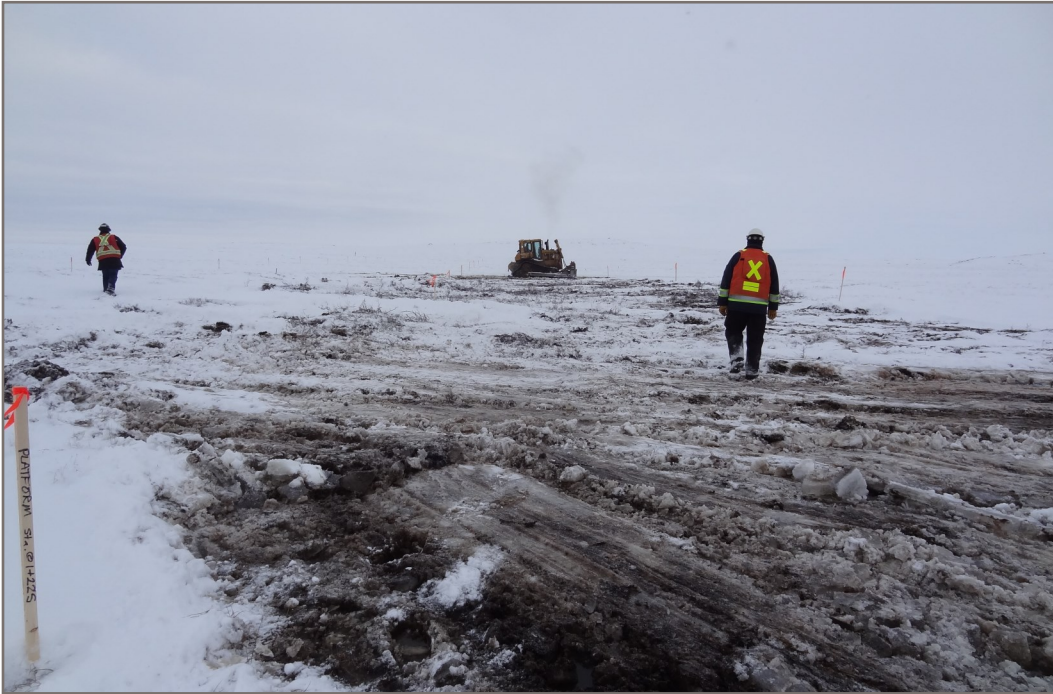
Photo 1: Working platform foundation snow clearing
View from Station 1+225 facing up chainage

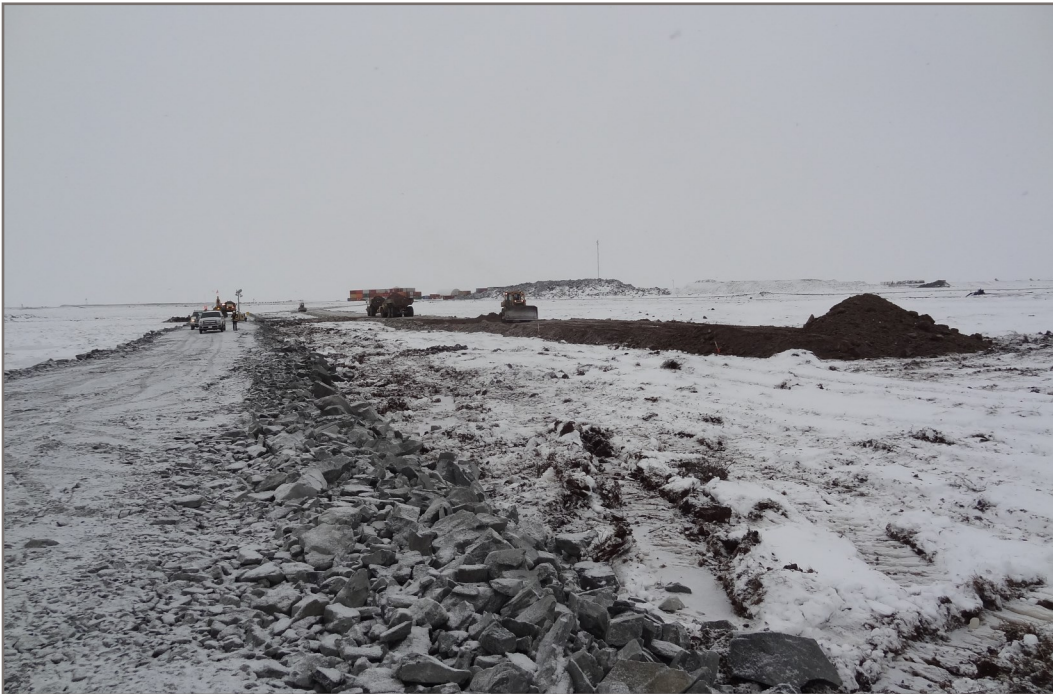
Photo 2: Placing Type H material along the upstream working platform, Type A material on downstream side
View from Station 1+300 facing down chainage

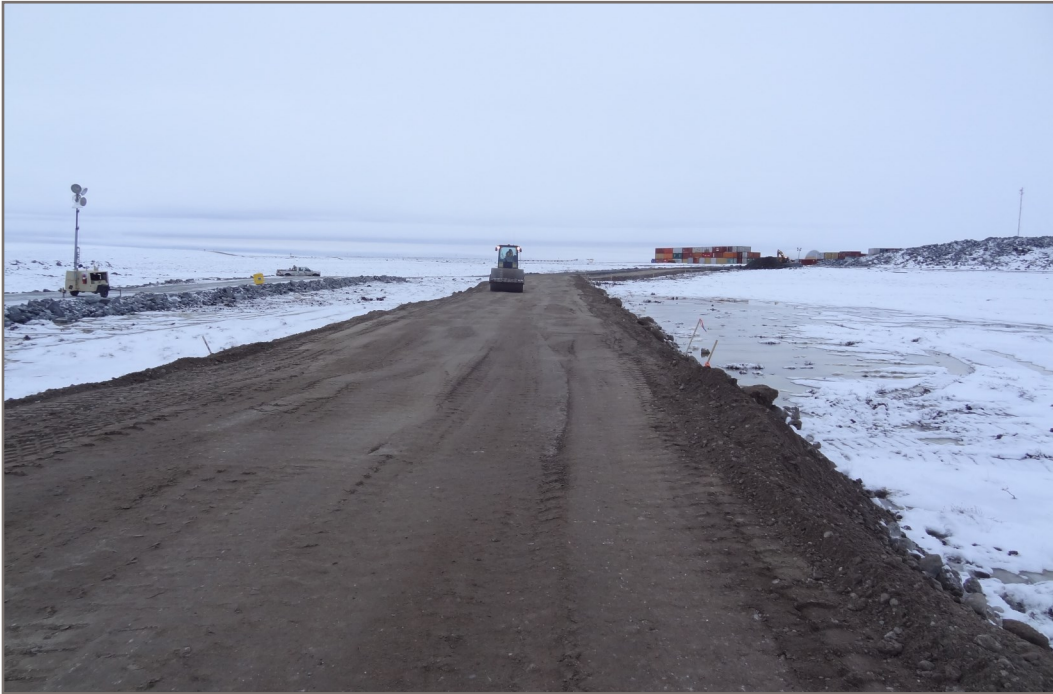
Photo 3: Compacting a lift of Type H material on up stream working platform
View from Station 1+280 facing down chainage

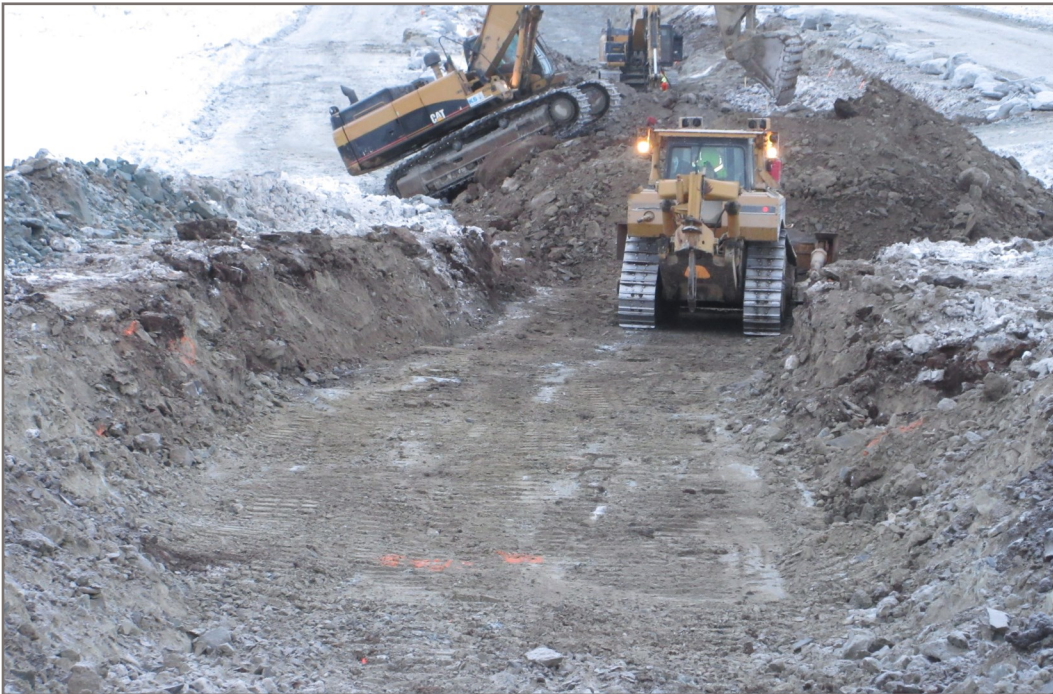
Photo 4: Key trench excavation activities
View from Station 0+550 facing down chainage

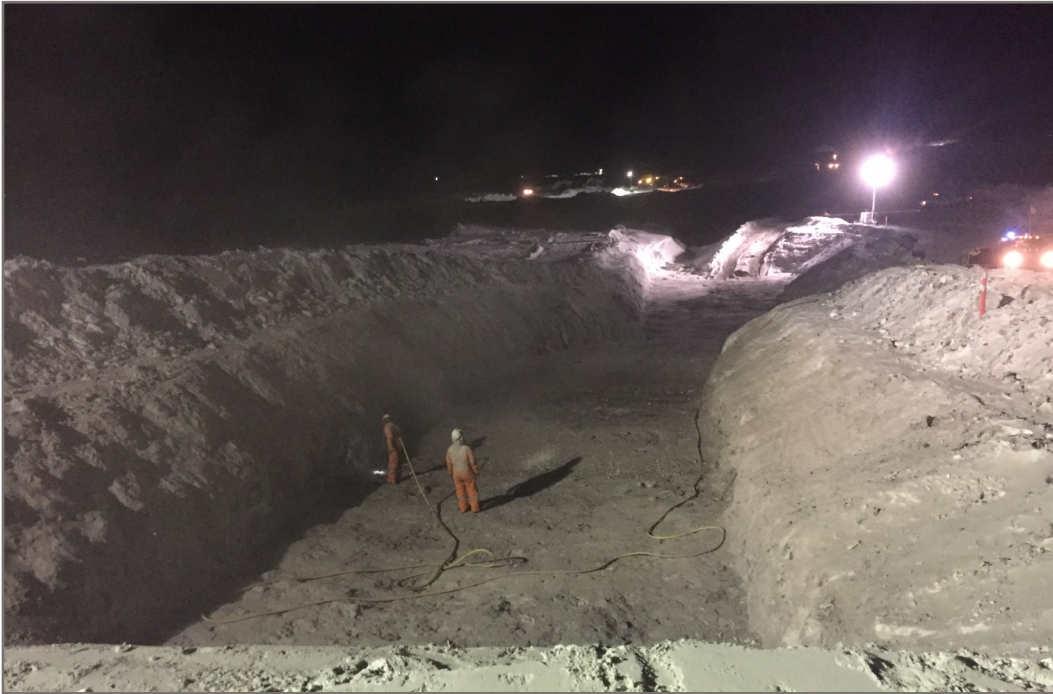
Photo 5: Key trench bottom and slopes final dental cleaning prior to Type F placement
View from Station 0+585 facing down chainage

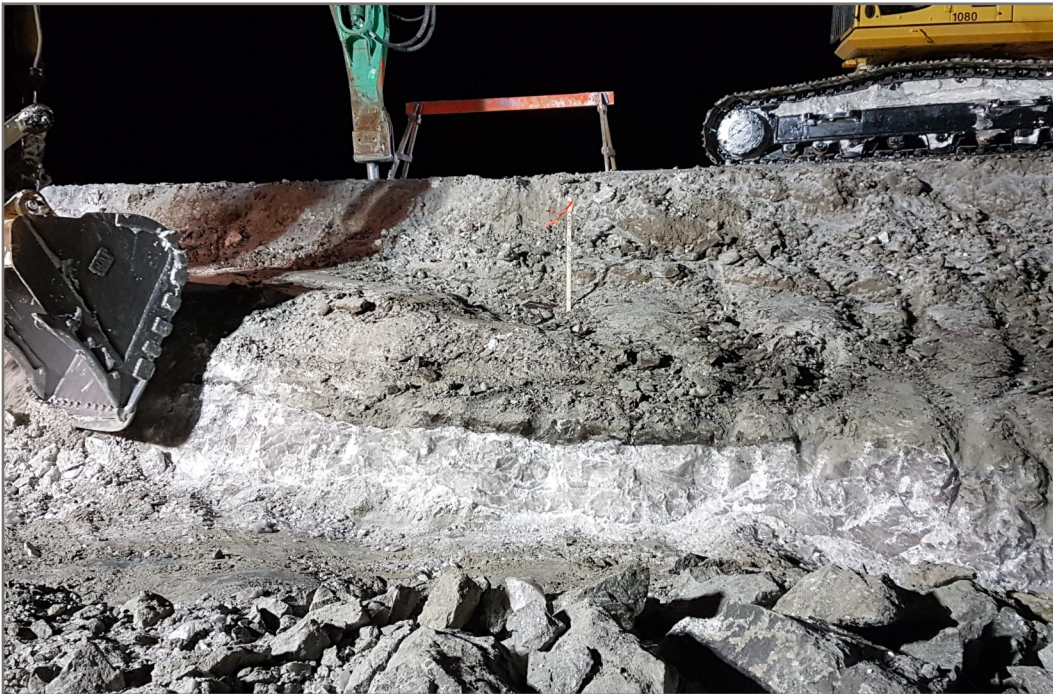
Photo 6: Key trench excavation—massive ground ice on the upstream slope being excavated
Between Station 0+492 and 0+507

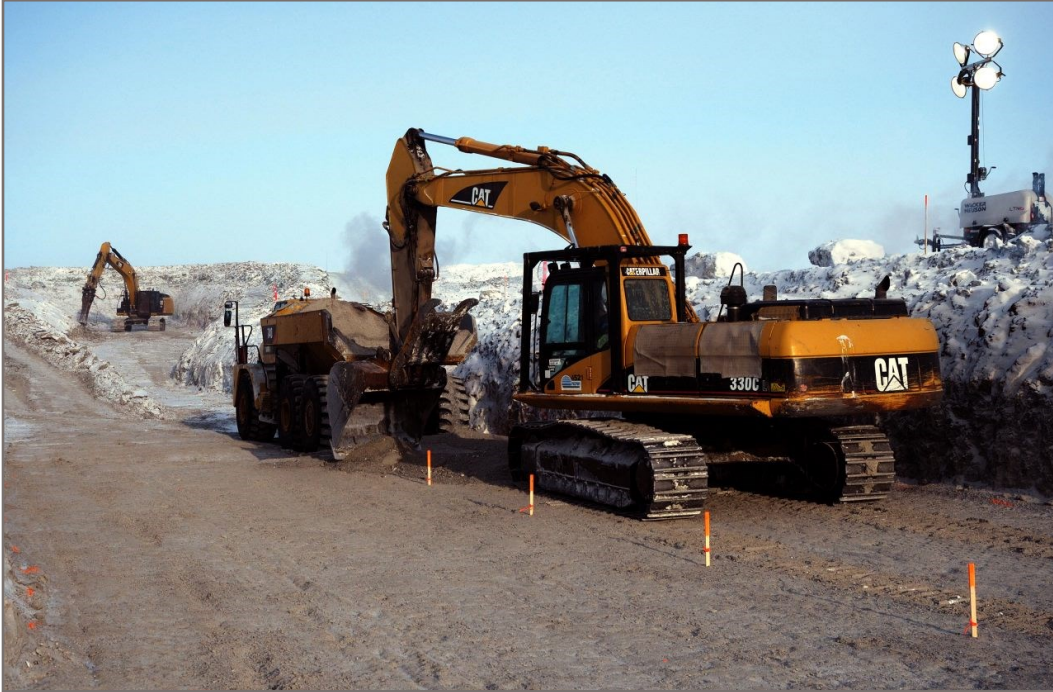
Photo 7: Placing Type F material along key trench bottom around Station 0+470

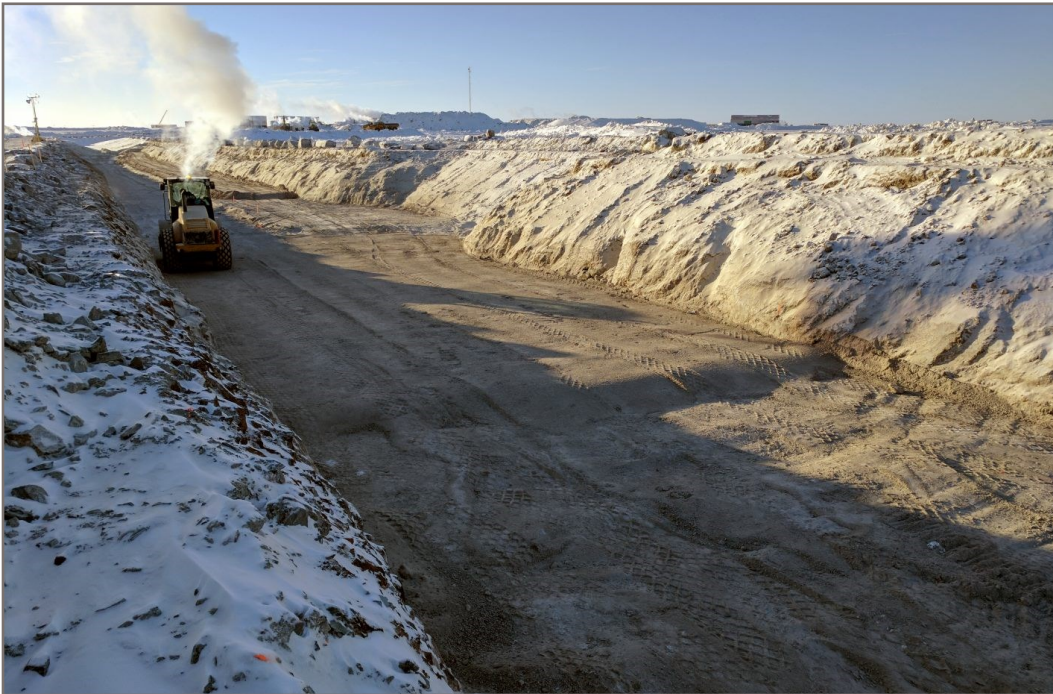
Photo 8: Compacting Type F material placed between Stations 0+450 and 0+475
