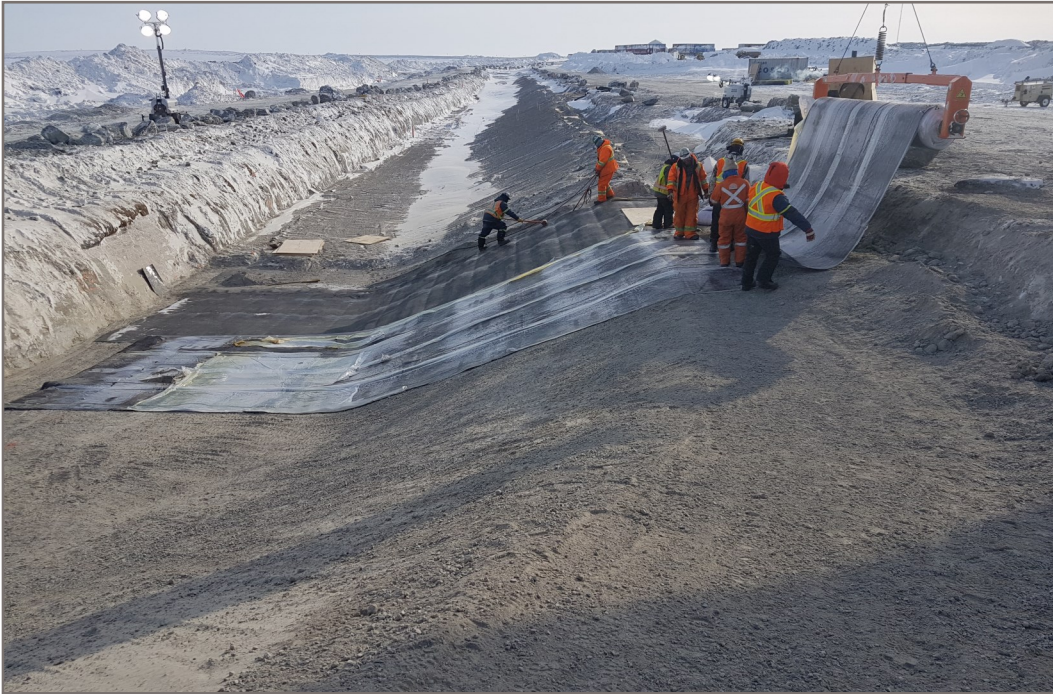
Photo 19: Deploying Phase 1 liner (within the key trench) from Station 0+522 to 0+532
View from Station 0+545 facing down chainage

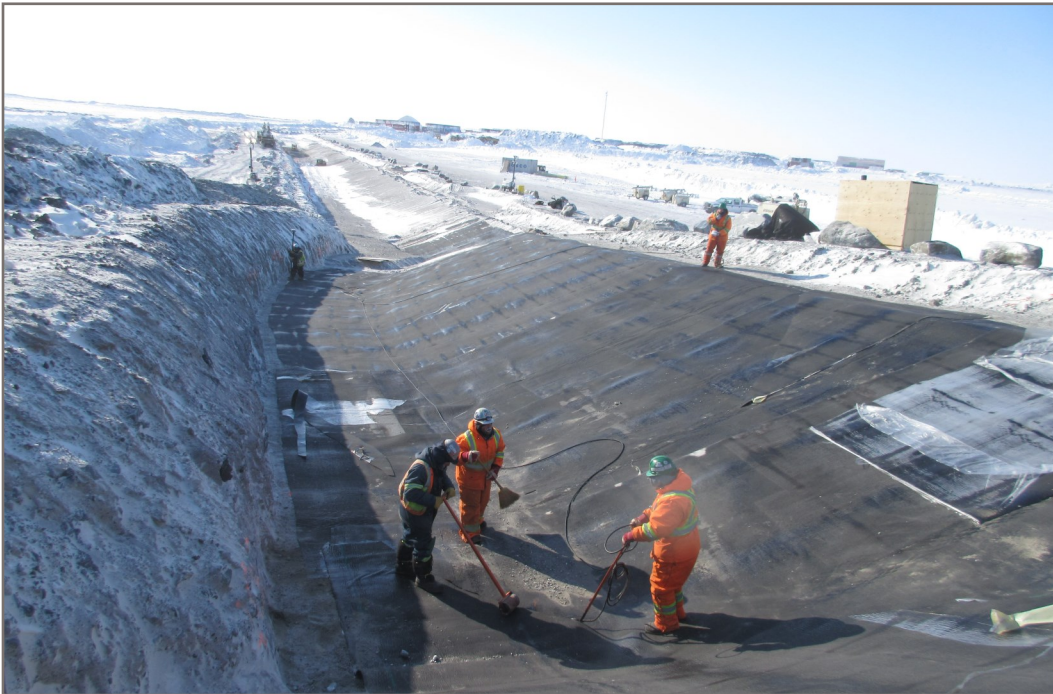
Photo 20: Looking at Phase 1 liner placed between Station 0+545 and 0+585
View from Station 0+585 facing down chainage

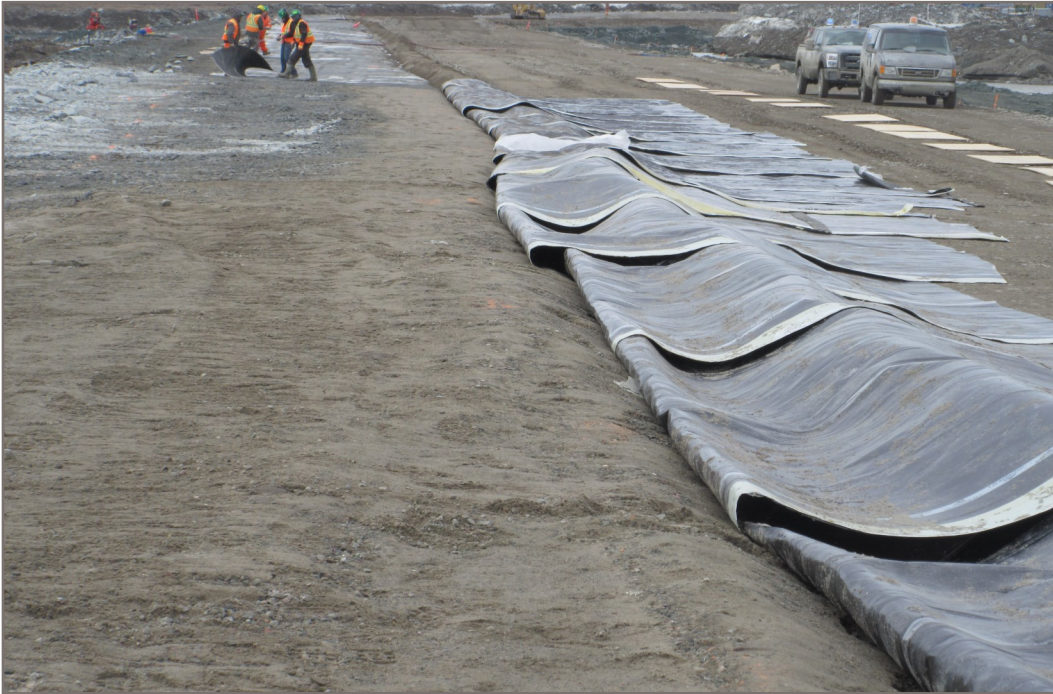
Photo 21: Previously placed Phase 2 liner that was welded to Elev. 66 m being flipped to finalise the construction of downstream material to final elevation
View from Station 1+490 facing down chainage

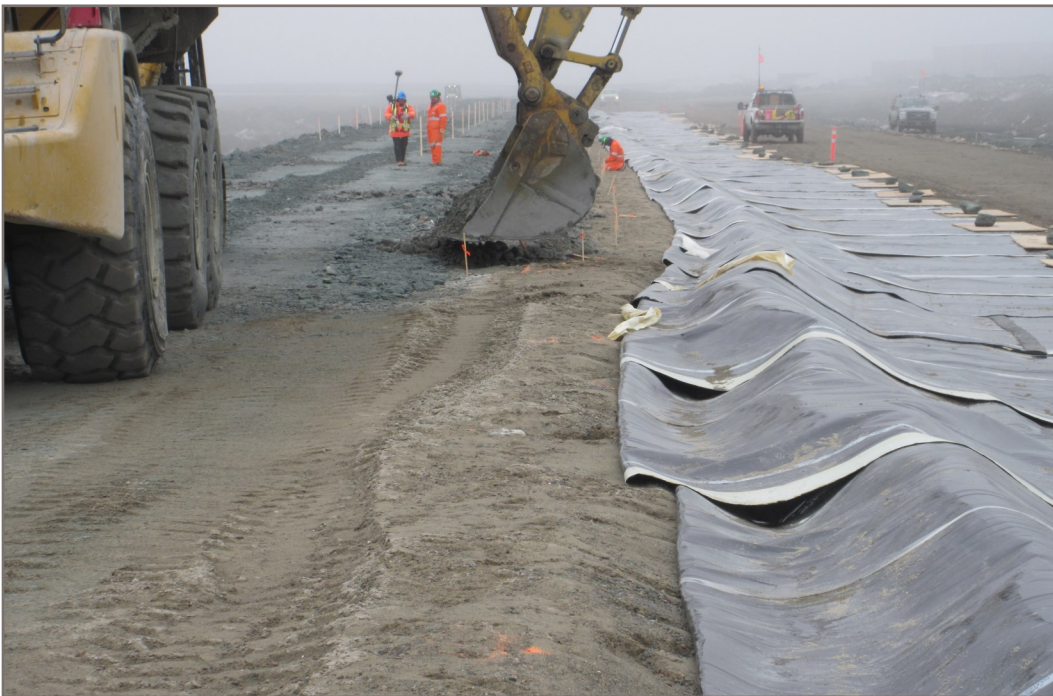
Photo 22: Placing downstream materials (Types A1, B and C) to final elevation for liner panels to be flipped back and placed on it and welded to top.
View from Station 1+500 facing down chainage

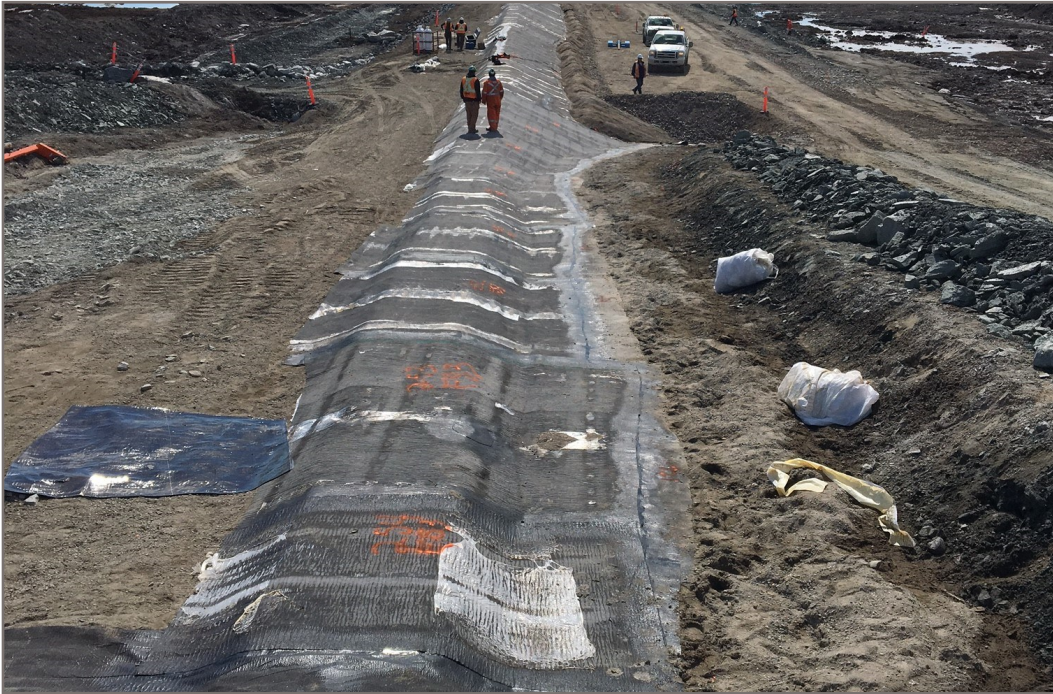
Photo 23: Phase 2 liner flipped back on downstream materials and welded to design elevation
View from Station 1+585 facing down chainage

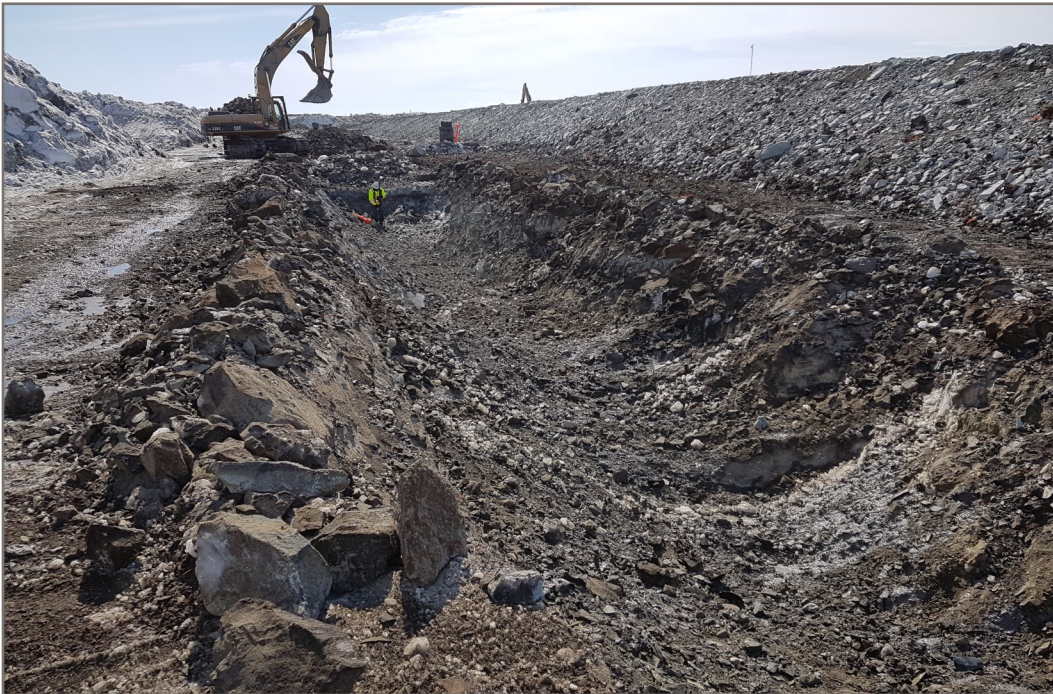
Photo 24: Mucked out north water collection channel
View from Station 4+050 facing up chainage
