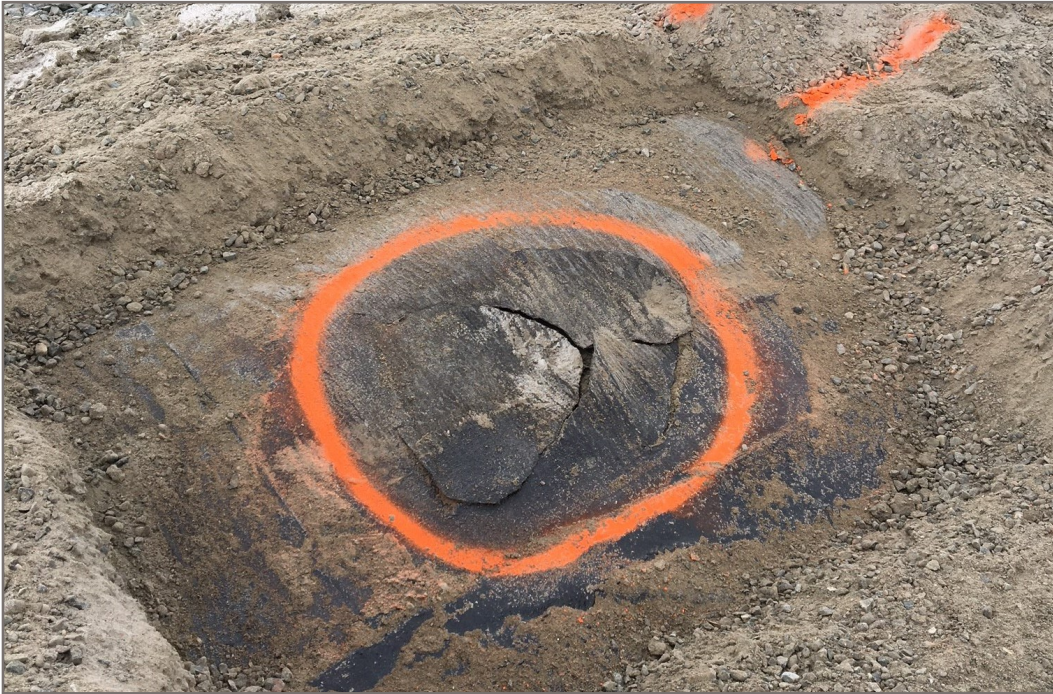
**Photo 50:** Top Liner punctured by excavator while placing Type C material; Station 1+040

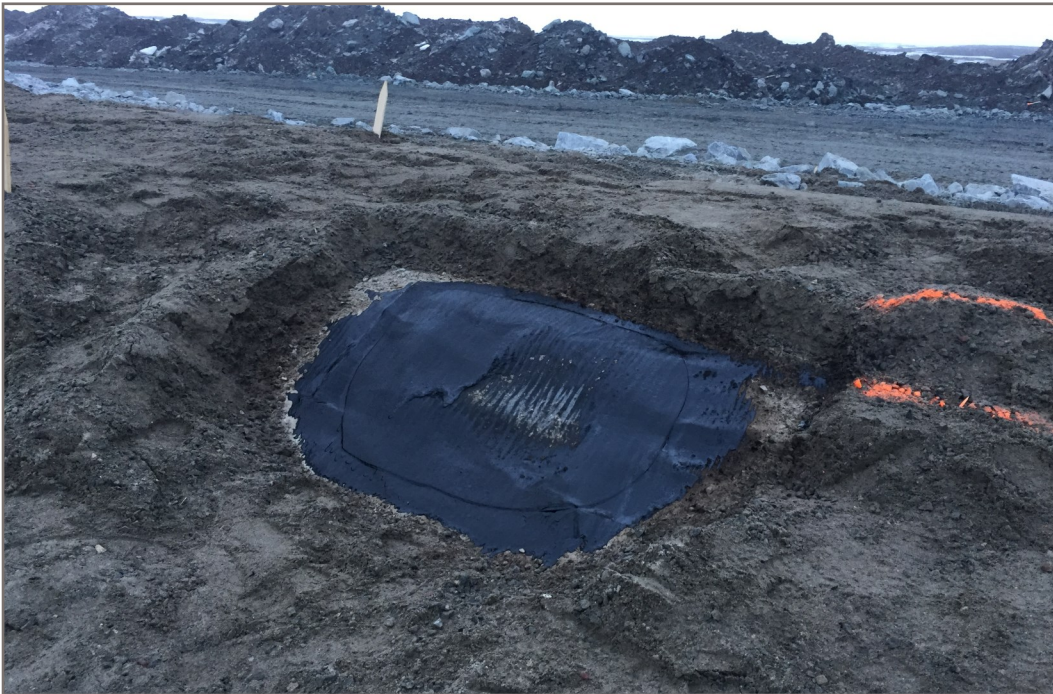
**Photo 51:** Patch completed on punctured Top Liner at Station 1+040

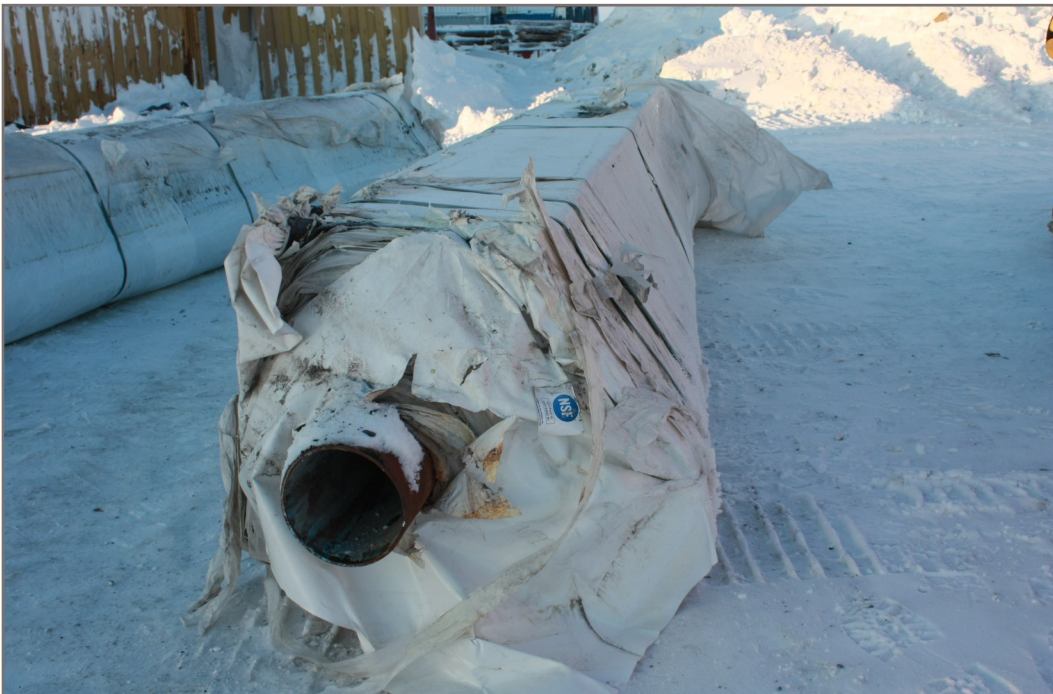
**Photo 53:** Deformed Coletanche ES3 liner panel pulled out of shipping/storage sea can

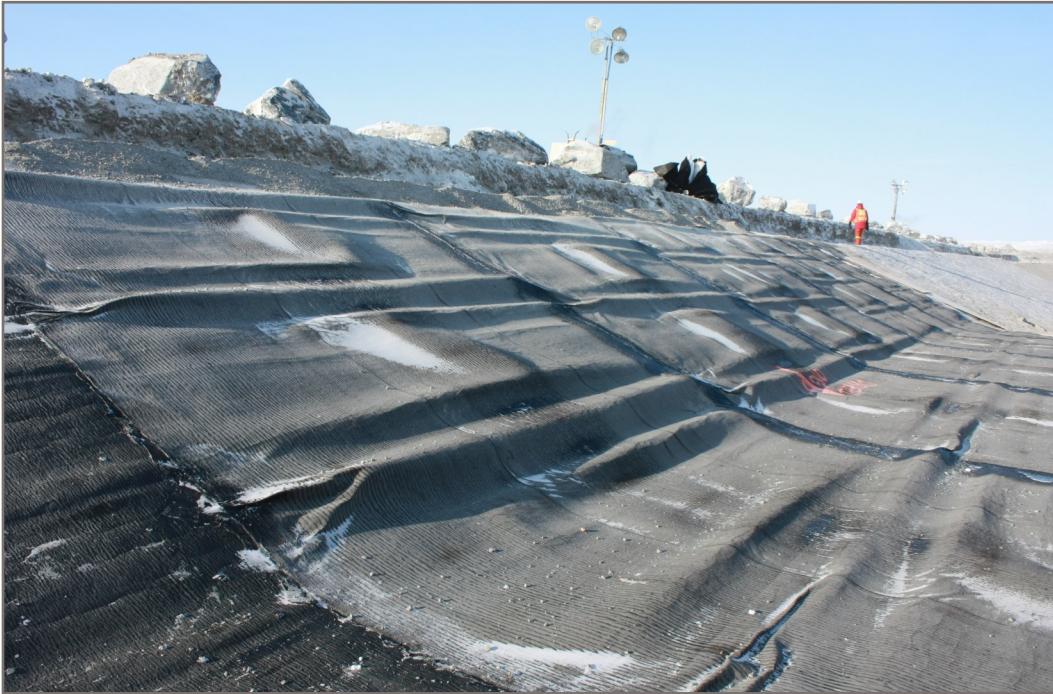
**Photo 54:** Excessive wrinkling on Liner Panels 62 to 66

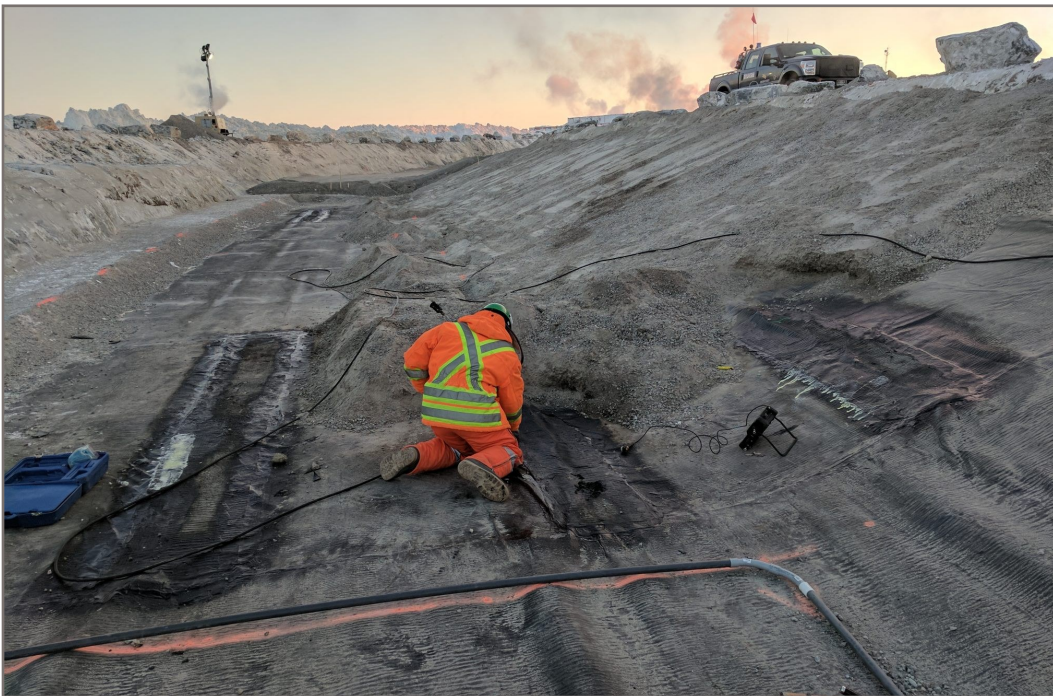
**Photo 55:** Finalizing Patches R4, R5 and R6
