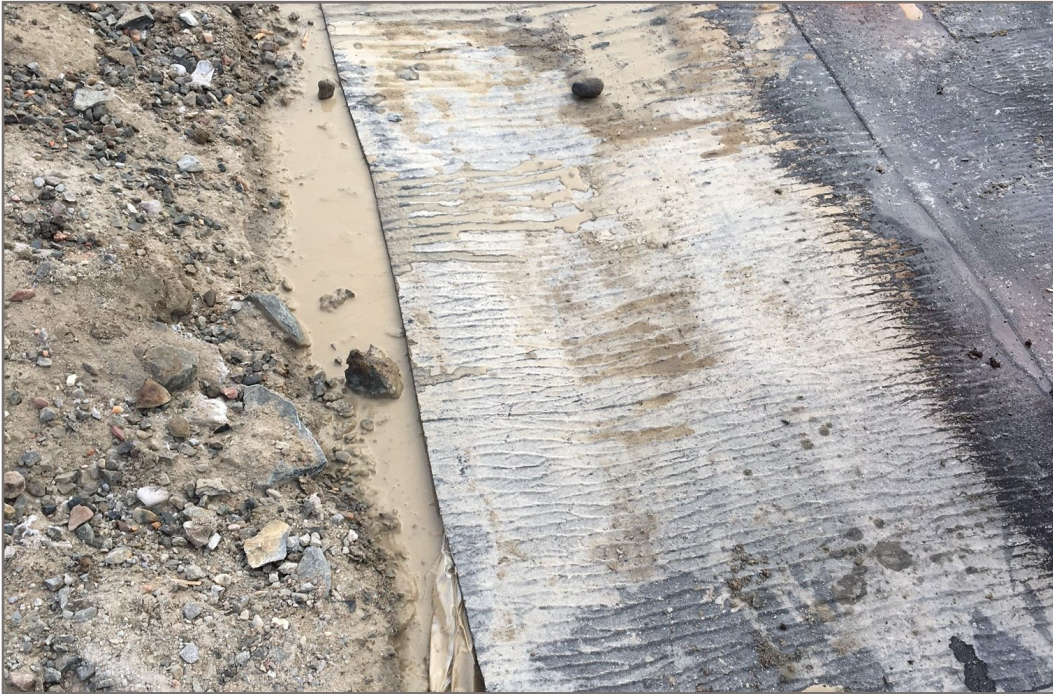
**Photo 56** Water ponding at under liner hinge point  
View at Station 1+390

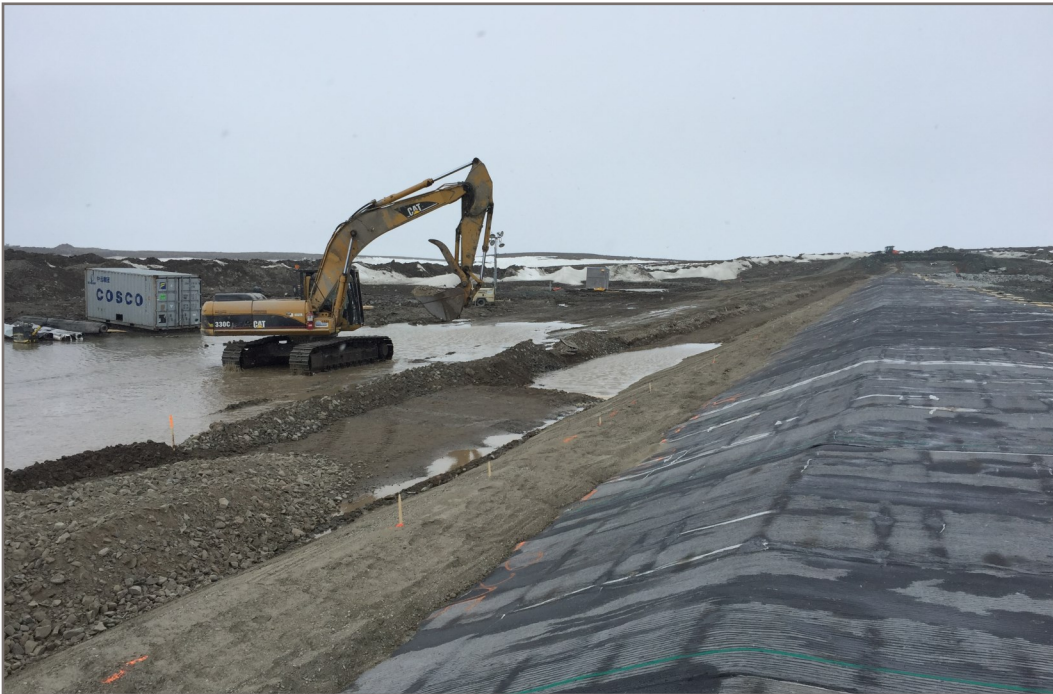
**Photo 57:** Water breach over Type H upstream material on working platform  
View from Station 1+400 facing down chainage

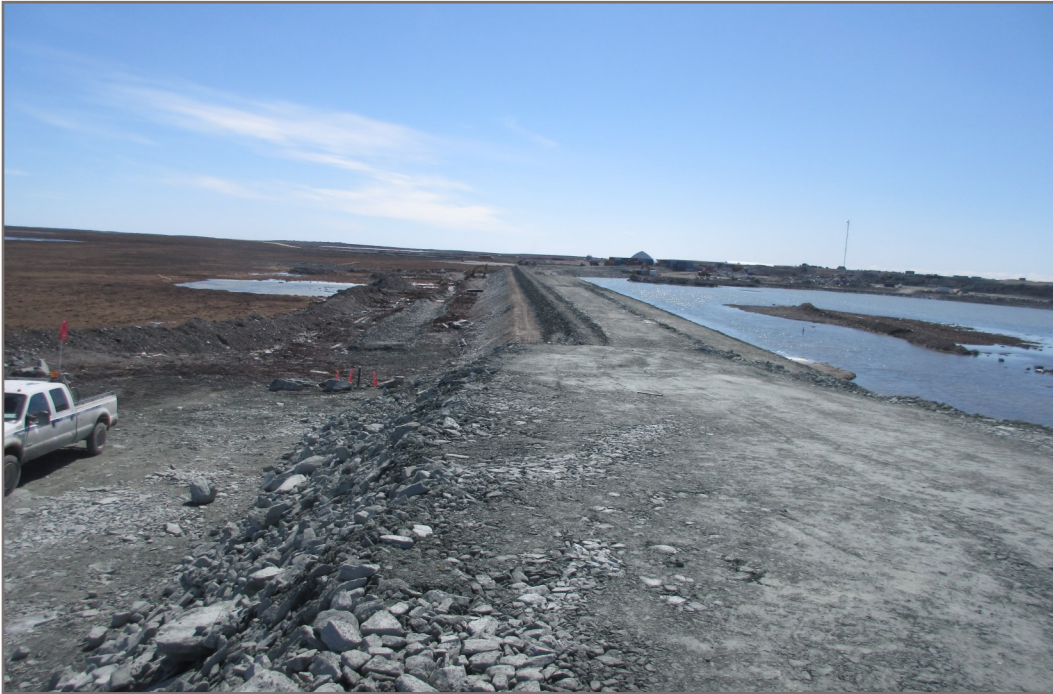
**Photo 58:** View of completed Dike D-CP1 from Station 1+585 facing downstream side

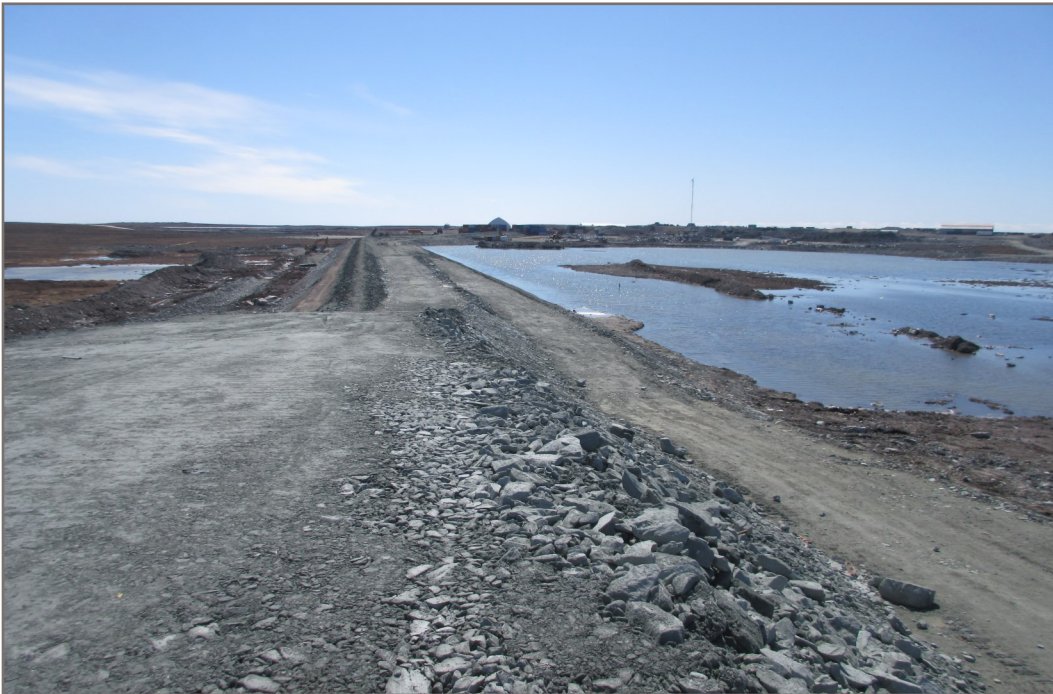
**Photo 59:** View of completed Dike D-CP1 from Station 1+585 facing upstream side
