PHOTOGRAPHS

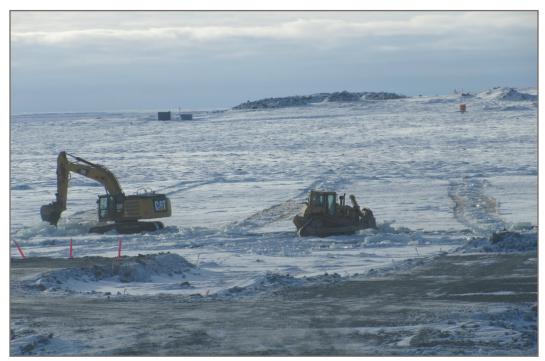
Photo 1: Pushing Lake Ice, snow, boulders and cobbles from dike's footprint to construct working platform (first lifts of dike's shell)

View from Station 1+300 facing down chainage

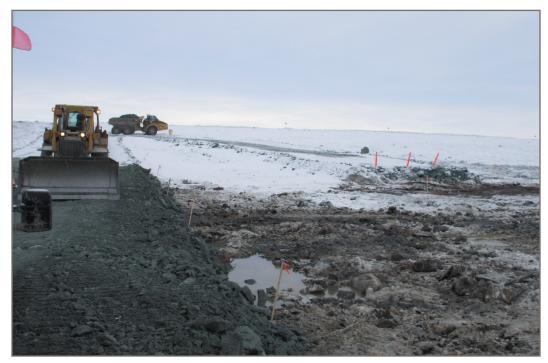
Photo 2: Placing first lift of Type A material (working platform) on the upstream side View from Station 1+280 facing up chainage

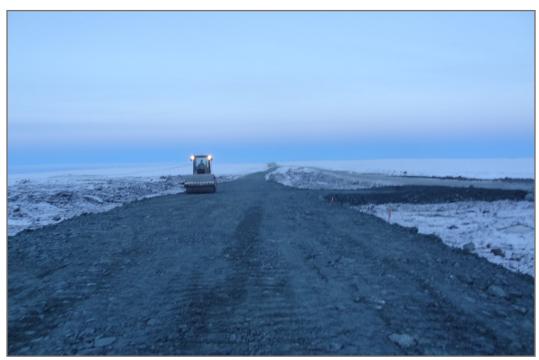
Photo 3: Compaction of first lift of Type A material on the upstream working platform View from Station 1+090 facing up chainage

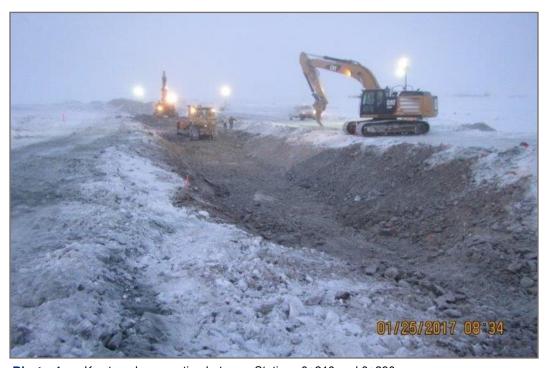
Photo 4: Key trench excavation between Stations 0+210 and 0+290

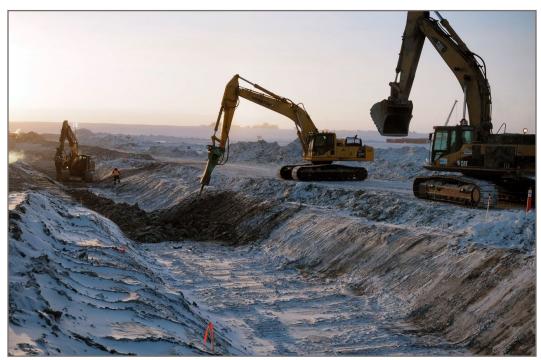
Photo 5: Key trench sloping and hammering View from Station 0+190 facing up chainage

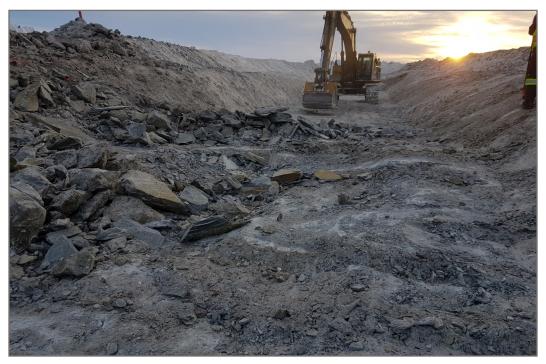
Photo 6: Key trench - bedrock encountered at ~1.4 m depth below original ground surface Between Stations 0+040 and 0+060

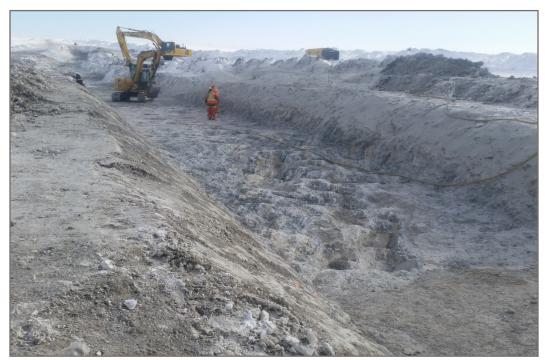
Photo 7: Final dental cleaning on key trench bottom prior to placing Type F material View from Station 0+30 facing up chainage

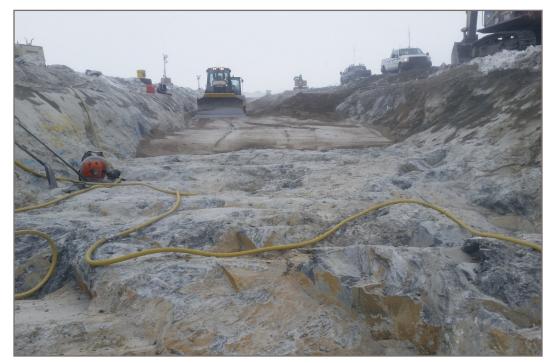
Photo 8: Type F material placement View from Station 0+155 facing down chainage

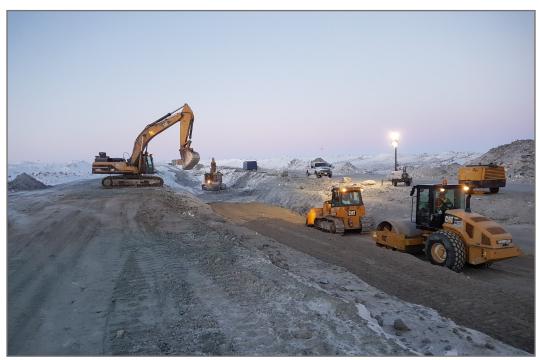
Photo 9: Type F material placement and compaction View from Station 0+180 facing up chainage

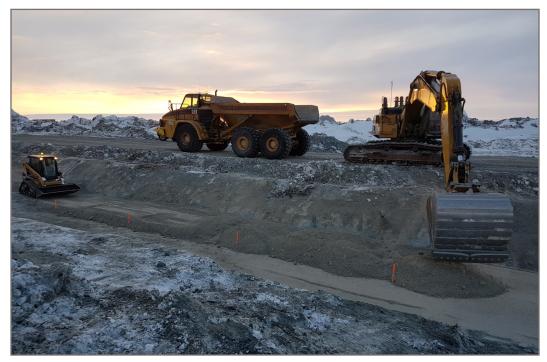
Photo 10: Placing first lift of upstream fillet Type F material View from Station 0+100 facing down chainage
