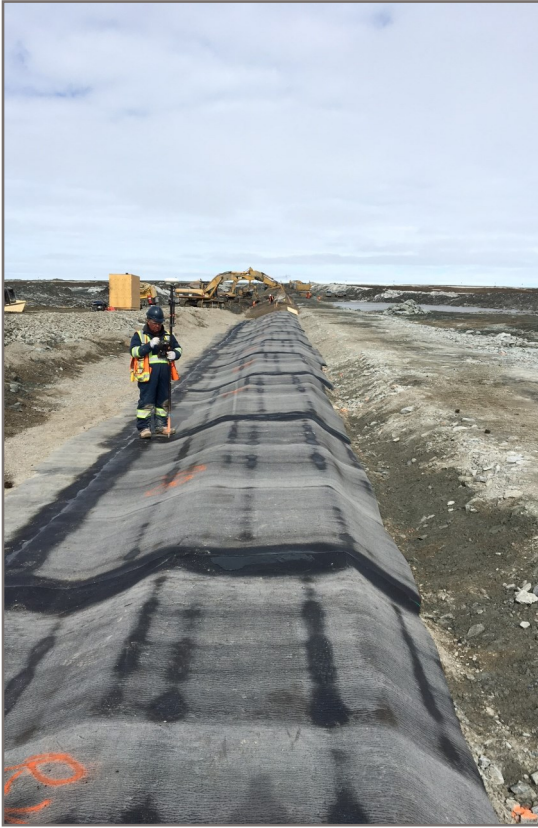
Photo 21: Completed Phase 2 liner
View from 1+050 facing up
chainage

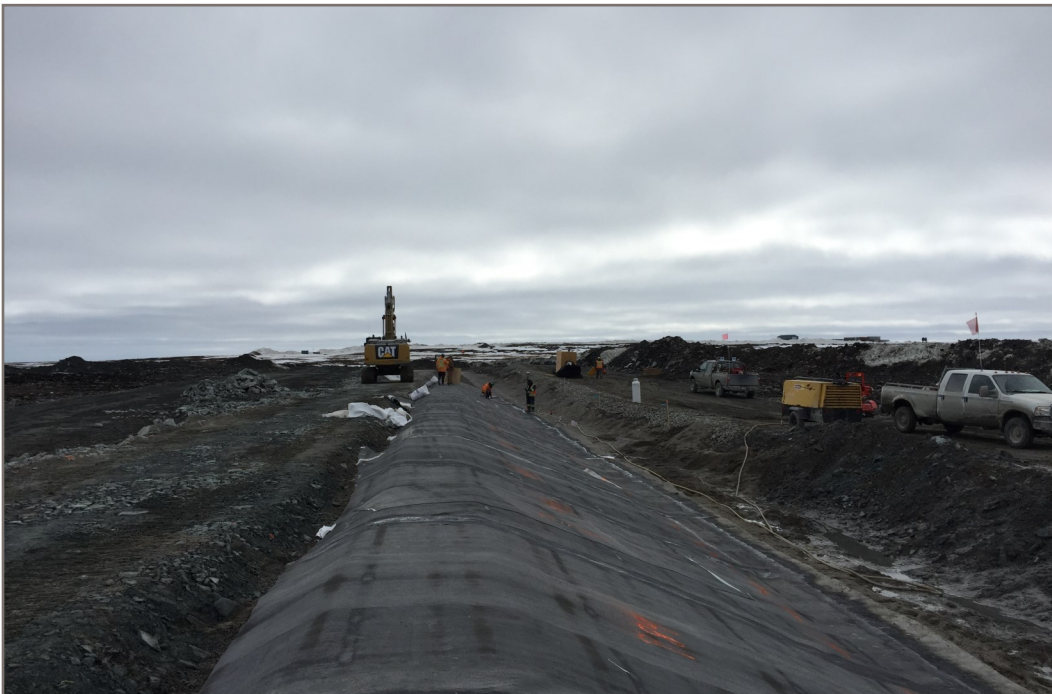
Photo 22: Phase 2 liner placement
View from Station 1+100 facing down
chainage

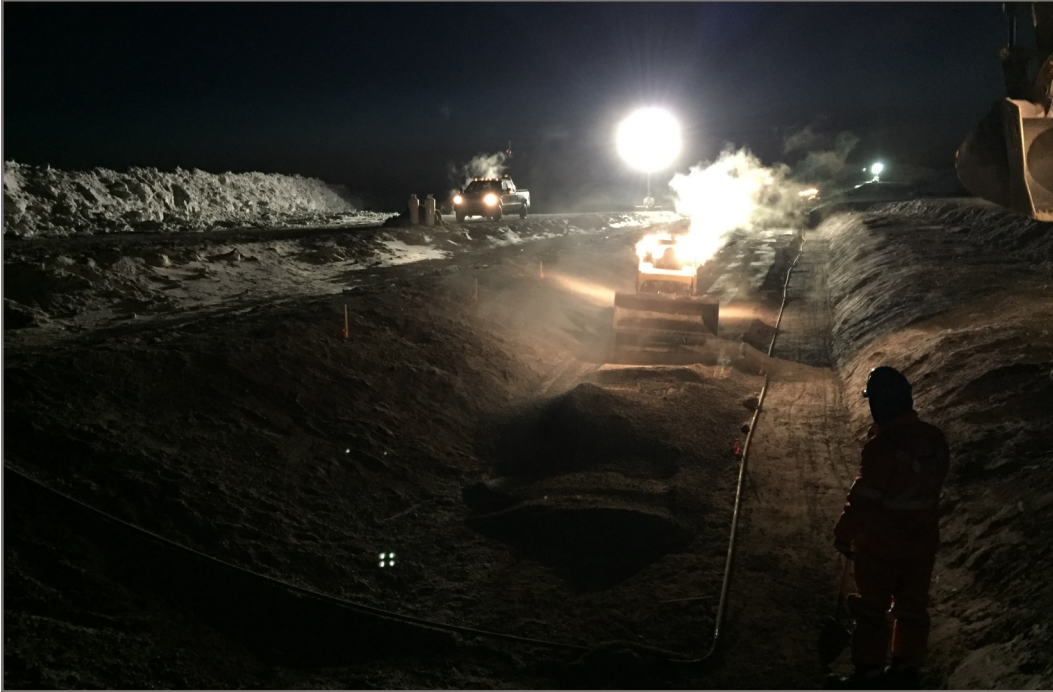
Photo 23: PVC Pipe housing HGTC-1 lying on first lift of Type C material over bottom liner
View from Station 0+004 facing up chainage)

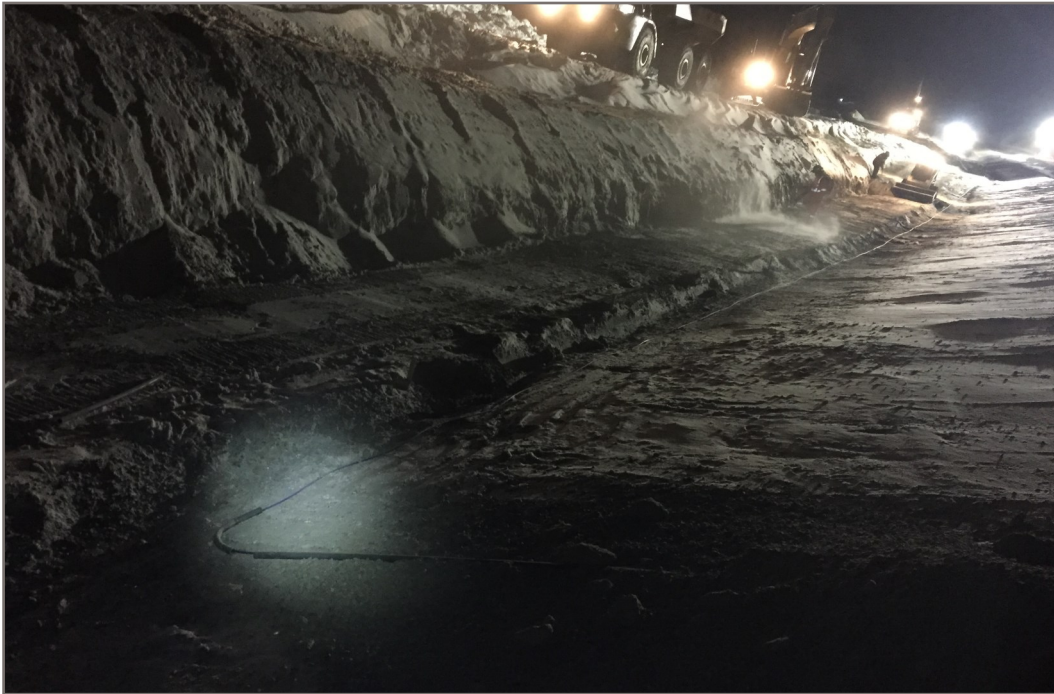
Photo 24: PVC pipe housing HGTC-2 lying on first lift of Type C material over bottom liner
View from Station 0+298 facing down chainage

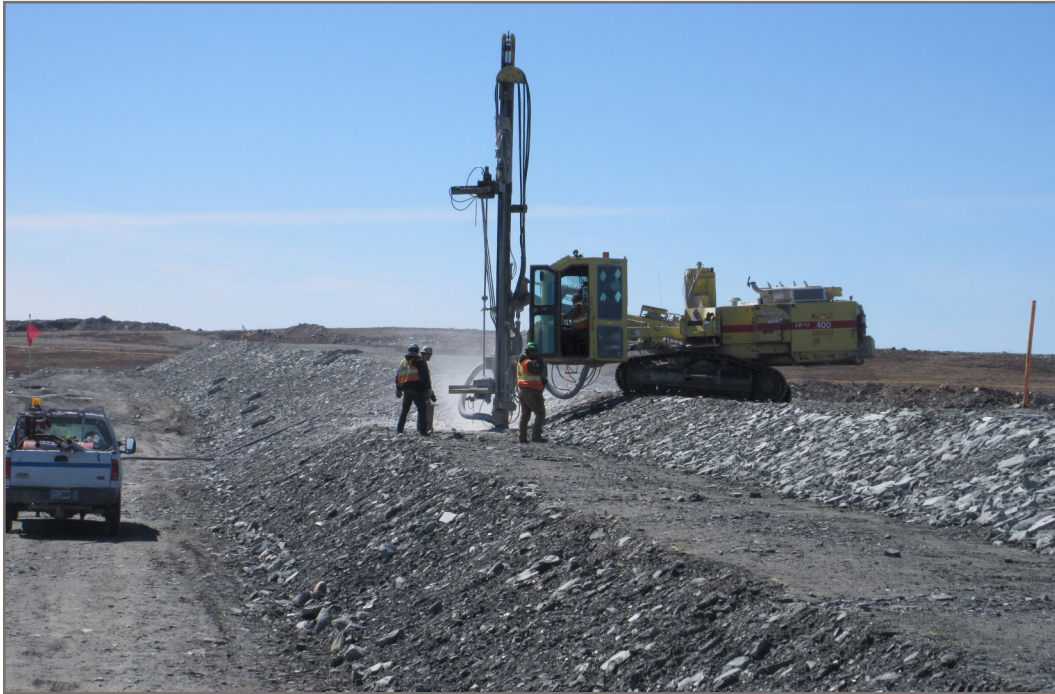
Photo 25: Drilling hole to install VGTC-3
View from Station 1+195 facing down chainage

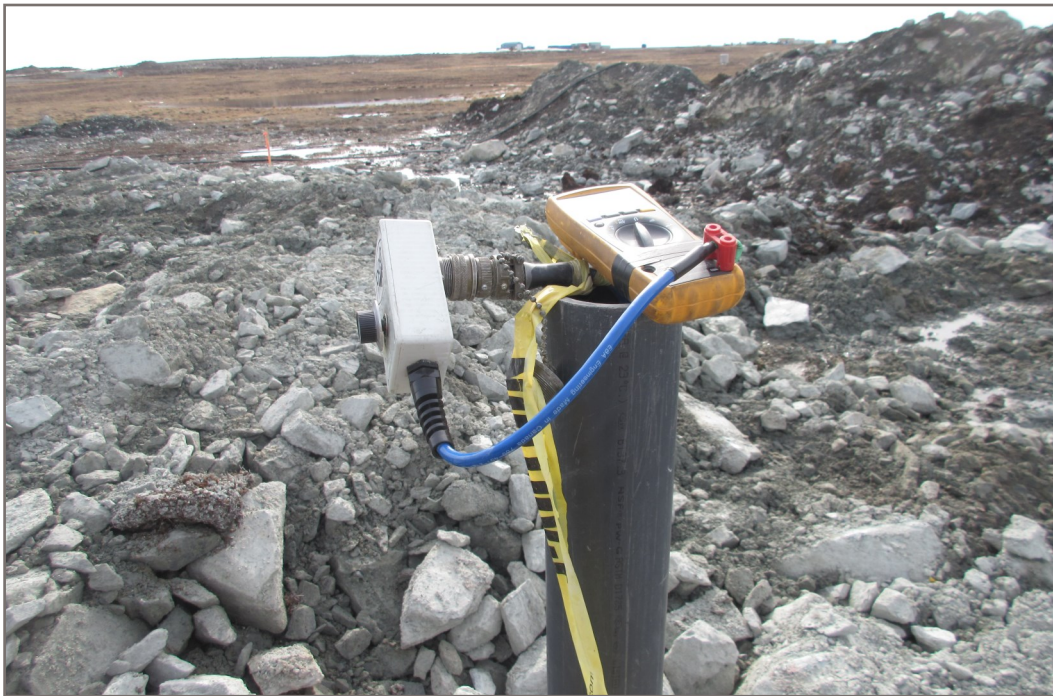
Photo 26: Taking readings from HGTC-2

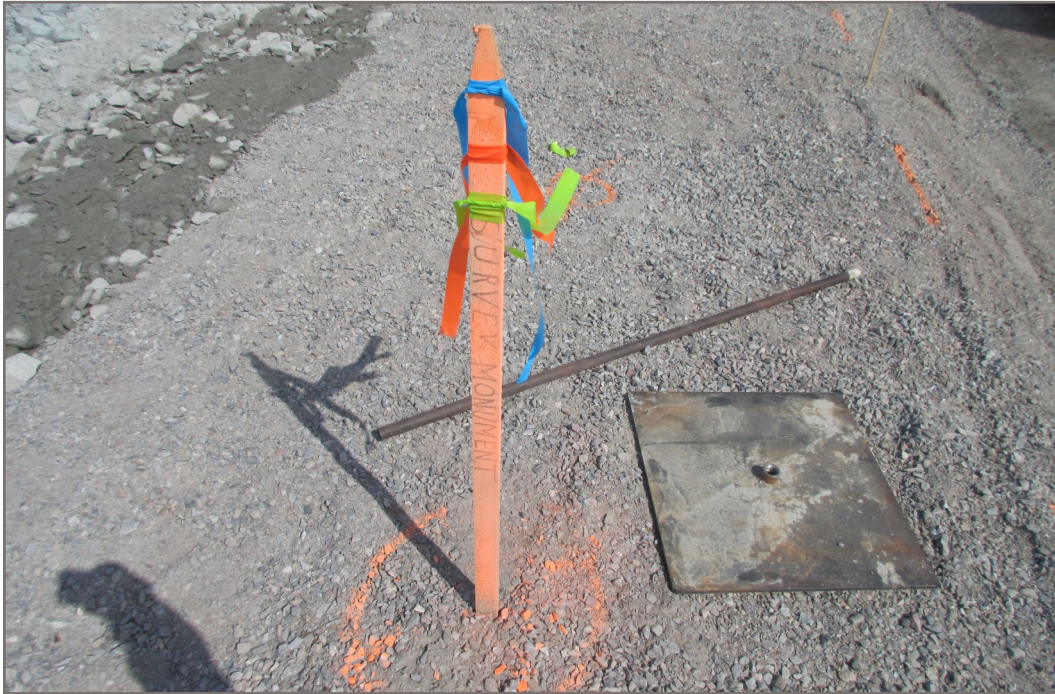
Photo 27: Survey Monument M2 to be installed

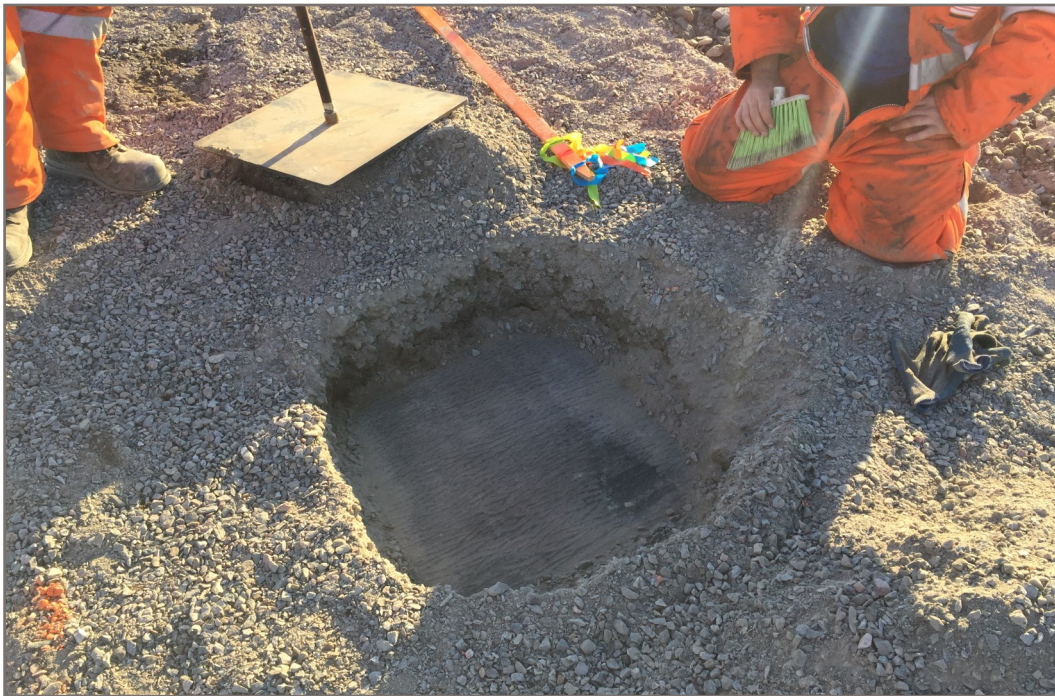
Photo 28: Survey Monument M2 installation
