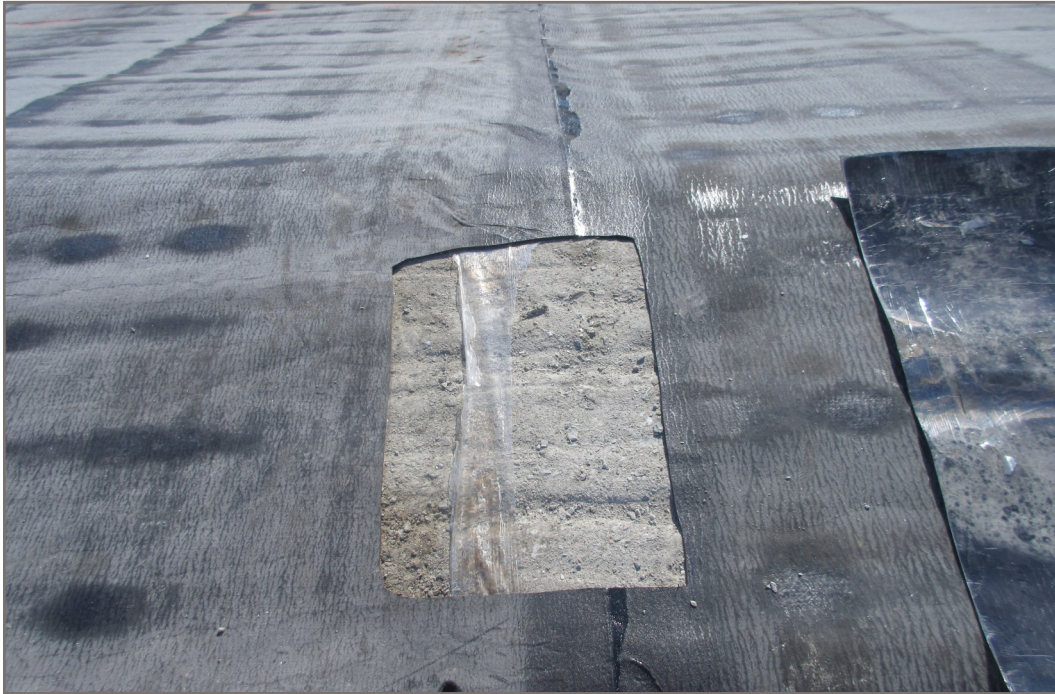
Photo 39: Destructive test sample location between Panels 35 and 36

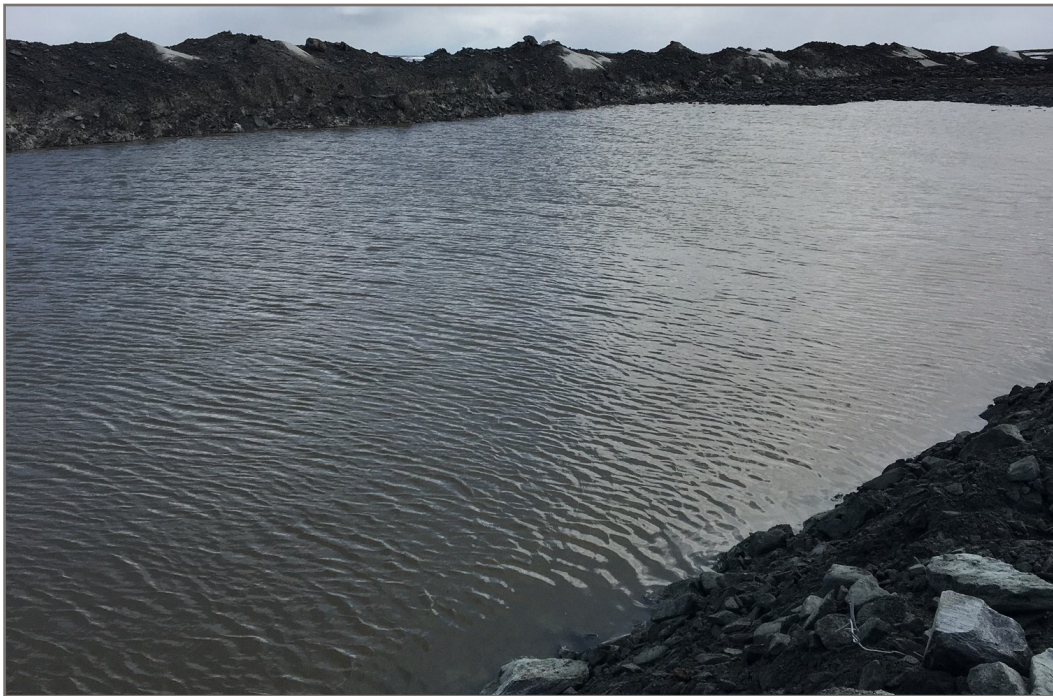
Photo 40: Water ponding downstream, afternoon of May 13, 2017
View from Station 1+200 facing down chainage

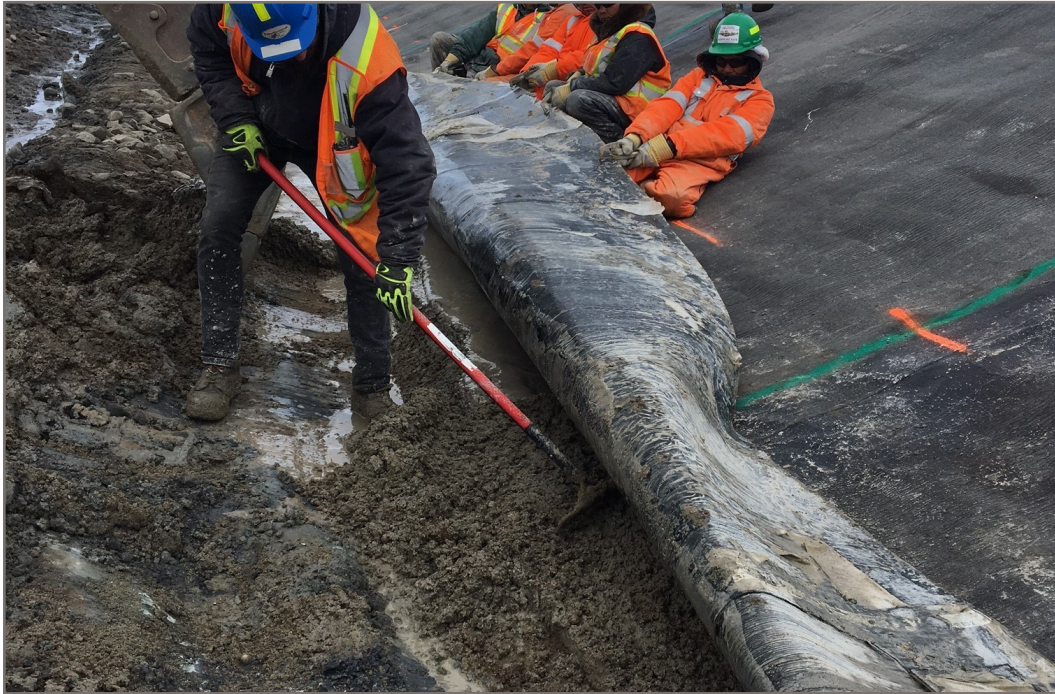
Photo 41: Removal of saturated Type F under liner at hinge point
Approximate Station 1+210 facing up chainage

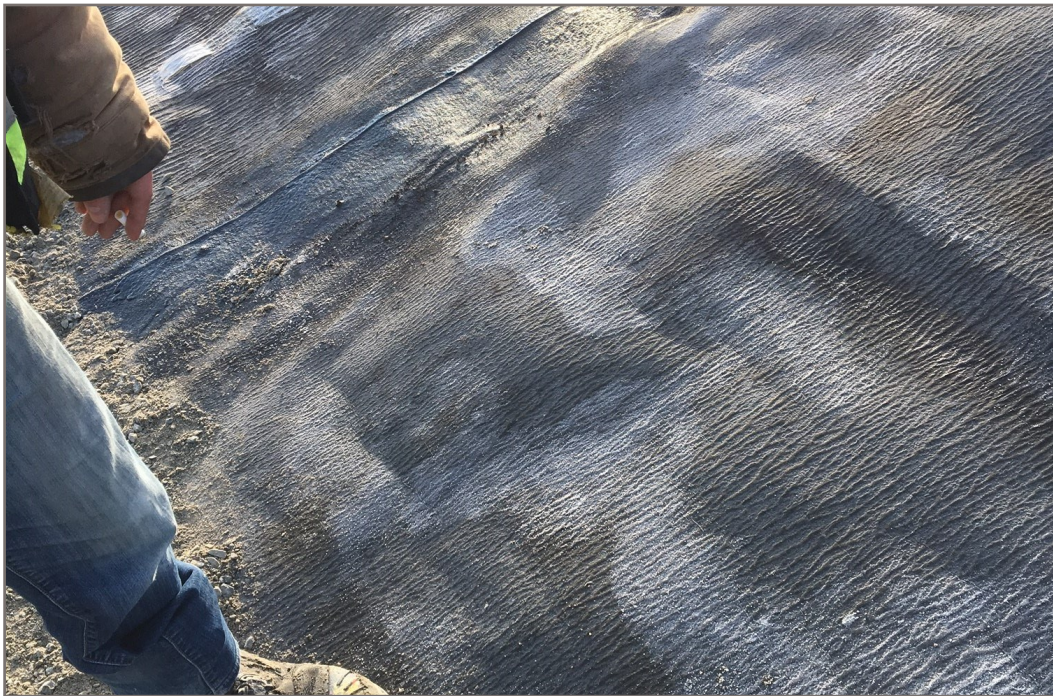
Photo 42: Area of water behind liner—granular material is Type F over liner at hinge point
Approximate Station 1+190
