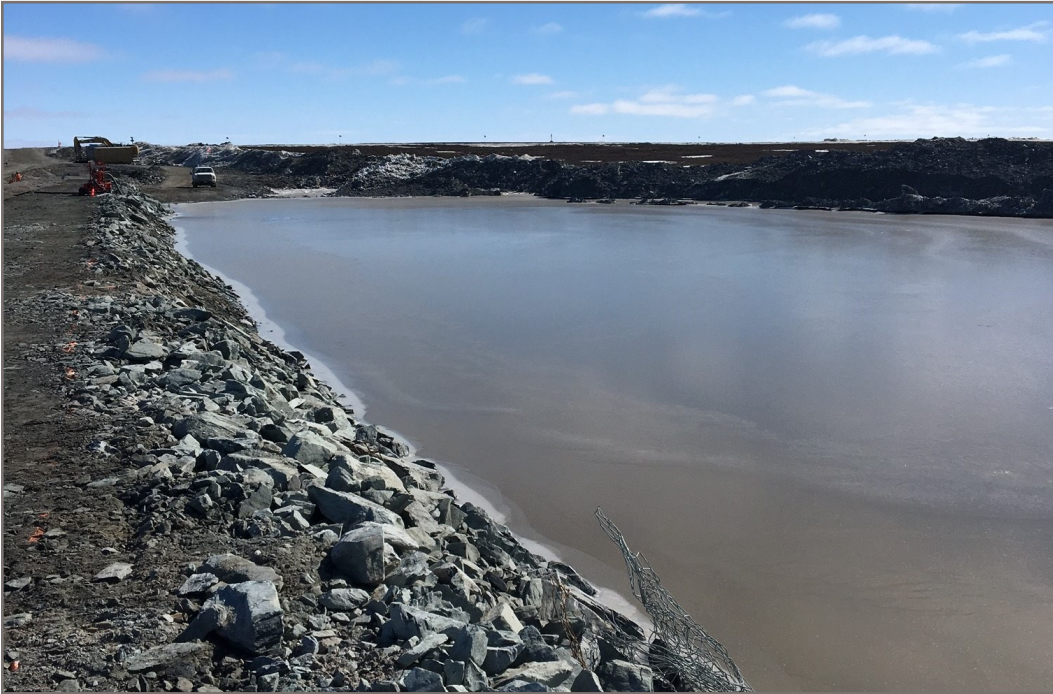
**Photo 43:** Ponding water downstream, morning of May 15, 2017  
View from Station 1+090 facing up chainage

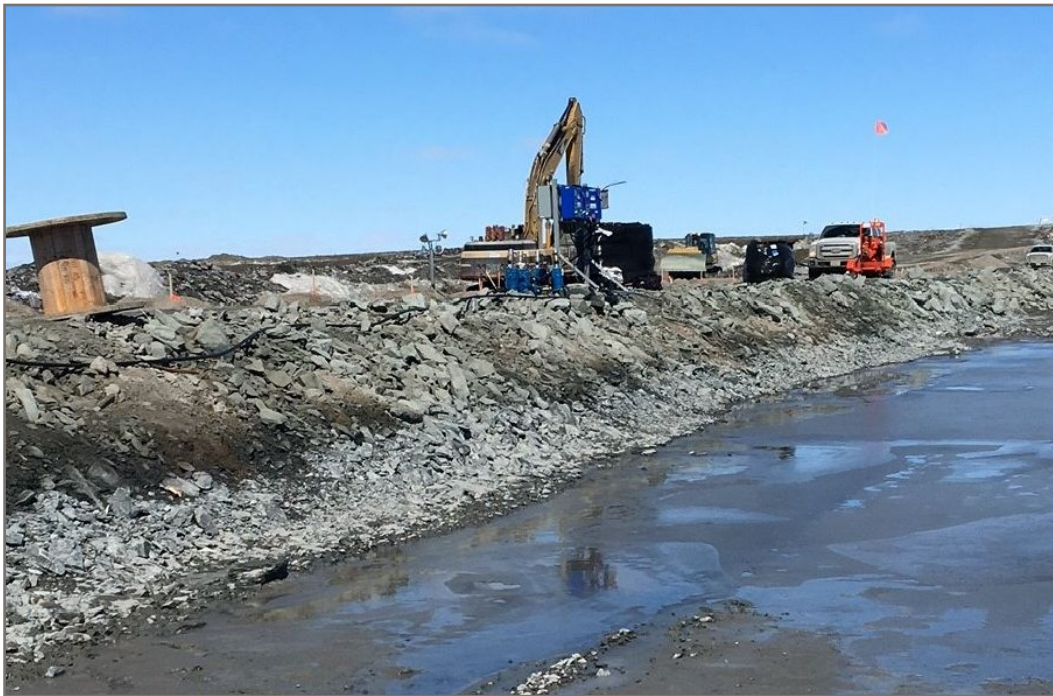
**Photo 44:** Downstream toe on May 16, 2017 with high water line down following pumping  
View from Station 1+100 facing up chainage

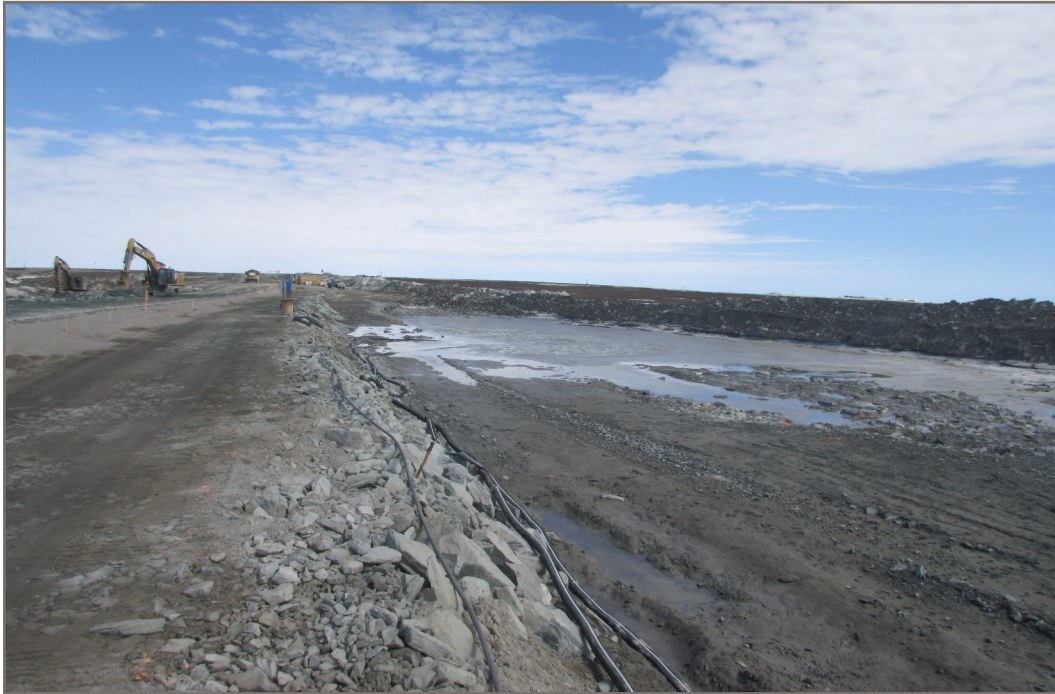
**Photo 45:** Downstream side of dike on May 18, 2018 showing low water level

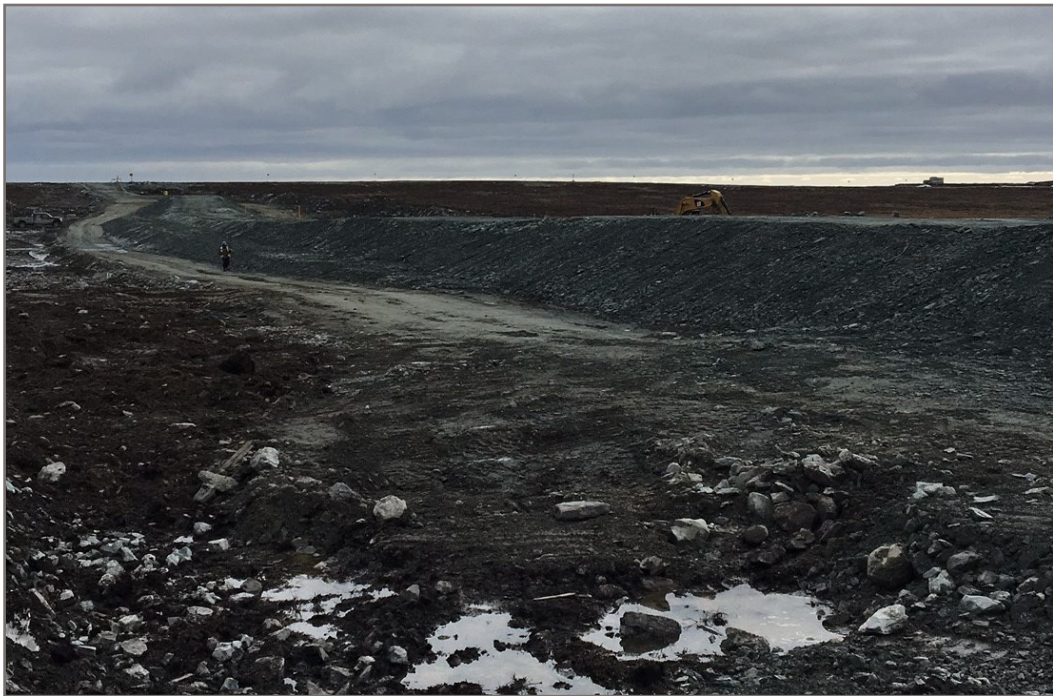
**Photo 46:** D-CP5 overview of upstream side from Station 1+020 facing up chainage
