Re: Water License 2AM-MEL1631 Part D, Item 3 / NIRB Project Certificate 11MN034
Condition 18 - Submission of Construction Summary Report for Culvert3 and
Culvert4

CONSTRUCTION SUMMARY REPORT FOR CULVERT3 AND CULVERT4 MELIADINE PROJECT, NUNAVUT

DECEMBER 2016
ISSUED FOR USE
TETRA TECH PROJECT NUMBER: 28920
AGNICO EAGLE DOCUMENT NUMBER: 6515-E-132-005-132-REP-005

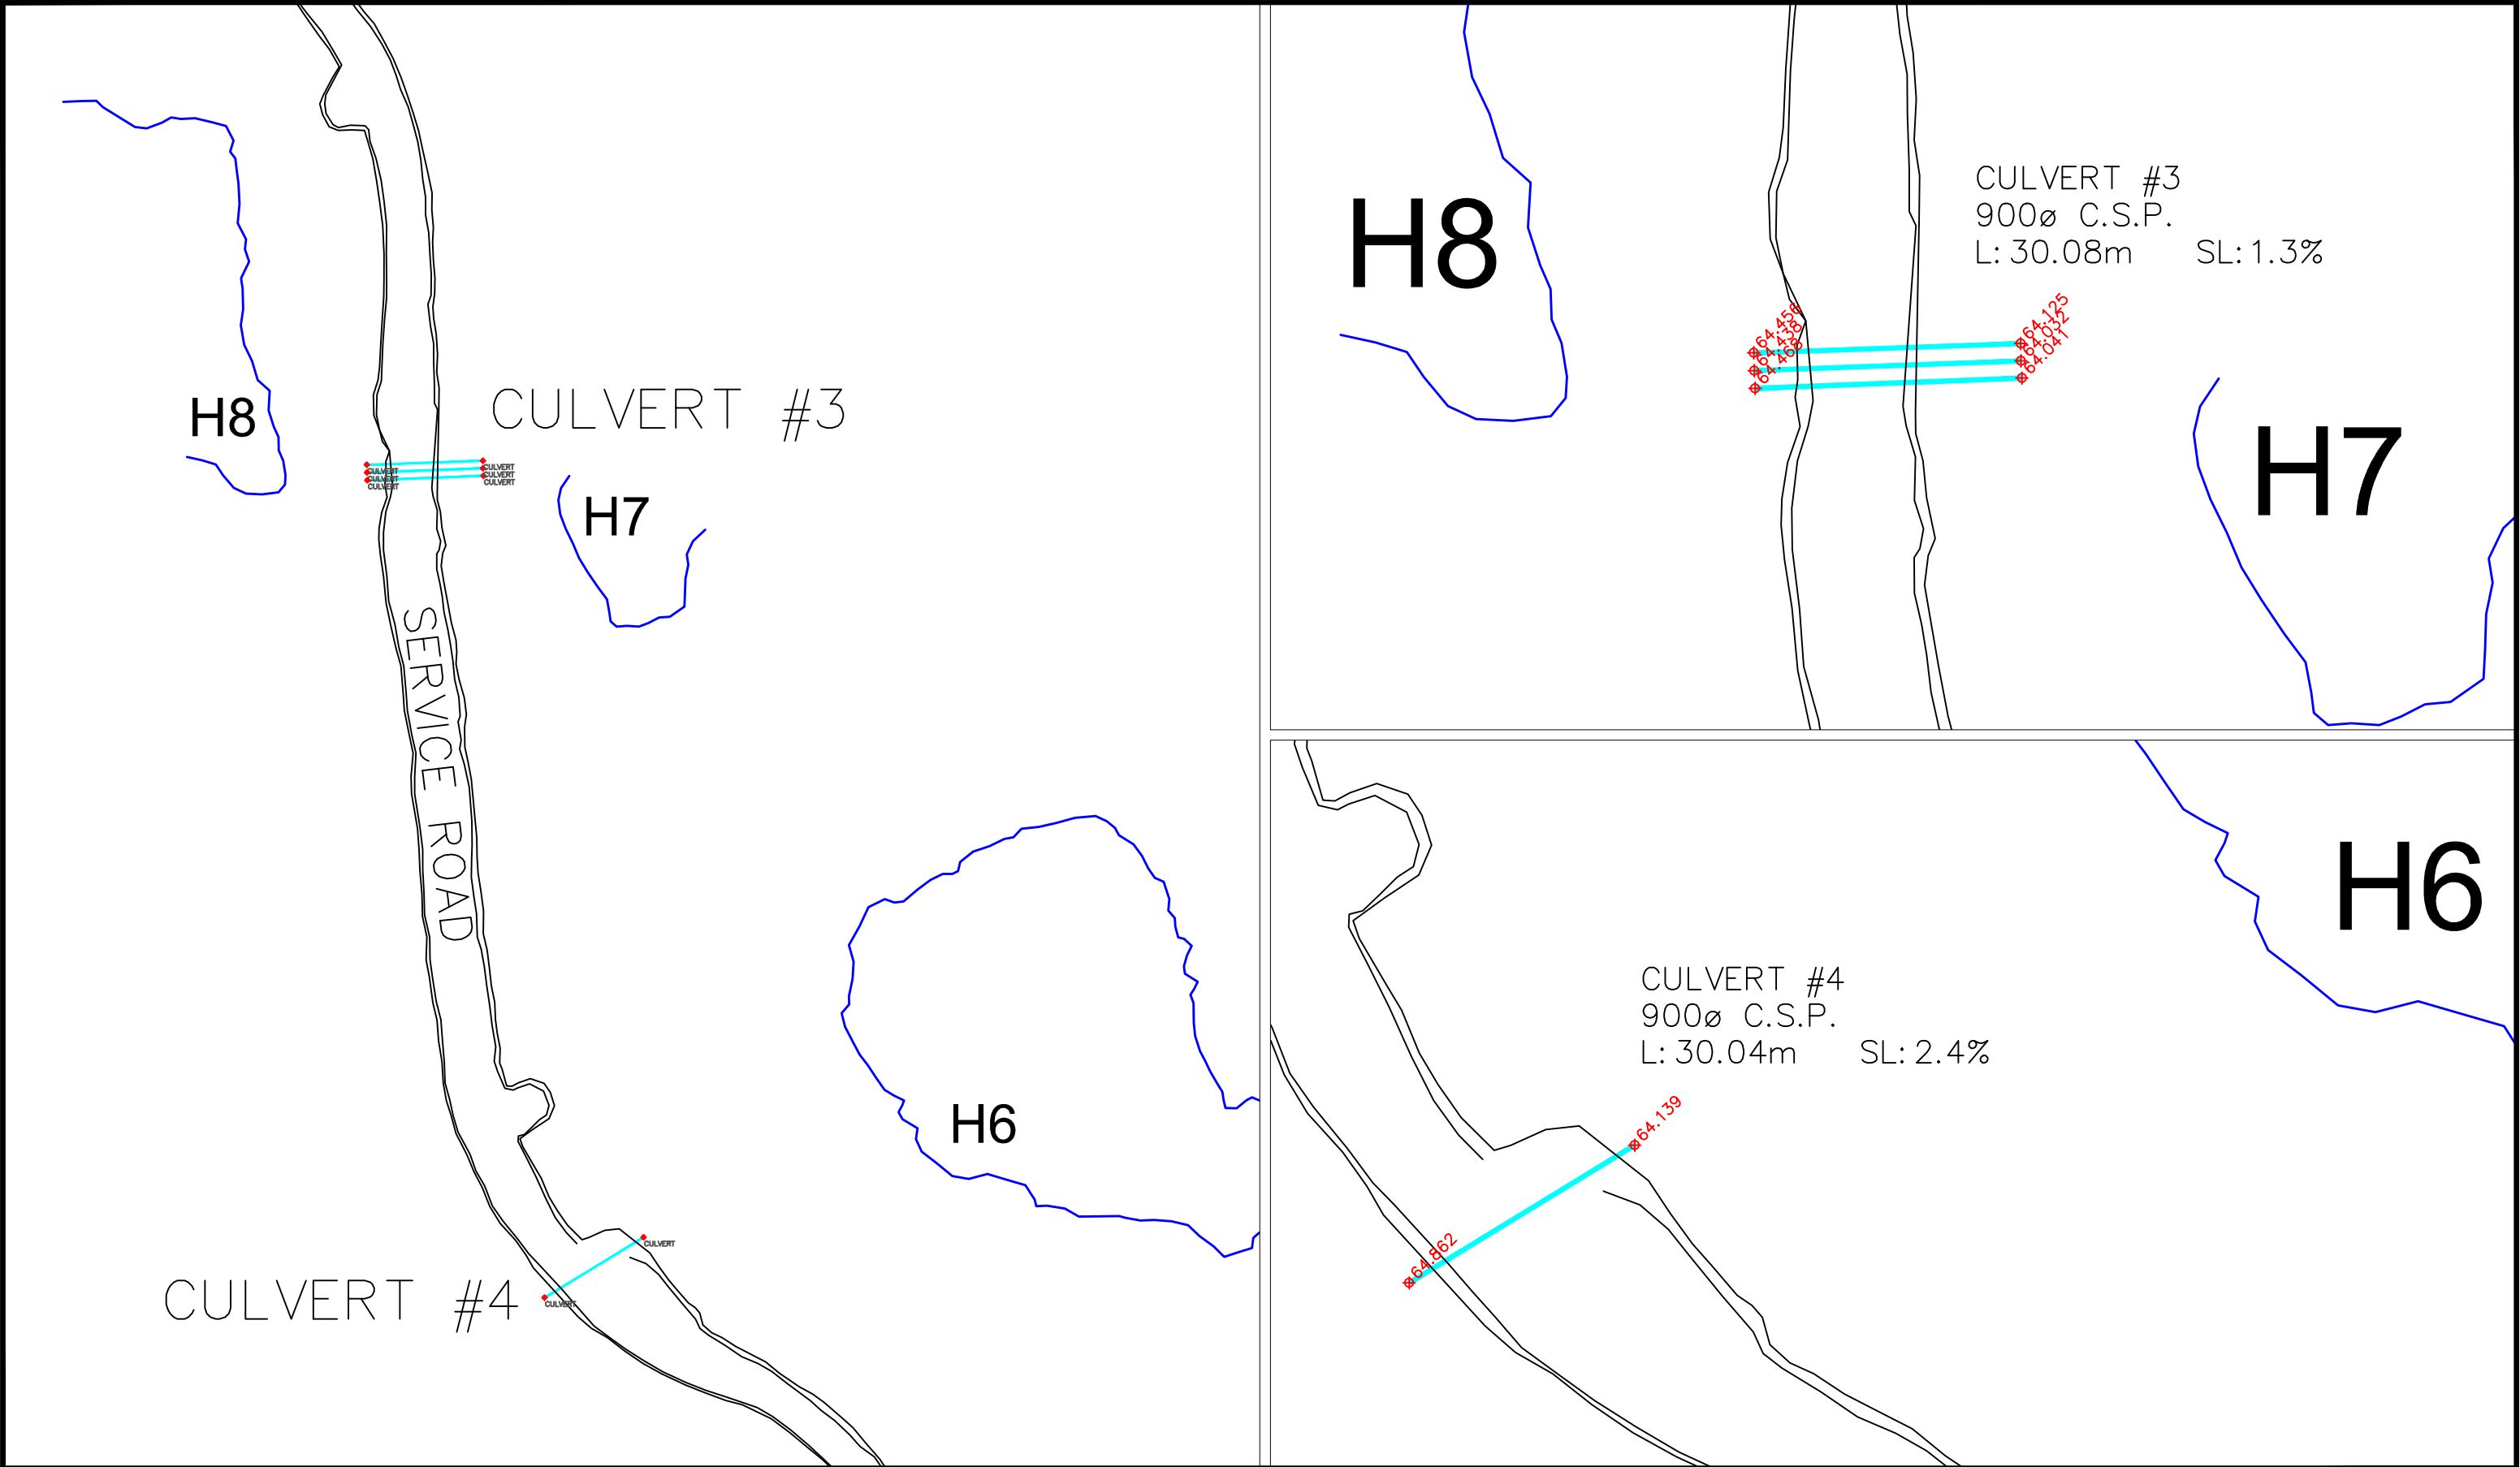
Système de Coord.: NAD83 UTM15	No plan: As Built – Culvert 3&4.dwg	AS BUILT CULVERT #3 & #4	AGNICO EAGLE	Date des travaux : 2016	Dessine par: JF Landreville
	Echelle: n/a				Date d'envoi : 2016-11-14	Approuve par: Hamel Arpentage

The lengths of the culverts installed are longer than those proposed in the original plans and design report. The culverts were lengthened to adjust for site conditions. The table below presents the lengths of the culverts originally proposed versus the lengths of the culverts built.

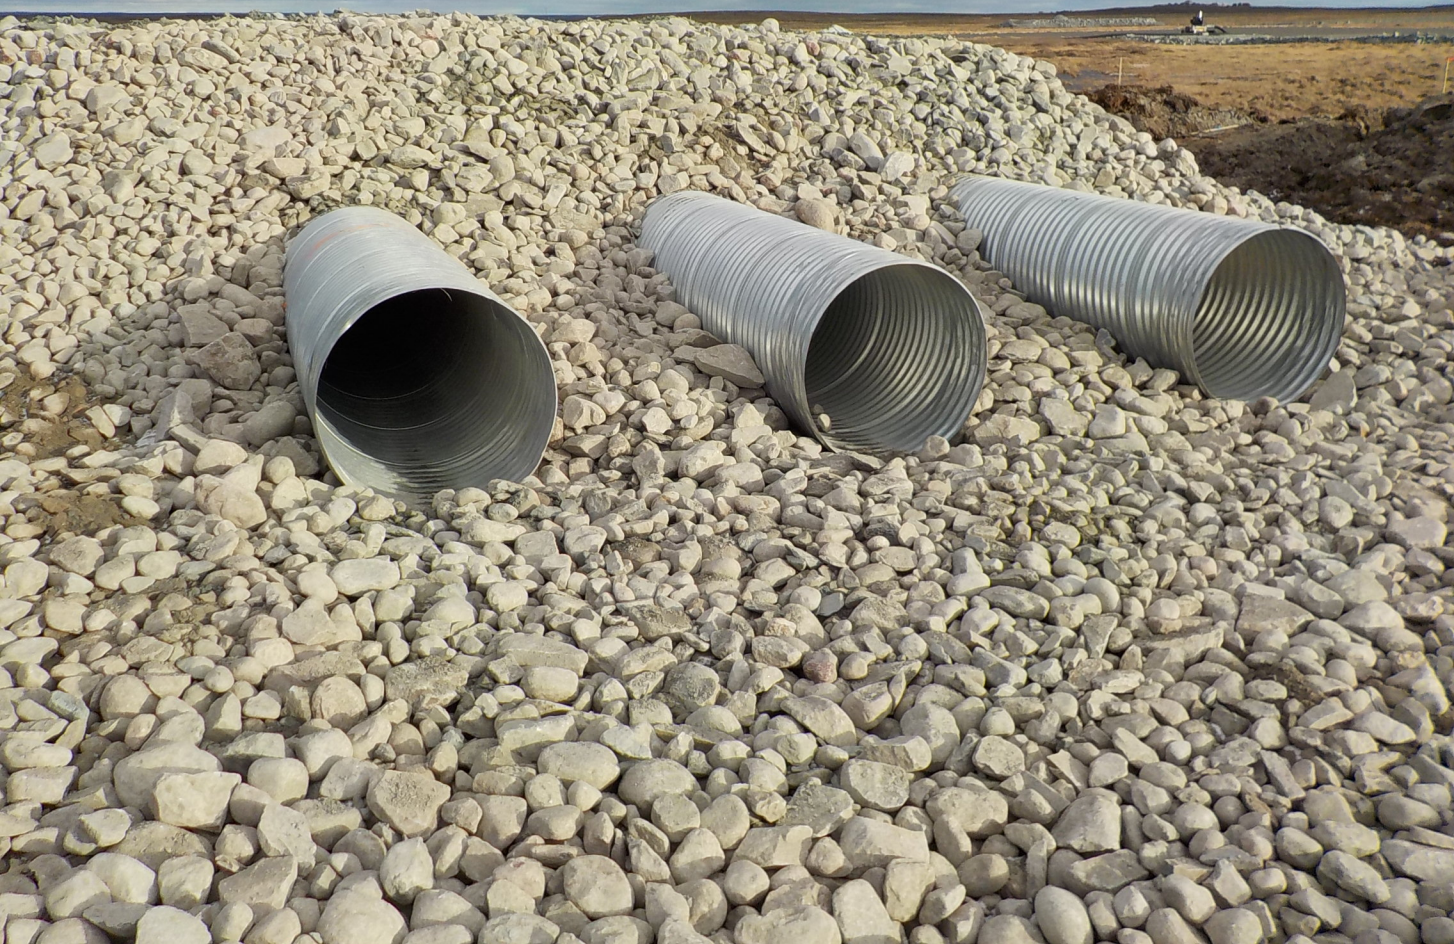
Picture 1 :

Culvert3 viewed from the upstream side
