Re: Water License 2AM-MEL1631 Part D, Item 3 / NIRB Project Certificate 11MN034
Condition 18 - Submission of Construction Summary Report for the Saline Pond

CONSTRUCTION SUMMARY (AS-BUILT) REPORT FOR SALINE WATER STORAGE/TRANSFER POND AND BERM, MELIADINE GOLD PROJECT

FEBRUARY 3, 2017
ISSUED FOR USE
FILE: 704-E14103230-01 TASK 025

AGNICO EAGLE DOCUMENT NUMBER: 6515-E-132-007-132-REP-006

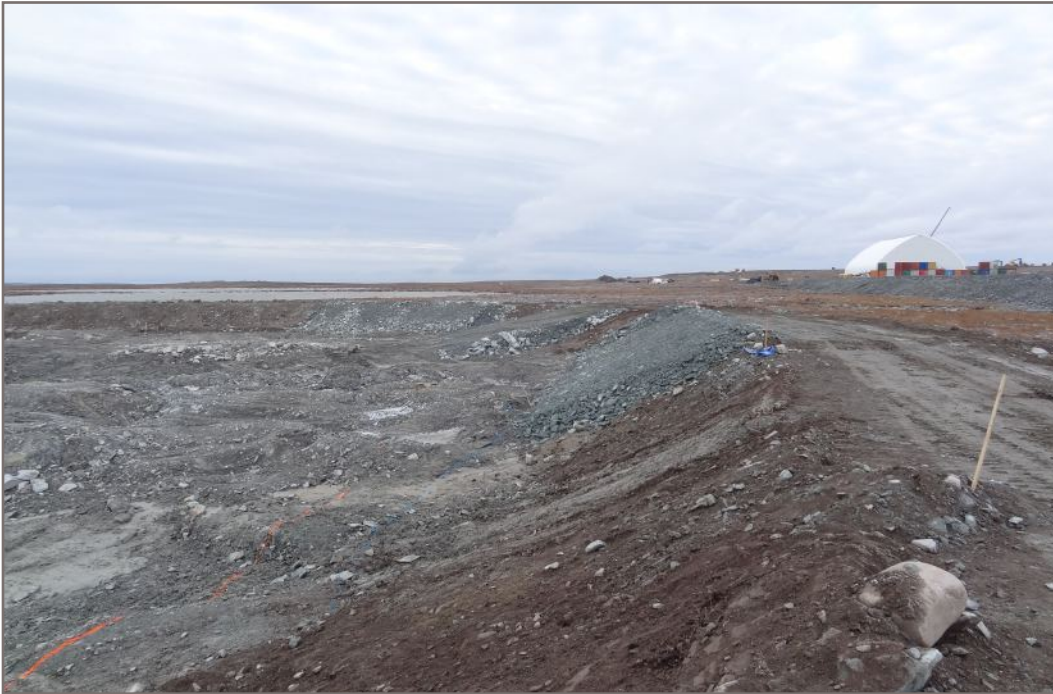
Photo 1: Excavation of overburden down to bedrock surface (looking south)

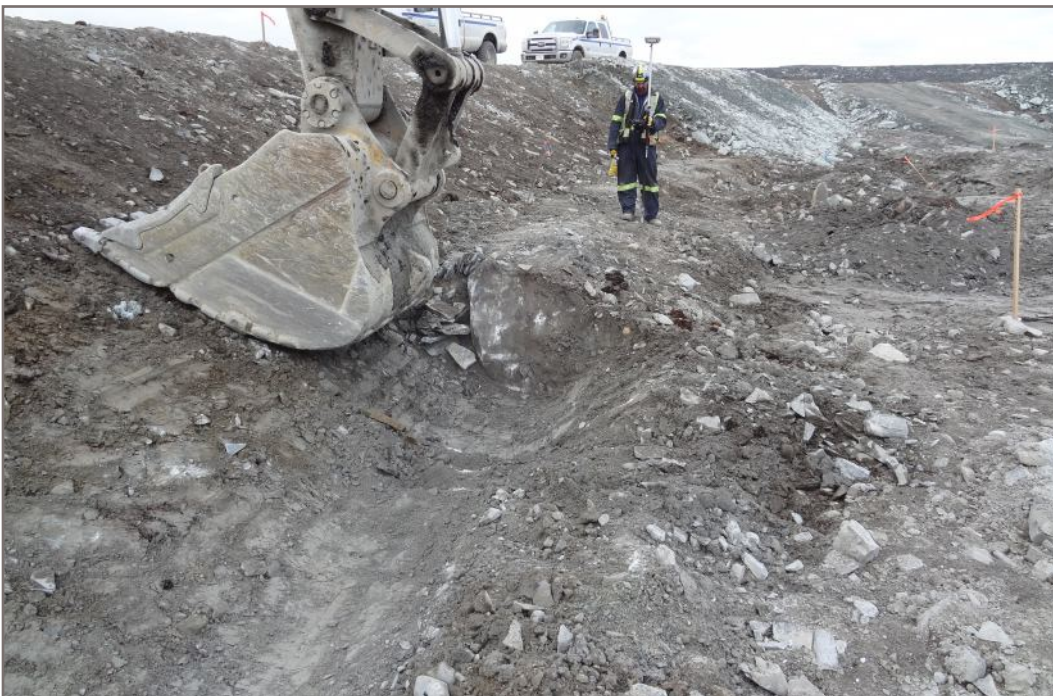
Photo 2: Shaping overburden slope (south wall)

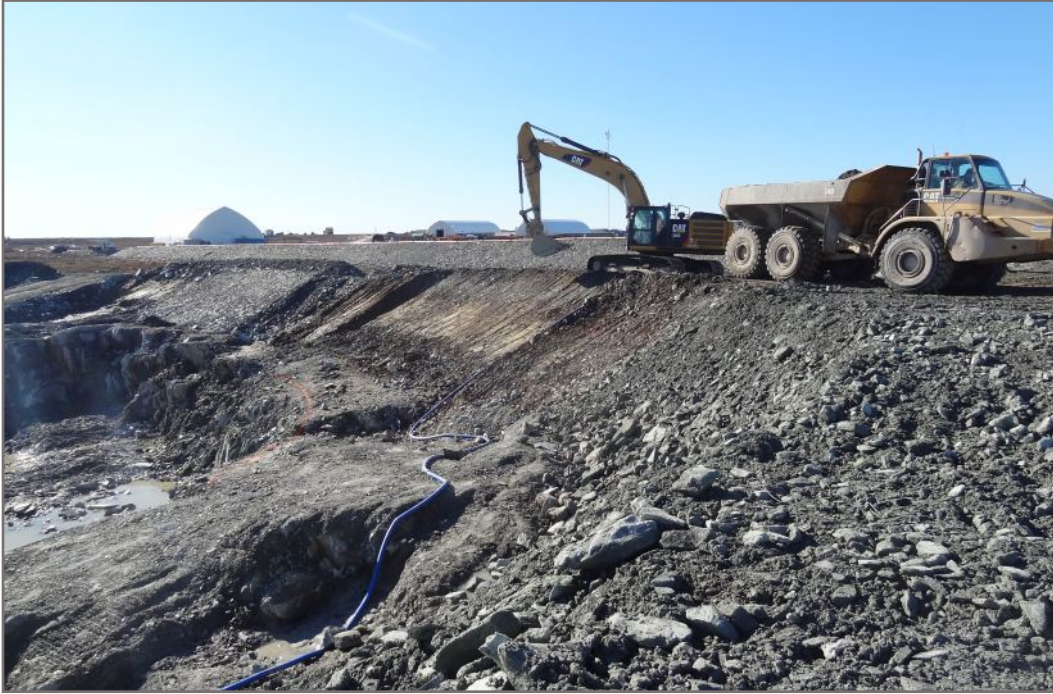
Photo 3: Shaping overburden slope (west wall)

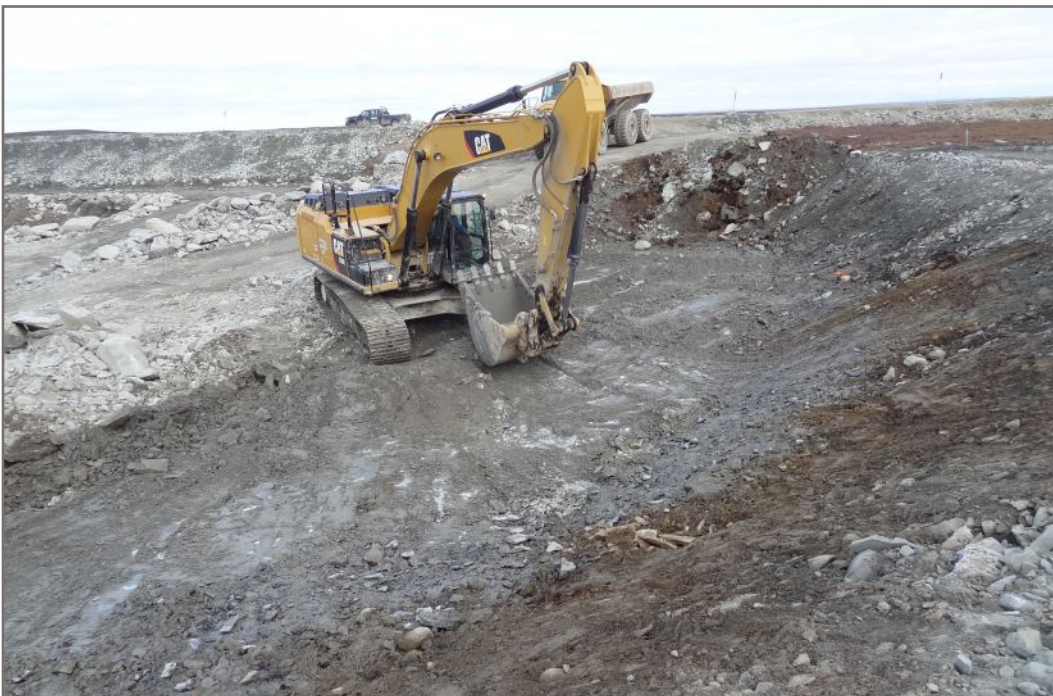
Photo 4: Excavating to competent bedrock (southeast corner)

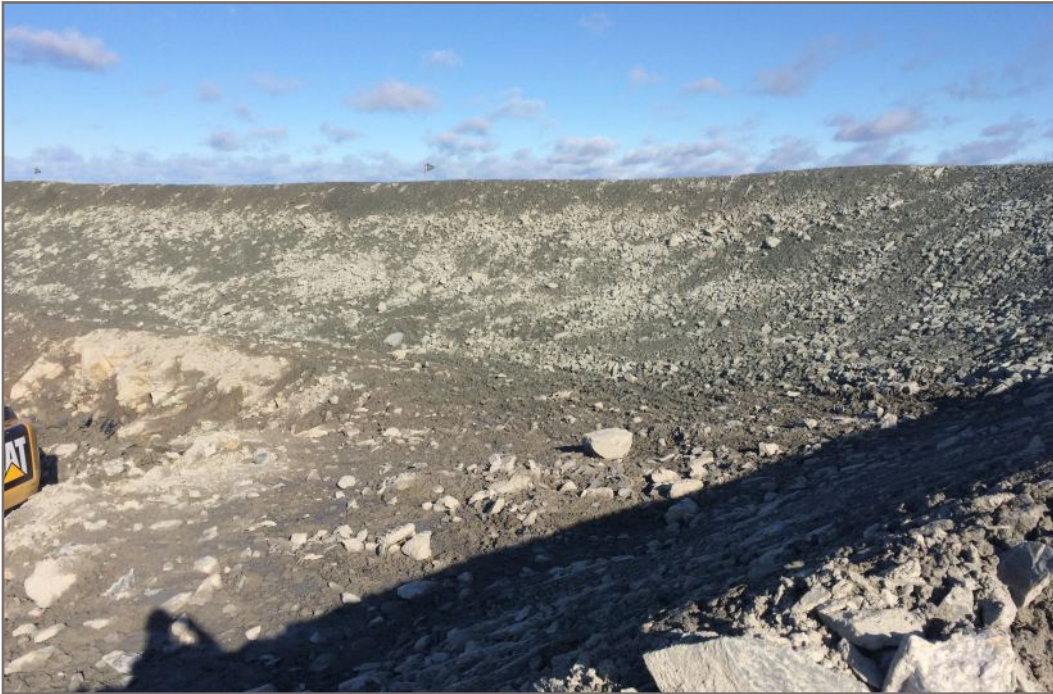
Photo 5: Completed ROM fillet (north wall)

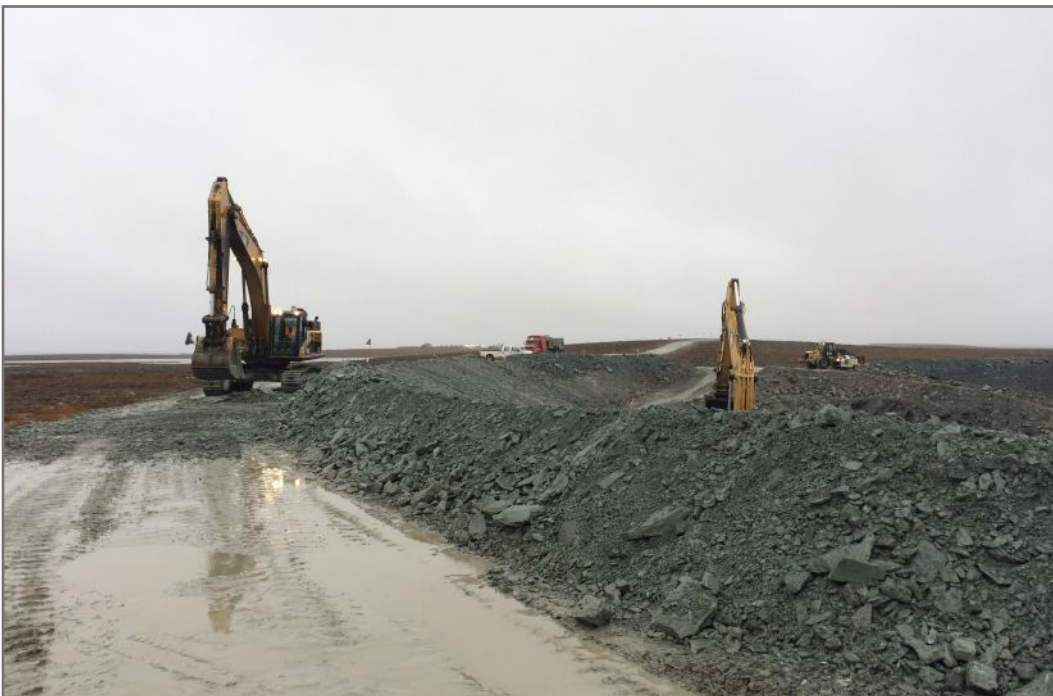
Photo 6: Safety berm along road (looking east)

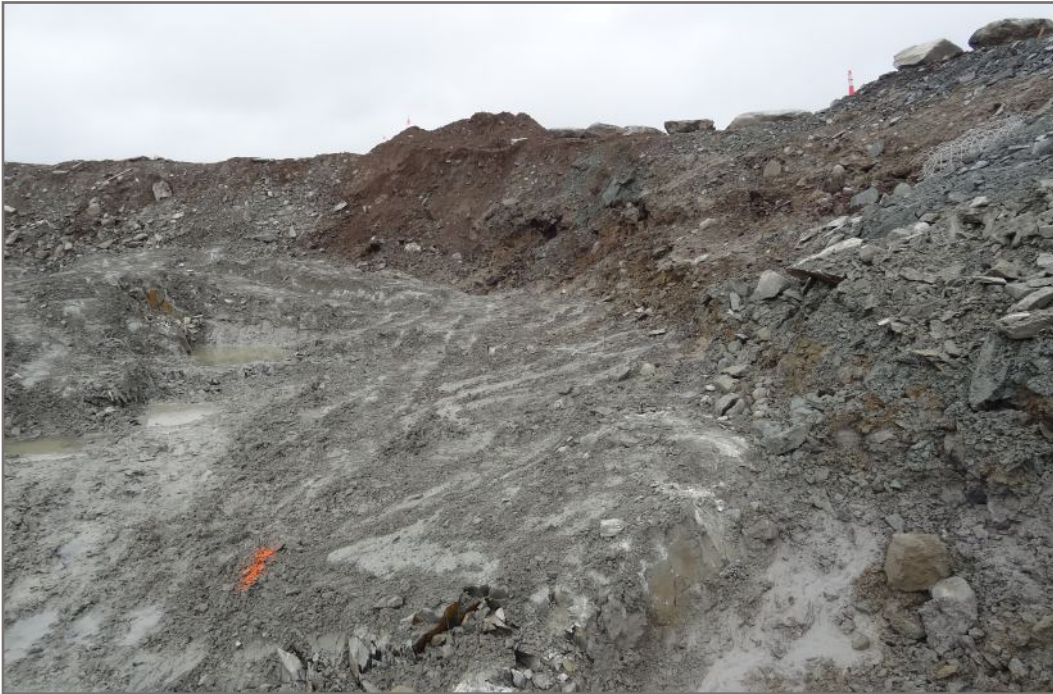
Photo 7: Over excavation of thawed overburden (northwest corner)

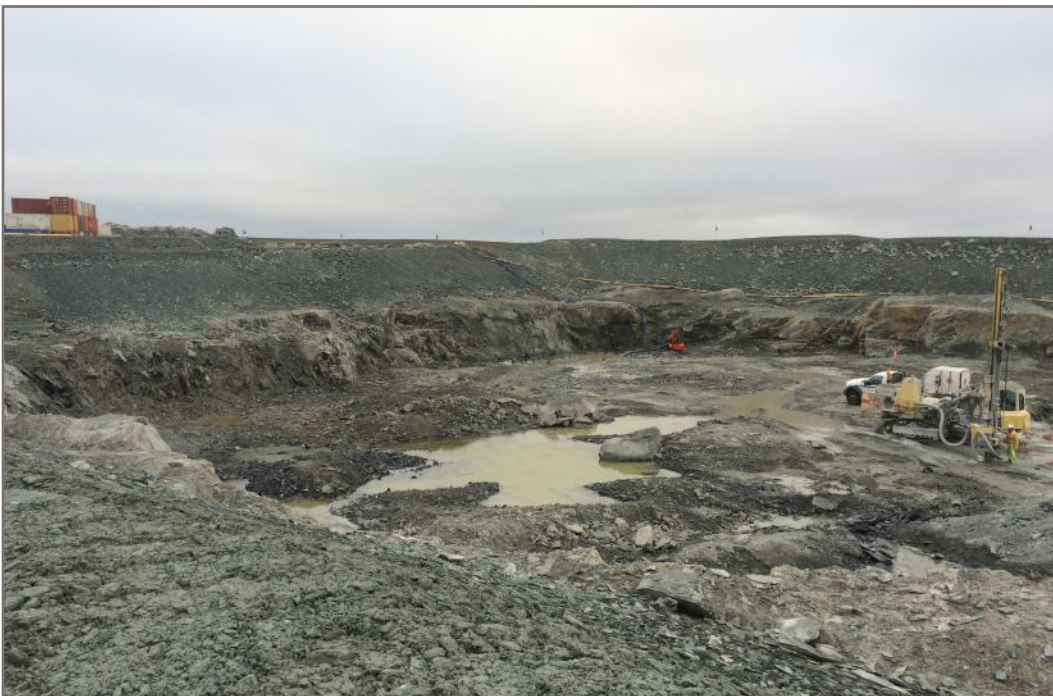
Photo 8: 59.5 m bench (looking northwest)

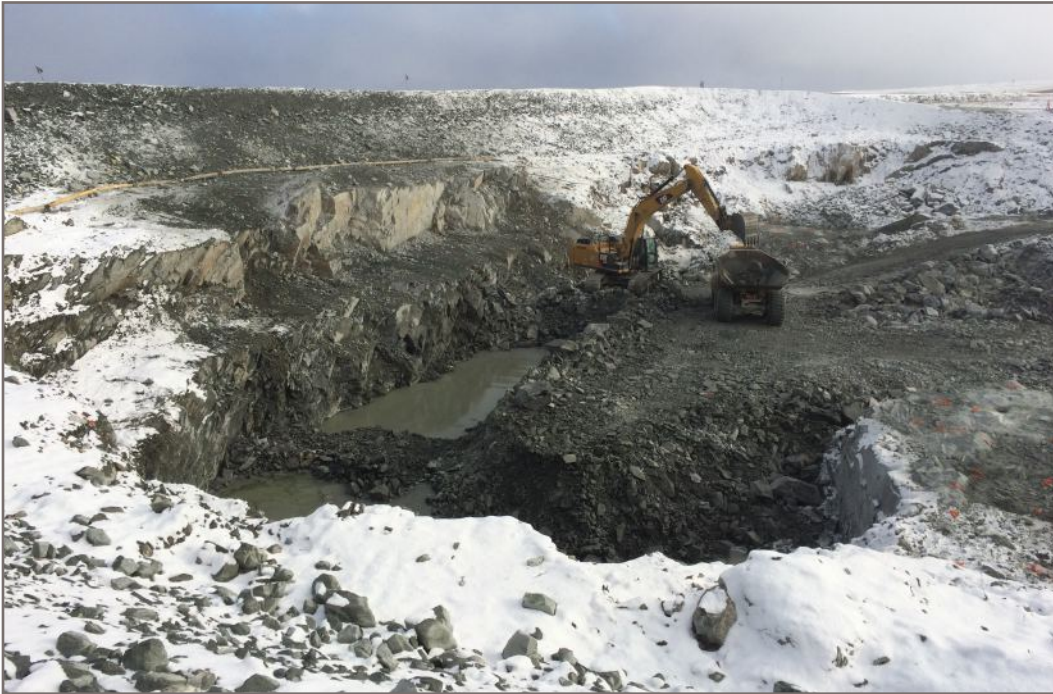
Photo 9: Excavating to 53.5 bench (north side)

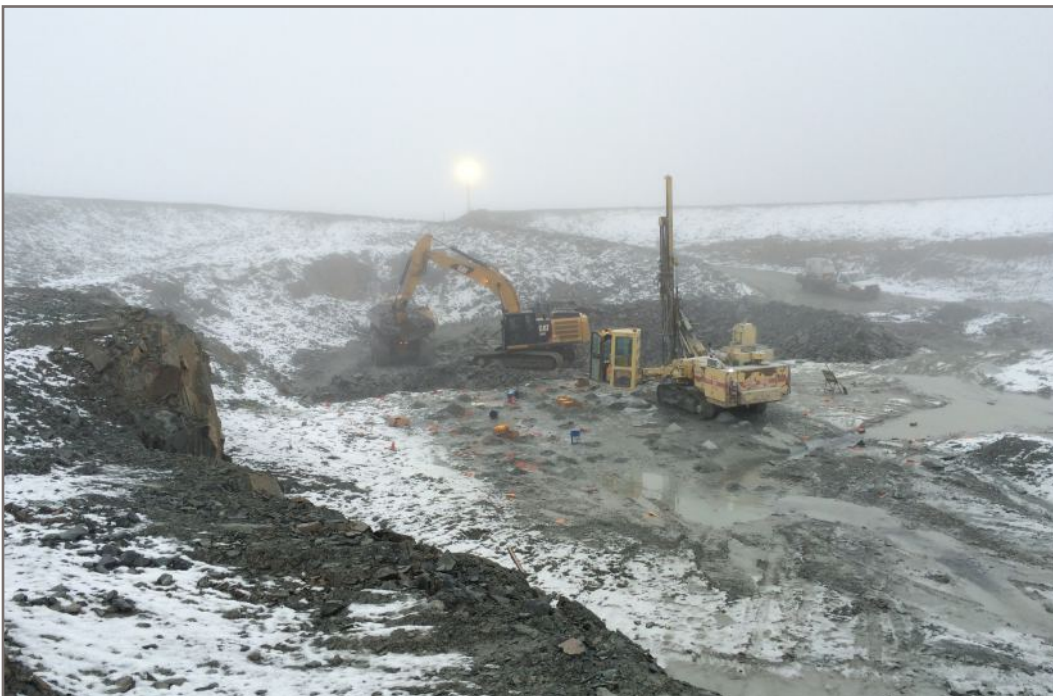
Photo 10: 2.15 m spacing blast pattern (looking east)

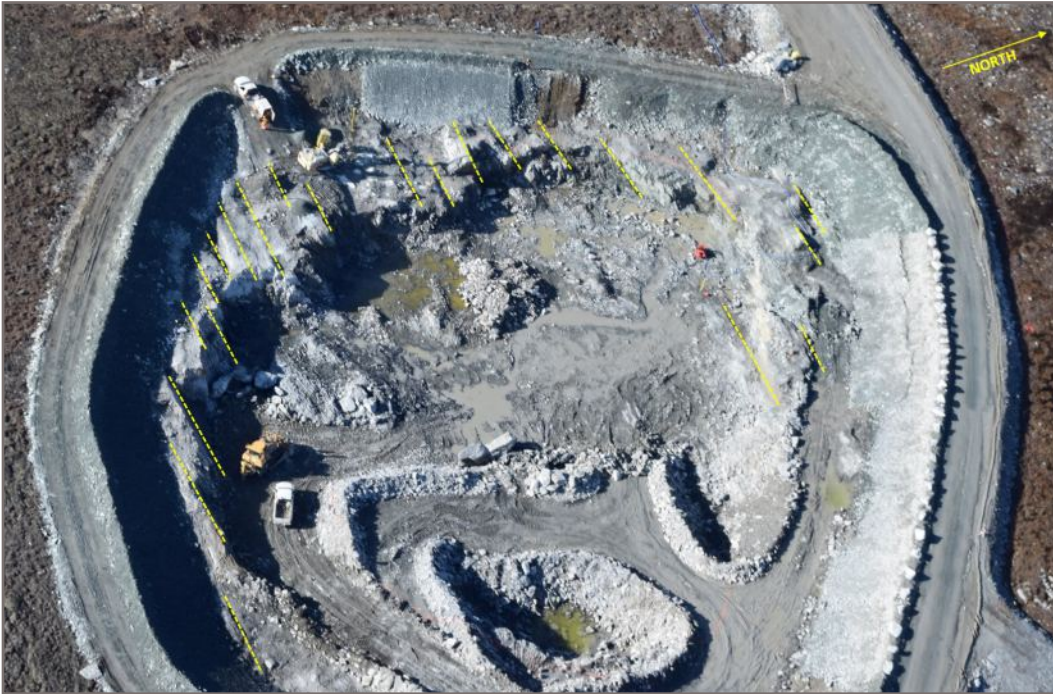
- Achieving the design crest and slope geometry proved difficult due to a combination of the blast methods employed and rock conditions encountered. The geometry of the pond walls was largely dictated by the strong East-West trending, steeply north dipping, foliation (Photo 11) that acted as preferential planes of weakness for rock breakage. Scaling of the rock faces followed each blast along the bench walls; however, in most cases the face was excavated back to a persistent foliation plane before a stable slope was achieved (Photo 12). This was especially common on the north and south walls because the trend of the face was nearly parallel to the foliation;

Photo 11: Ariel view with East-West lineaments highlighted

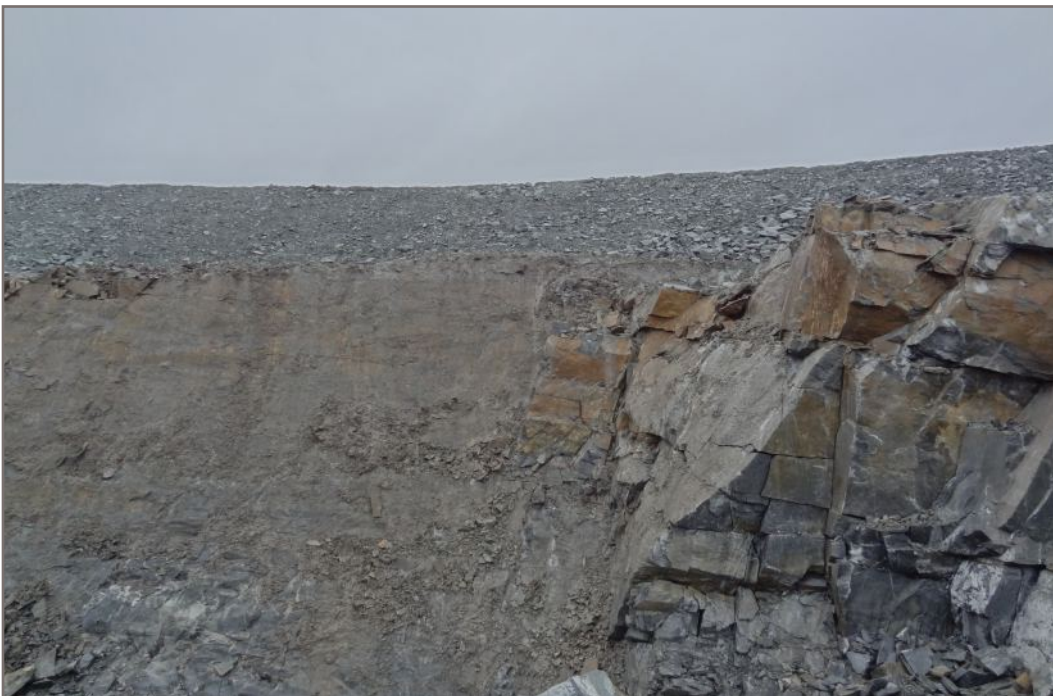
Photo 12: Excavating to stable foliation plane (south wall)

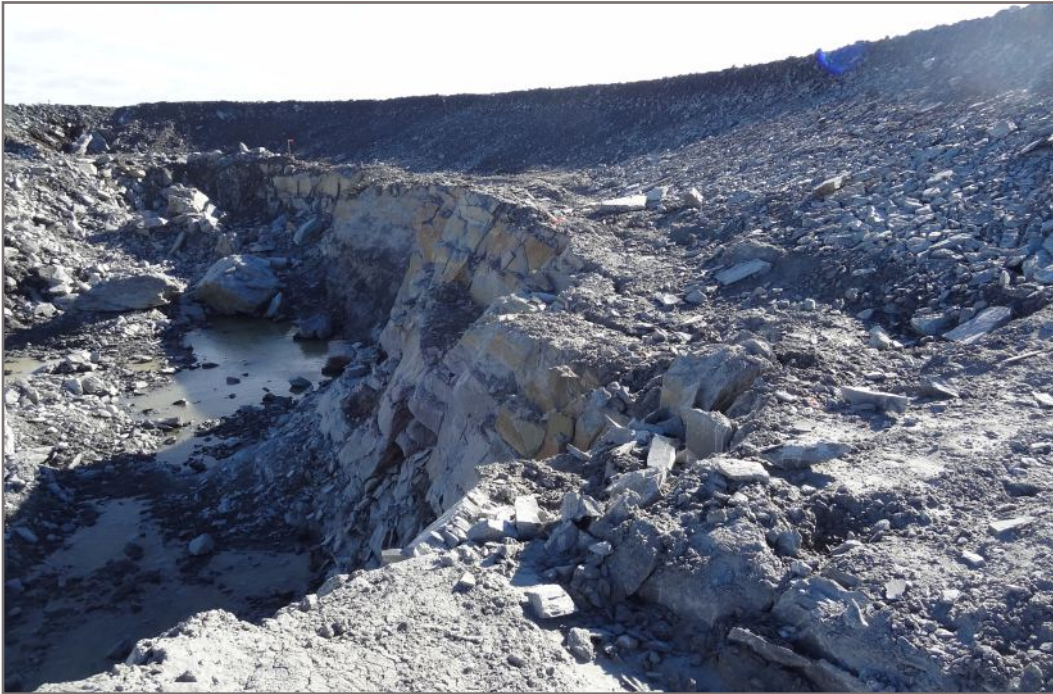
Photo 13: Irregular crest (south wall)

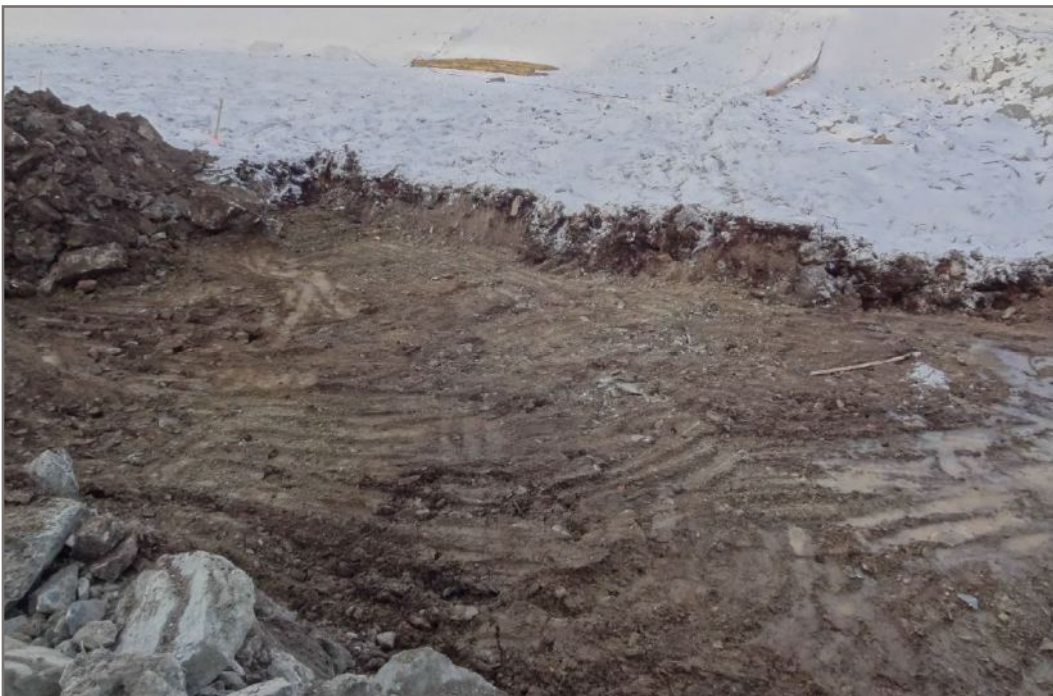
Photo 14: Berm trench after excavation of organics

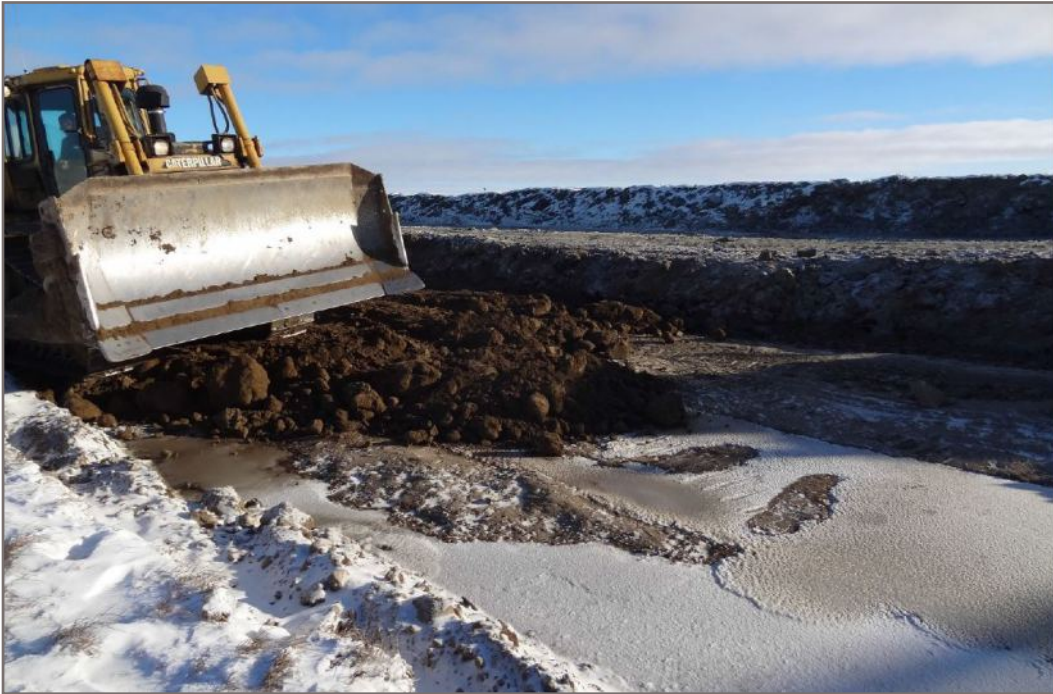
Photo 15: Frist lift of till

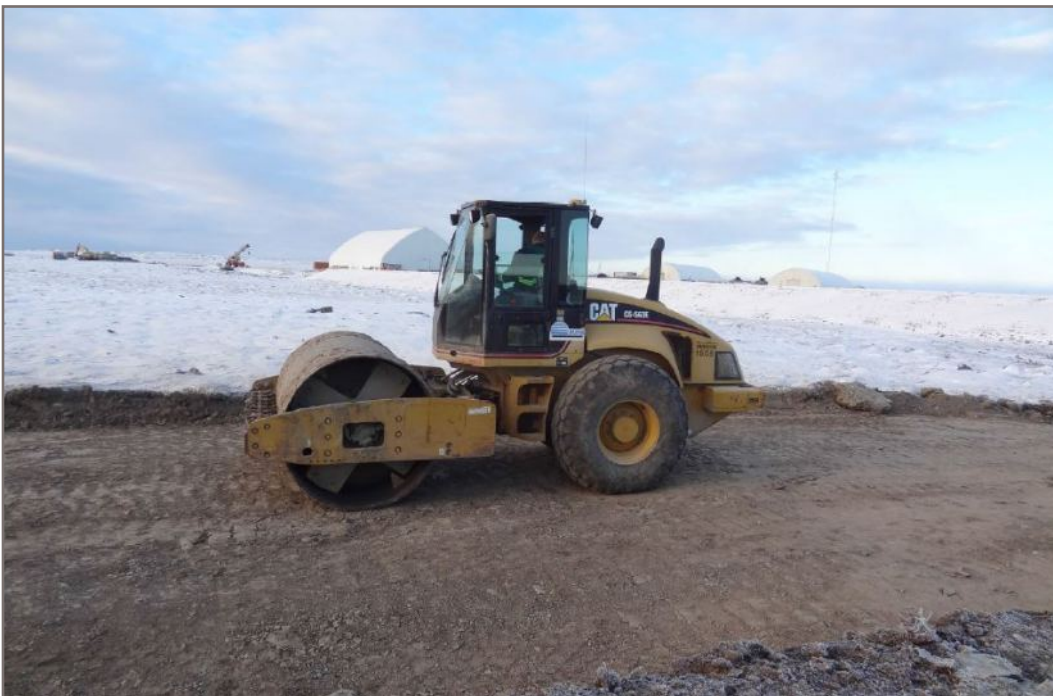
Photo 16: Compaction of till with roller

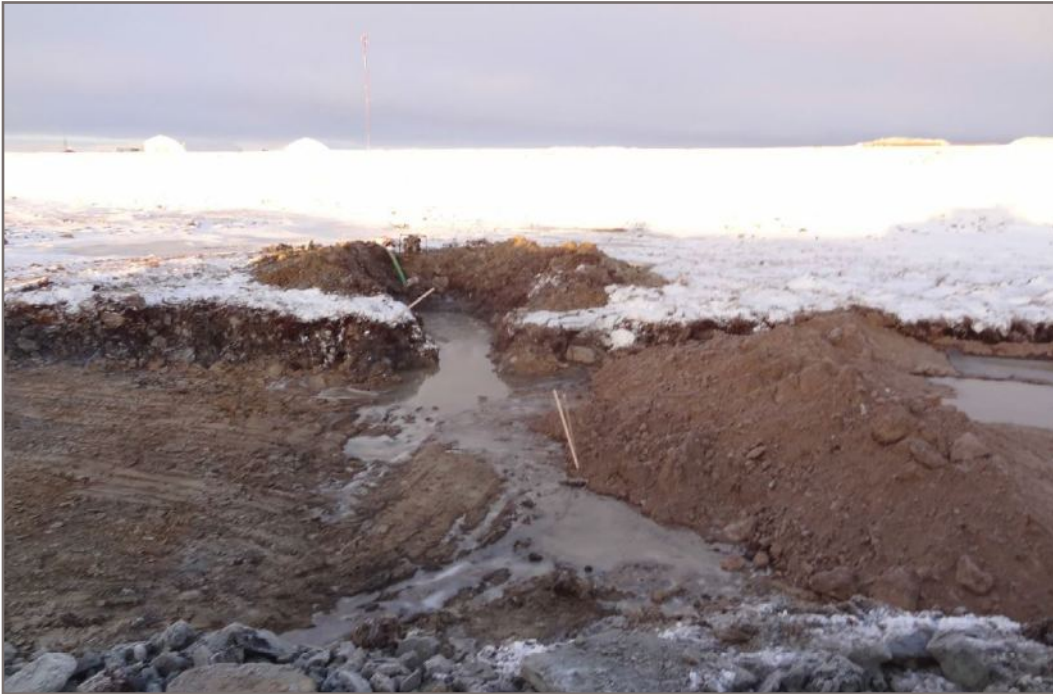
- Water infiltration into the excavated berm trench was generally observed to be minimal, and the excavation was not allowed to remain open for any length of time. However, at approximate chainage 0+060, seepage water was observed and attributed to a possible seepage path from the nearby P3 pond. A temporary sump was dug to the west of the excavation footprint and pumping commenced until the berm was completed in this area (Photo 17);

Photo 17: Temporary sump (west side)

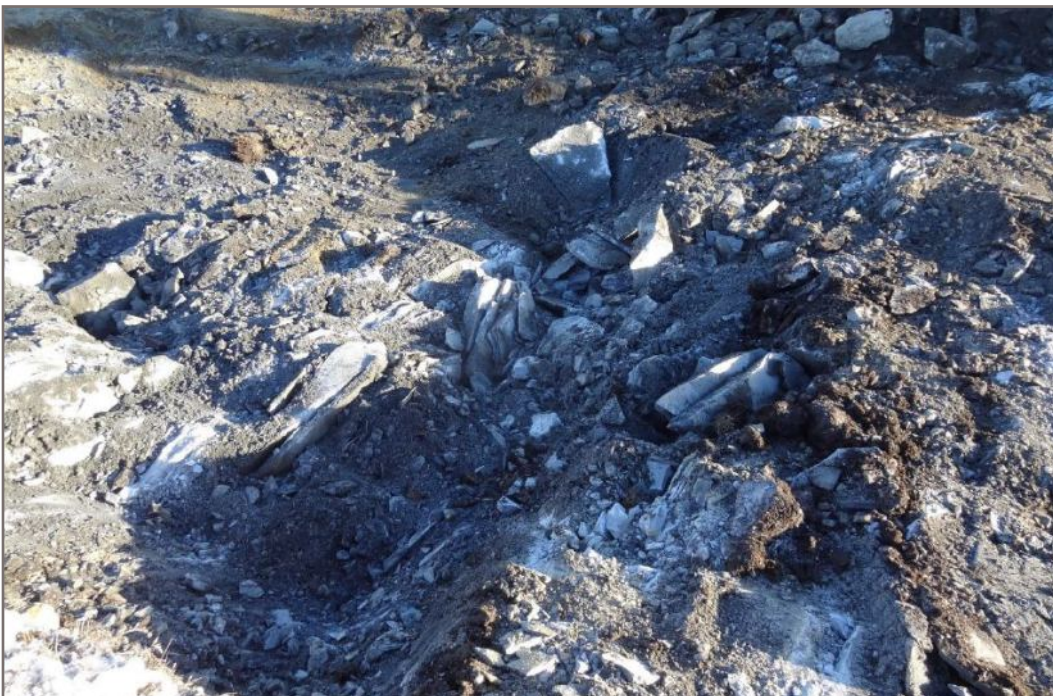
Photo 18: Bedrock encountered during trench excavation

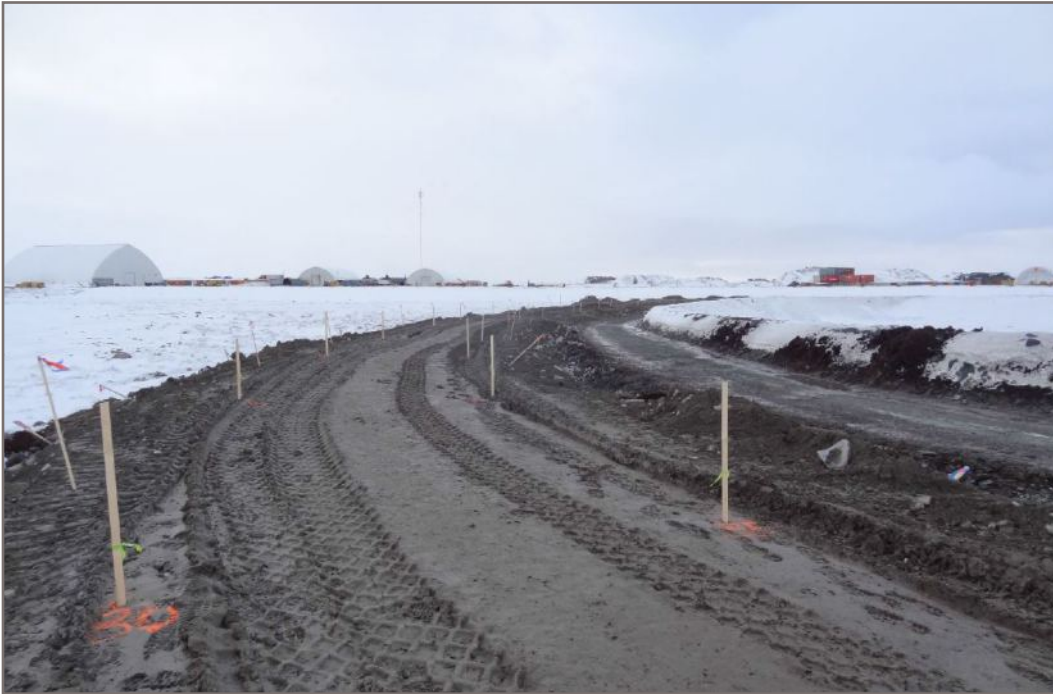
- On October 18, 2016, Tetra Tech observed that the berm was overbuilt (Photo 19) and that removal of material was required. This work was completed on October 20, 2016; and

Photo 19: Crest and toe stakes showing overbuild, approx. chainage 0+190 (looking west)

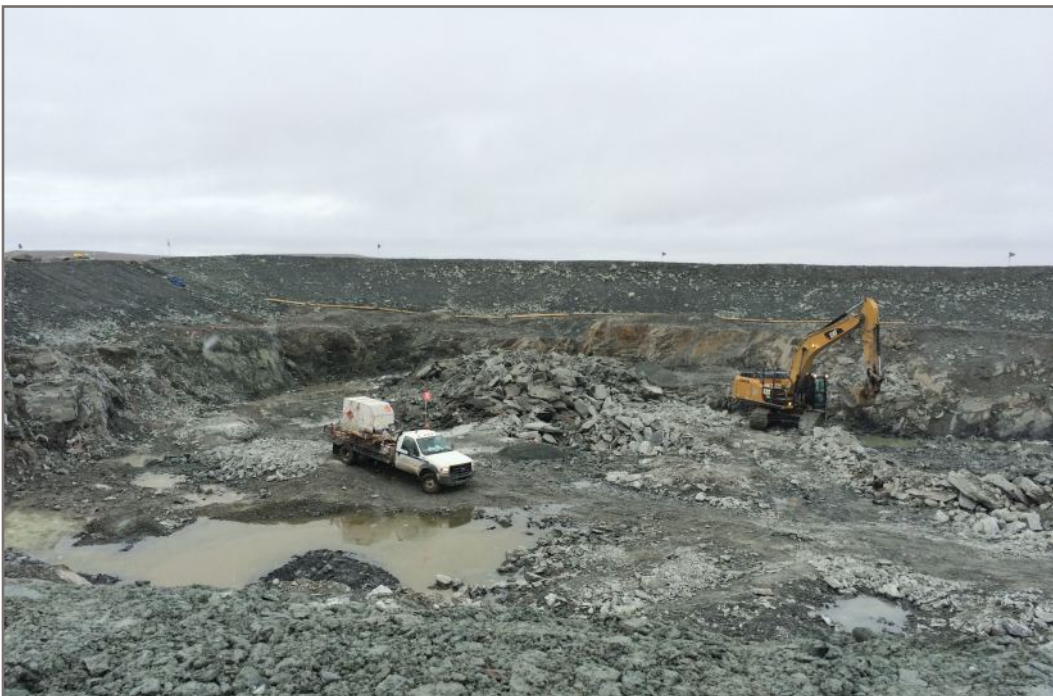
Production of oversized material was an issue throughout saline pond excavation. It was especially problematic for the 59.5 m (elevation) bench and many of the blasts were estimated to contain up to 40% oversize material (Photo 20). A number of factors likely contributed to the oversize material, including but not limited to, using explosive mixtures designed for underground use and a failure to account for the orientation of the dominant rock fabric when designing blast patterns and/or timing. The significance of having a large amount of oversize is the inability to use it as crusher feed without further treatment/cost (i.e. additional blasting or mechanical rock breaking).

Photo 20: Blast showing oversize material (looking north)

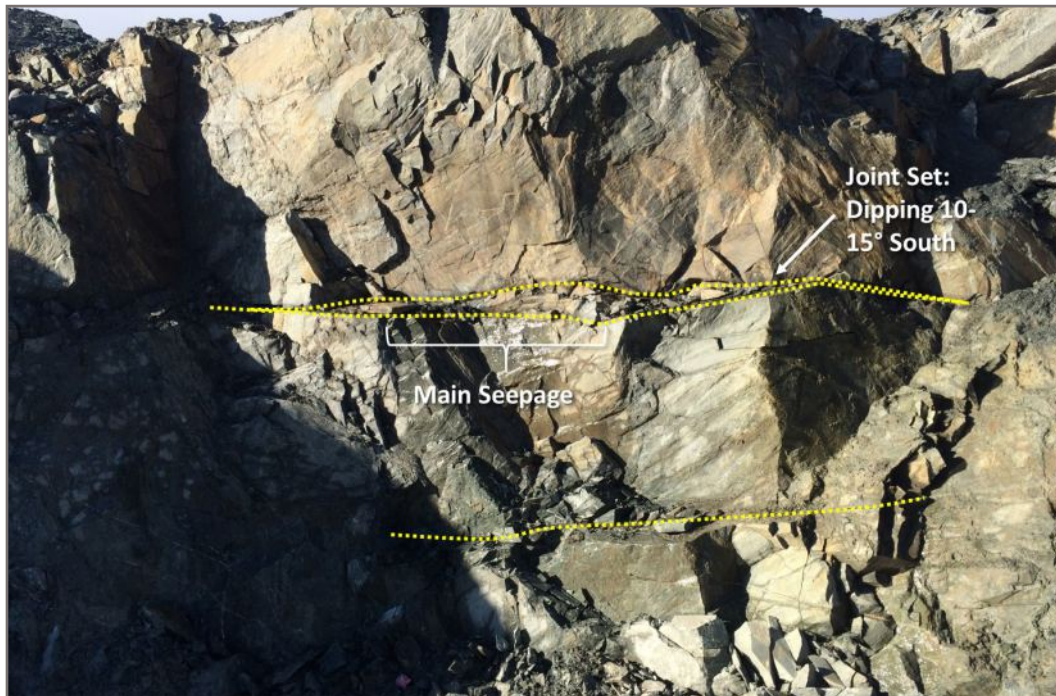
Water inflow was observed from several discrete locations on the excavated faces during the early stage of construction of the saline pond, ranging from minor seeps along partially open fractures to measurable flows. On the west wall near approximate chainage 0+020, clear water was observed exiting a steeply dipping (east) joint approximately 2 m below the original bedrock surface (Photos 21 and 22). Seepage rates at this location were originally estimated to be between 1 litre/minute to 2 litres/minute, but as the excavation progressed, increased to between 7 liters/minute to 10 litres/minute with the exit point migrating along the existing fracture network to the north. On the south wall, between approximate chainage 0+130 and 0+140 at elevation of 60.5 m, clear water was observed seeping from a steeply dipping (east) fracture approximately 1.5 m from the bedrock surface (Photos 23 and 24). Flow rates here were estimated at 3 litres/minute to 4 litres/minute but again appeared to increase as additional excavation took place. At their peak, combined inflows from these two areas was estimated at 30 litres/minute by Agnico Eagle Operations personnel.

Photo 21: Inflows observed in northwest corner

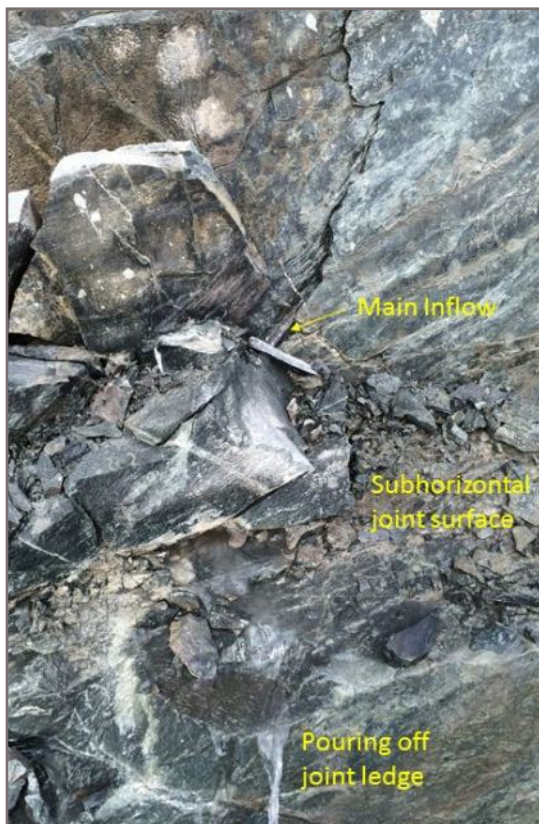
Photo 22: Close-up of inflow (northwest corner)

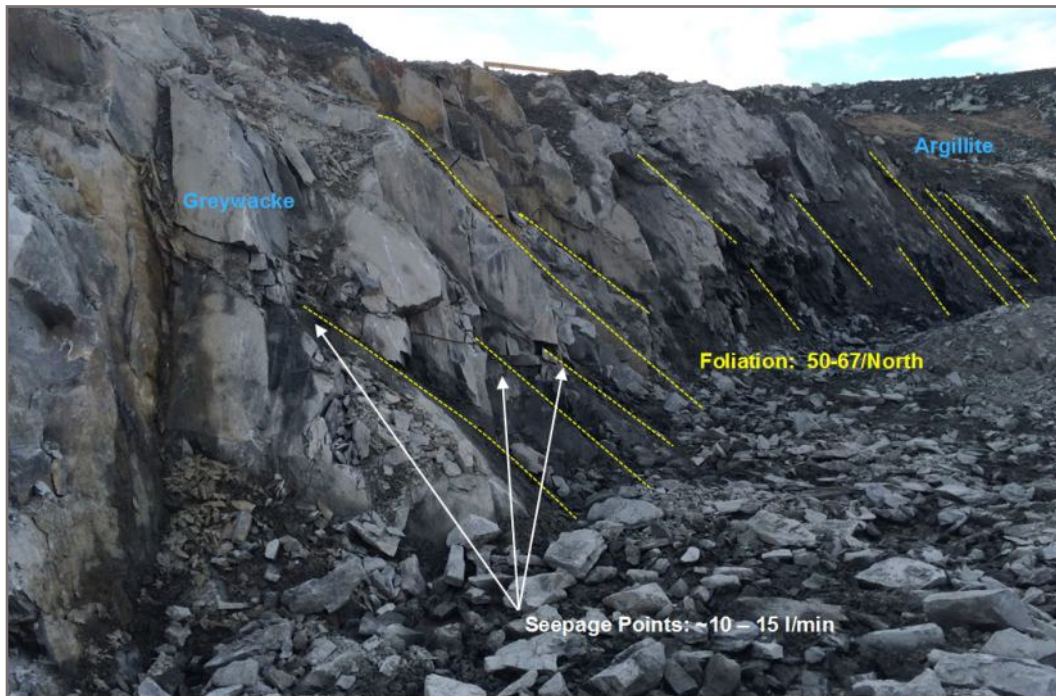
Photo 23: Seepage points observed in south wall

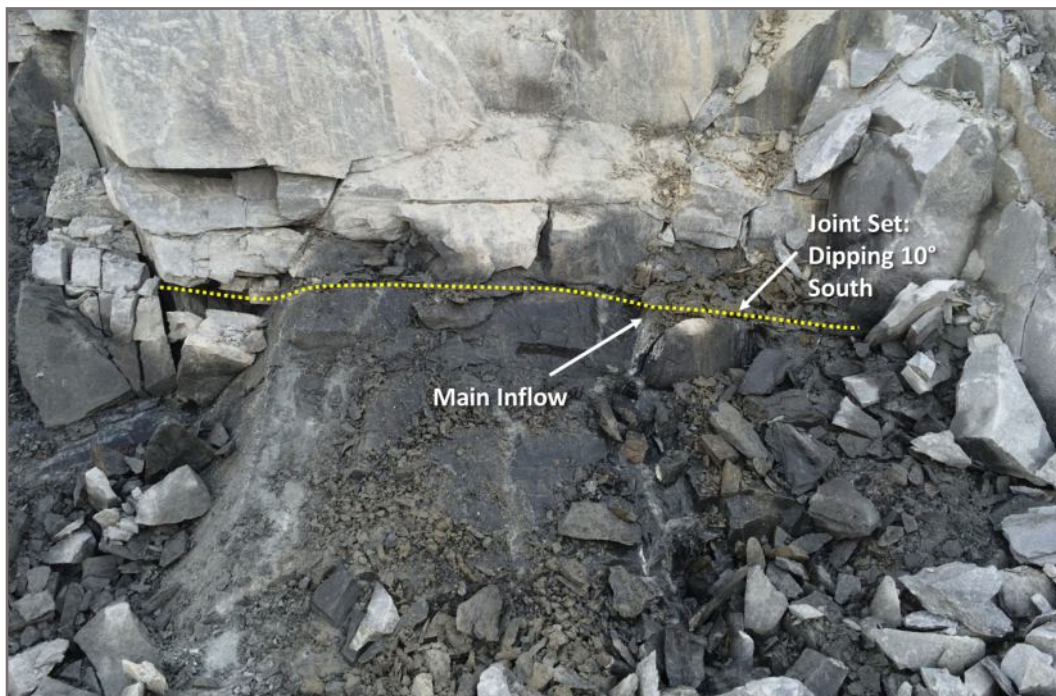
Photo 24: Close-up of inflow (south wall)

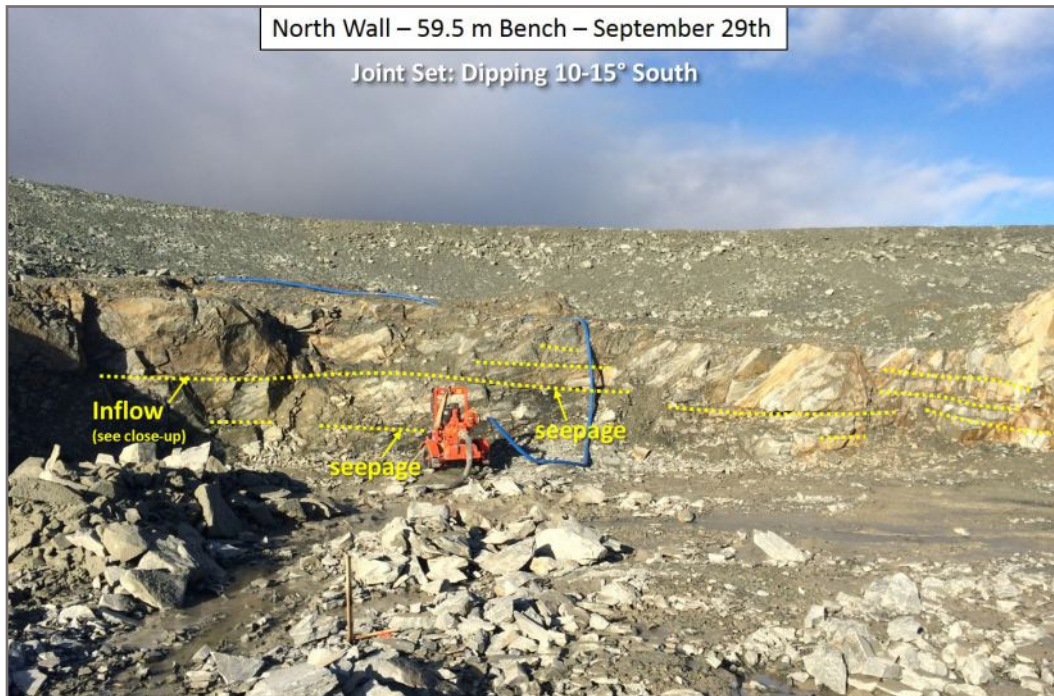
Photo 25: Sub-horizontal jointing associated with water infiltration (looking north)

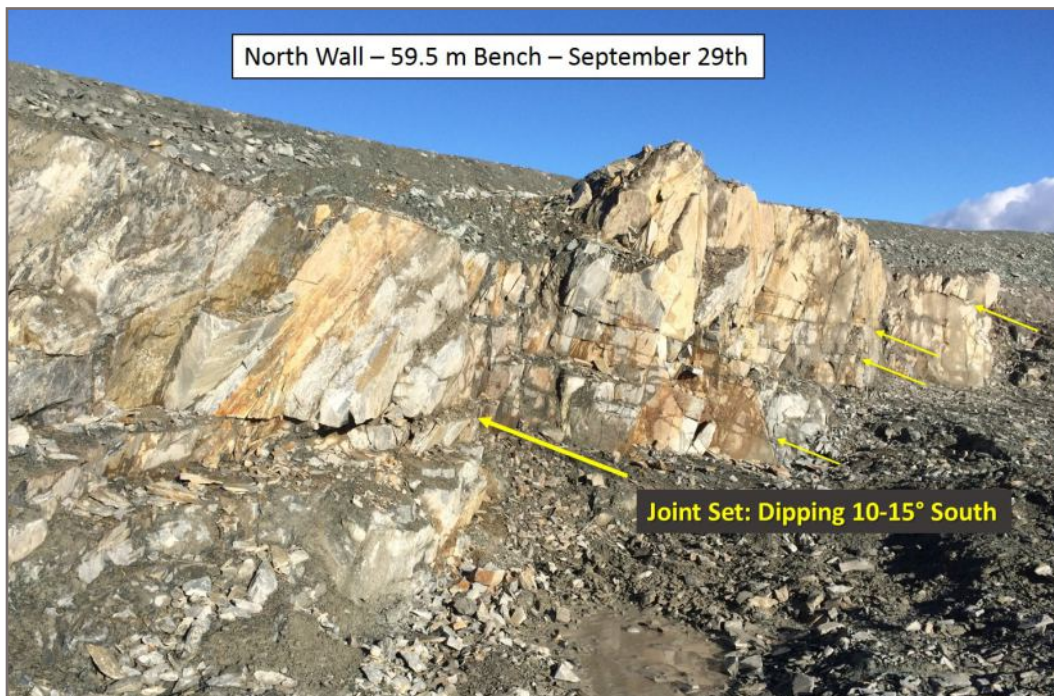
Photo 26: Sub-horizontal jointing associated with water infiltration (looking northeast)

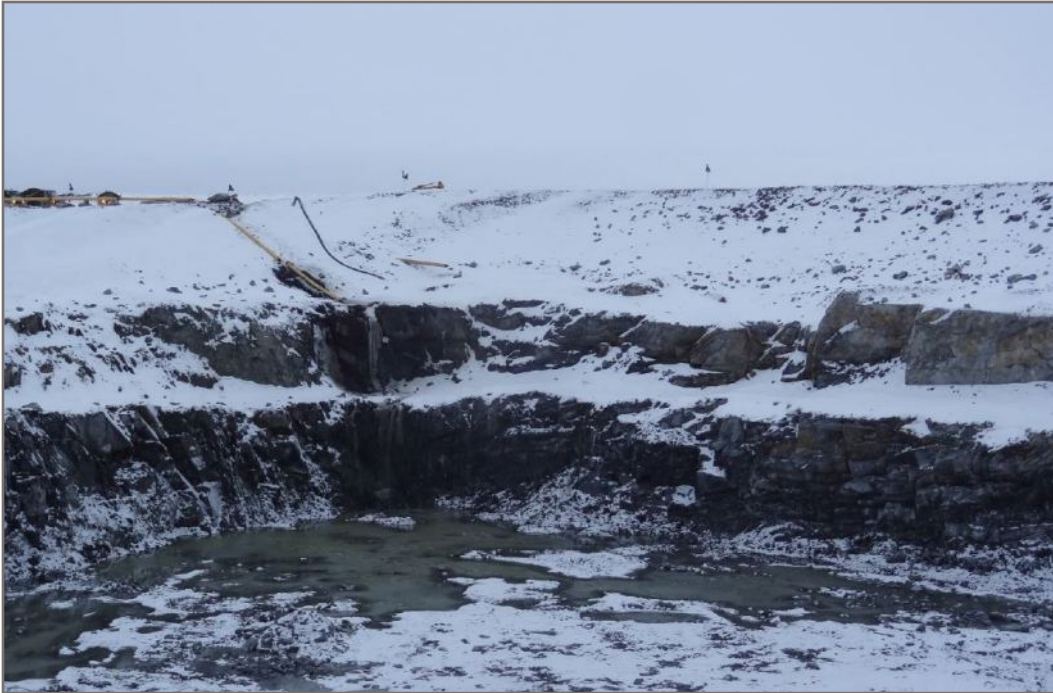
Pumping of saline water from underground into the saline pond began on October 20, 2016. Tetra Tech observed that the discharged point was onto the ROM fillet slope approximately three quarters down the slope at approximate chainage 0+020 (Photo 27). The concern was raised that the introduction of large, continuous volume of saline water onto the slope would cause local erosion, negatively impact local stability at this location, and increase the salinity of the fill and overburden soils in the area.

Photo 27: Discharge of saline water onto ROM slope (looking northwest)
