| Endroit du travail : | Site Meliadine Gold Mine at | File no : | |

## **Field Erected Fuel Storage Tank Handover Package**

| REVISION HISTORY | | | |
|---|---|---|---|
| | | TK #1 - 20,000CUM TANK 43M DIA X 14M H | |

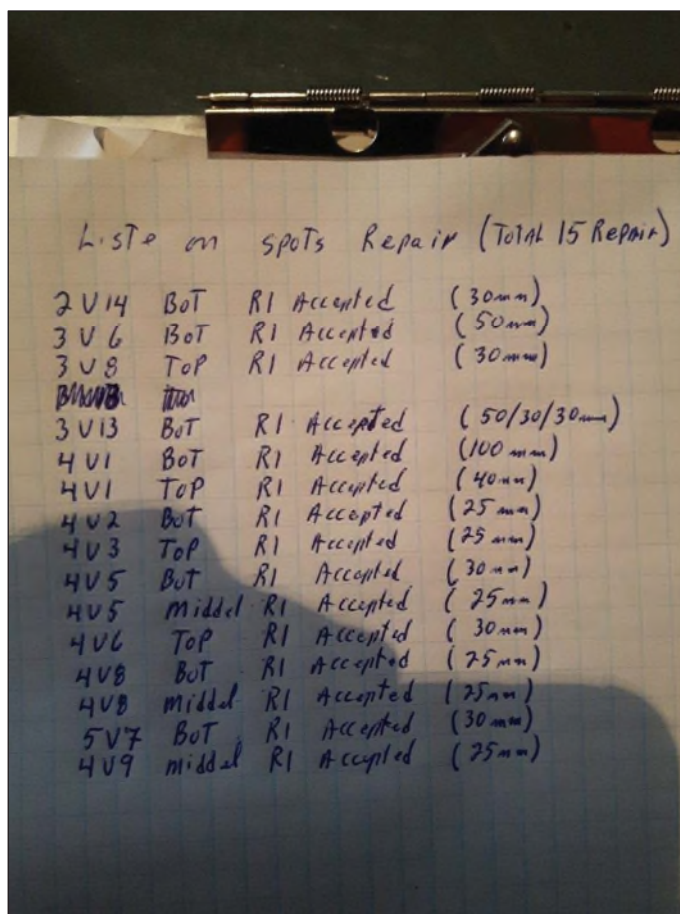
List the spots repairs with regulated length and accepted after repair R1

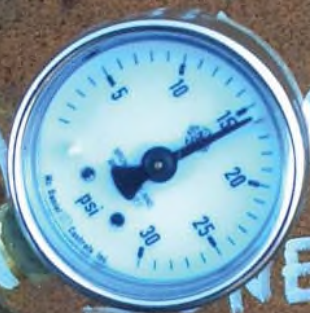
M1614

ST. OK

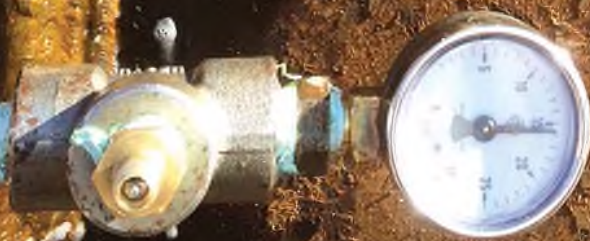
M1601

AIR TEST OK MM

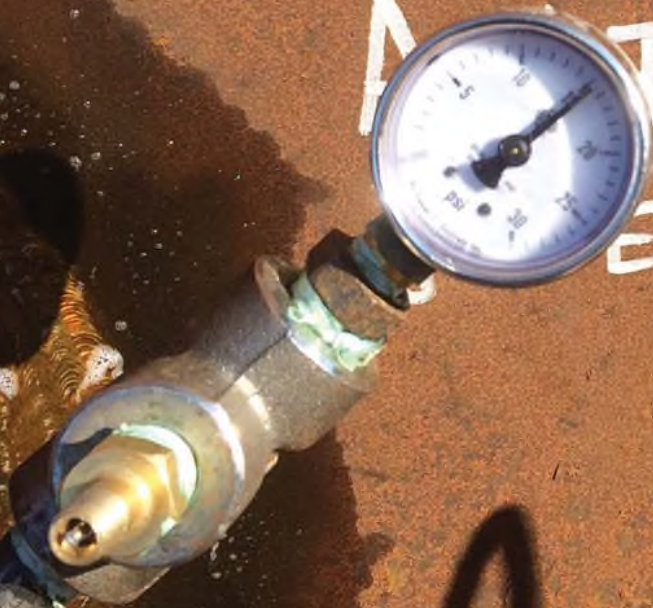
M1614

TEST OK MMCB

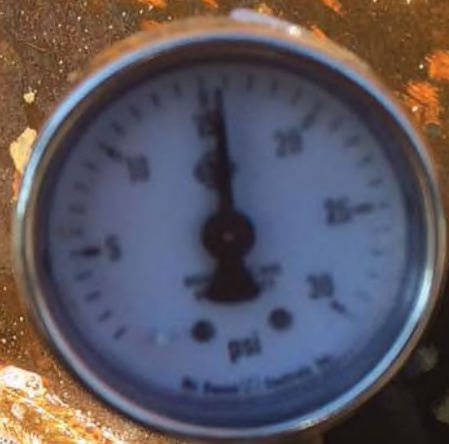
M1602  
45°  
M1603 AIR TEST OK  
JUNE 24/18

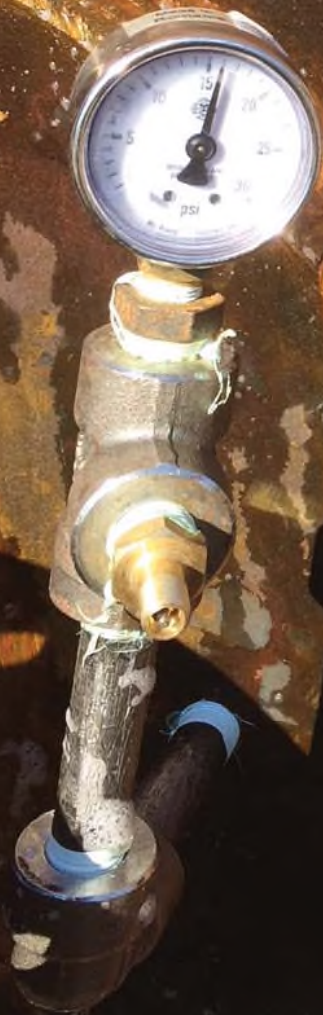
M1602

AIR TEST

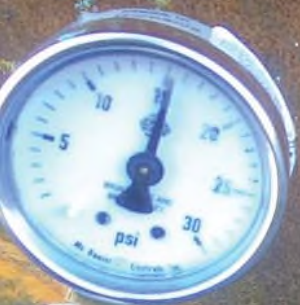
M1614

AIR TEST OK MMCA

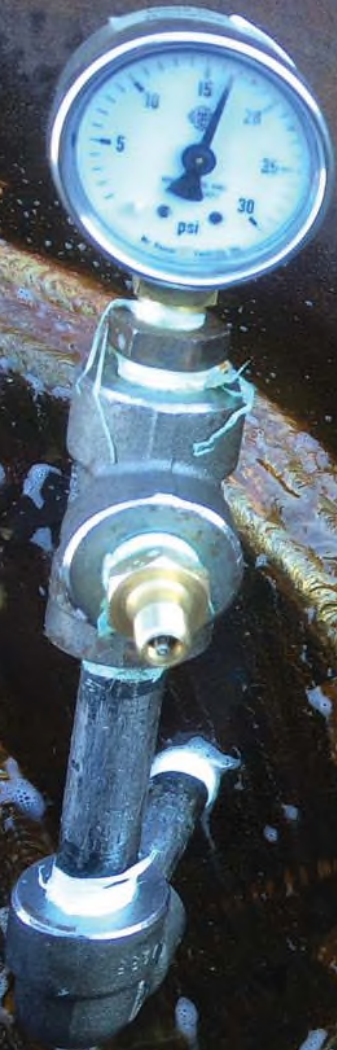
M1614

AIR TEST OK MM CB

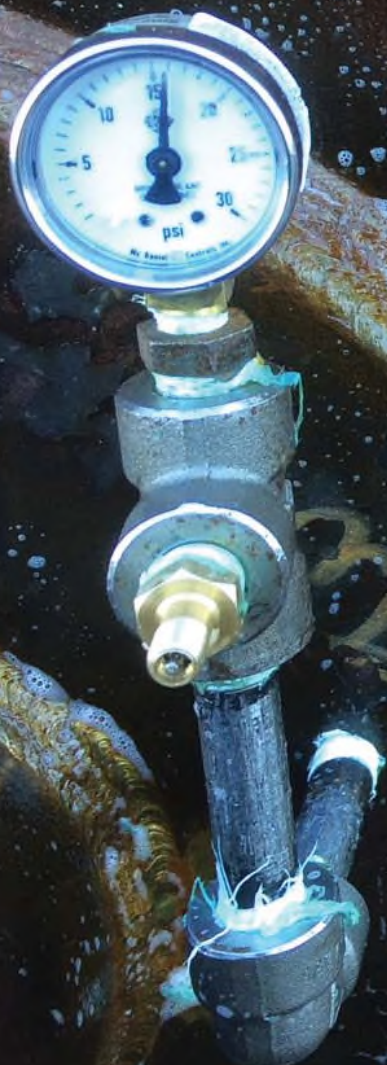
M1602

AIR TEST OK MM

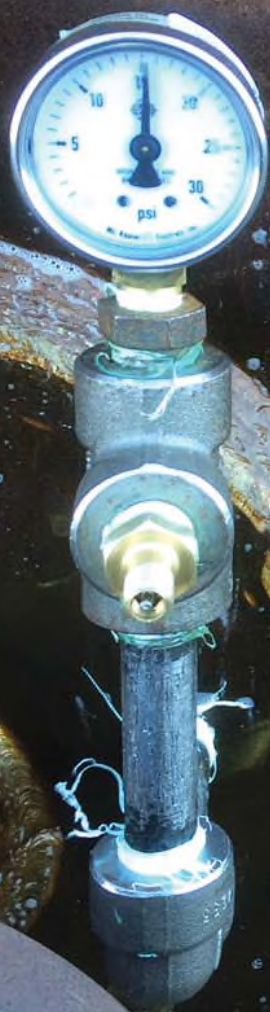
M1614  
231"

AIR TEST OK MM CB  
JUNE 24/18

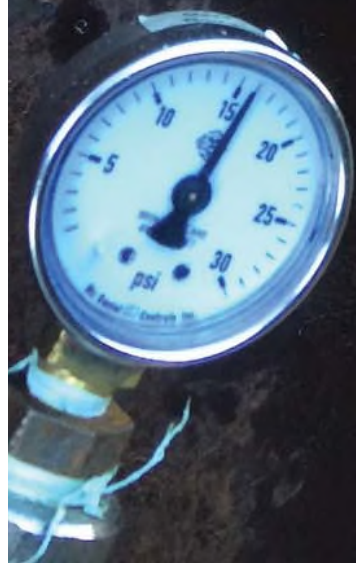
MAN HOLE  
270'

AIR TEST OK  
JUNE 24/18 MM. CB

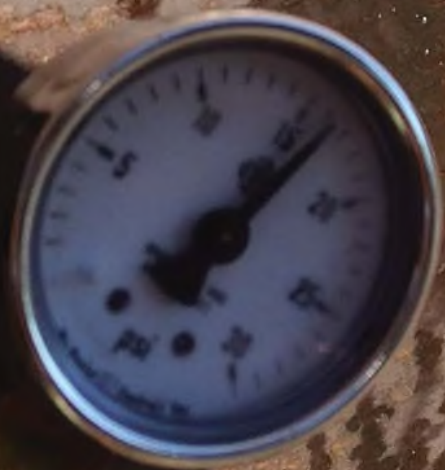
MAN HOLE  
0°

AIRTEST OK MM C

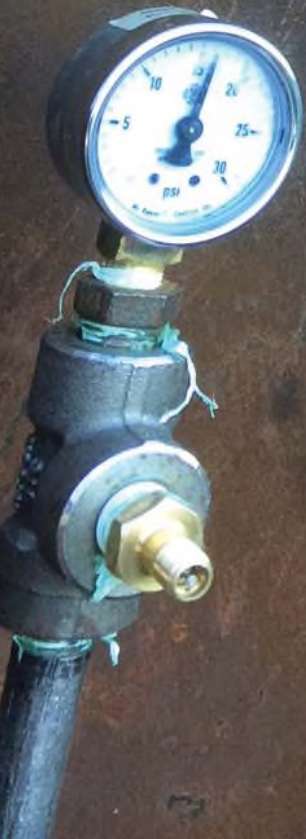
MAN HOLE

AIR TEST OK MM CB
