Project Name / Nom de Projet: Rankin Inlet Tank Farm

Project No. / No. de Projet: C-15152

Rankin Inlet Fuel Farm

Photographs of corrective measures on piping under road, between Fuel Farm and Melvin Bay Shore
(Nov. 2018)

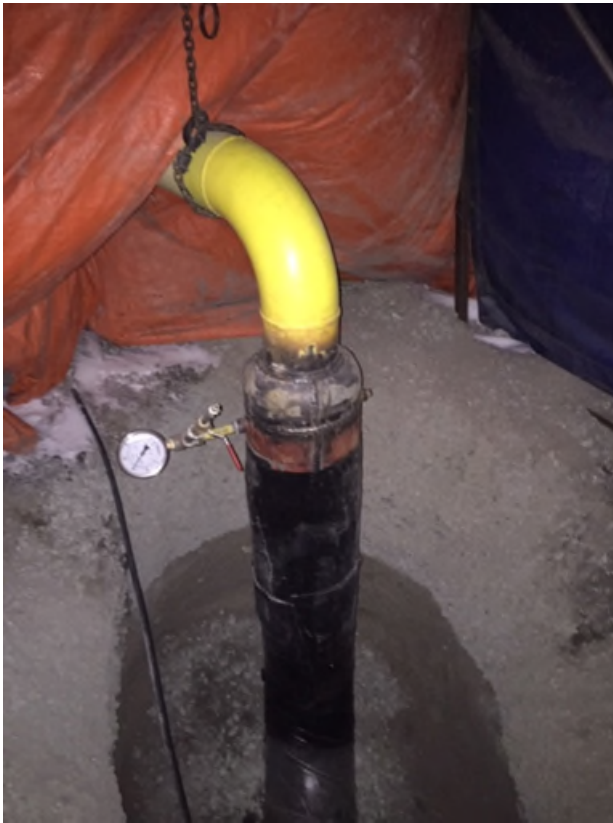
Photo 1a New double-wall elbow and vertical section on the East side of the road

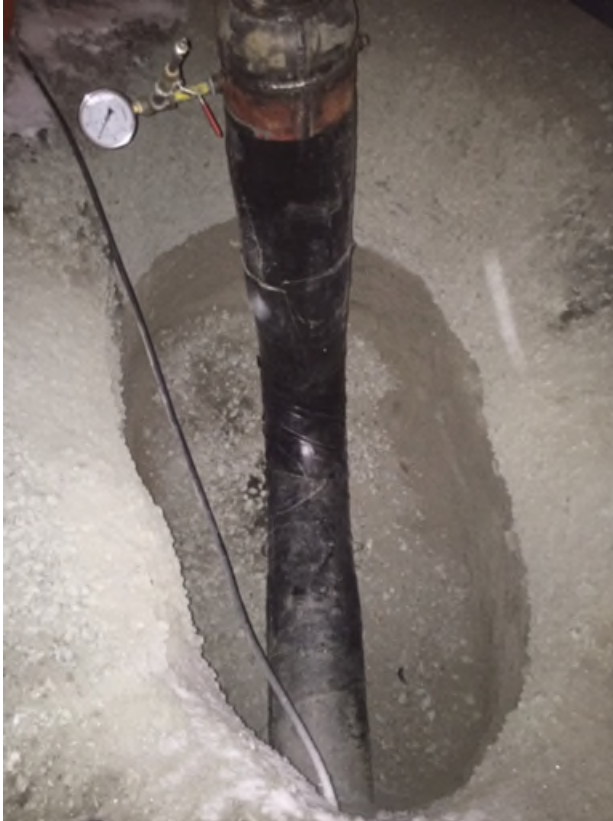
Photo 1b New double-wall elbow and vertical section on the East side of the road

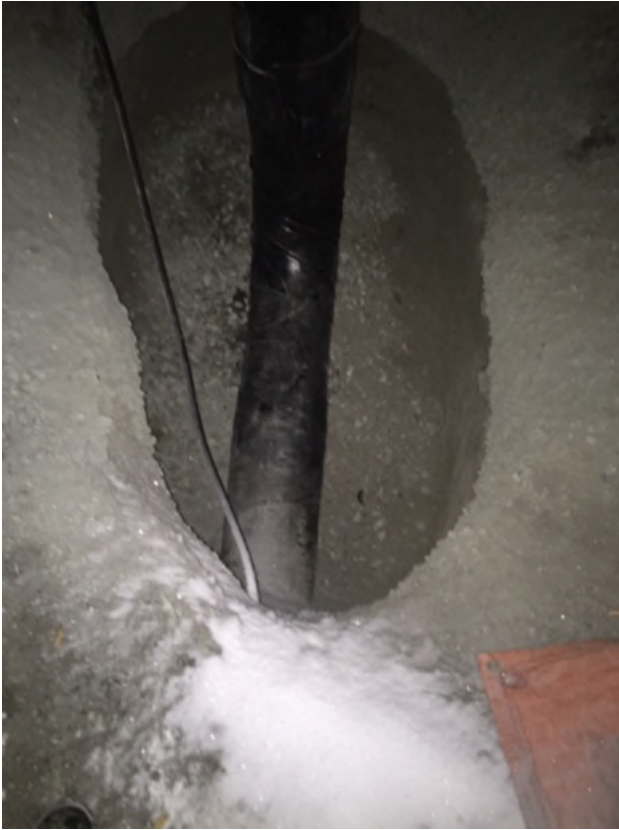
Photo 1c New double-wall elbow and vertical section on the East side of the road

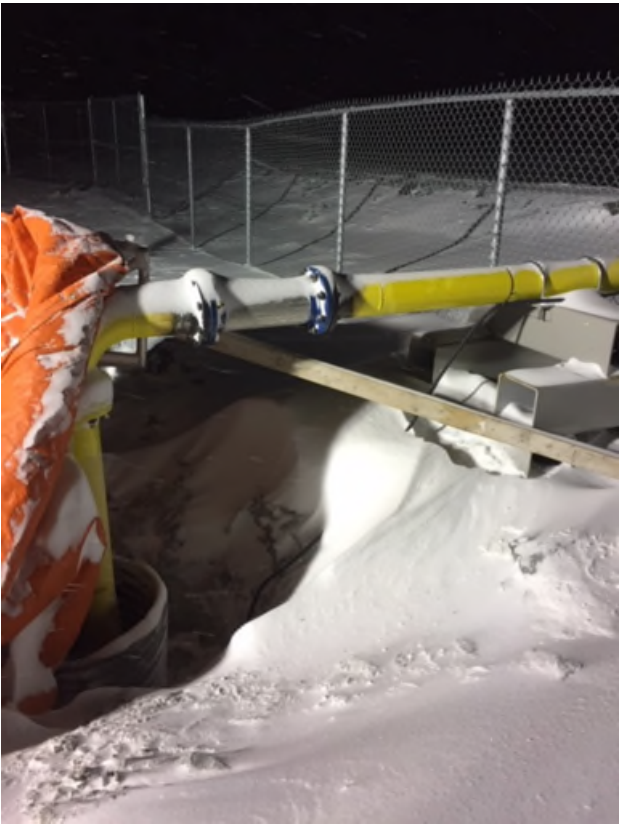
Photo 2a Single-wall above-ground pipe in a corrugated steel (manhole 'regards') pipe to ensure pipe is visible on the edge of the 'Fuel Farm' side of road

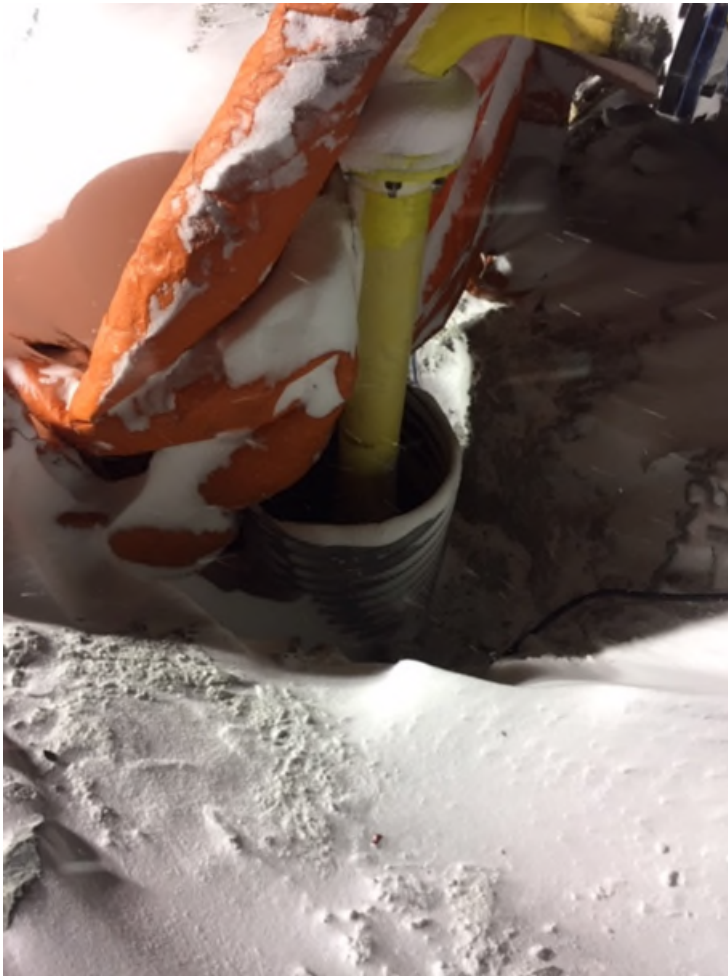
Photo 2b Single-wall pipe and manhole pipe in a corrugated steel pipe to ensure pipe is visible on the edge of the 'Fuel Farm' side of road

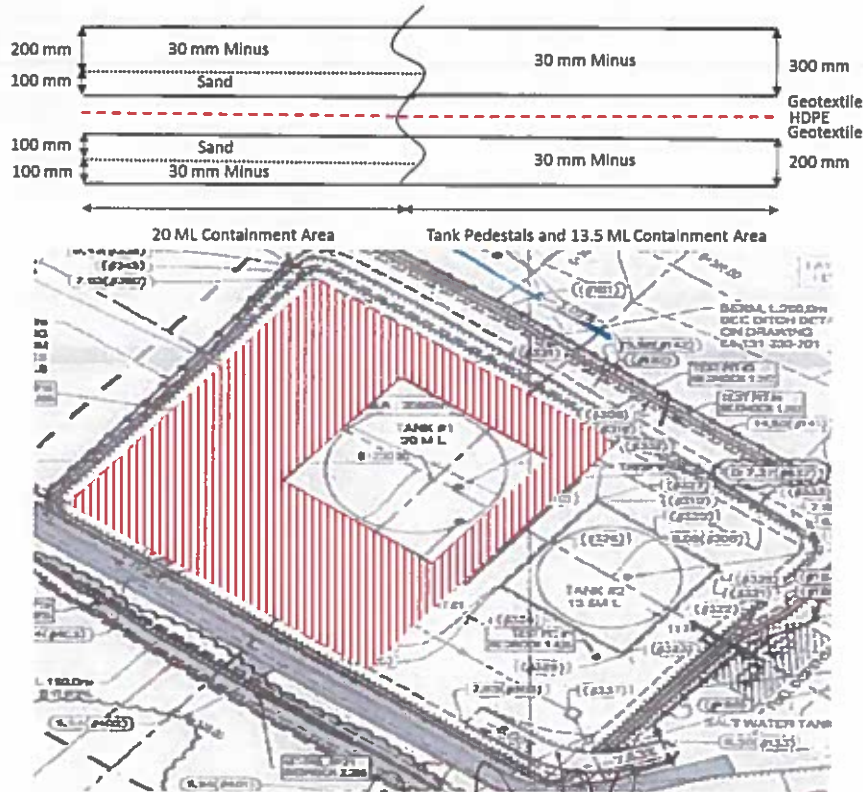
Currently, all under liner material has been placed to design grade throughout the entire containment area, including both tank pedestals. Due to contractor concerns regarding trafficking of the 50t crane to be used for tank erection on the liner system as currently designed and the potential for damage to occur, the liner system has presently been installed on the tank pedestals only, with the intent of completing the liner installation process following tank erection. However, time and schedule constraints have dictated that erection and filling of the 13.5 ML tank at the Rankin Inlet Fuel Farm will be completed in 2017, while erection and filling of the 20 ML tank will be completed in 2018. Therefore, in order to complete the containment facility to remain in regulatory compliance after the 13.5 ML tank is filled in 2017 and still be able to complete erection of the 20 ML tank in 2018, the following design revisions are requested:

1. Substitution of 30 mm minus with sand, 100 mm both under and over the liner system (see detail below)
2. The above substitution will apply only within the 20 ML tank containment area (excluding the 20 ML tank pedestal) (see detail below)
