## **Construction Summary (As-Built) Report Saline Pond No. 3 (SP-3)**

**6528-695-132-REP-001**

Prepared by:  
WSP Canada inc.

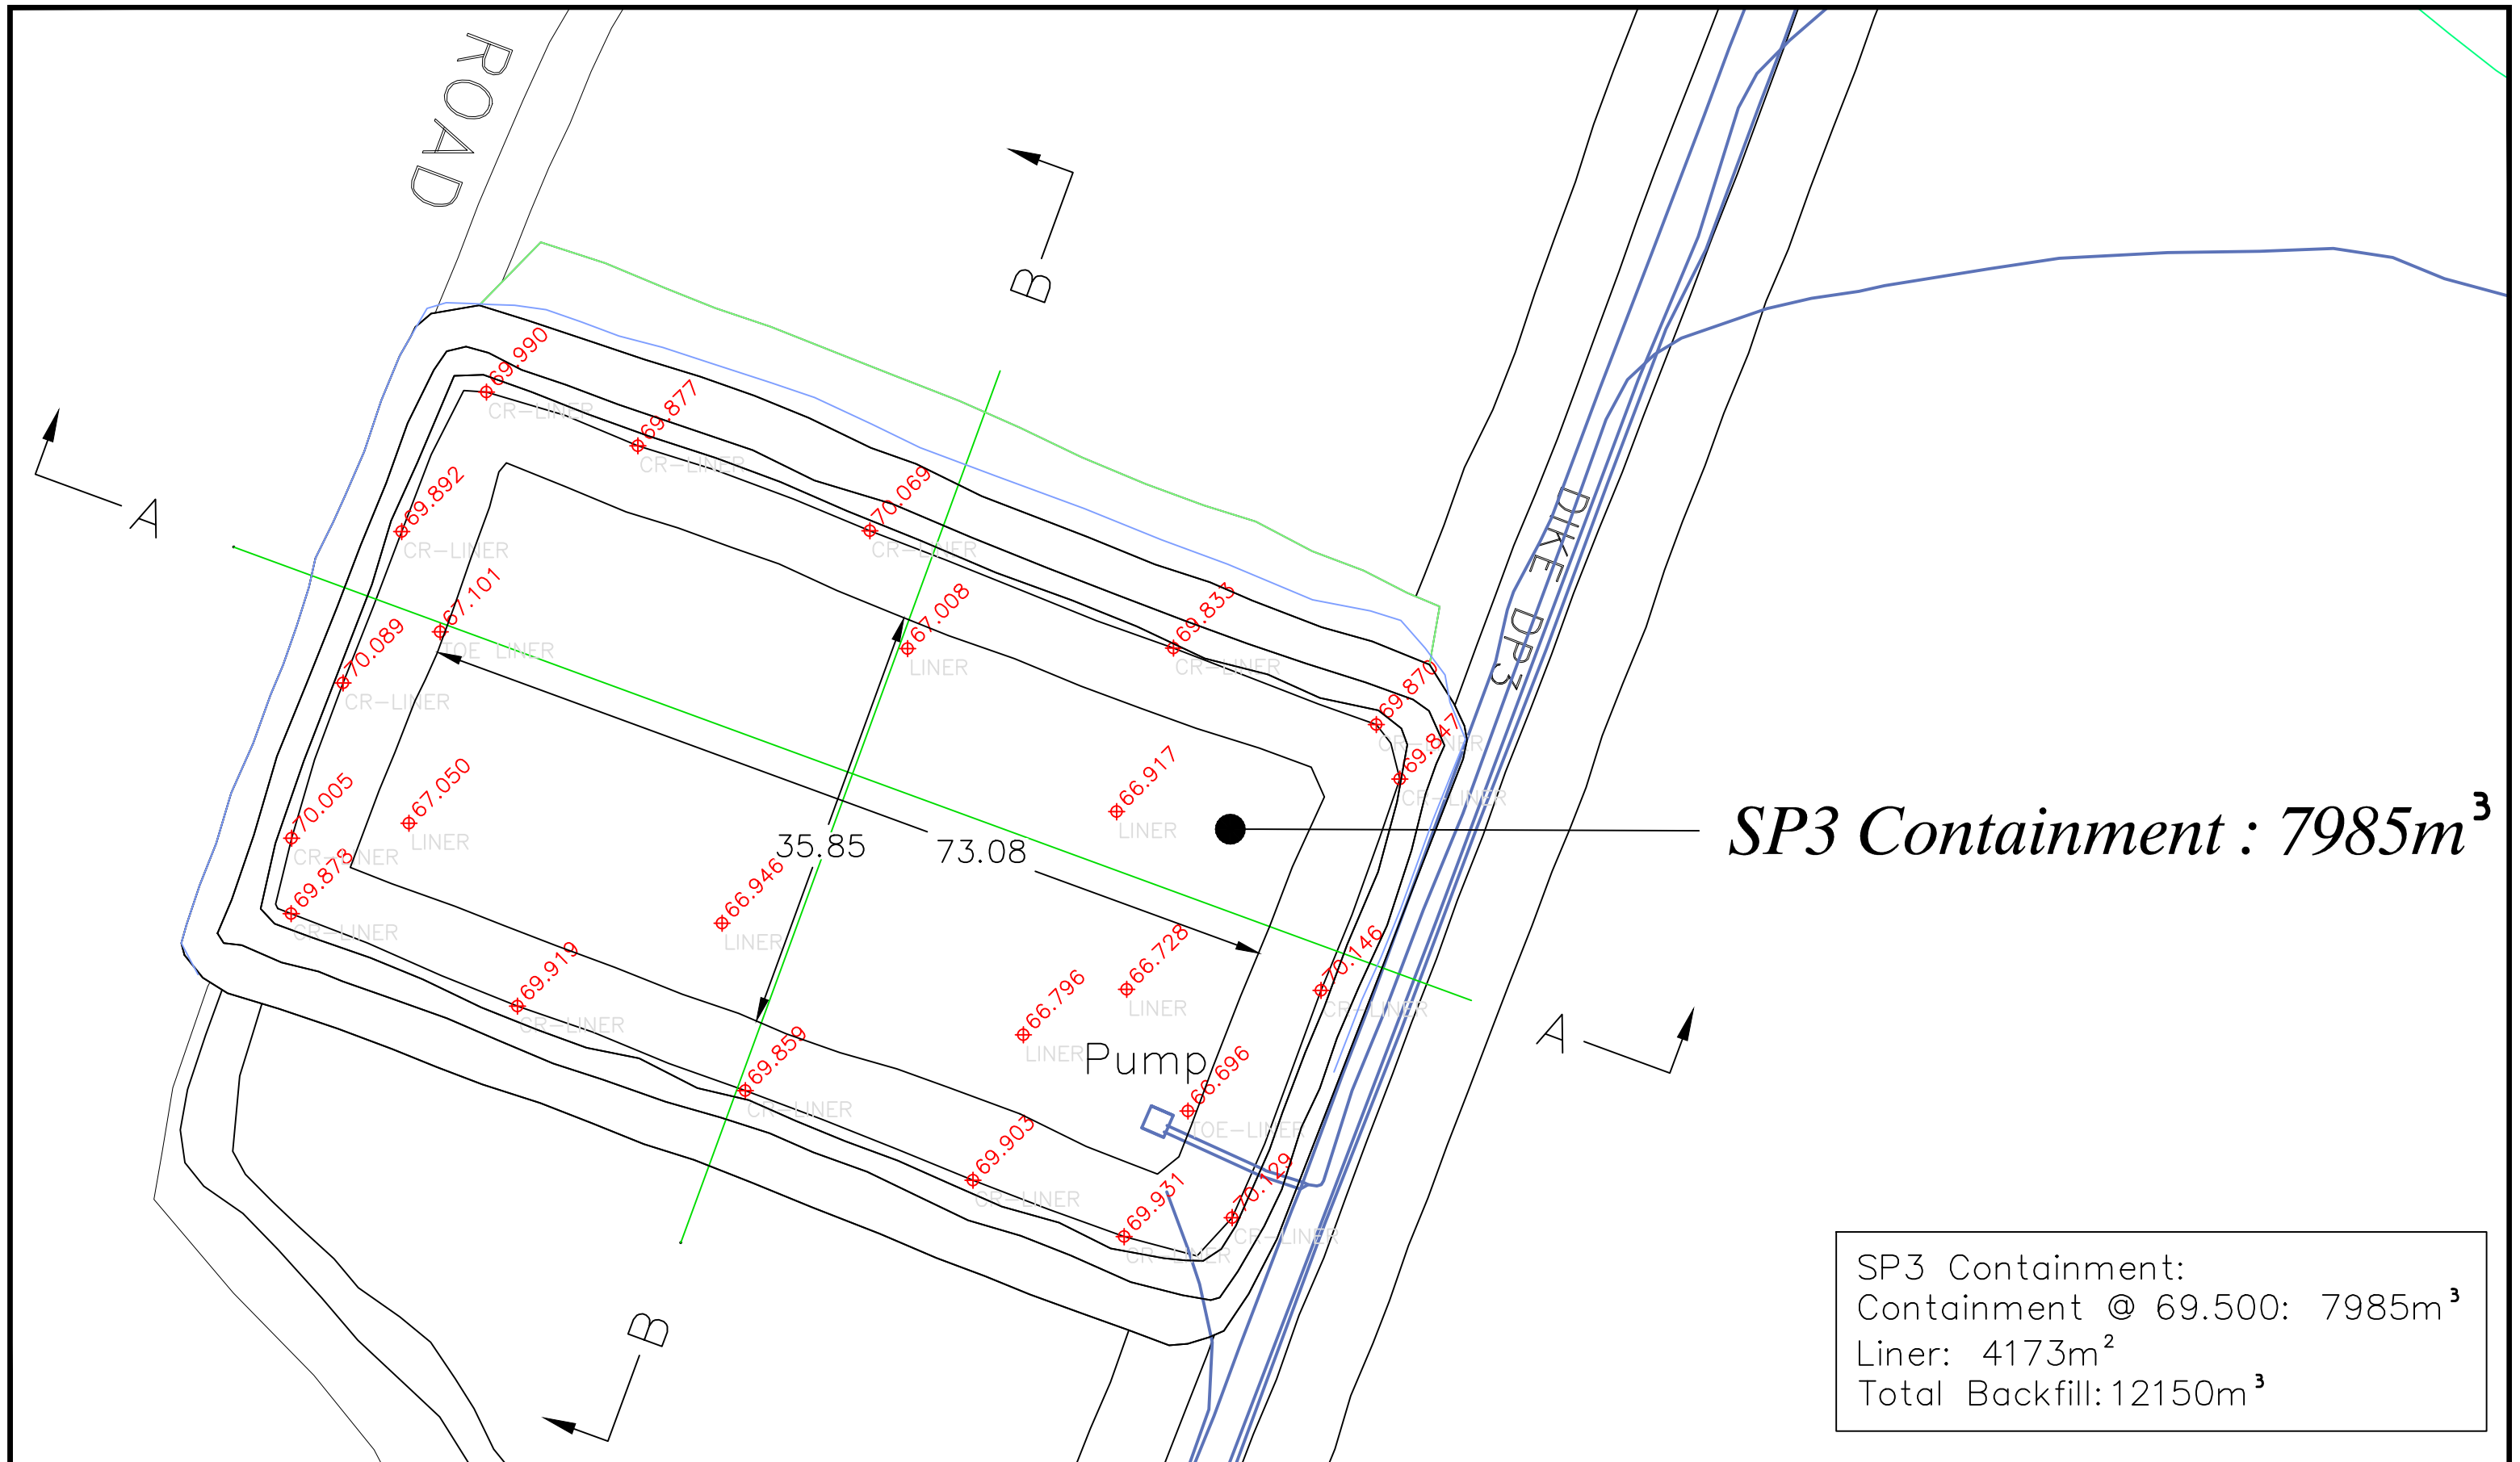
SP3 Containment:  
Containment @ 69.500: 7985m<sup>3</sup>  
Liner: 4173m<sup>2</sup>  
Total Backfill: 12150m<sup>3</sup>

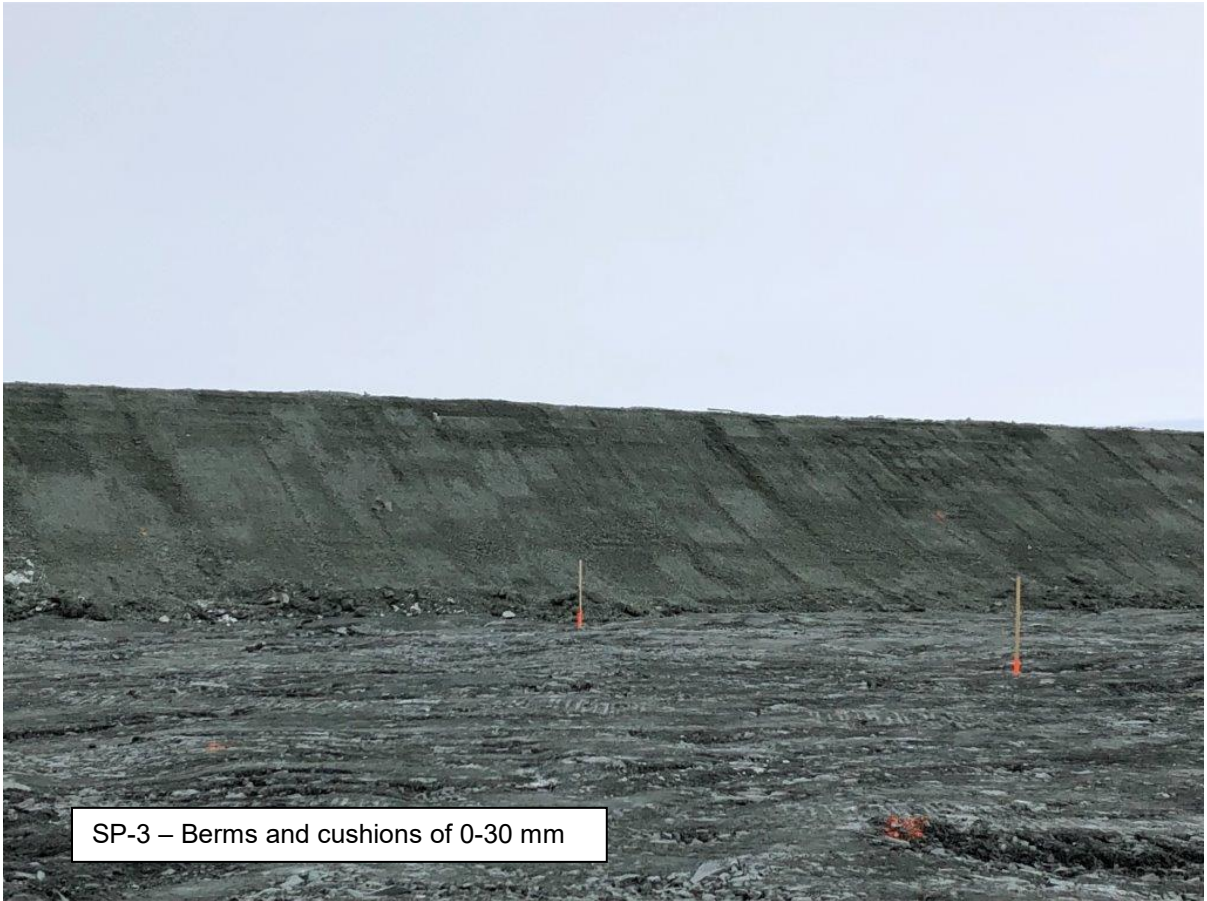
SP-3 – Berms and cushions of 0-30 mm

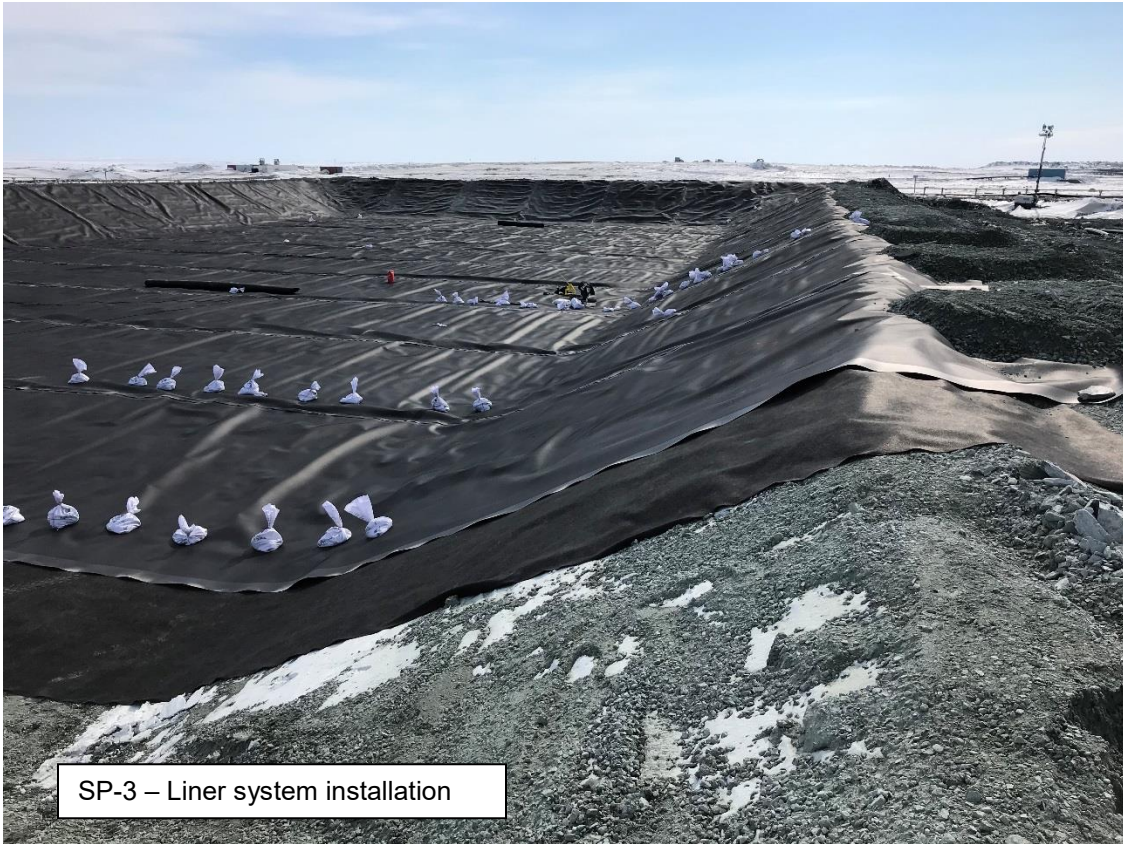
SP-3 – Liner system installation

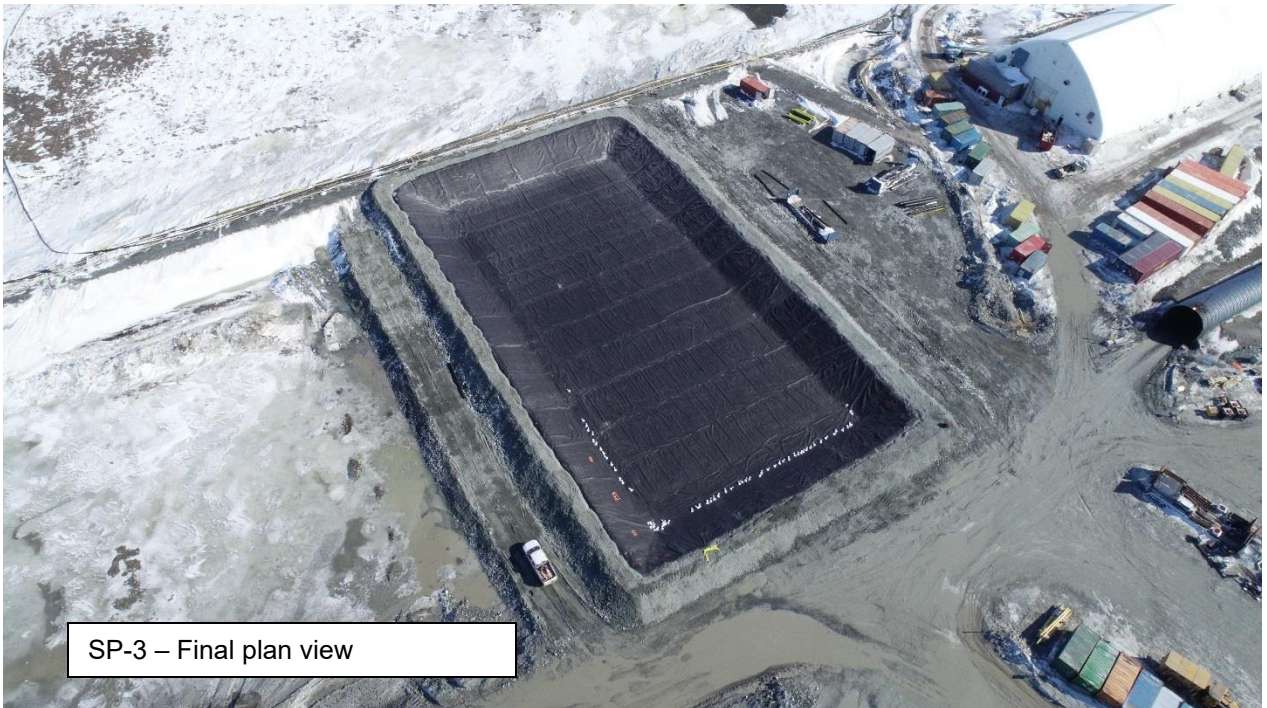
SP-3 – Final plan view
