TSF WEEKLY INSPECTION FORM

Date: November 13, 2019	Time: 12:30
Weather: -18.6C; 33 km/h NW; overcast	Inspected by: Jennifer Pyluk
Present: Alex Plasse

Placement Area: Center Cell

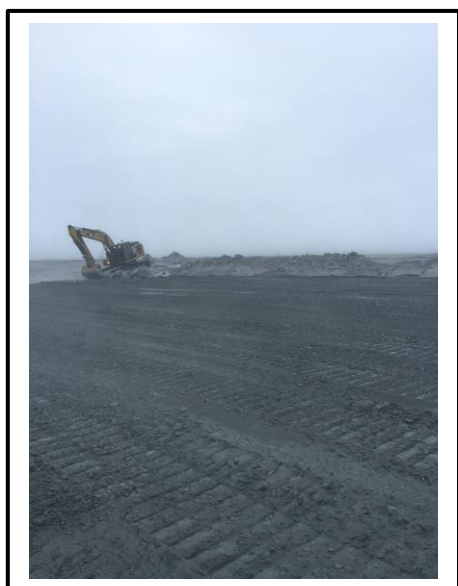
- Active tailings placement occurring over the past week in the center cell to approximate elevation 70.3 m.
- Considerable dust was observed to be generated from the surface of recently placed tailings material. This is expected to be due to the rough surface of the tailings material. At the time of inspection, tailings were being placed in a frozen or near-frozen condition and compaction was not occurring immediately after placement due to staffing issues. This resulted in a tracked surface only and dusty conditions.

- It was observed that compaction specifications were not being obtained, particularly in the top 4-6", due to the placement of tailings material in the frozen (and dried) condition. It is noted that placement of already frozen material in the center cell is preferable from a stability standpoint however.

Photo 1: Recently placed tailings in center cell; view facing southwest

- Winter placement conditions must be followed in order to achieve proper compaction and reduce settlement in the summer months:
 - Tailings should be removed from the Church immediately** to avoid freezing of this material prior to placement. Stockpiling in the Church should only occur in extreme conditions.

- Compaction of tailings should also occur immediately following placement.** If compacted while unfrozen, the same number of passes (3 slow passes on high vibrate) applies. If frozen tailings material has to be placed, Engineering must be notified so that the least harmful placement location and compaction specifications can be chosen.

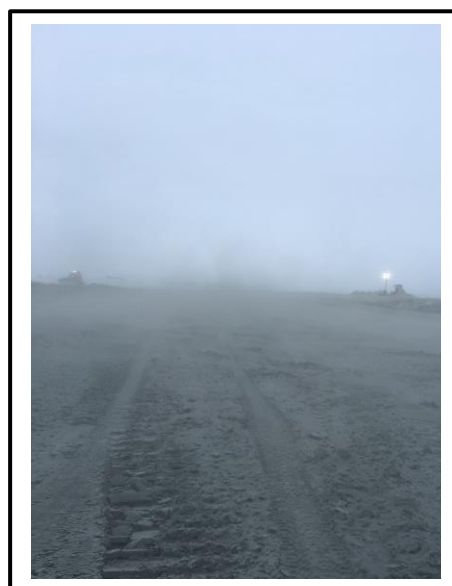
Photo 2: Recently placed tailings in center cell and dust; view facing north

- There should be no vehicle traffic on the finished tailings surface.** Flash freezing of the surface will occur and erosion/dust generation will be at its peak. Traffic over snow will grind/compress the snow into the tailings surface and will make snow removal in these areas more difficult.

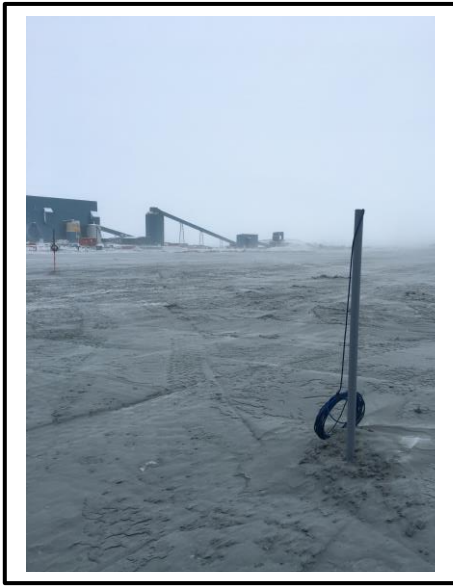
- Dust generation was also observed on the surface of sub-cells 3 and 2, particularly in the area around the recently completed extension of the historical GTC. Track marks and tire tracks were clearly visible throughout this location and the remainder of these sub-cells.

Photo 3: Track marks and tire tracks around historical GTC extension sub-cell 3; view facing southeast

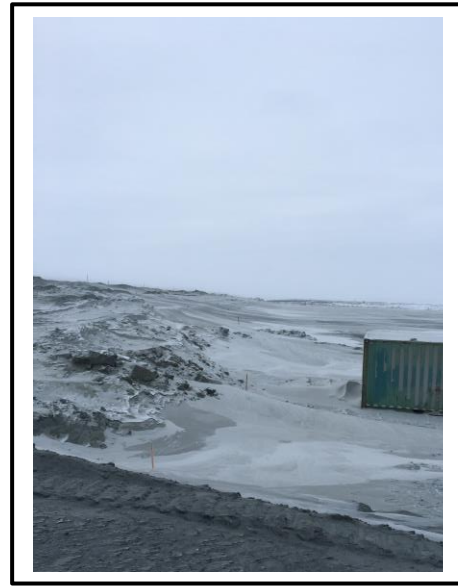
- Sea cans with what are assumed to be unplaced filter cloths were seen on sub-cell 6, which appeared to have restricted the placement area.

Photo 4: Sea cans causing snow to build up and restricting placement area in sub-cell 6; view facing west

5. **Filter cloths should be placed as soon as possible** to avoid additional work to separate the cloths prior to placement if they are all frozen together.
