TSF WEEKLY INSPECTION FORM

Date: December 2, 2019	Time: 10:15
Weather: -28.1C; 35 km/h NE; sunny	Inspected by: Jennifer Pyluk
Present: Pierre-Luc Sevigny

Placement Area: **Center Cell**

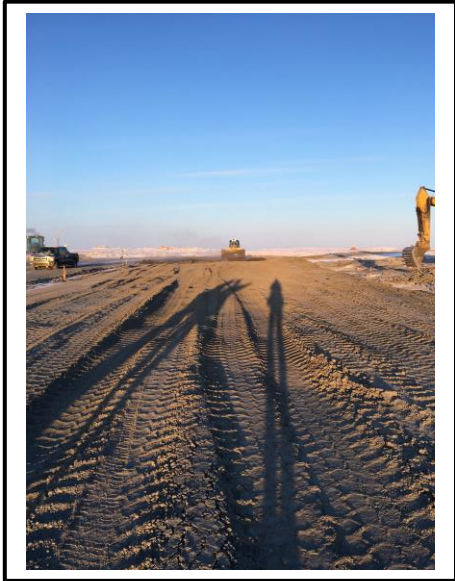
- Tailings being placed in the center cell at the time of the inspection were seen to be “fresh” (unfrozen) as steam was observed to be coming off the material being pushed. Compaction was not observed to be occurring immediately after placement however, and at the ambient temperatures on the morning of the inspection, freezing of the material can be expected to occur very quickly.

- Haul trucks leaving the active area were observed to be trafficking on “undulating” placed tailings. This is expected to be due to unfrozen ground conditions underneath the tailings (as observed from ground temperature readings), incomplete compaction efforts in this location, and freezing/breaking apart of the top few inches of placed tailings.

Photo 1: Steam from placed tailings in center cell; snow removal on slopes; broken top inches on placed tails; view facing north

- Compaction of tailings must occur immediately following placement.** If compacted while unfrozen, the same number of passes (**3 slow passes on high vibrate where “1 pass = 1 forward + 1 backward”**) applies. If frozen tailings material has to be placed, Engineering must be notified so that the least harmful placement location and compaction specifications can be chosen – **frozen/dried tailings must**

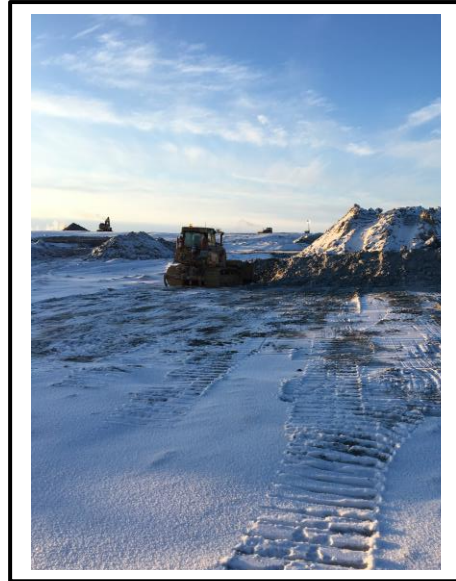
- Snow removal was on-going from the side slopes of sub-cell 4 and the esker. Snow removal had also been started in sub-cell 1 in anticipation of completing placement in the center cell within the next few shifts.

Photo 2: Snow removal started in sub-cell 1; view facing west

- Once placement in the center cell is completed, the next area of placement should be sub-cell 1. **All excess snow/ice must be removed from trenches, the tailings/ground surface and the side slopes prior to placement.** This is expected to be difficult in the areas of the trenches, as the material removed to form the trenches has now frozen into place on the side. Heavier equipment (ie. CAT D8) may be required in this area to suitably prepare for tailings placement.

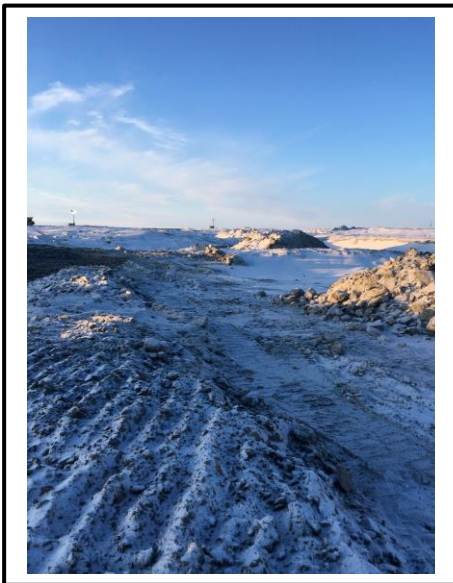
Photo 3: Frozen piles of debris/snow in sub-cell 1 requiring removal before tails placement; view facing west
