MELIADINE DIVISION

**Final Report for Spill on October 4, 2016**

**GN Spill No. 2016368**

**November 14, 2016**

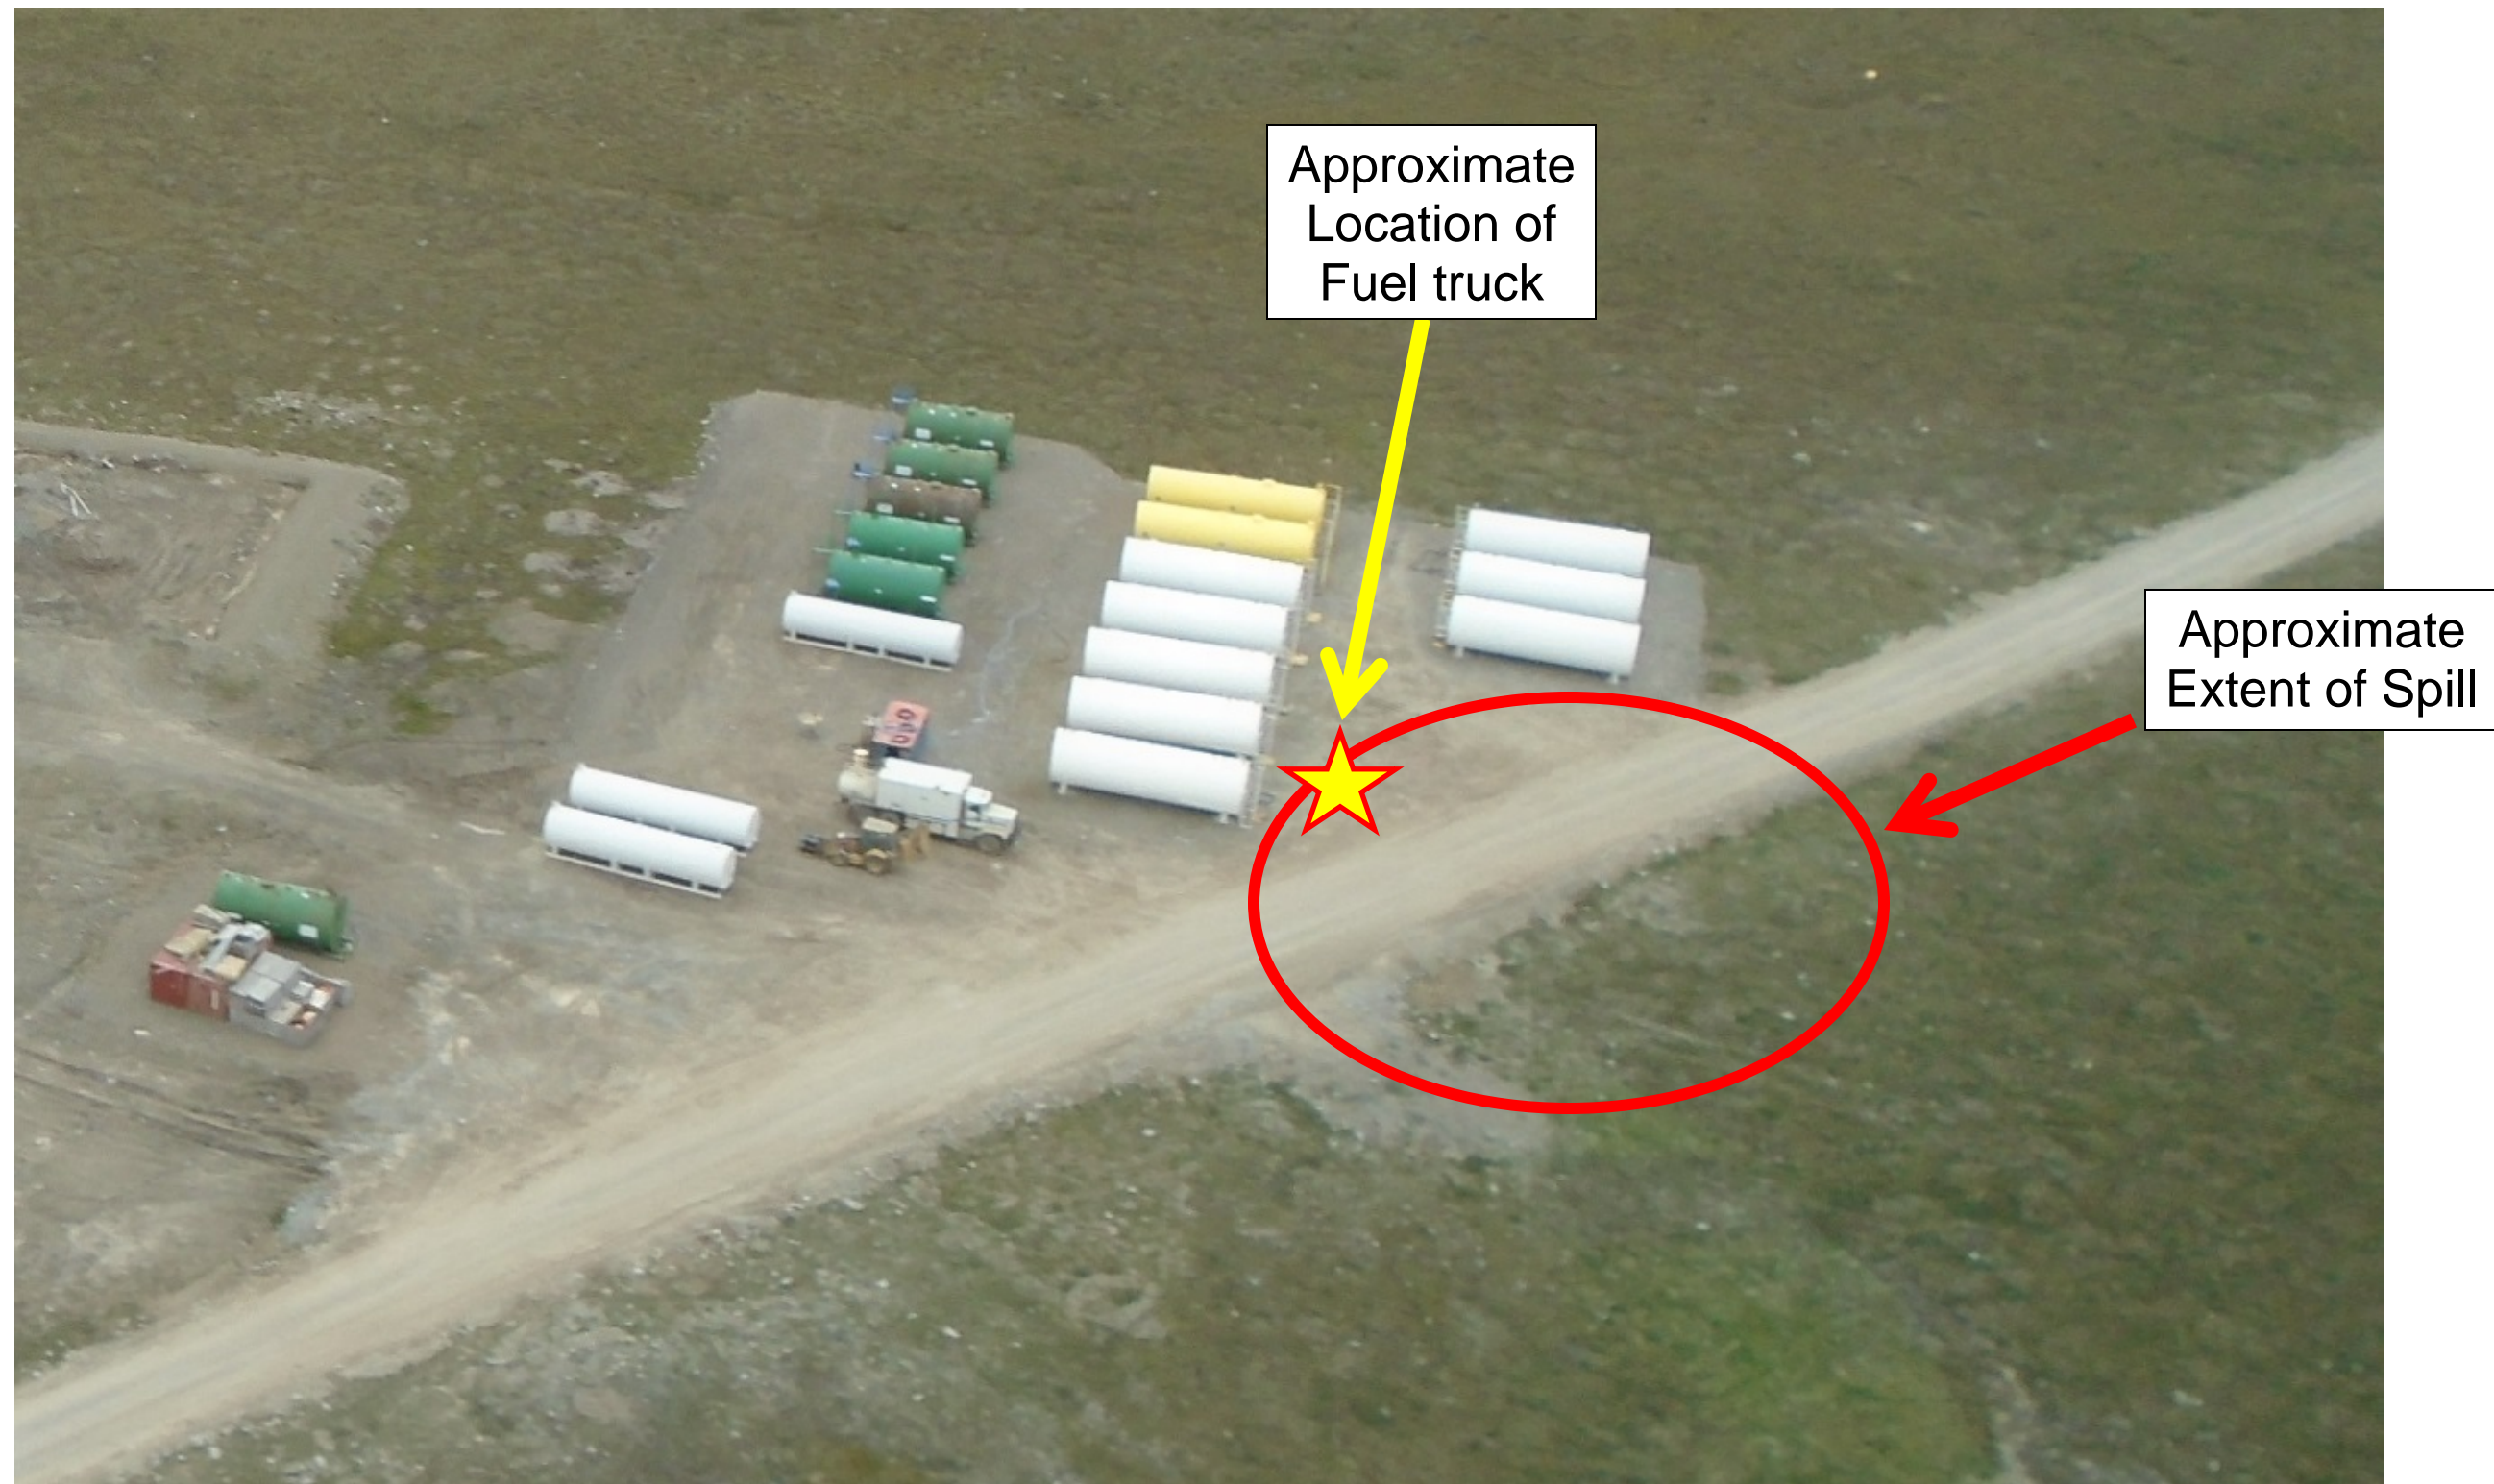
The re-fueling truck involved in this incident is on loan to MTKSL from Agnico Eagle. Approximately 1200L of diesel fuel contaminated the immediate area and migrated towards the adjacent tundra to various depths.

Figure 1 - Aerial View of Spill Location and Fuel Spill Extent

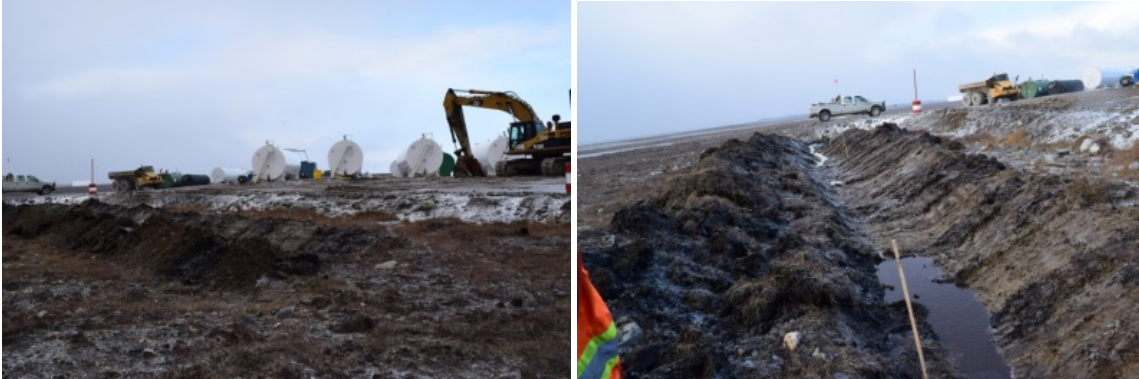
**9h30 to 14h00:** Contaminated soil was excavated from the tundra adjacent to the roadway near the spill area.

**Figure 6 – Contaminated soil excavation**

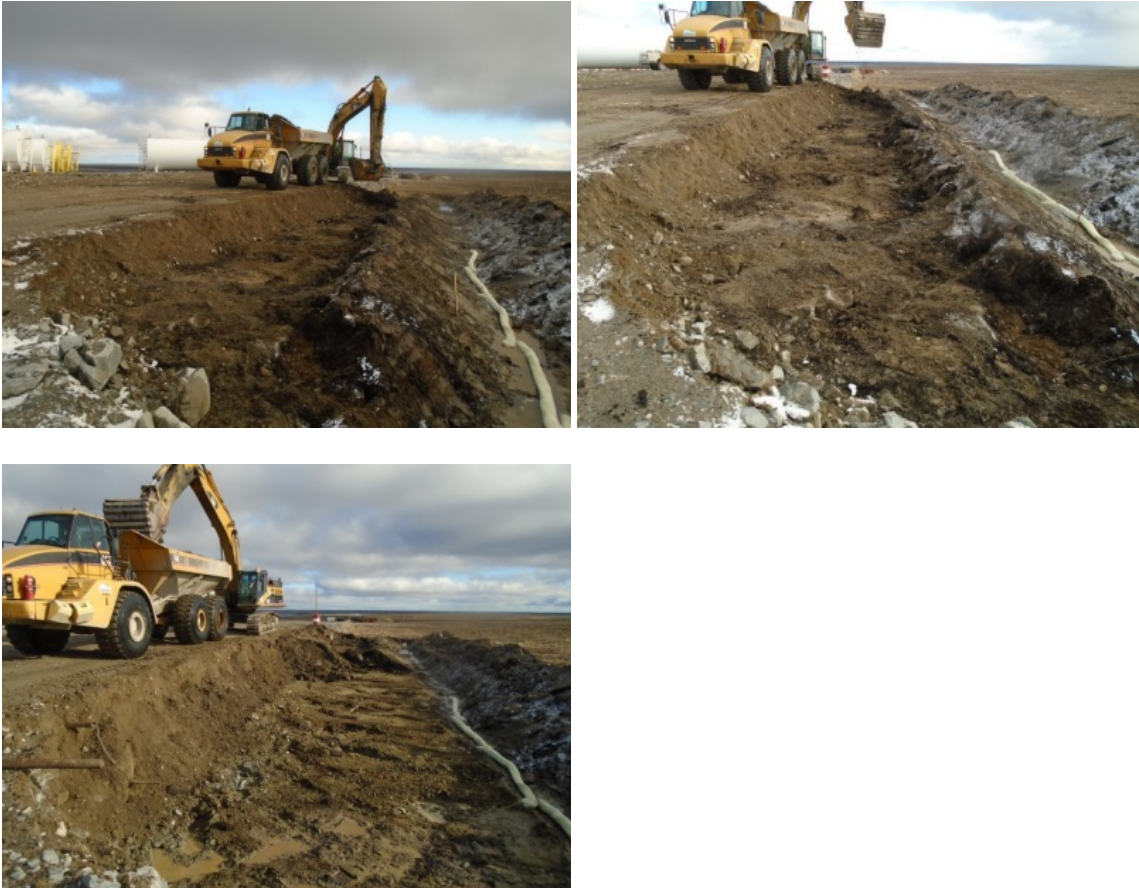
**Figure 7 - All contaminated soil removed from the trench up to the road shoulder**

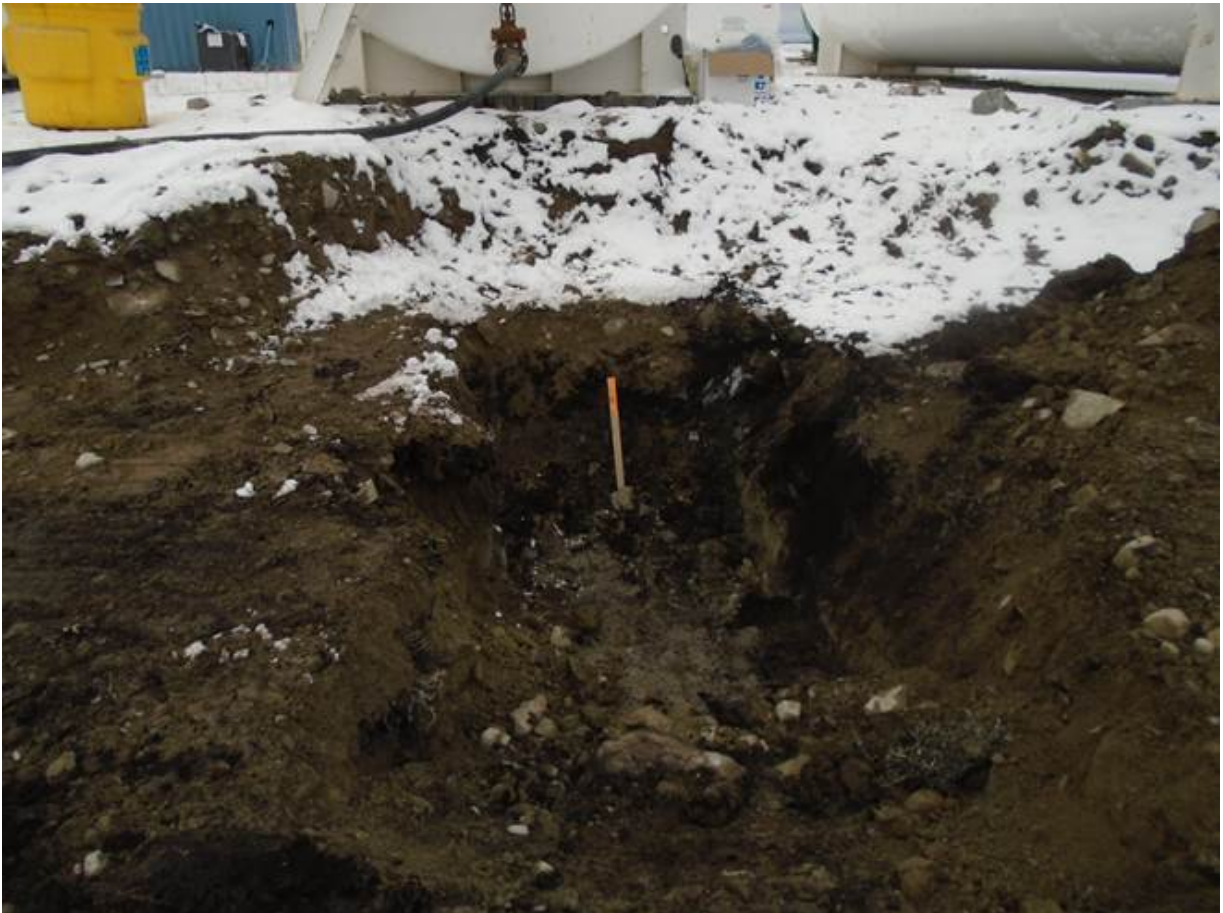
Excavations continued to remove any contaminated soil. At the location of the spill an area labelled as “Nuna Test Pit” was dug in order to determine the depth of the spill migration. At the extents of this pit, a composite sample was collected in order to determine if any contaminants had migrated below the depth that had been excavated.

**Figure 8 - Nuna Test Pit**

No contaminants above Industrial CCME Guideline for surface soils, were found to be outside the excavation, see Table 1 for laboratory analysis results of the collected samples.

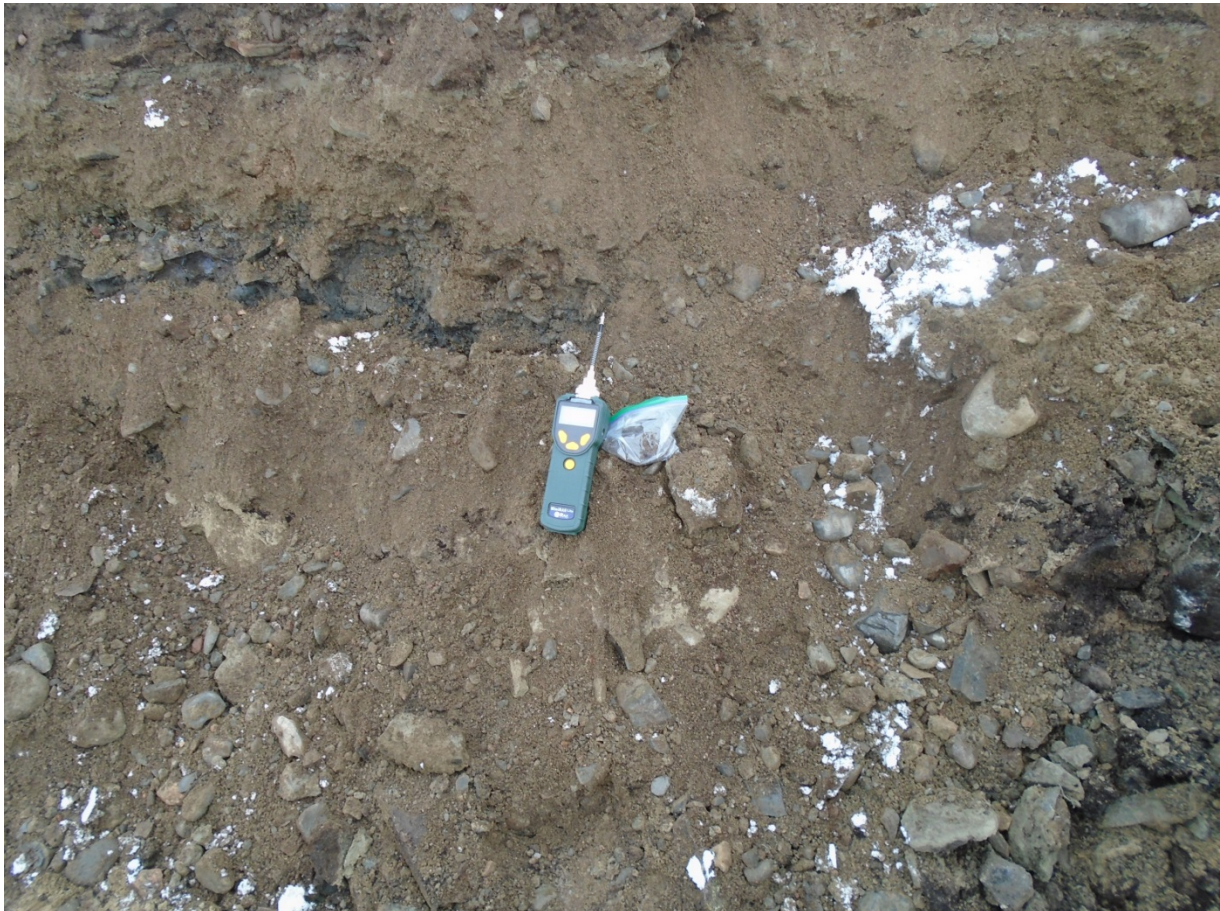
The trench that was excavated was also sampled to ensure that the excavated material included the extent of the spill plume. Soils along the edges of the trench were tested with a MiniRAE Lite handheld Volatile Organic Compound (VOC) tester. Any locations that appeared to have elevated levels of VOCs were further excavated until hydrocarbons were no longer detected.

Figure 9 - MiniRAE Lite VOC Gas Monitor

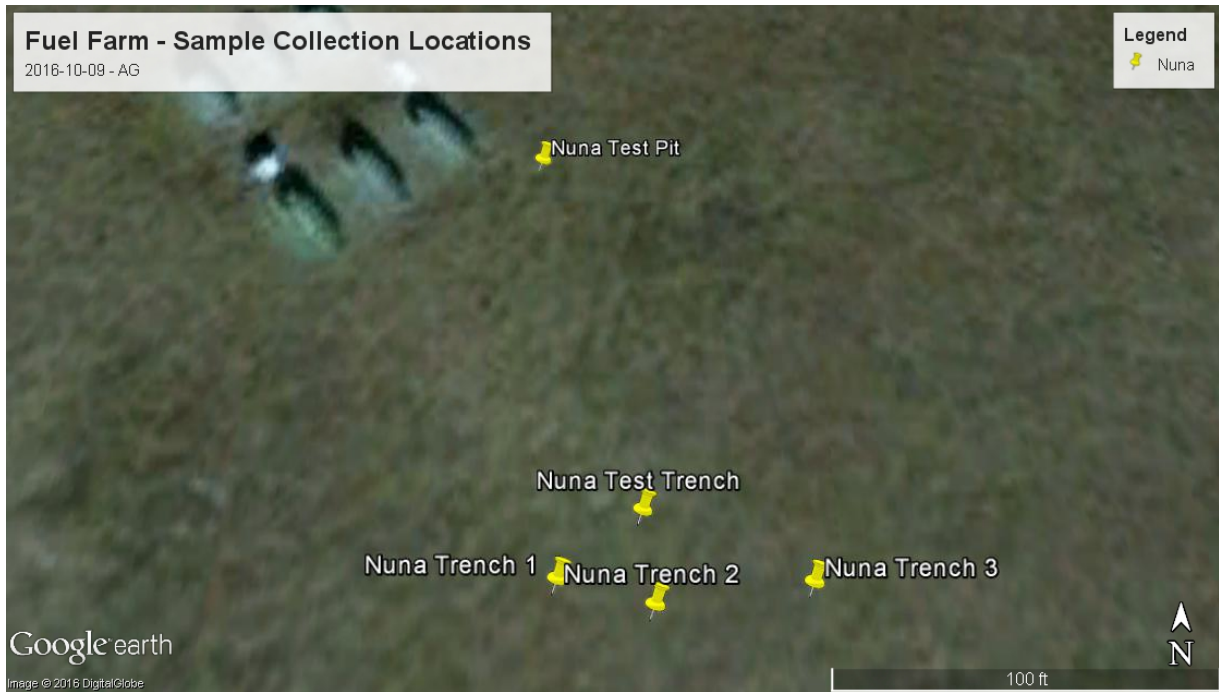
After all readings were found to be negative for VOC's, 4 composite samples were collected on each edge of the trench for laboratory submission. The results for these can be found in Table 1 and are labelled *Nuna Test Trench*, *Nuna Test Pit*, *Nuna Trench 1*, *Nuna Trench 2*, *Nuna Trench 3*. The GPS coordinates for the collected samples are also located in Table 1.

Figure 10 - Location of samples collected - referenced on Google Earth

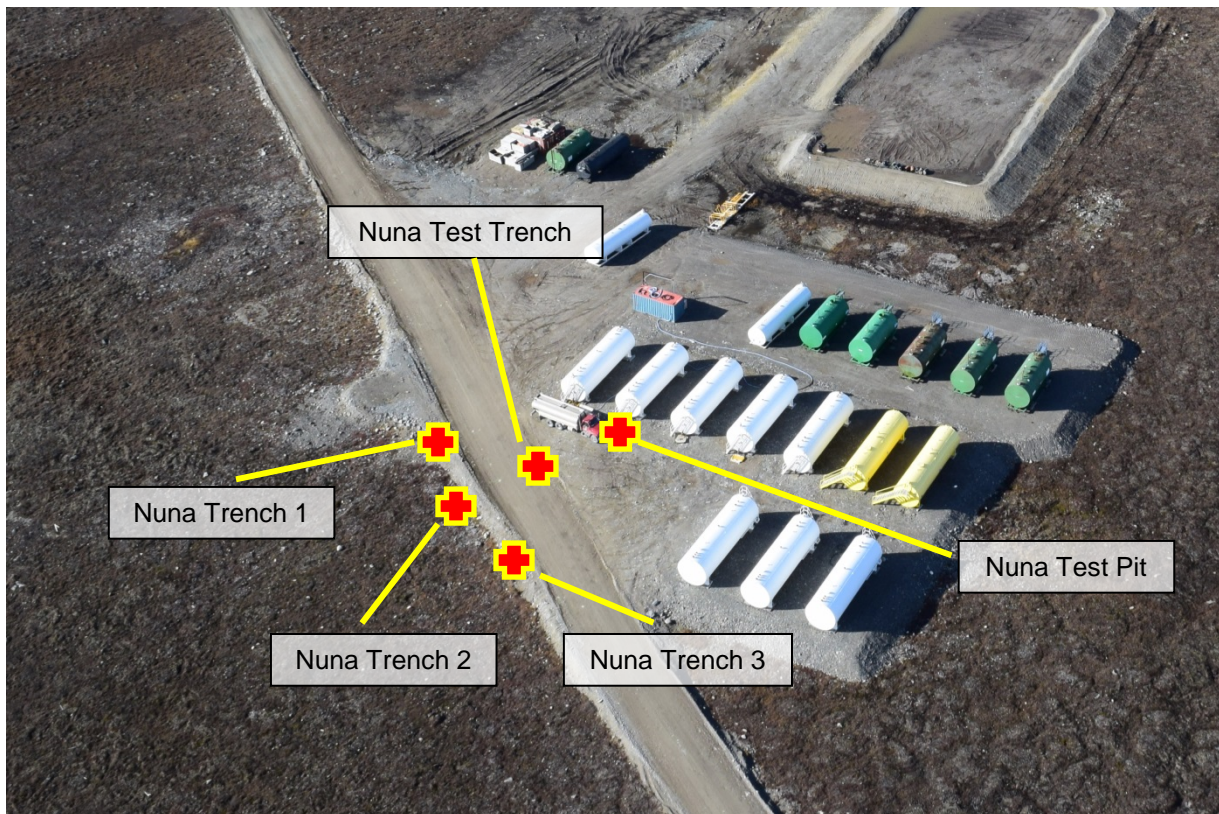
Figure 11 – Approximation of sample locations on aerial photo

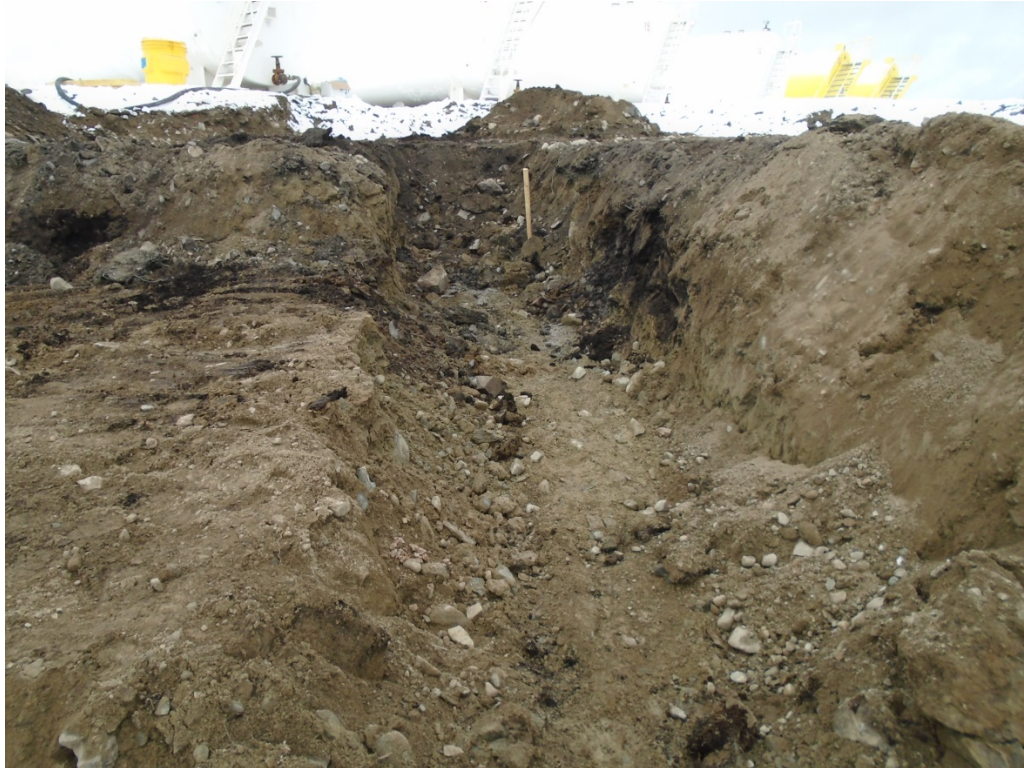
**Figure 12 - Nuna Test Trench**

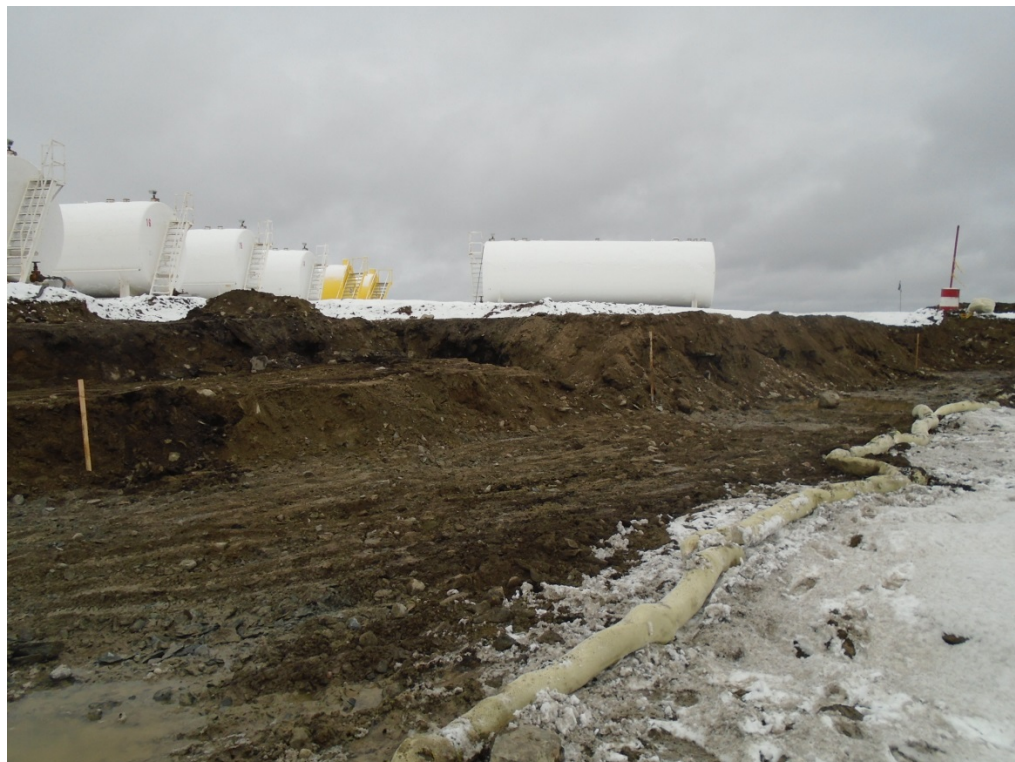
**Figure 13 - Nuna Trench 1, 2, & 3 Locations**

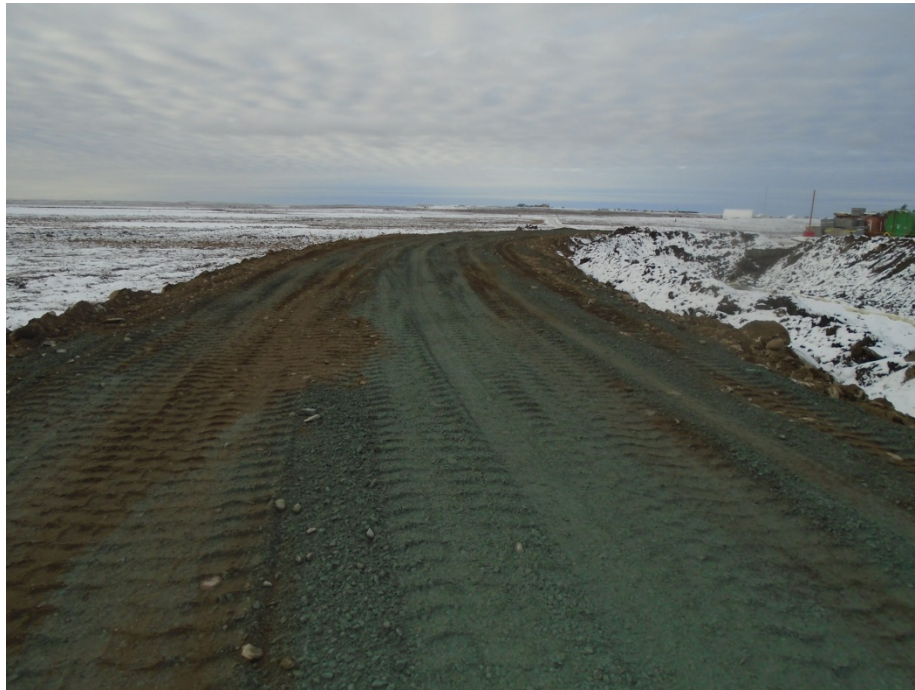
A bypass road was constructed to get around the excavation area. This bypass road will be the main access to the Exploration camp until backfilling of the trench is approved.

**Figure 14 - Bypass looking South/West**

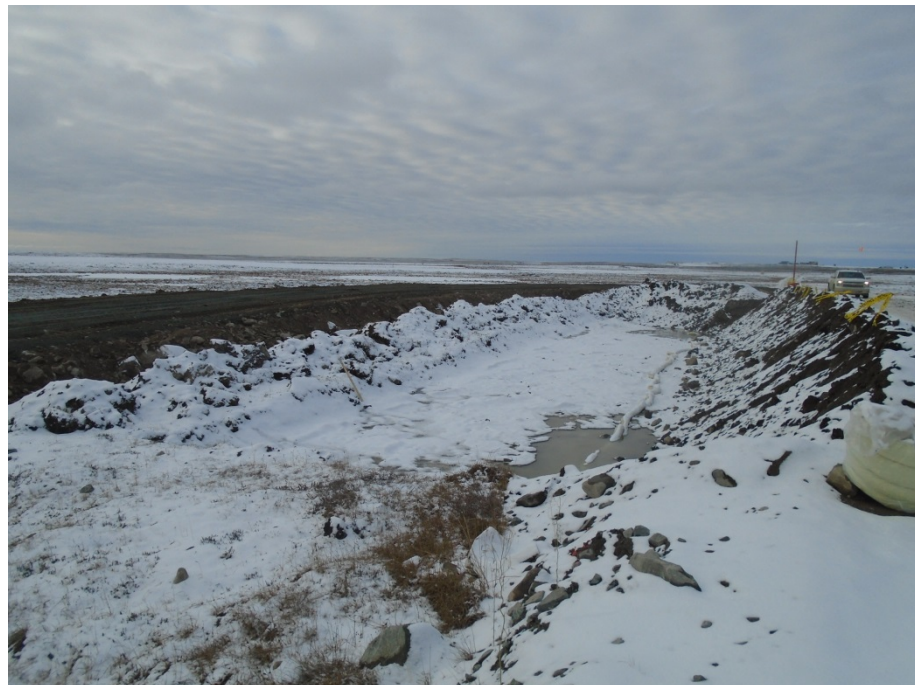
**Figure 15 - Trench between spill area and bypass road**

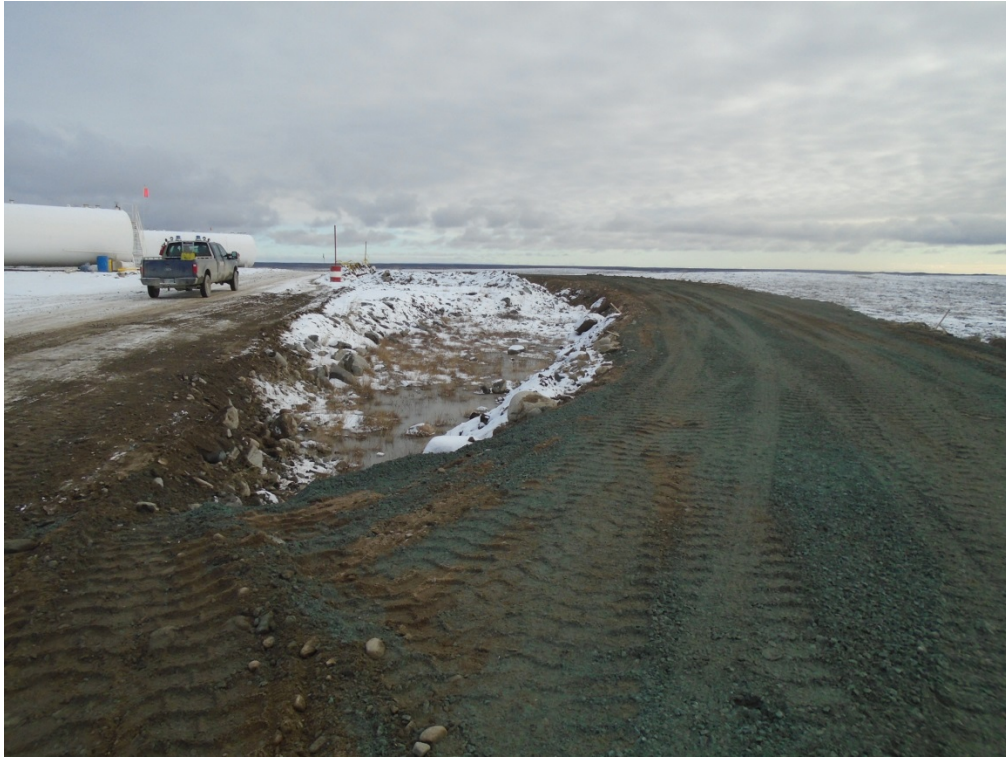
**Figure 16 - Bypass looking North/East**
