Follow Up Report – Spill # 2017359 September 22nd 2017 Punctured Tote

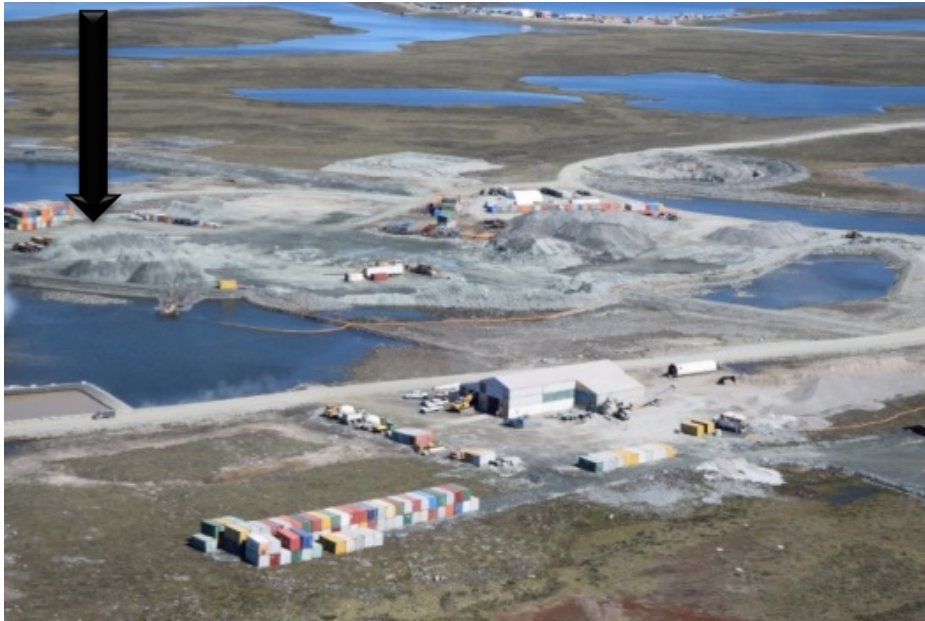
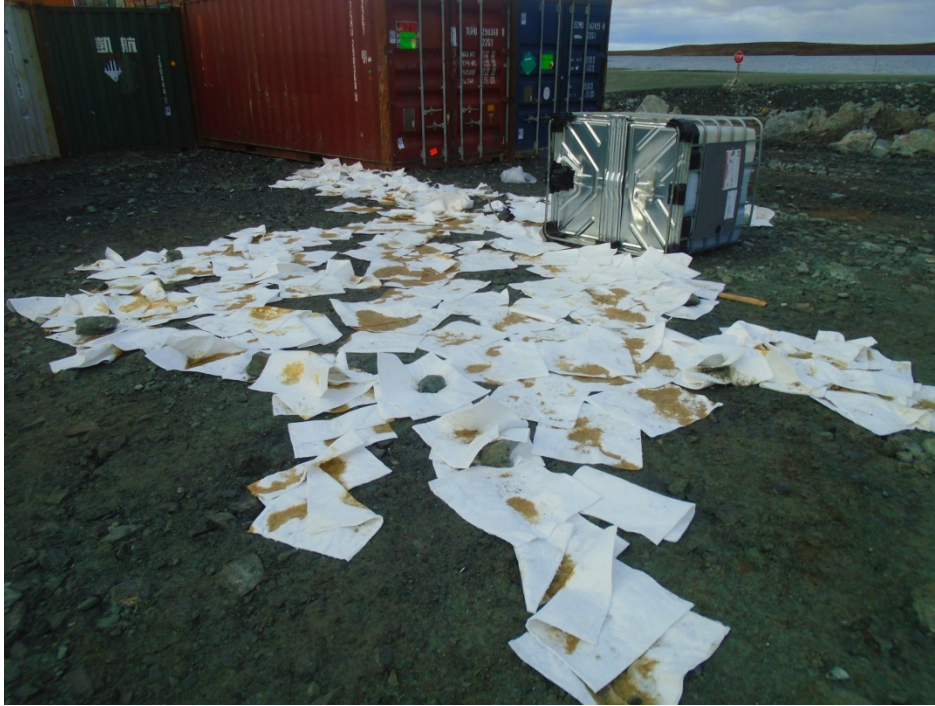
On September 22nd 2017, when off-loading totes of oil from a trailer, the operator was setting two totes together and had his forks set too high and hit the plastic portion of the tote and the forks punctured the tote. The tote was immediately flipped on its back preventing continuous spill of the product. Absorbent pads were immediately deployed to absorb the oil spilled. spill report was issued through the NT-NU Spill Report.

The spill occurred in the area of the transit pad.

Spill was caused by human error. The judgment on the placement of the forks was incorrect.

The response to this spill was second to none. Upon puncturing the tote the operator knew immediately if the tote was flipped with the puncture hole facing up that it would minimize the spill. He immediately flipped the tote with the zoom boom and by doing this minimized the spill from 150 liters instead of the entire container which was 1000L. Spill pads were deployed onto the spilled oil to absorb as much as possible. The absorbent pads were disposed of in the Hazmat waste area at the Meliadine site. The soil which was contaminated was excavated and taken to the exploration Landfarm.
