Follow Up Report – January 31st 2018 Sewage Spill #18-027

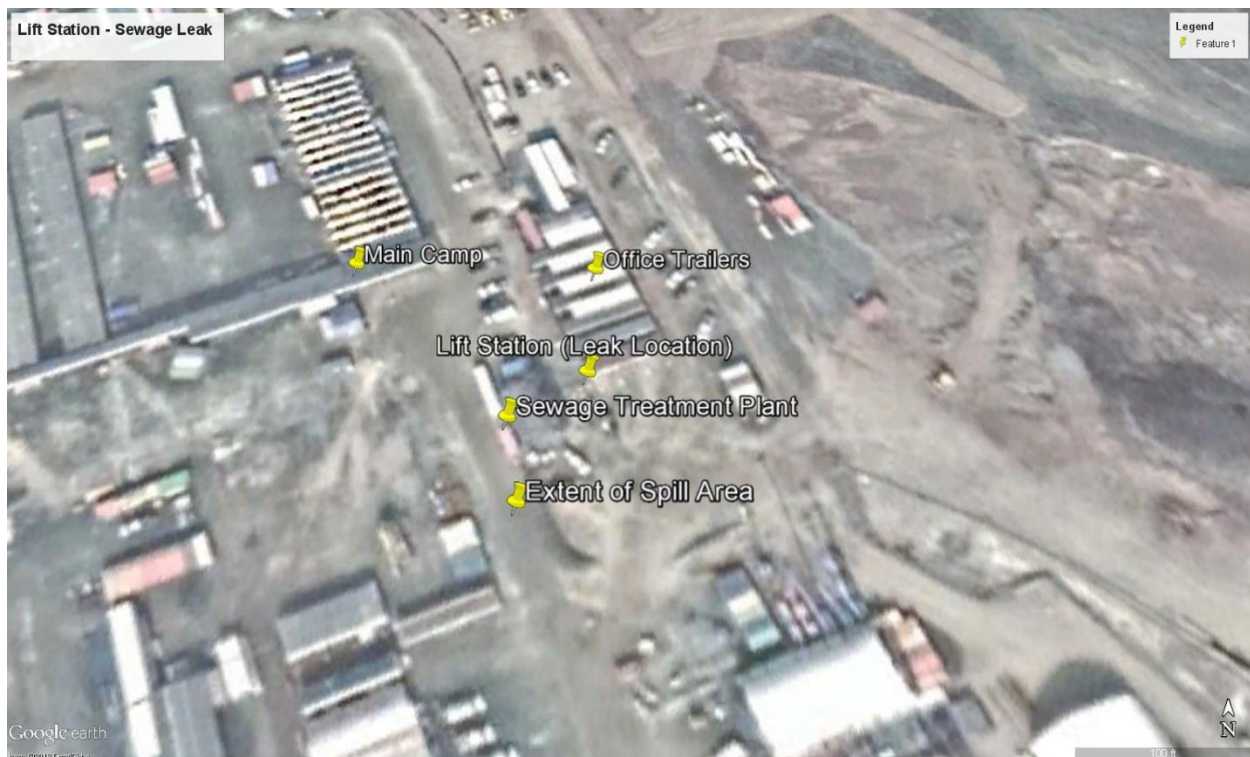
The spill occurred at the Meliadine main camp sewage treatment plant. The fluid flowed from the lift station, pasted the sewage treatment plant, and ceased flowing approximately 20m from the source. The spill covered an area of approximately 10m².

Figure 1: View from above – Main Camp: Location of lift station piping (source of leak) and spill area.

A rubber joint on the sewage treatment plant piping failed. The equipment failure was likely due to the material fatiguing in frigid temperatures.

The spill froze to the immediate area and was excavated and disposed of appropriately. The joint has been replaced with a mechanical joint made of more suitable material. A third party review of the system was completed and recommendations have been provided to Agnico Eagle for implementation in order to improve the performance of the STP.
