Follow Up Report: #18-231

May 27, 2018 Itivia Surface Water Run-off

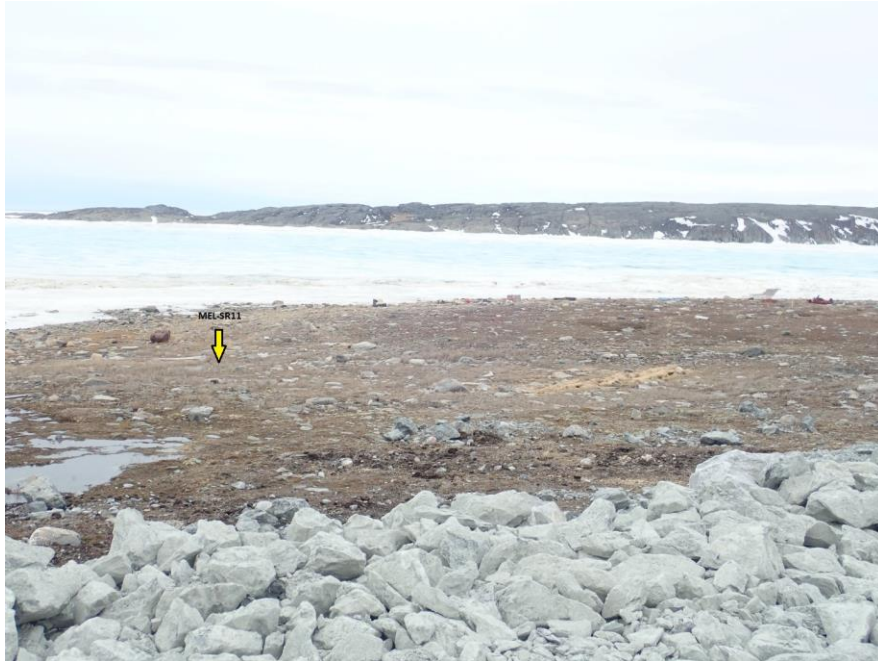
While conducting a routine inspection of the Itivia construction site on May 27th, turbid surface water run-off was observed crossing over a roadway and through a culvert into Melvin Bay.

Picture 1: Sampling location between access road and Melvin Bay.

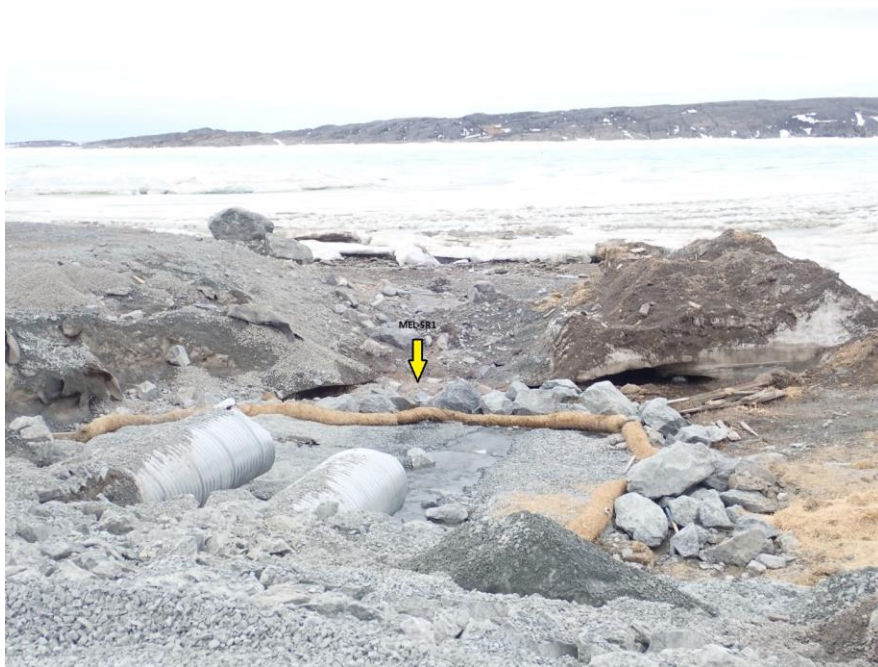
Run-off was caused by snow melting inside and outside the site disturbance area. A sediment trap was created using gravel and straw logs prior to the run-off event being sampled. The sediment traps were not effective enough to reduce TSS below acceptable levels. Improving the snow management plan and following the procedure will help reduce run-off volumes in the future.

Picture 2: Sample location immediately after sediment controls at culvert.
