Follow Up Report: #18-247

June 3rd, 2018 Itivia Surface Water Run-off

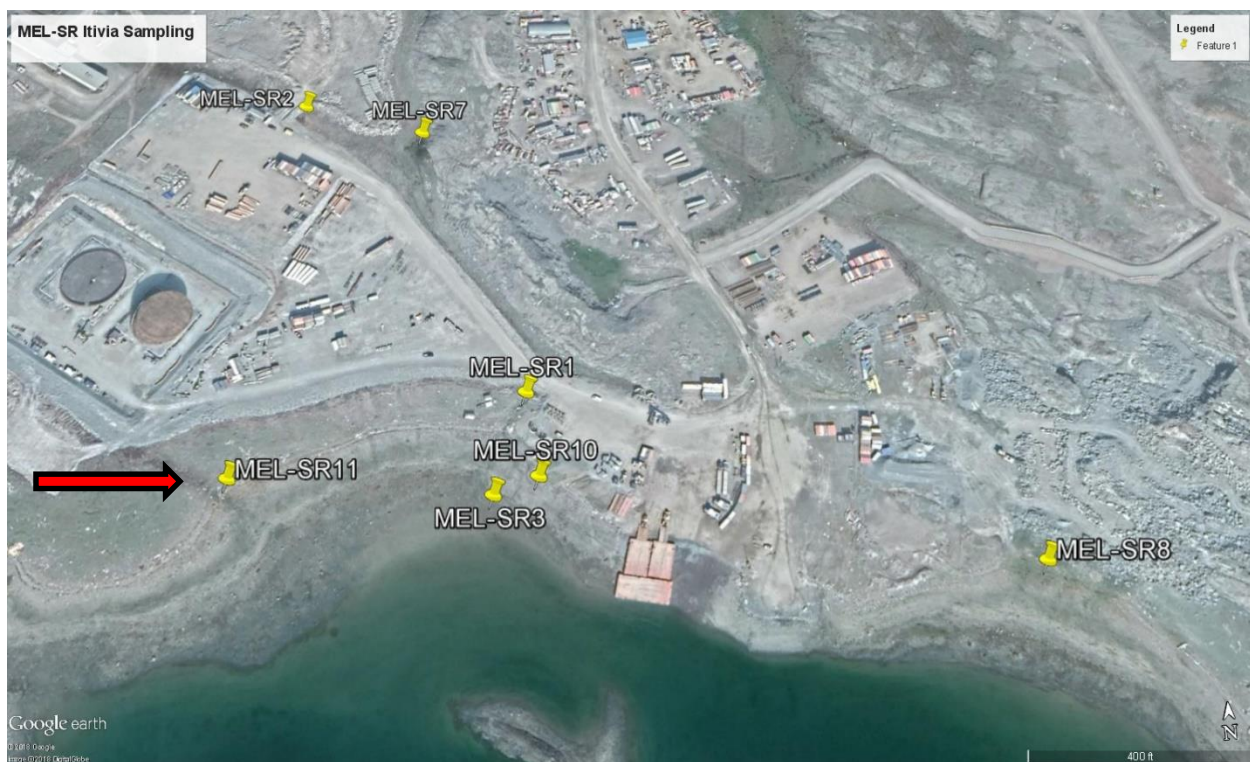
While conducting a routine inspection of the Itivia construction site on June 3rd, turbid surface run-off water was observed flowing into Melvin Bay from the eastern entrance to the bypass road. This is an area of foreshore with a gentle gradient. The sampling location is referred to as SR11.

Figure 1: Sample location at Melvin Bay foreshore

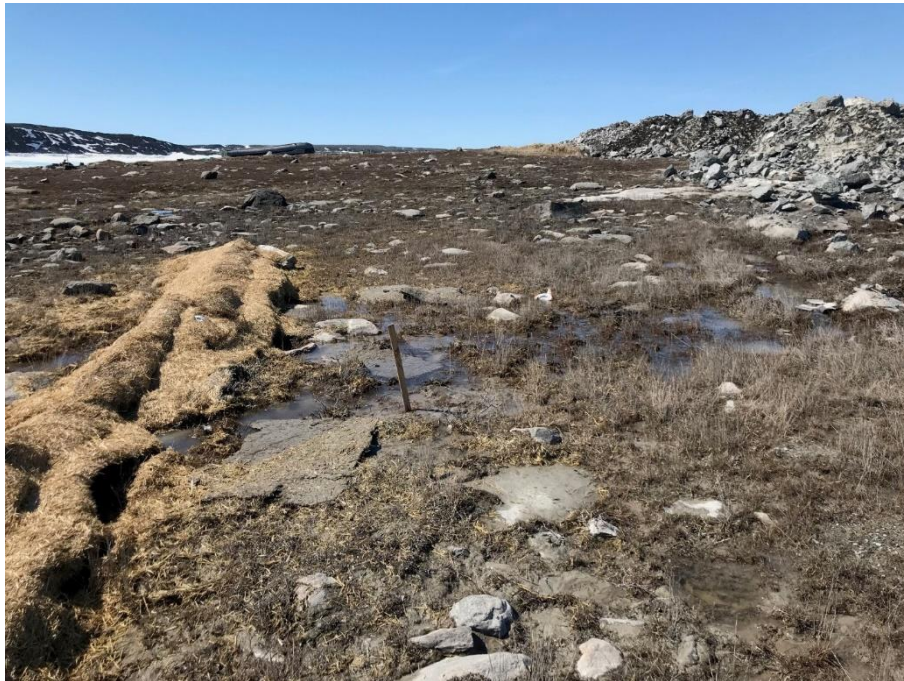
Run-off was caused by snow melting inside and outside the site disturbance area. A sediment trap was created using straw logs prior to the run-off event being sampled. The sediment traps were not effective enough to reduce TSS below acceptable levels. Improving the snow management plan and following the procedure will help reduce run-off volumes in the future.

Picture 1: Straw log sediment trap between Bypass Road entrance at Itivia and Melvin Bay.

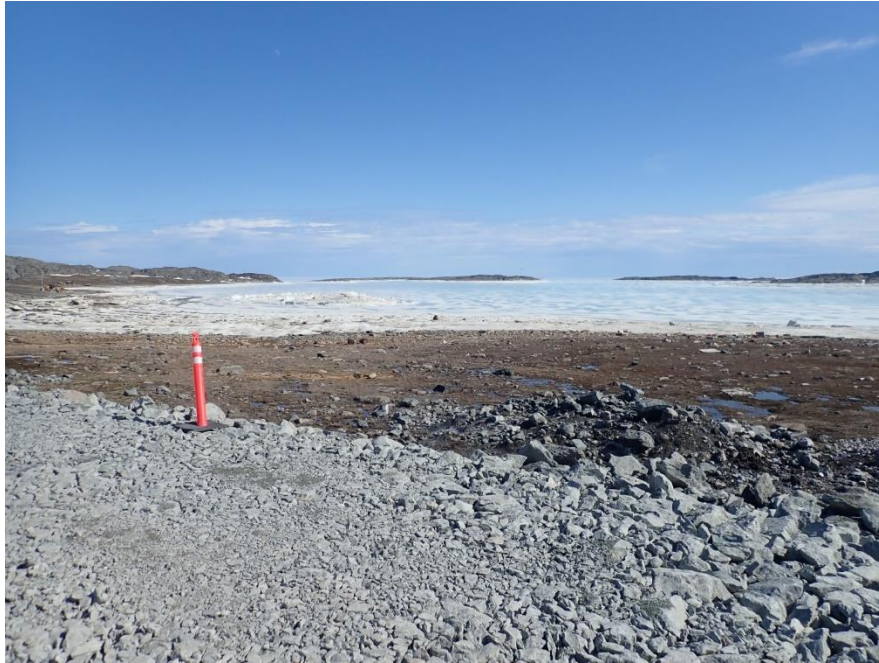
Picture 2: Run-off area from Bypass Road entrance at Itivia to Melvin Bay.

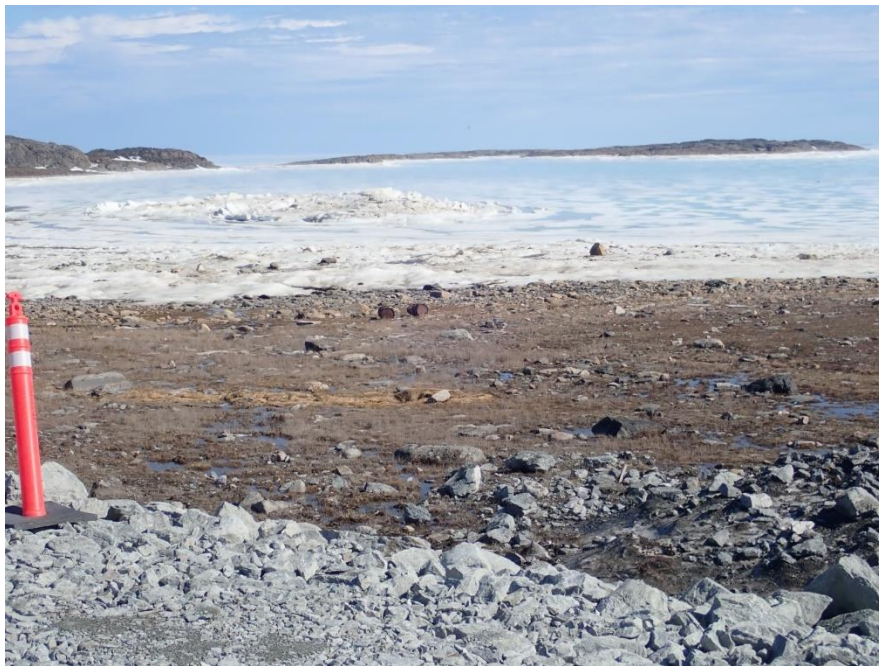
Picture 3: Run-off area from Bypass Road entrance at Itivia to Melvin Bay.
