Follow Up Report – #18-213

June 8th 2018 Drill 3 Hydraulic Oil Spill at B8

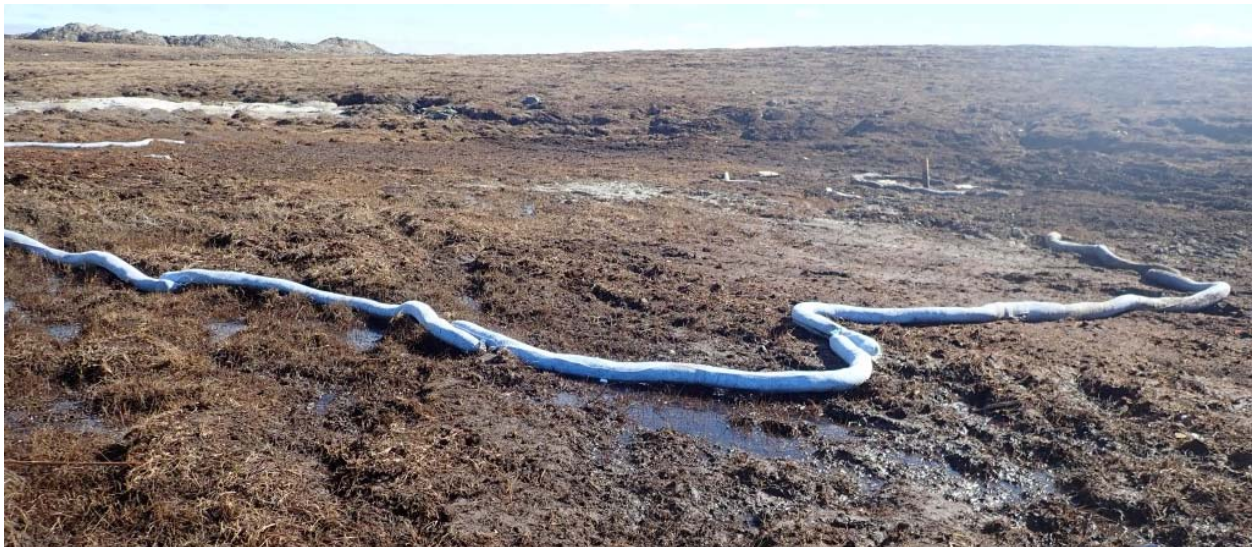
Booms were placed around the spill area to prevent hydrocarbon flow to B8. Some contaminated soil was removed and placed in the landfarm.

Figure 1: Booms placed downstream of spill location.
