## Follow Up Report #18-249

### September 27<sup>th</sup>, 2017 Itivia Surface Water Run-off

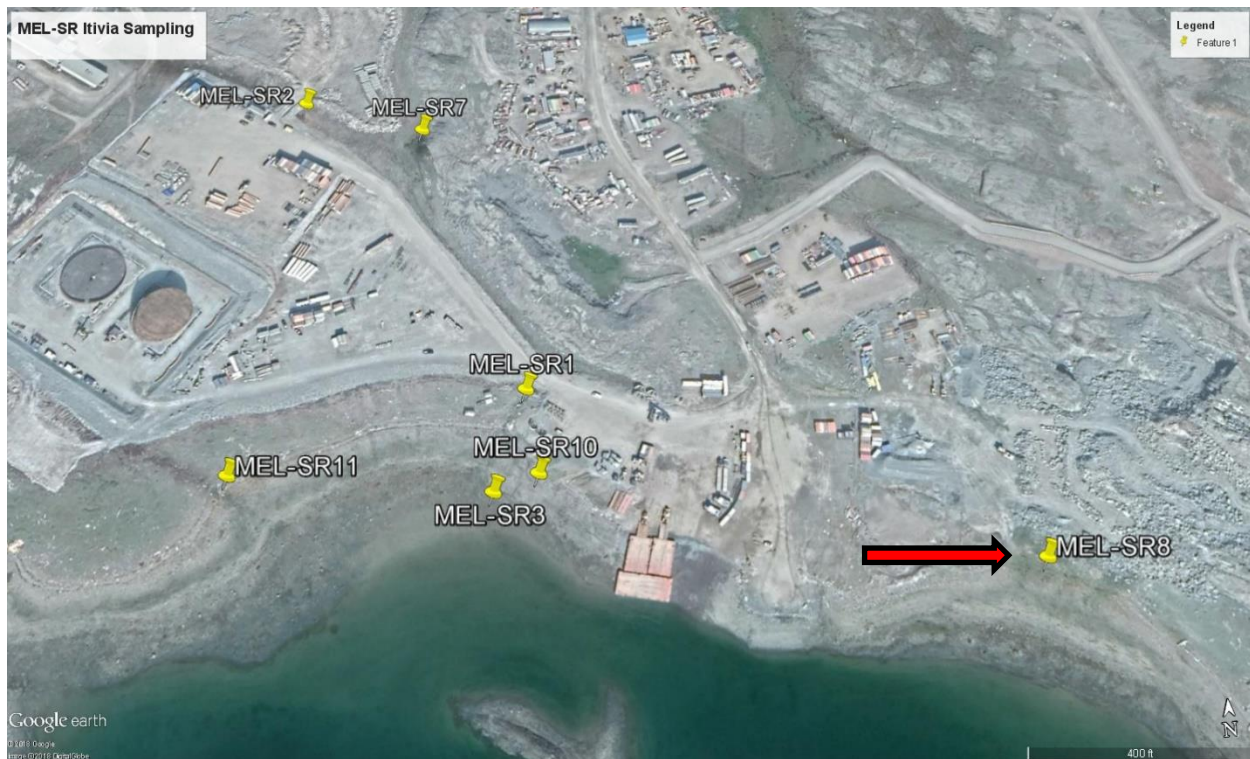
During quality control of historic data it was noted that an exceeded of 210mg/L total suspended solids occurred on September 27<sup>th</sup>, 2017. While conducting a routine inspection of the Itivia construction site on June 3<sup>rd</sup>, turbid surface run-off water was observed flowing into Melvin Bay from the quarry towards Melvin Bay. The sampling location is referred to as SR8.

**Figure 1:** Sample location at Melvin Bay foreshore

Straw logs were installed upstream to reduce TSS flow to Melvin Bay.

Run-off was caused by snow melting inside and outside the site disturbance area. Due to changes in the topography of the quarry, surface water is directed back towards the approved disturbance area, away from the quarry boundary.
