Follow Up Report: #18-313

June 20, 2018 Itivia Surface Water Run-off

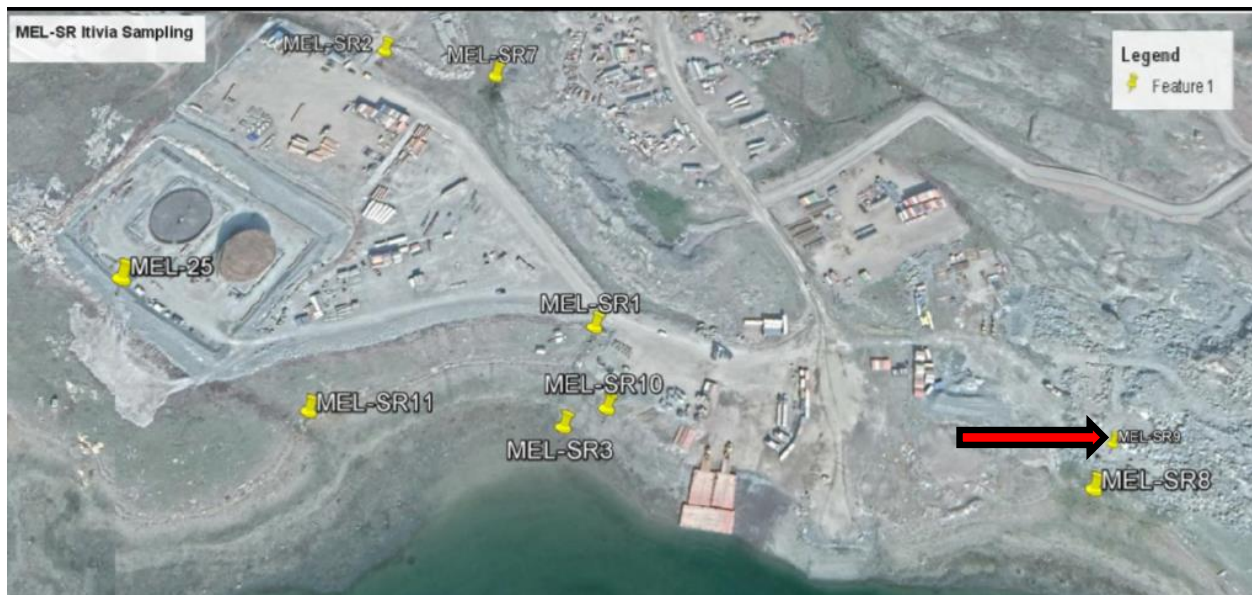
While conducting a routine inspection on June 20th, surface run-off water was observed at sampling station MEL-SR8 east of the Itivia Laydown and Storage Facility Pad. Samples were collected for laboratory analysis to assess the TSS concentration and other water quality parameters. The laboratory results were received on July 6, 2018 and TSS concentrations were 260 mg/L and exceeded the criteria of 100 mg/L, as per the obligations under the Nunavut Water Board License 2AM-MEL1631, Part D, item 18.

Figure 1: Sample location MEL-SR8 shown east of the Itivia Laydown

Run-off was caused by snow melting inside and outside the site disturbance area. Silt fences and straw logs have been installed upstream and downstream of the site and are inspected weekly. A third party consultant has inspected the area to recommend improvements to mitigate and reduce erosion and

Straw logs were placed downstream of the source to reduce TSS flow to Melvin Bay.
