Follow Up Report: #18-417

October 4th, 2018 Diesel fuel

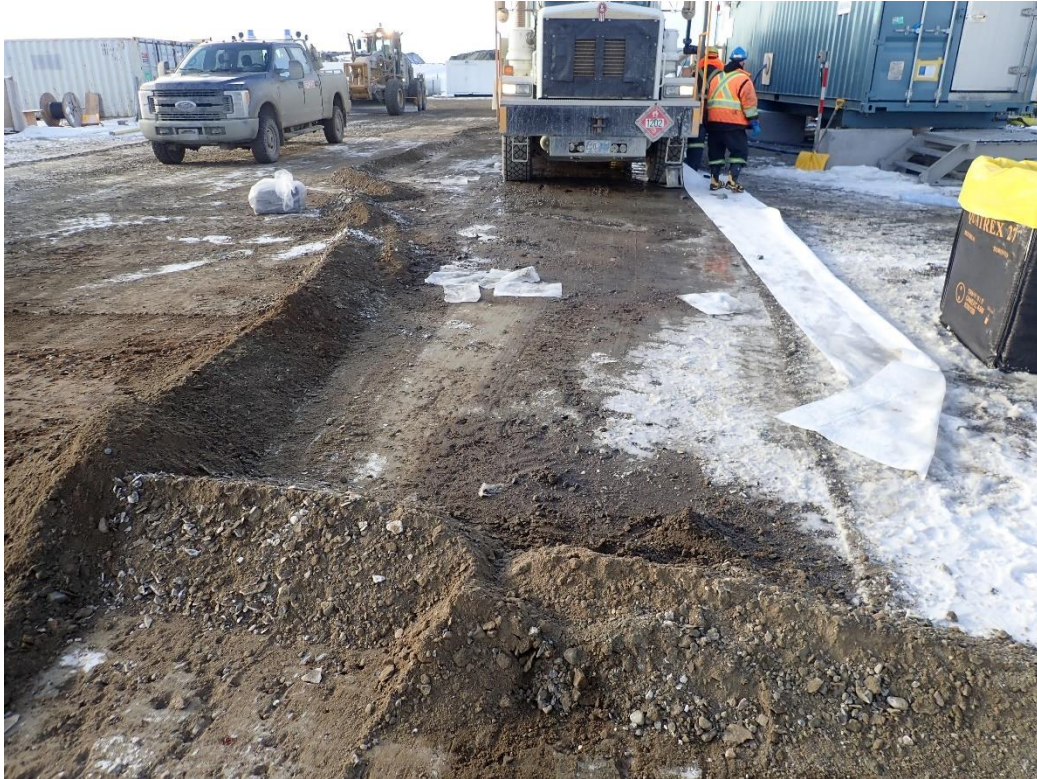
Photo 1: Contain the spill with berm and absorbent pads

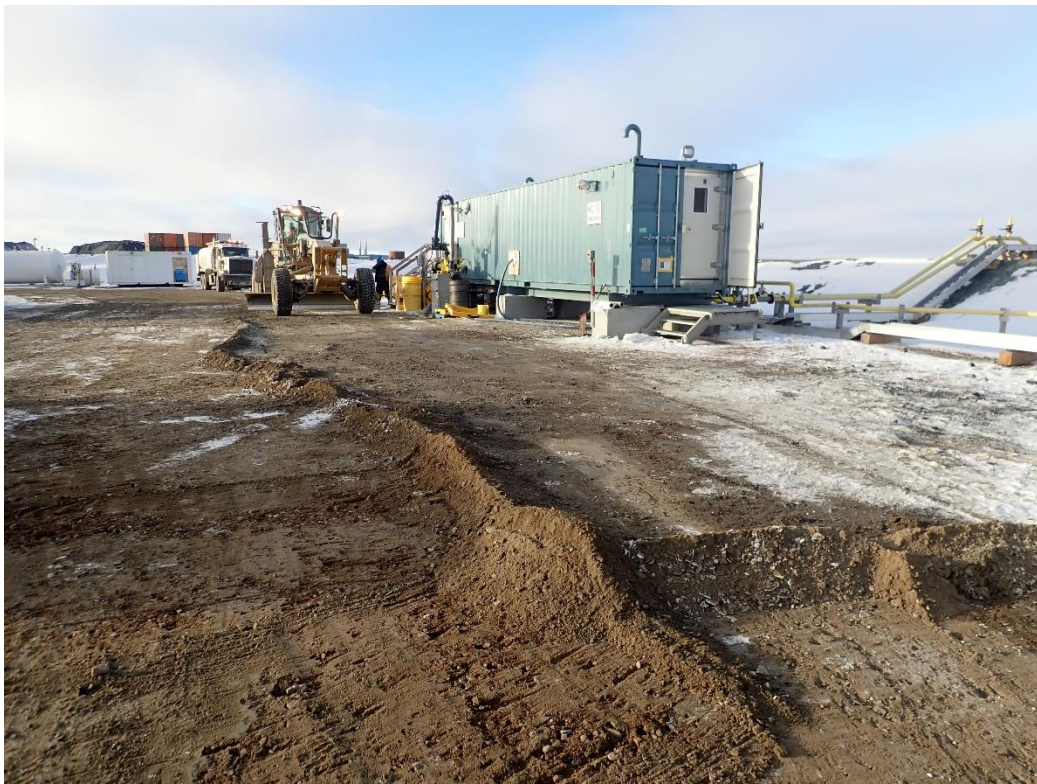
Photo 2: Scrapping of the surface material

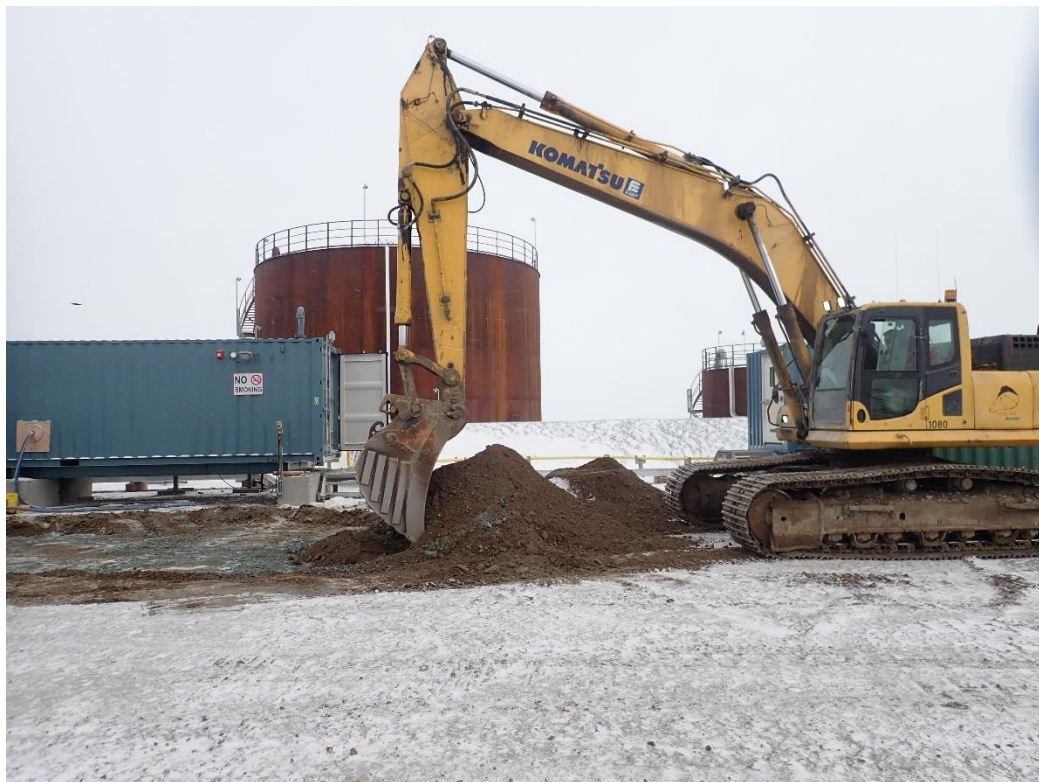
Photo 3: Excavation of the contaminated material

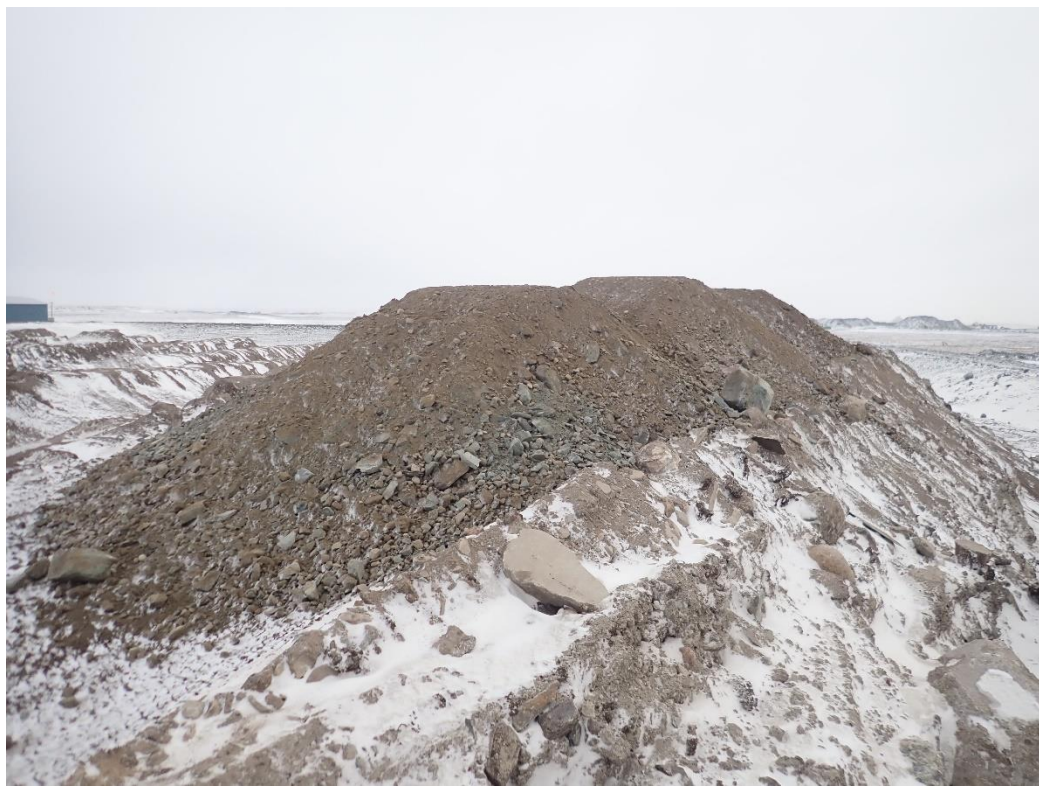
Photo 4: Contaminated material brought to the landfarm

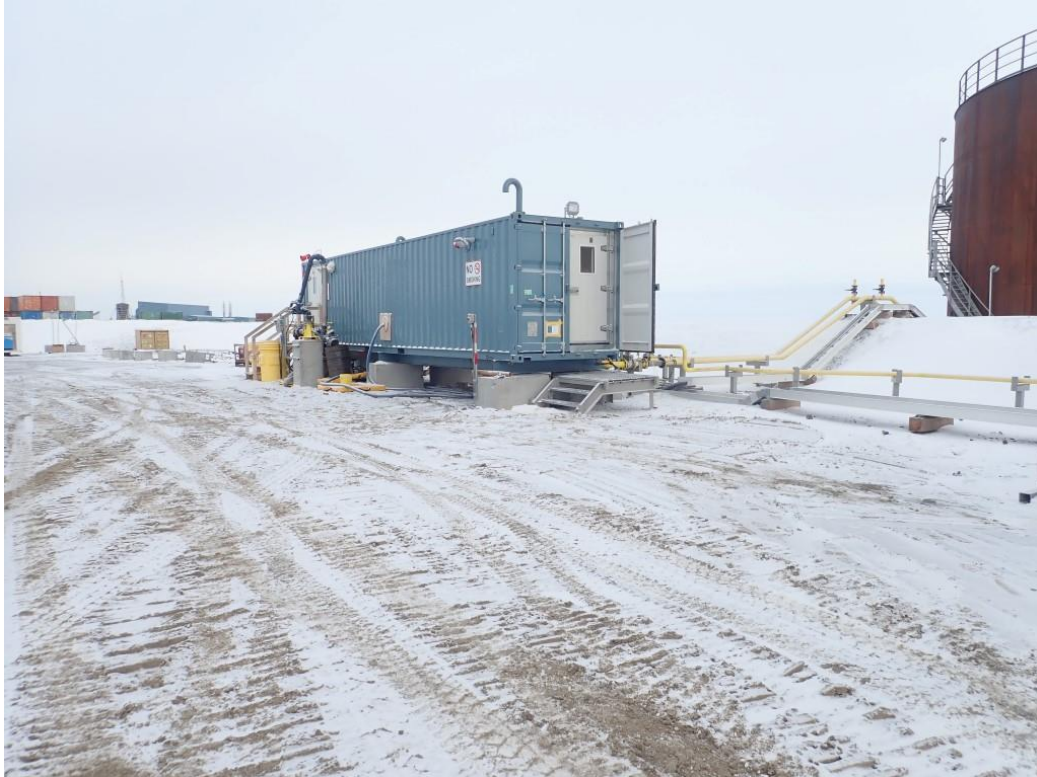
Photo 5: Spill area after cleanup
