Follow Up Report: #19-021

January 20, 2019 Boiler Recirculation Loop Leak

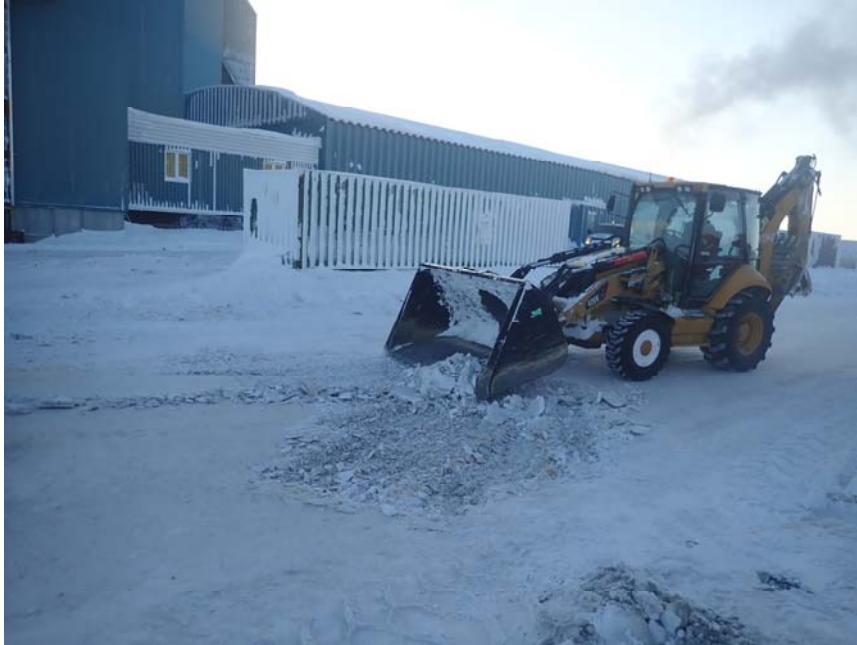
Due to failure of an expansion joint on the boiler recirculation system, approximately 200L of water with corrosion inhibitor (Drewgard 4109) spilled to ground. Most recently the of water was analyzed with a concentration of 0.195ppm of Drewgard. The water froze and 12m³ of snow and ice was transferred to P3, a containment pond within the site's managed water system. No water body was impacted. The nearest body of water is >300m away. The coordinates of the spill were, 63° 2'19.52"N, 92°13'39.97"W.

Figure 1: Water from boiler recirculation system being removed from ground.

Site personnel shut off valves preventing further release of water from the boiler recirculation system. Water followed through the floor of the Arctic corridor to ground and froze. Frozen water from the system was cleaned up with heavy equipment. Material was transported and contained in P3, part of the site's water management system.

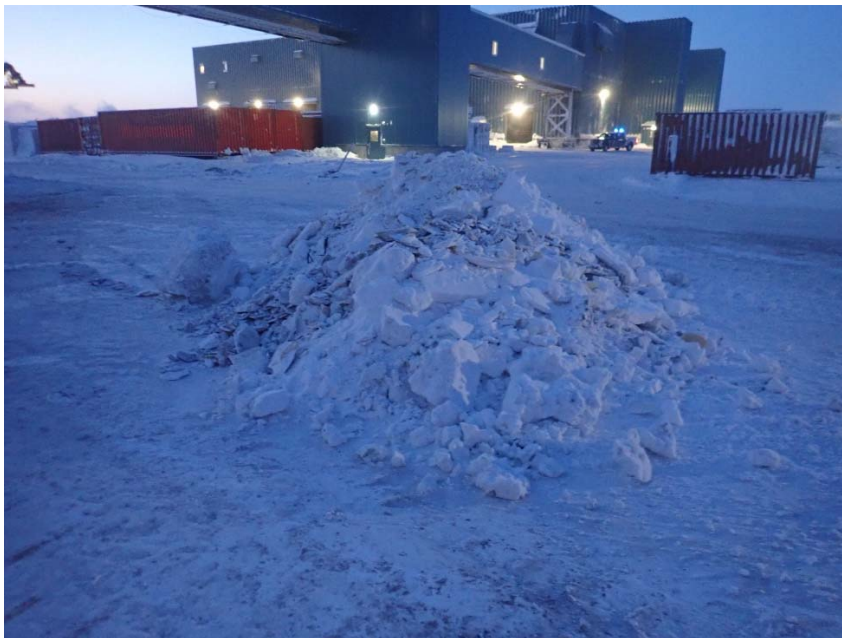
Figure 2: Frozen material prior to being transported to P3.
