Follow Up Report: #2019-123

March 20, 2019 MSB Retention Tank Drain Pipe

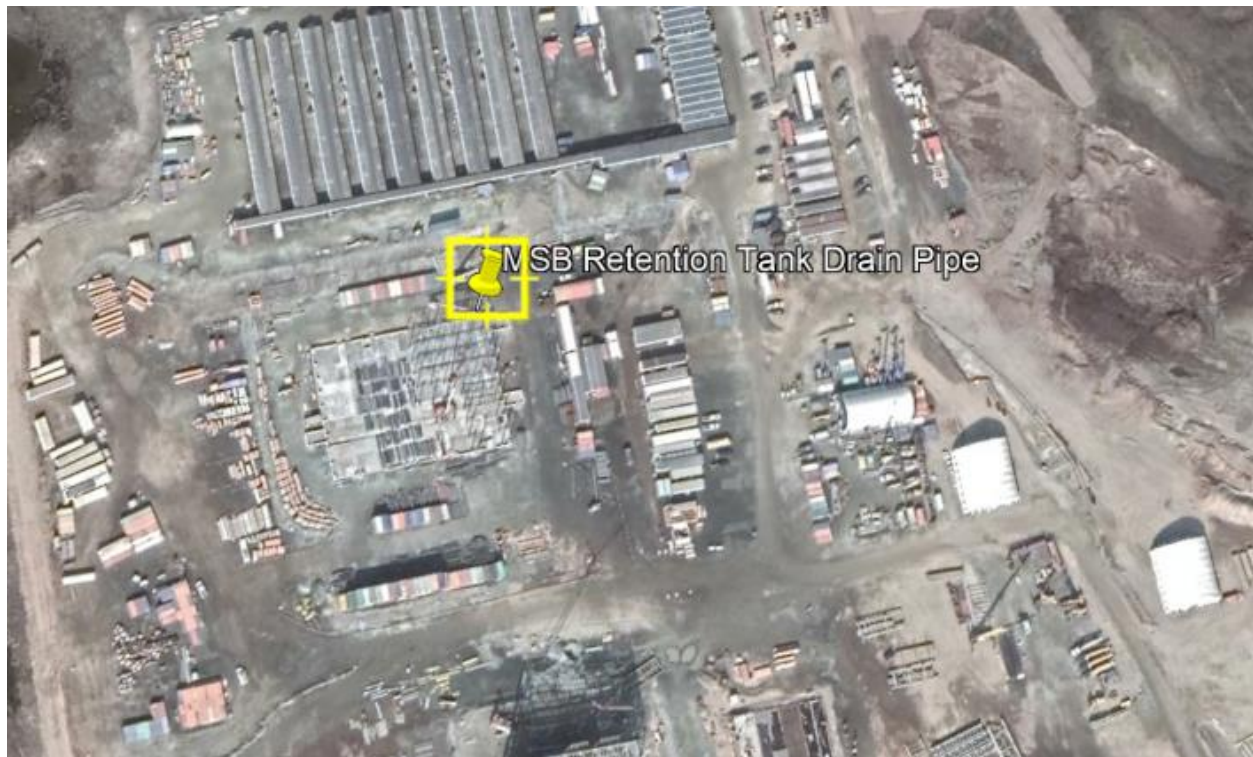
At approximately 6:45AM a site services electrician reported a liquid spilling from a pipe above the MSB lift station (Figure 1). The pipe was the drain leading to the MSB lift station. Due to the heat trace breaker tripping, the heat trace was off for an undetermined amount of time, this caused a freeze in the line. The area affected was a 'Y' in the pipe (Figure 2) - the dead end of the 'Y' was capped. This cap was forced off by the freeze/pressure. Due to this the sewage drained from that 'Y' onto the ground.

Figure 1: Location of the MSB Lift station where the spill occurred.

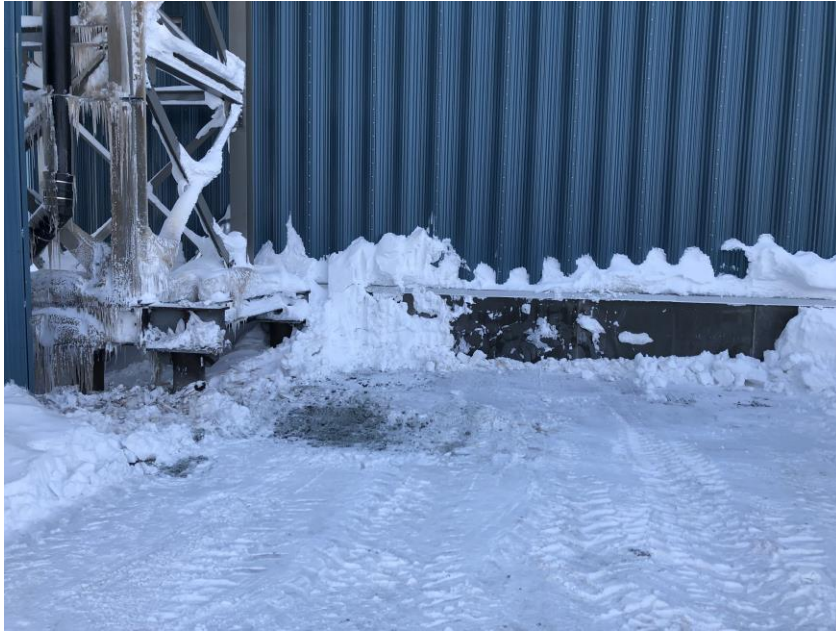
Figure 2: Area of contaminated snow removed and brought to the Meliadine Landfarm; contaminated ice will be collected when ice melts to prevent structural damage with equipment

once material thaws and brought to the landfarm once it falls; as contaminated ice melts; secondary basins shall be placed under to catch contaminated ice material.

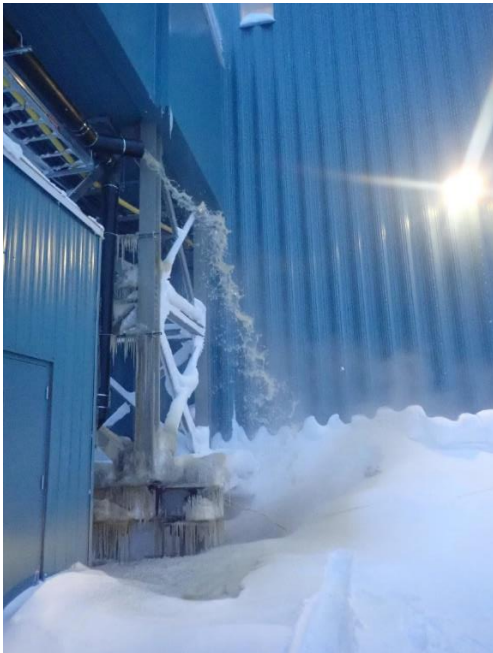
The cause of the spill was traced back to a heat trace line, which had switched off due to a breaker tripping. This led to the pipe accumulating frozen liquid inside which ultimately cause the end cap on the pipe to break off. The heat trace was fixed and the end cap on the pipe was replaced and sealed.

Figure 3: Upon arrival of the Environment Technicians water was periodically draining from the 'Y' in the pipe. It was not a steady, constant flow of water. It is unknown how long this was going on before it was noticed.
