## Follow Up Report: #19-171

### April 16<sup>th</sup>, 2019 Orbit Drill 3 Spill

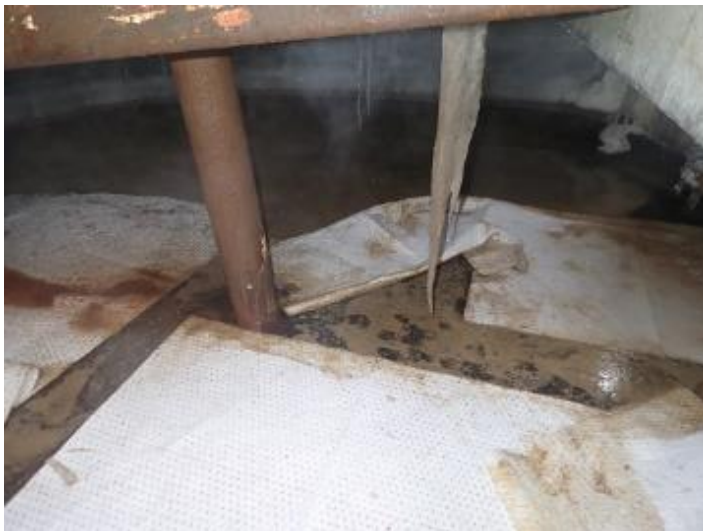
The body valve was replaced, stopping the leak. Heat from the operation of the drill caused the ice to melt and oil flowed into the hole under the rig. During clean up on April 25<sup>th</sup>, it was noted that approximately 1 litre of additional oil had leaked from the rig to the absorbent pads below. Absorbent pads were used to collect oil from the water surface. Used absorbent pads were collected and disposed of in compliance with the hazmat management plan.

**Figure 1:** Absorbent pads used to remove oil under drill 3, on lake B7.

Agnico Eagle's Environment department completed an investigation and determined the cause of the spill was a failed body valve. It was determined the spill occurred 16<sup>th</sup> April 2019, but was not reported until 24<sup>th</sup> April 2019. AEM Geology completed further follow up investigation and determined more thorough pre-op inspections must be completed in order to identify equipment failures.
