## Follow Up Report: #19-169

### April 24<sup>th</sup>, 2019 Orbit Drill 6 Spill

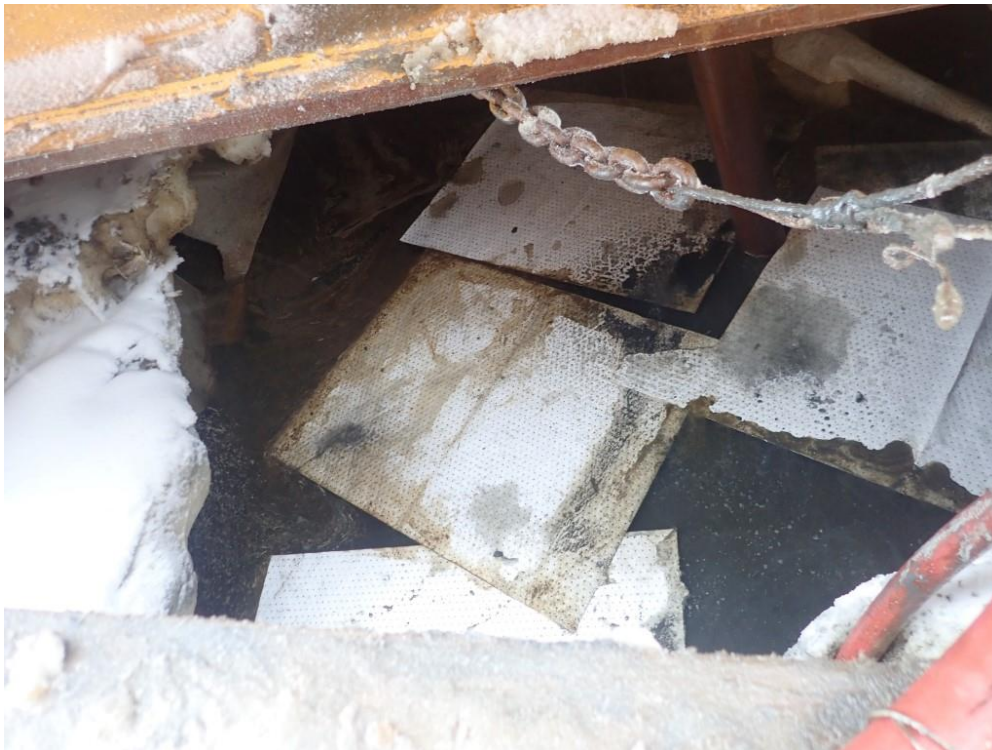
On April 24<sup>th</sup> 2019, an inspection of Orbit Drill 6 was completed. A spill was discovered covering an area of approximately 0.5m<sup>2</sup>. It was estimated approximately 4 litres of oil was released onto the frozen surface of Lake B7. The incident occurred at drill hole M19-2518. GPS coordinates of the location are 538374.94N, 6989189.85W.

Heat from the operation of the drill caused the ice to melt and oil flowed into the hole under the rig. Absorbent pads were used to collect oil from the water surface. Used absorbent pads were collected and disposed of in compliance with the hazmat management plan.

**Figure 1:** Absorbent pads used to clean up oil spilled beneath drill 6, on Lake B7.

The rotation head broke causing oil to leak to the drill floor and flow into the cutting tub. The cutting tub overflowed releasing approximately 4 litres of oil to the ice hole beneath the rig on Lake B7.

- Agnico Eagle staff will confirm clean-up of spills and complete drill inspections prior to drills relocating.
- Maintenance records will be kept for decantation tubs and cutting tubs under the drill.
- Orbit foremen will ensure thorough pre-operation inspections are completed.
- This incident will be used as an example during toolbox talks to remind staff of the importance of inspections and spill reporting.
