Follow Up Report: #19-170

April 24, 2019 Main Camp STP Sewage Spill

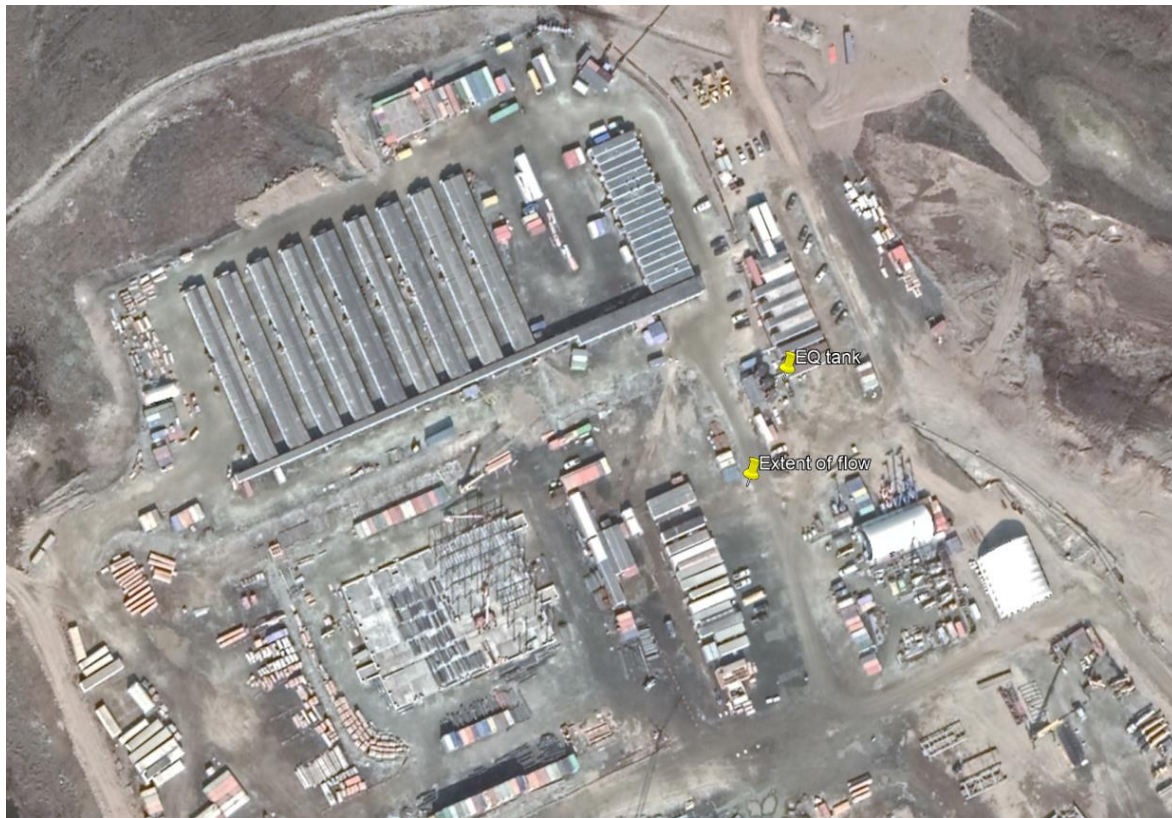
On April 24th, the discharge pipe leading from wing 10 to the equalization tank of the sewage treatment plant, disconnected at a glued PVC elbow. The resulted in approximately 10m³ of untreated sewage spilling onto the gravel pad approximately 15m south of the main entrance of the camp. GPS coordinates of the location are 63°02'23"N 92°13'37"W. The nearest water body is located over 250m to the north.

Figure 1: Spill source and extent of flow

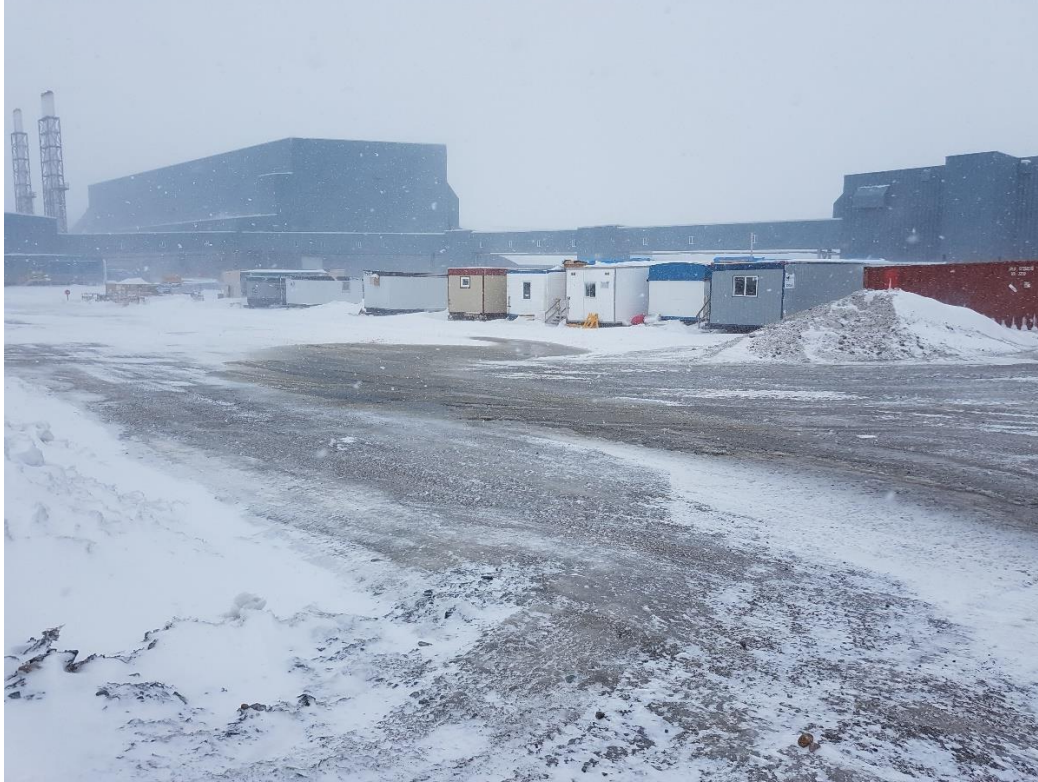
Figure 2: Extent of spill flow from main camp STP equalizer tank facing South East.

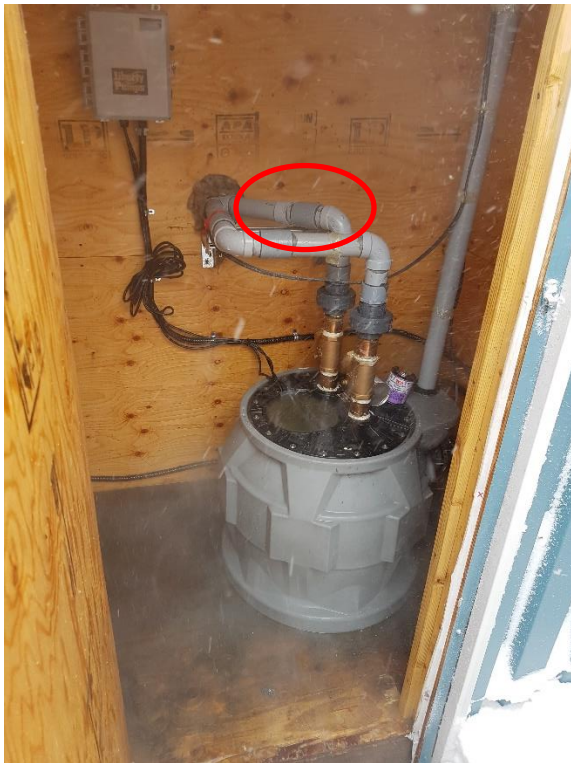
Figure 3: Wing 10 outflow to equalizer tank disconnected.

An investigation was completed and the cause of the spill was determined to be caused by a weakened PVC joint. This was likely caused by expansion and contraction due to temperature fluctuation. The PVC joint was reconnected, resealed and leak tested.

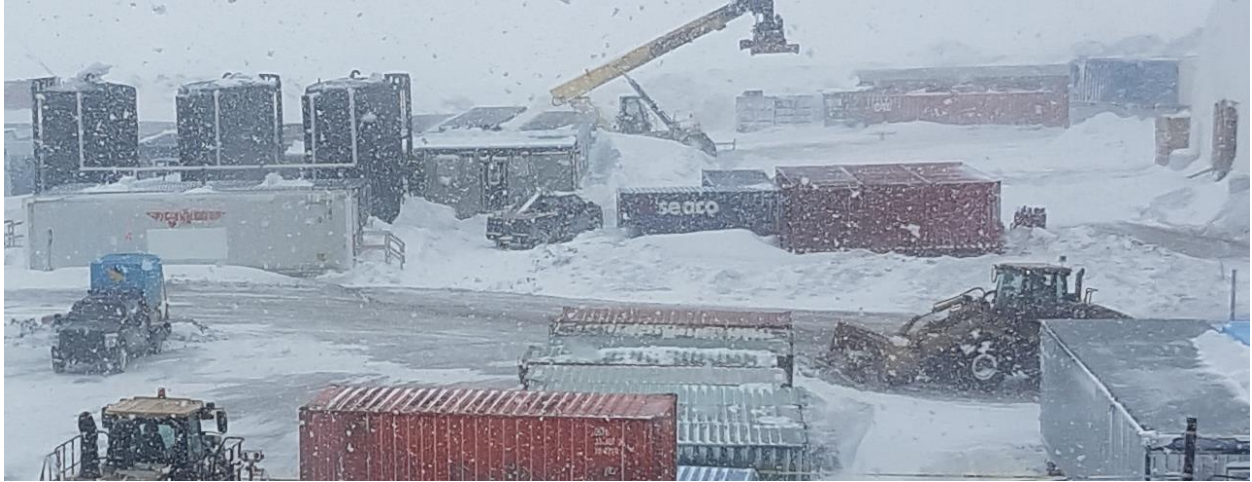
Figure 4: A loader was used to remove contaminated gravel for transport to Landfarm A.

Initially, an employee who was outside at the time noticed the water flowing and called the E&I supervisor over the radio. The power supply was disconnected and the valve leading from the equalizer tank was closed. Contaminated material was scraped up with a loader and brought to the License A Landfarm (approximately 5m³), and will later be spread over existing windrows to enhance the bio-remediation process. INAC was previously contacted to ensure that this was a suitable plan of action for disposing of the sewage-contaminated material.
