Follow Up Report: #19-208 May 16th, 2019 – Main Camp Lift Station – Treated Sewage Water

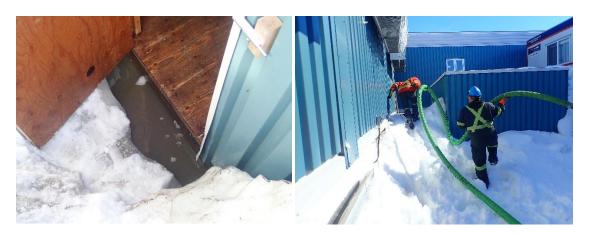
Figure 3: Standing water outside of the lift station was removed using the sucker truck.

Employees noticed the water and pumping from the truck was stopped immediately. A vacuum truck was used to remove standing water around the lift station building. Contaminated snow and soil was transported to the landfarm using a loader.
