Follow Up Report: #19-346 (formerly #19-345) August 19, 2019 Total Suspended Solids (TSS) Exceedance– MEL-26 Discharge Point

The following information is being provided in accordance with MDMER Section 31 and section 38(7) of the Fisheries Act, and relates to spill report #19-346, submitted August 27th 2019, by Agnico Eagle Mines Ltd., Meliadine Division.

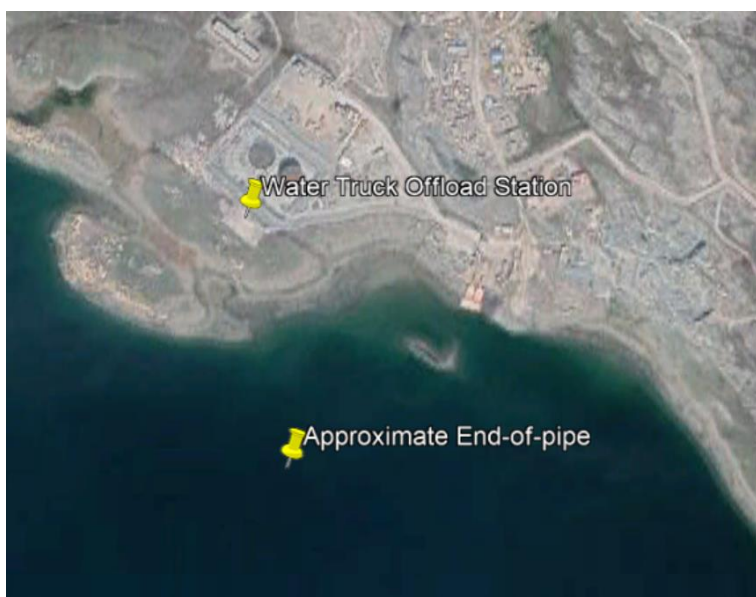
A weekly effluent sample at the MEL-26 final discharge point (Figure 1) for treated saline water was collected on August 19, 2019. Visually, the sample did not appear to be indicative of high TSS, and the field measurements taken at the time were within the acceptable limits.

Results from this sample were received August 27, 2019, at which time Total Suspended Solids (TSS) analysis showed 53mg/L and 33mg/L on a duplicate sample, which exceeded the limit of 30mg/L for any given grab sample to comply with MDMER Schedule 4 authorized limits.

Figure 1: Location of the truck offloading station of treated saline water, and the end of the pipe where discharge enters Melvin Bay.

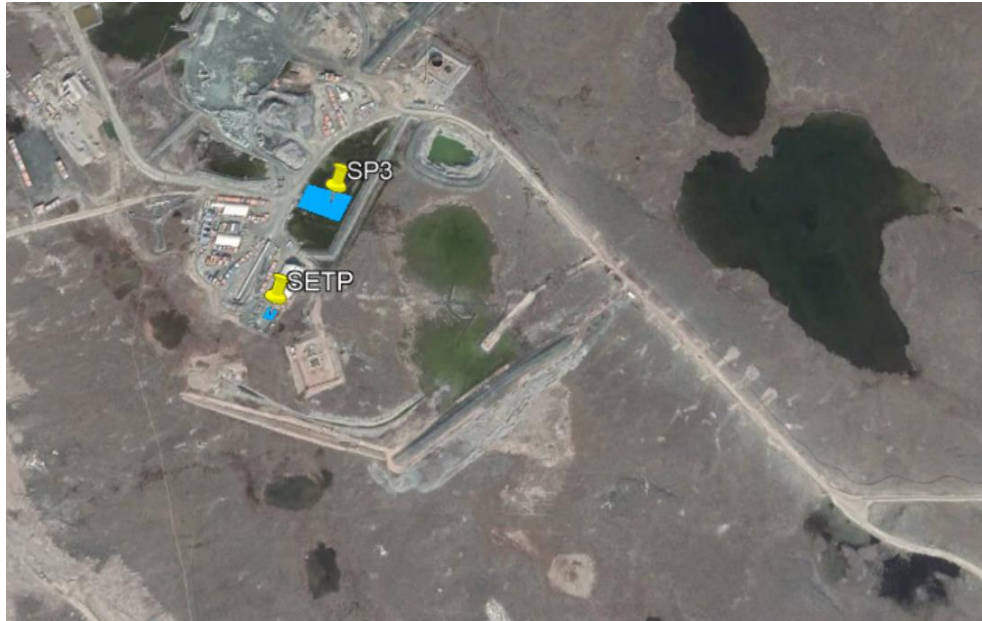
During the week leading up to August 27th, algae was observed in the SP3 (Figure 2) pond which was thought to have been a major contributor to the high TSS in the MEL-26 sample. Before receiving lab results, BV Labs was contacted and asked to include Volatile Suspended Solids (VSS) analysis to elucidate between organic and inorganic solids. Laboratory analysis showed VSS accounted for approximately 50% of TSS, indicating the TSS exceedance was likely due to algal growth in the sample post-collection.

Figure 2: Locations of SETP and SP3.

The initial cause of the Total Suspended Solid exceedance was due a combination of high wind agitating sediment and algae in Saline Pond 3. Algae growth is suspected to be the result of nutrient levels. Sediment is suspected to be the result of dust, insufficient filtration, and feed source.

In response to the TSS exceedance, VSS analysis was added to determine the source of the TSS. Results showed the source was approximately 1:1 organic to inorganic, indicating algae was a contributing factor. Algaecide was added to SP3 to reduce TSS. The intake pipe was raised approximately 30cm from the bottom of the pond to reduce the quantity of sediment being pumped into tanker trucks, which transport effluent to the discharge point at Itivia. A minimum operating water level was implemented to allow settling within the retention pond.
