Follow Up Report: #19-380 September 15th, 2019 – Cyclone Separator Process Water Spill

The following information relates to spill 2019-380 reported by Agnico Eagle Mines Ltd. September 15th 2019, and is being provided in accordance with:

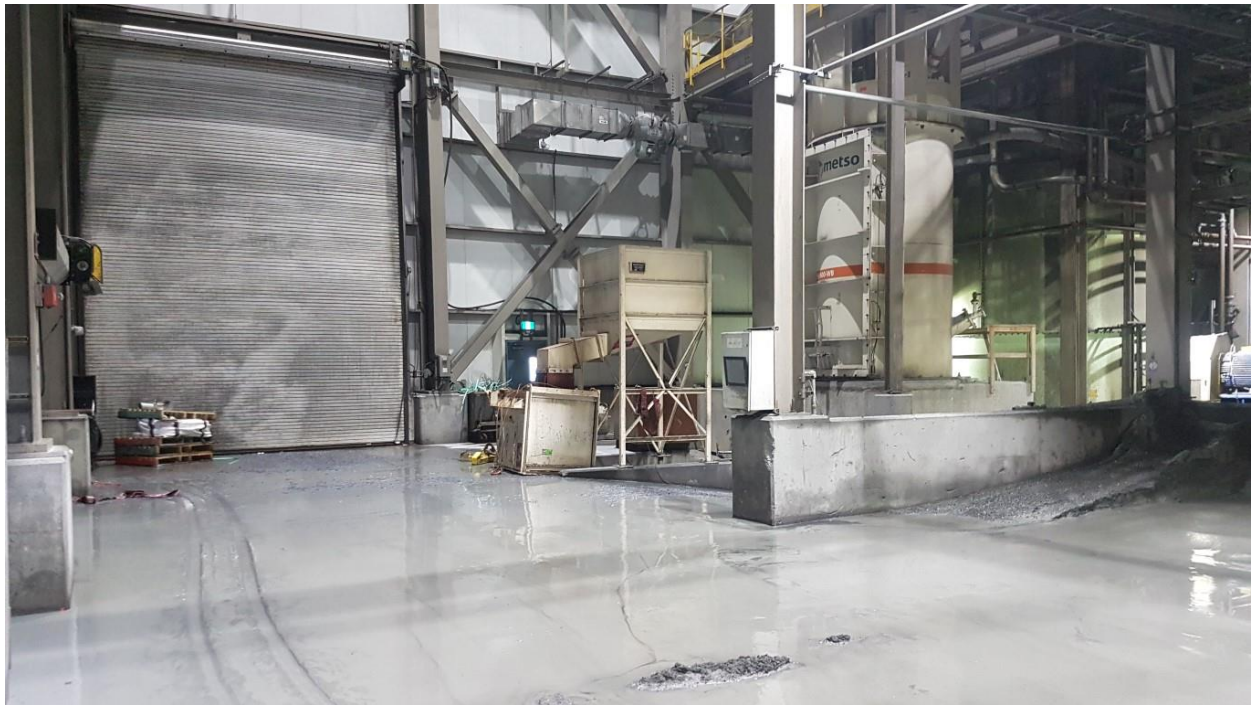
At 12:30pm, Saturday 14th September 2019, during start-up of the cyclone system in the process plant, a blockage occurred preventing slurry and process water from passing through the cyclone unit. The system backed up causing process water and slurry to overflow to the floor of the process plant. Approximately 8m³ of process water and slurry flowed outside of the building, onto the industrial pad. The majority of the slurry remained on the plant floor. The spill volume was estimate based on the area and depth of the spilled material.

Figure 2: Slurry overflow on Process Plant floor facing south.

A blockage on cyclone separator #1 went unnoticed by the control room operator, causing the system to overflow before the operator could stop the inflow. Slurry overflowed into the trash screen sump, which did not have capacity to contain the volume of overflow. The sump then overflowed and slurry flowed out of the building.

To prevent recurrence, operators grinding ore input have been instructed to increase the frequency of their inspections of the cyclone separators. To prevent the trash screen sump from overflowing, a hole will be drilled through the concrete wall to allow flow to migrate to the grinding sump pump.

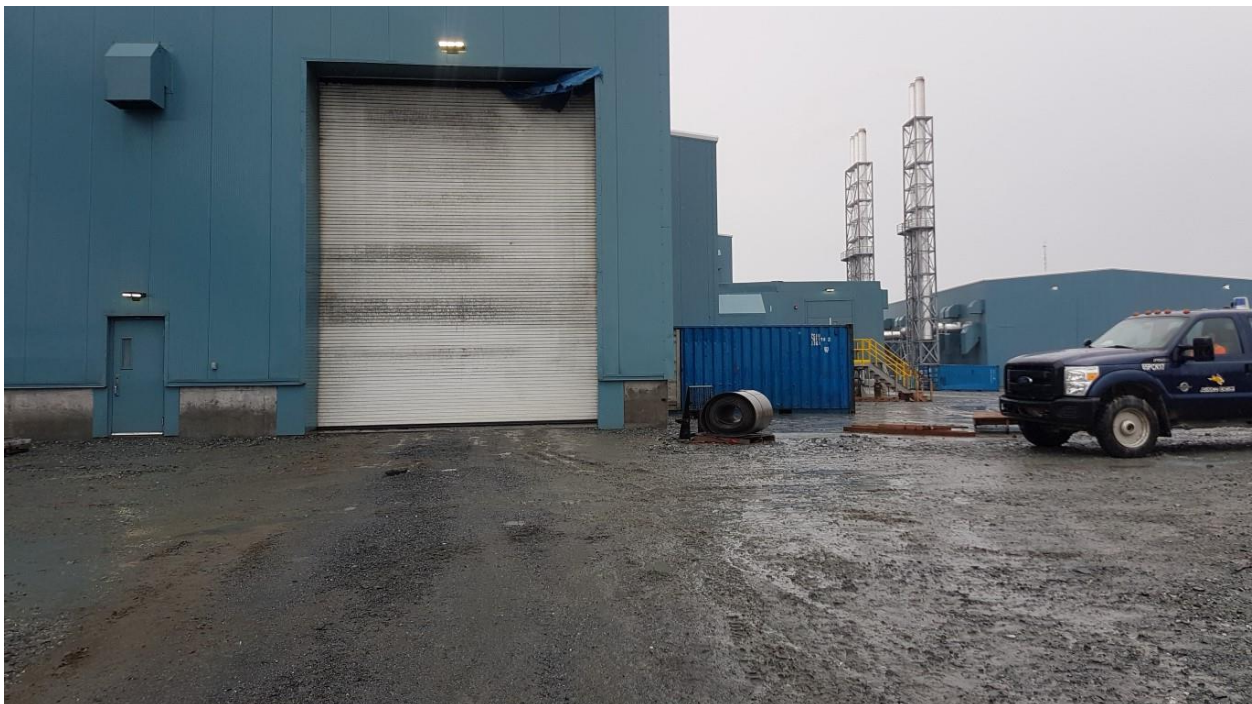
Slurry, which spilled to the process plant floor, was collected for reprocessing. Slurry and contaminated material unsuitable for reprocessing has been stockpiled for disposal. The affected area was cleared with heavy equipment. Environment staff investigated the affected area and interviewed the plant manager.

Figure 3: Affected area outside of Process Plant following clean up, facing North.
