Follow Up Report: #19-405

September 28th, 2019 – Copper Sulphate powder spilled

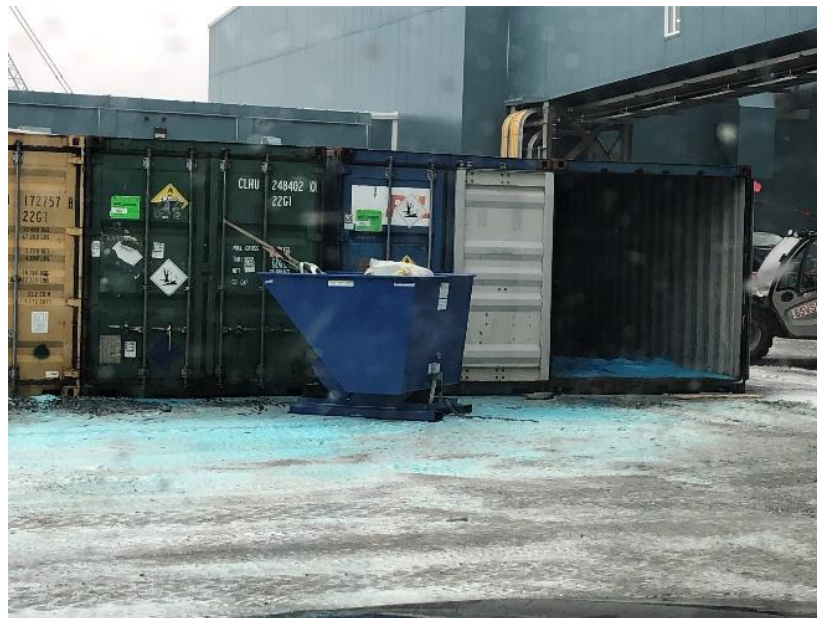
At 11:00a.m. on Saturday September 28th, we received a verbal report of a potential spill of an unknown blue powder outside of some sea-cans near the Mill (Figure 1-4). Further investigation revealed that this was Copper Sulphate (aka Cupric Sulfate, CuSO_4 UN3077).

Figure 1: Area outside the container which was contaminated.

The torn bag of CuSO_4 was patched and removed from the sea-can. The sea-can was unloaded and the pallets were brought inside the Mill. The spilled material in the sea-can was shoveled into buckets and replaced into the original bag. The material outside the sea-can was scraped up and brought to the Mill to be disposed of within the process plant. Figure 6 shows the cleaned up area where the spill had occurred.

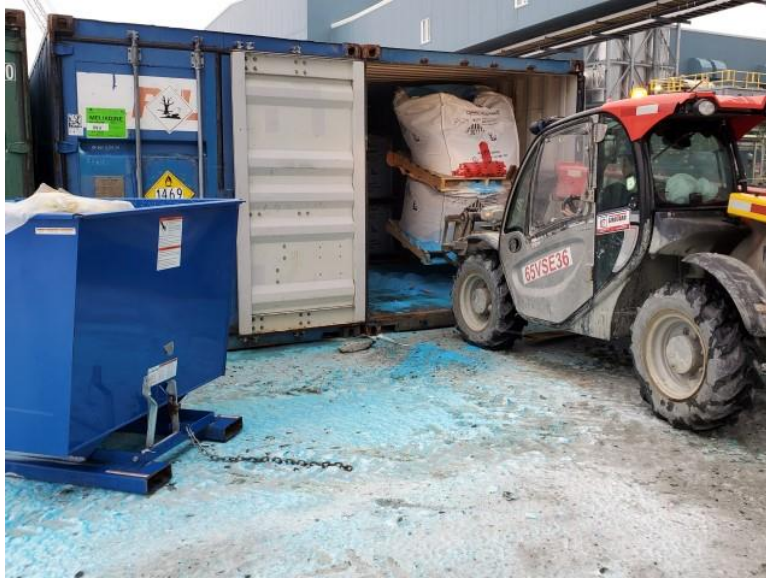
Figure 2: Forklift operators removing the torn bag/pallet to bring inside the Mill.

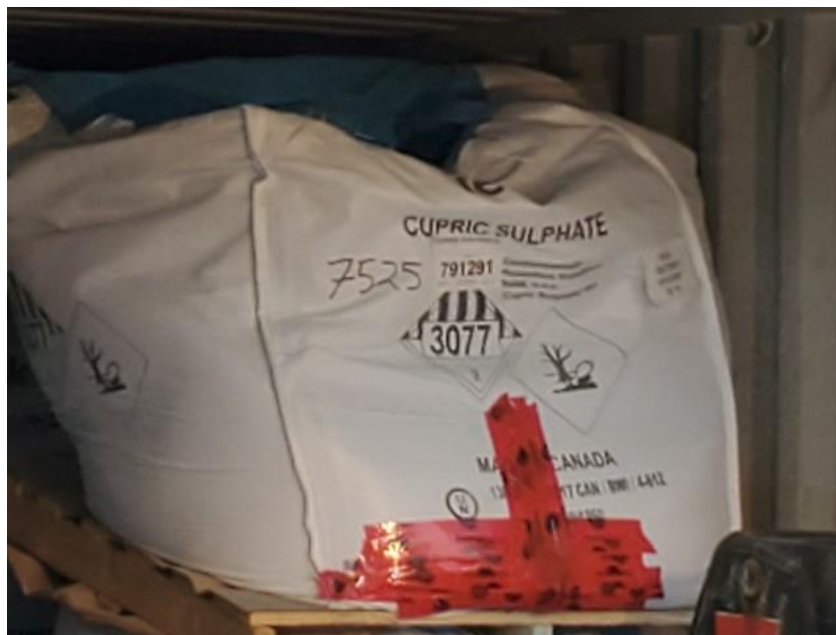
Figure 3: Damaged pallet which has been patched so that no more material is released during transport.

The bag containing CuSO_4 was ripped, which likely occurred during transport. The day they were unloading this sea-can we experienced very high winds (gusting up to 80km/hr). The wind blew a significant amount of the material out of the sea-can. In these situations, the operators should try to remove as much material as they can from the pallets before removing the pallets from the container, so that it does not fall onto the ground. Inspection of each of the bags of material before handling them with the machinery should also be implemented in order to avoid removing an already damaged bag before it can be patched.

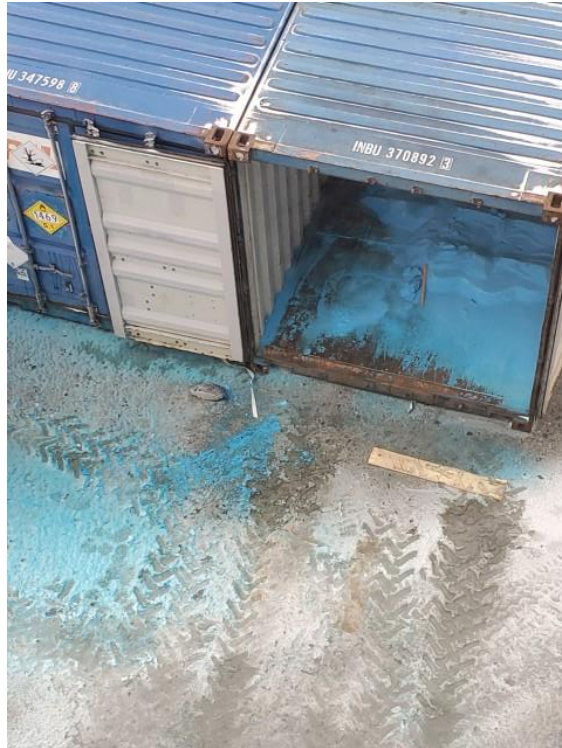
Figure 4: View from inside the container after the pallets were removed. Most of the material was contained inside the sea-can.

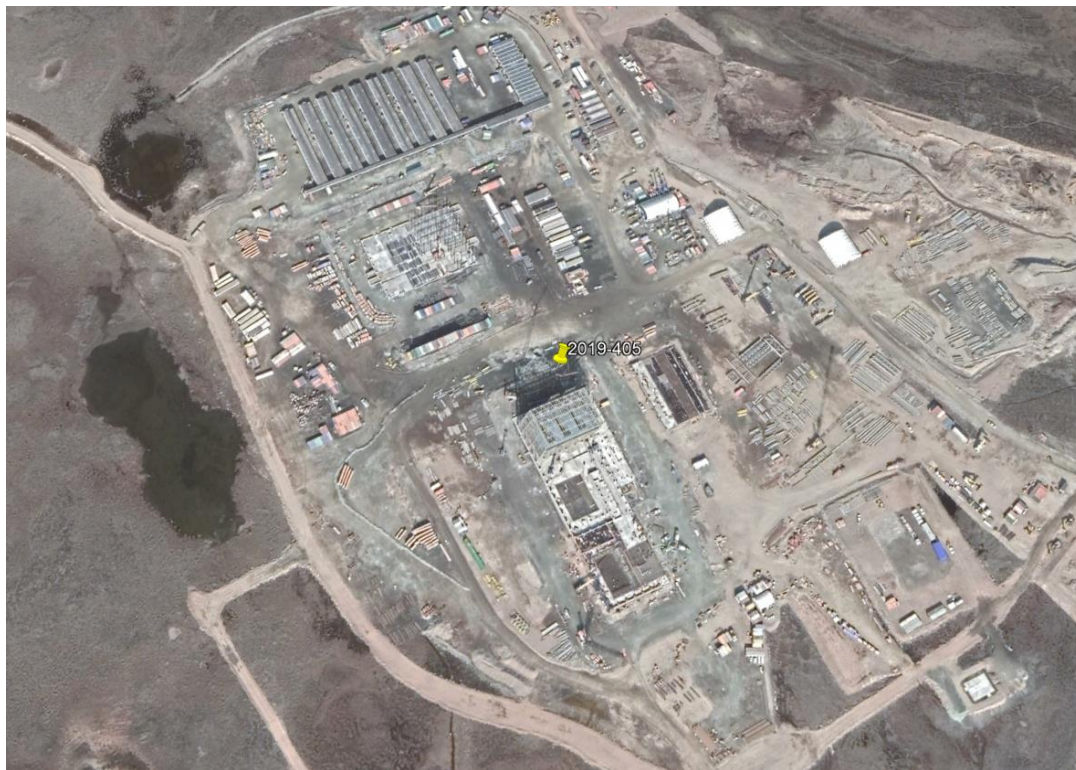
The nearest natural water body (G2), 475m to the north, was not impacted. The spill occurred at 63° 2'16.83"N, 92°13'35.50"W, within the Meliadine managed water catchment.

Figure 5: Location of Copper Sulphate spill within Meliadine's managed catchment area.

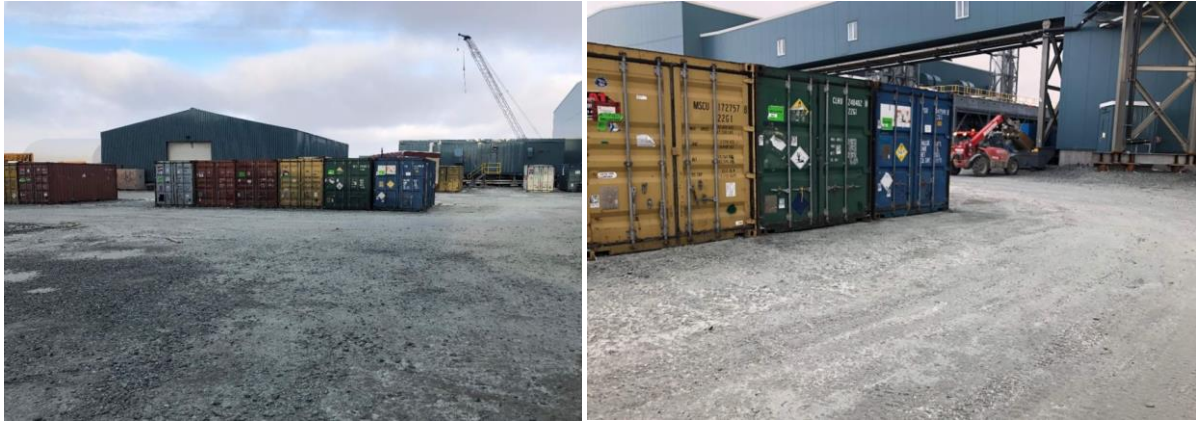
Figure 6: Affected area after clean-up was completed.
