Follow Up Report: #19-457

November 7, 2019 Sewage Spill

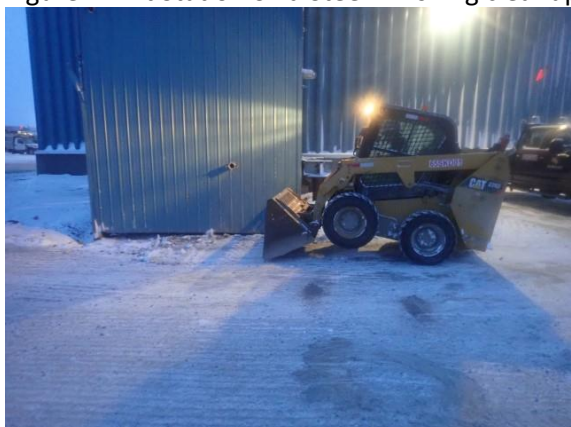
The truck operator shut down the pump. The sewage was then removed from surface with a backhoe, and surface gravel and ice was excavated and disposed of into the landfarm. A skid steer was used to remove more contaminated material that was close to the building. Approximately 0.5 tonnes of contaminated snow/ice and gravel were removed and placed into Landfarm A.

Figure 1: Lift Station:Skid Steer finishing cleanup

The spill investigation indicated that the camlock on the hose was not installed securely on the vacuum truck. Discussions between the Environmental department and Energy/Infrastructure (E/I) have decided that a secondary method of securing the camlock to the vacuum truck will be reviewed and utilized. E /I will review different available methods including using tie wraps, wire, Velcro, and/or tape to secure the camlock. In addition to this, the sewage truck procedure will be modified and the procedure will be reviewed with the vacuum truck operators. Figures 1 and 2 show the area after clean up.

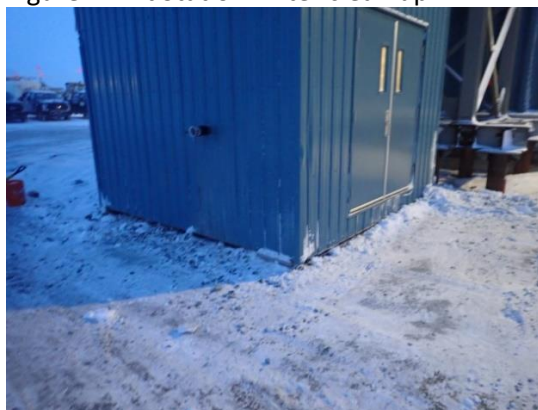
On November 7th at approximately 11:00 am, ~25 L of sewage was spilled at the MSB sewage lift station. When hooking up the sucker truck line to the lift station the camlock coupler on the hose was improperly affixed to the connection resulting in the spill when the truck started pumping. No contaminants reached any water body. The closest water body, G2, was over 350 metres from the location of the spill.

Figure 2: Lift Station: After clean up
